# Statement of Findings

Proposal to Maintain, Rehabilitate and Construct  
National Park Service and Concession Facilities  
at  
Rising Sun, Many Glacier and Lake McDonald  
Developed Areas

**Glacier National Park, Montana**

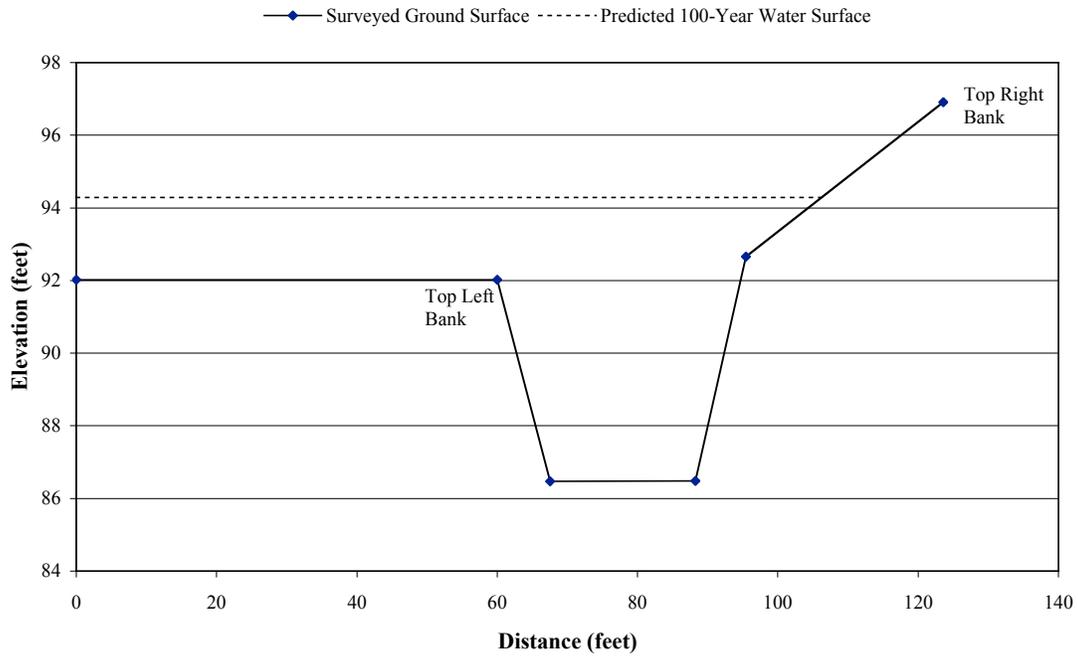
**Figure 1: Snyder Creek cross-section downstream of access road bridge**

The reach from just upstream of the GTS bridge down to just above the pedestrian bridge (including the access road bridge) was surveyed and simulated using HEC-RAS. The pedestrian bridge is below most development and was, therefore, not analyzed for flood hazard. It was found that the GTS bridge can pass up to about a 30-year flood (1800 cfs) if the bridge opening is unobstructed by debris. The lower bridge can only pass up to about the 15-year flood (1100 cfs). Should woody debris collect in the bridge openings, a likely scenario during a large flood, less capacity would be realized. Sediment deposition does not seem to be a large issue in this reach of Snyder Creek.

Modeling of the 100-year flood, assuming free-flowing bridges, suggests that over-bank flooding may be problematic in several areas. The GTS bridge would be overtopped and likely fail, severing access along that road. Flooding would occur upstream of the bridge due to the backwater effect, but no structures or facilities are located here. Flooding would also occur immediately upstream of the lower bridge, however, modeling suggests that the residences on the left bank (looking downstream) would not be inundated during the 100-year flood. Over-bank flooding would occur for at least 150 feet or so downstream of the lower bridge, as illustrated in Figures 1 and 2. This means that the buildings on the left bank in this area should be considered to be within the 100-year floodplain. The lodge building itself is out of the 100-year flood, assuming no blockage of the bridge. If the bridge were to fail, buildings downstream on the left bank would still be flooded during a 100-year flood, but risk to the lodge would be diminished. In this case, over-bank flooding upstream of the bridge is also somewhat reduced.

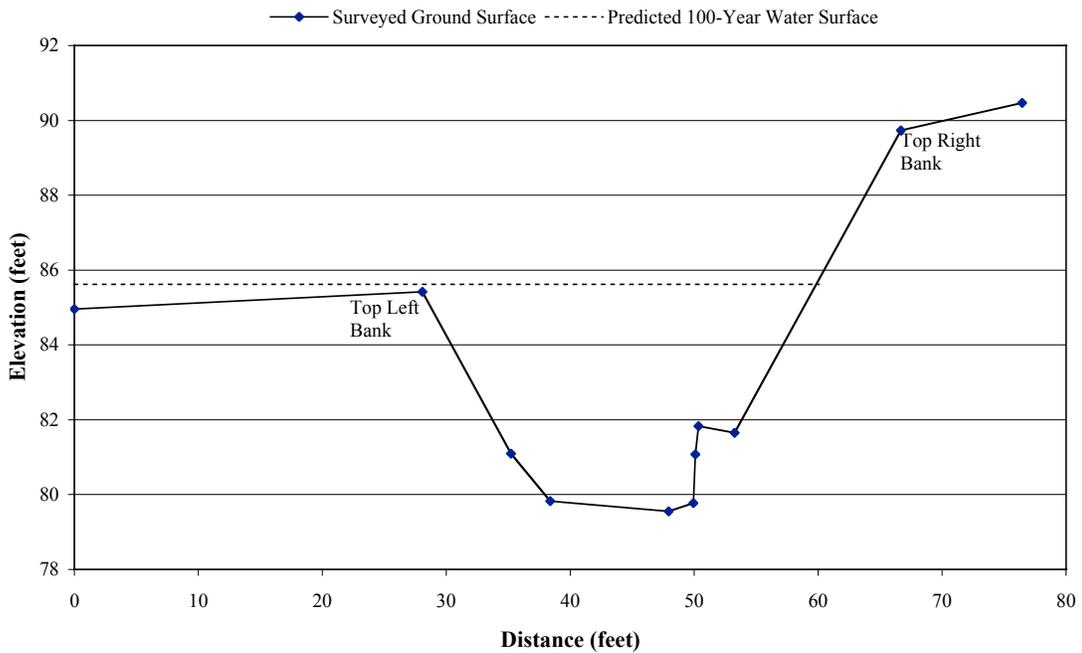
**Figure 2: Snyder Creek cross-section 130 feet downstream of access road bridge**

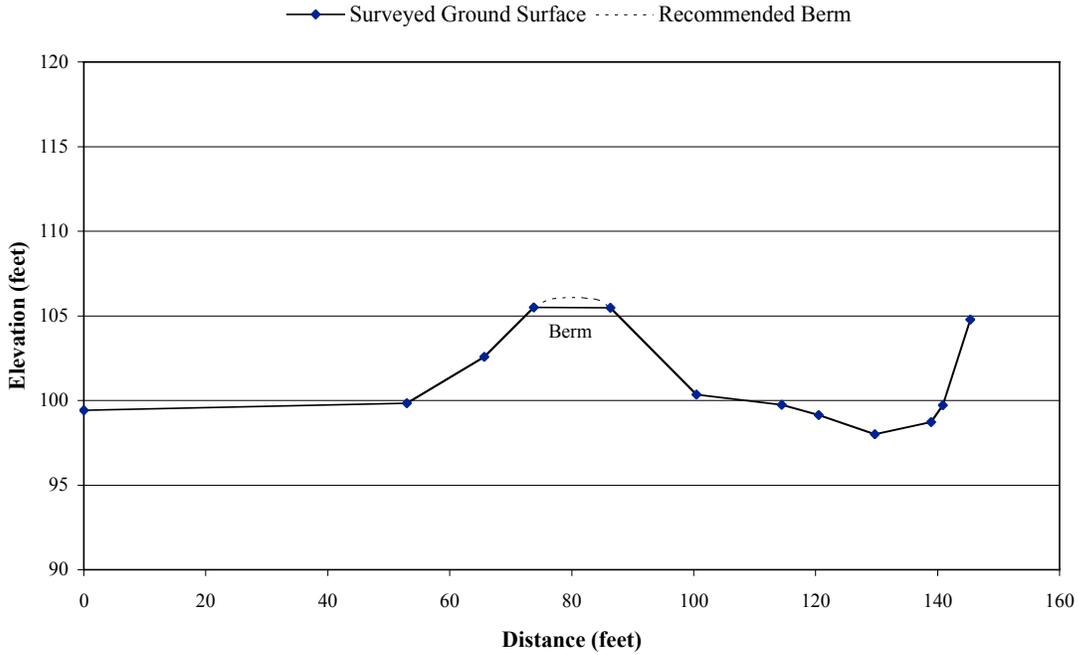
**Figure 3: Rose Creek cross-section in area with berm behind store**

Two cross sections were surveyed in the reach near the Rising Sun General Store (Figures 3 and 4). One cross section was shot across the existing earthen berm and the other in the area just upstream of the berm where sandbags have been placed to fill a low area. Hydraulic modeling indicates that the existing berm would be over-topped with a flow slightly less than the 100-year flood. Adding one-half foot to the berm would provide 100-year protection. The sandbagged reach would be over-topped with a flow greater than the 10-year event if the sandbags were removed and at about the 25-year flow with the sandbags in place. A berm of about 2.5 feet in this area would provide 100-year protection. Channel aggradation and/or lateral erosion are other factors to be aware of in this reach of Rose Creek. Given our belief that the channel has been realigned upstream, the creek can be expected to make adjustments downstream in response to the changes upstream. If deposition occurs in the channel near the bermed reach, the predicted flood susceptibility described above will no longer apply. Under this circumstance, flooding would be expected to occur more frequently and with greater consequence than predicted above.

Given this information, the following has been recommended in the reach of Rose Creek near the Rising Sun General Store: add about one-half foot of height to the existing levee (see Figure 3). The berm should be continued upstream through the area now filled with sandbags and tied into the hill slope to make a continuous barrier to flow. The new portion of the berm should have a top-elevation that slopes upstream at about the same slope as the channel and have a total height of about 2.5 feet (see Figure 4). The entire berm should be armored to prevent failure by erosion during a flood event. If armor is not provided, observation of the berm during flooding should be made and, if needed, sandbags or rock placed to arrest erosion if it is occurring. Also, it is recommended that excavation of sediment be performed periodically if deposition occurs in the channel.

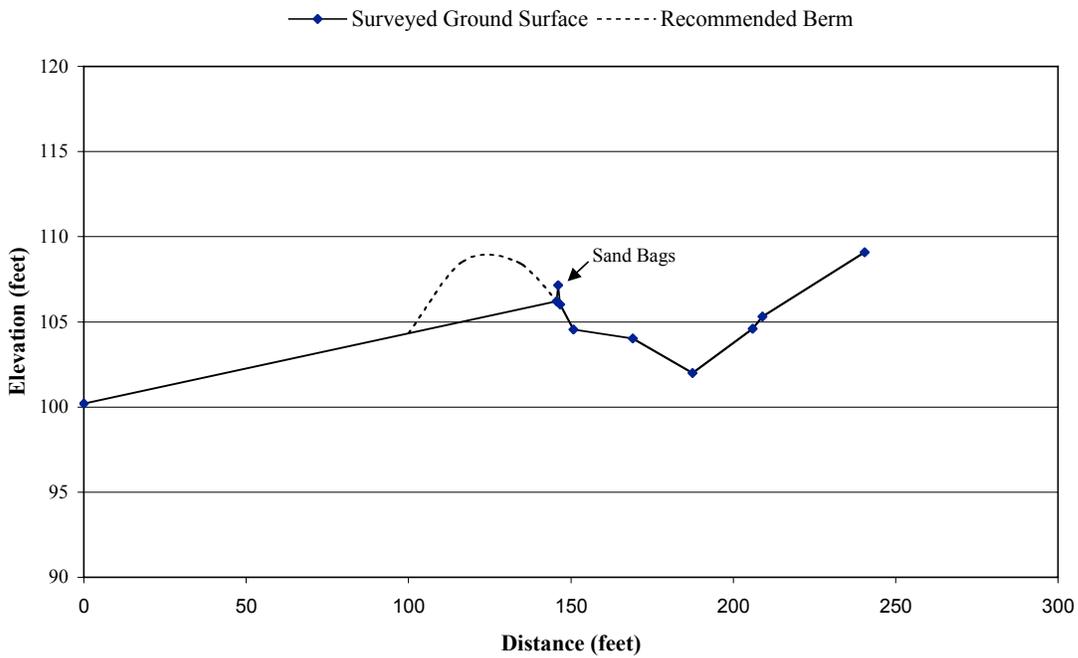
**Figure 4: Rose Creek cross-section in area with sand bags**
