**The Fort at Frederica**  
**By**  
**Albert C. Manucy**

**The Department of Anthropology**  
**Notes in Anthropology, Vol. 5**

**The Florida State University**  
**Tallahassee, Florida; 1962**

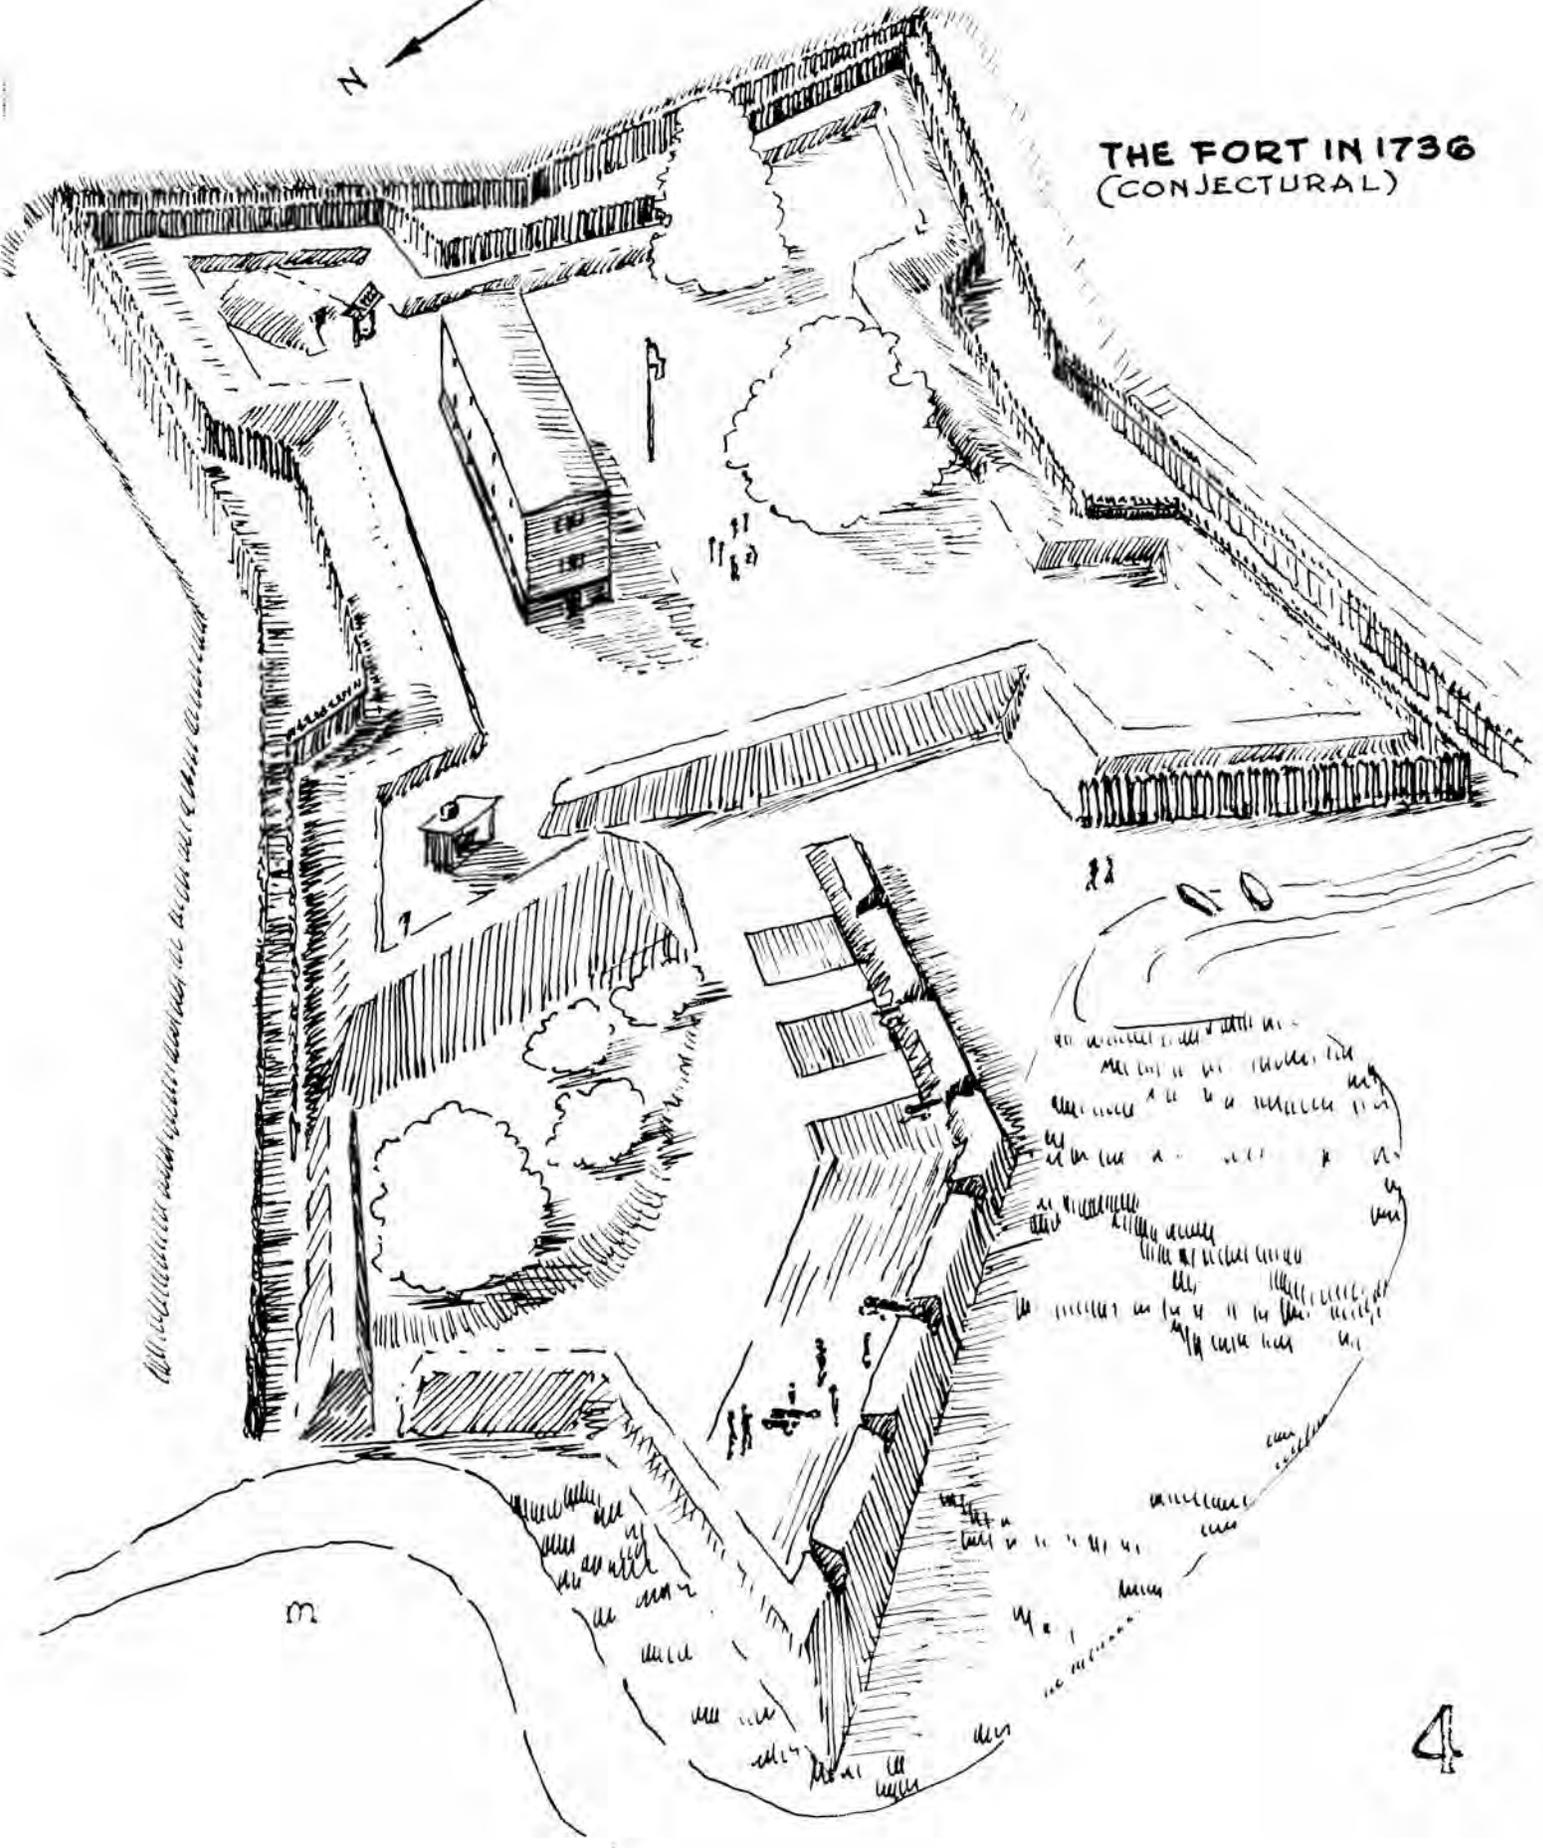
THE FORT IN 1736  
(CONJECTURAL)

The Early Fort -- February to June 1736. Construction of the defense works took about 4 months. By the beginning of June, when Oglethorpe left to survey the frontier near Spanish Florida, he told the settlers that their fort was "in a good condition to make a defence if men should land, and force their way through the country"; and there was "sufficient provision in

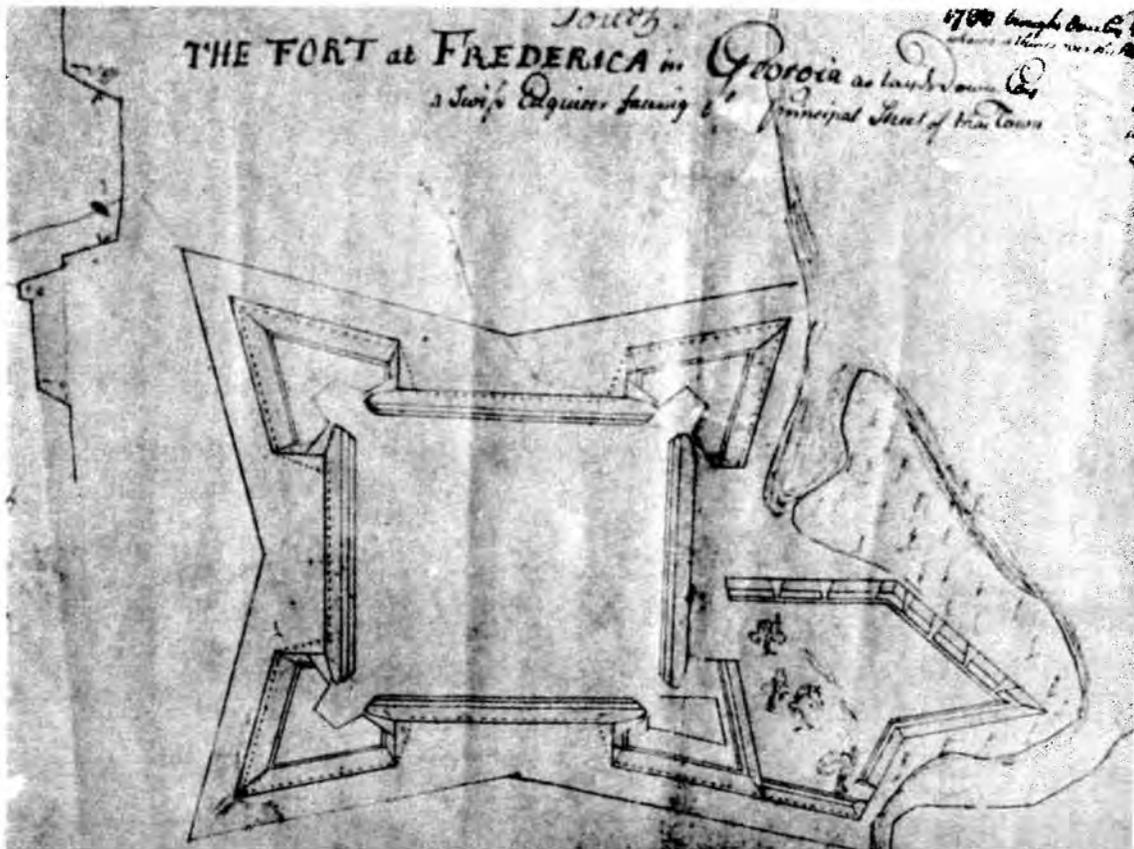
12. The 1736 Plan for Fort Frederica

Although other drawings were no doubt made, this is the only early plan of the fort thus far located. The original is in the John Carter Brown Library at Brown University.

This was a find of first importance. Here was the only known plan of the fort. An explanatory note pencilled on it, and the absence of buildings, showed its date to be early 1736. It confirmed our hypothesis about the fort design, and the dimensions were surprisingly close to our conjectural dimensions. A special outwork, which the records called a "spur" but failed to describe, appeared clearly in the drawing, and in a sense was compensation for the lack of buildings.

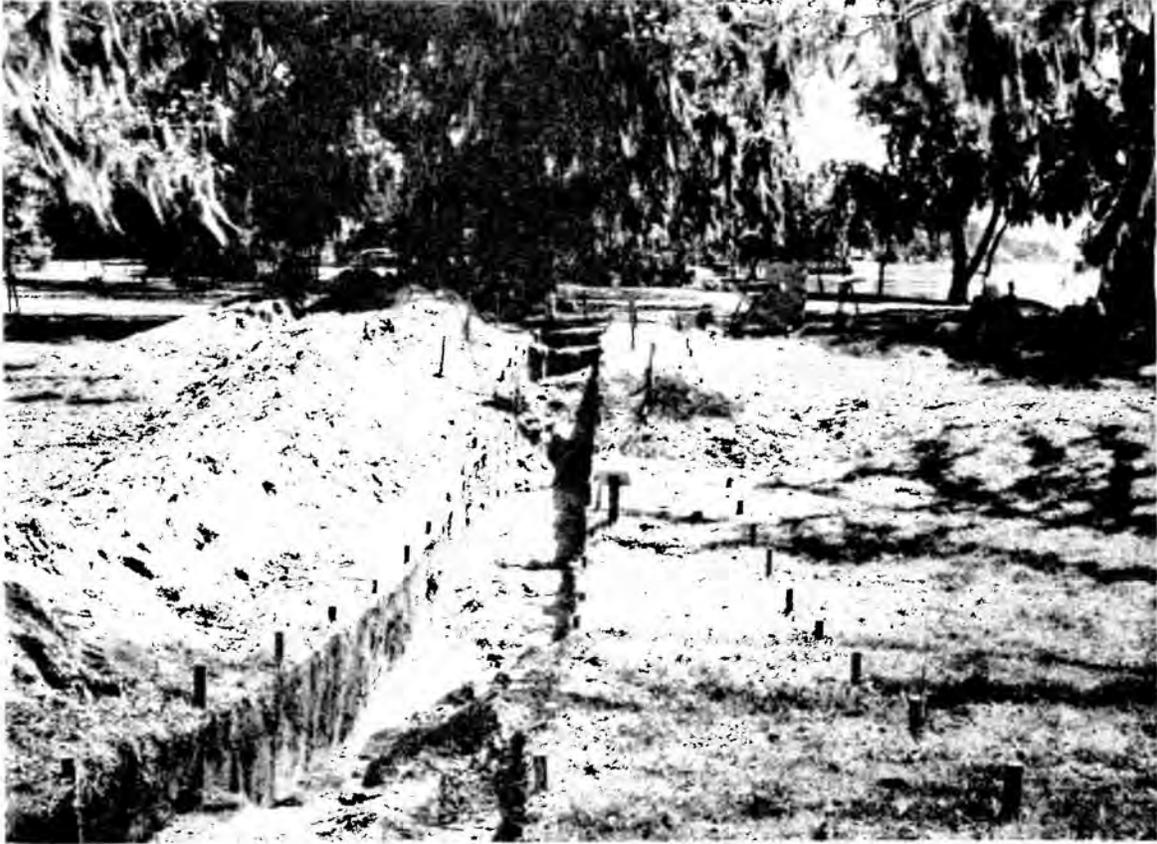
15. Fairbanks' Excavation through the North Moat

This view looks south from the outer bank of the moat toward the center of the earthwork fort. The foreground excavation has exposed the colonial ground level; beyond it, the floor of the trench shows the approximate floor of the moat. Notice the palisade stubs half-way down the trench. The steep slope at the far end is the wall of the fort. Just beyond is the fallen parapet, a wall built of tabby masonry.

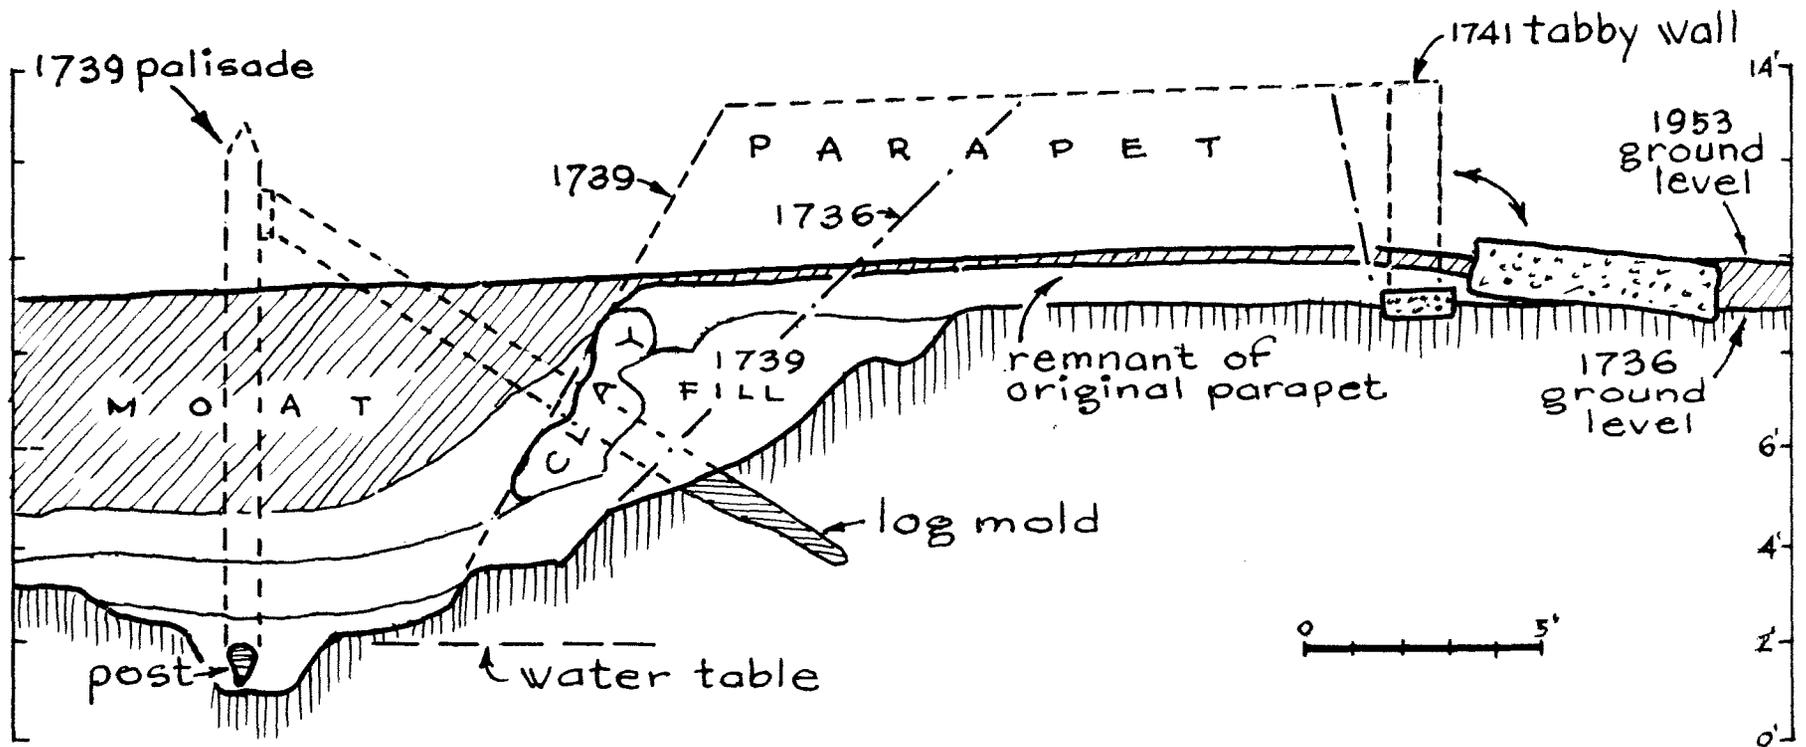
TYPICAL SECTION OF THE FORT WALL  
(NORTH FRONT)

But over this eroded face, Fairbanks saw that new fill had been piled on and held to a steep  $65^{\circ}$  slope with a thick facing of blue clay -- or, in less elegant terms, marsh mud. The toe of the new slope was a foot deeper than the old one, and 2 feet farther out. The change meant that the parapet had been widened to about 18 feet, which was the minimum recommended by the military textbooks. This was the "strong mud wall" described by Delegal in 1739.<sup>56</sup> Held by its 18-inch facing of dry salt muck, it would present a massive, masonry-like appearance. Both Fairbanks and Shiner found bits of blue clay throughout the lower levels of the moat fill, where they had been deposited by normal erosion from the slope.<sup>57</sup>

The floor of the moat was about 5 feet below the colonial land surface or some 3.5 feet above mean low tide. Normally, it was dry. The

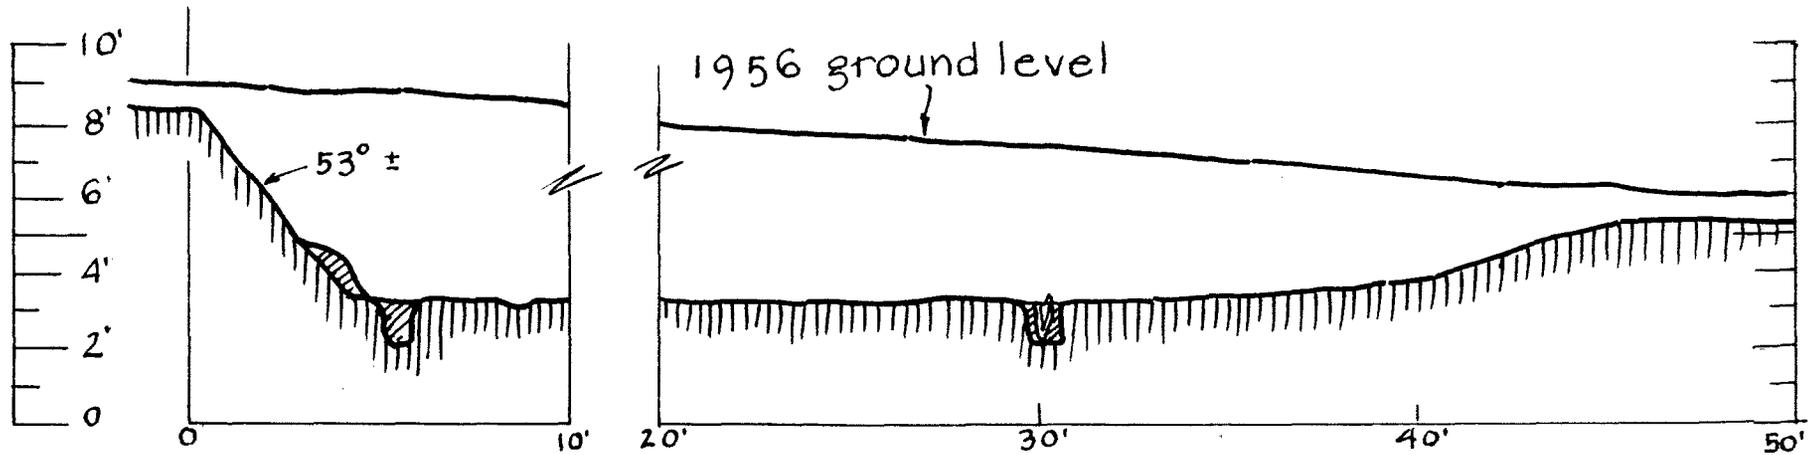
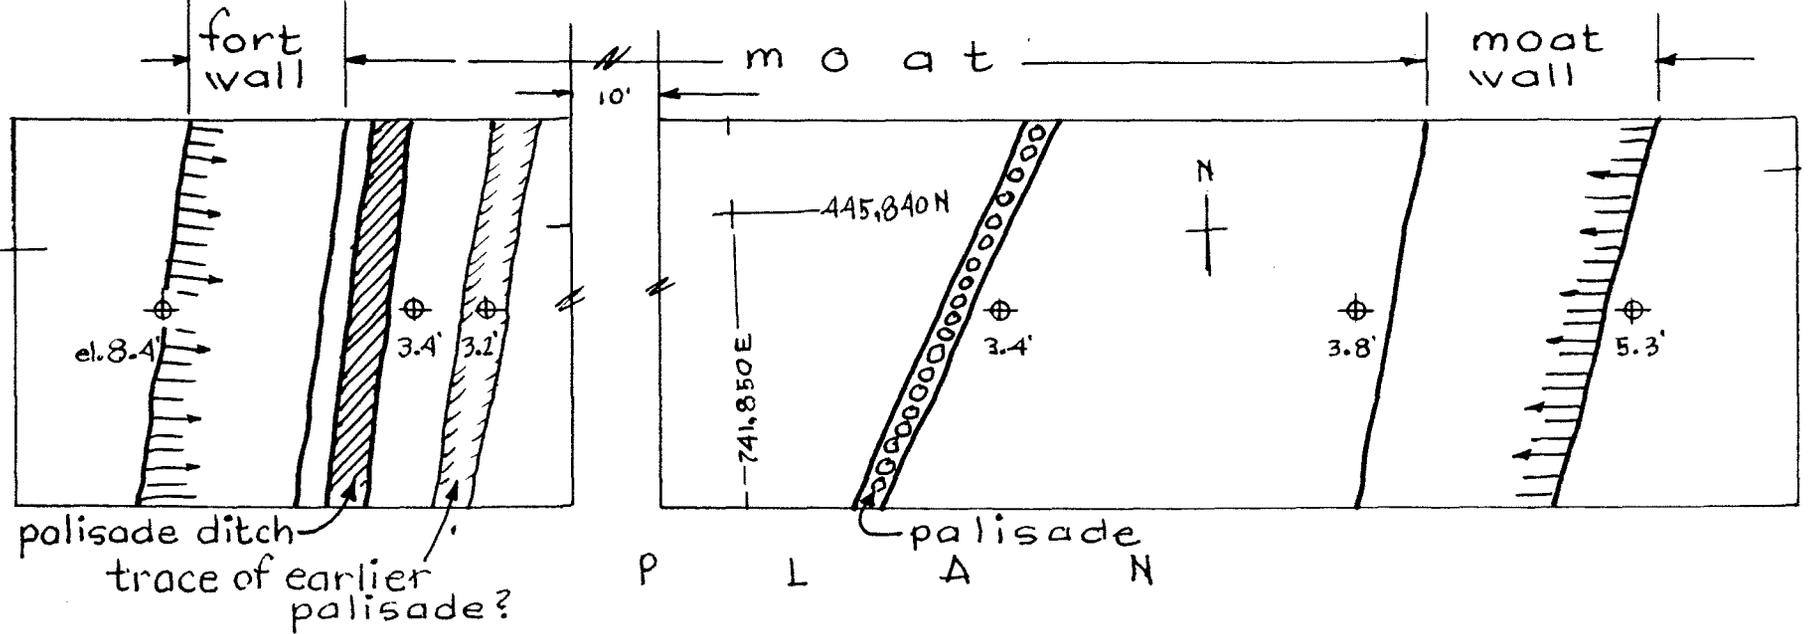
THE EAST MOAT EXCAVATION

Shiner's cross-section at the center of the east front showed a beautifully simple situation (Figure 17). From the parapet, the earth sloped downward at the traditional  $45^{\circ}$  angle to the floor of the 5-foot-

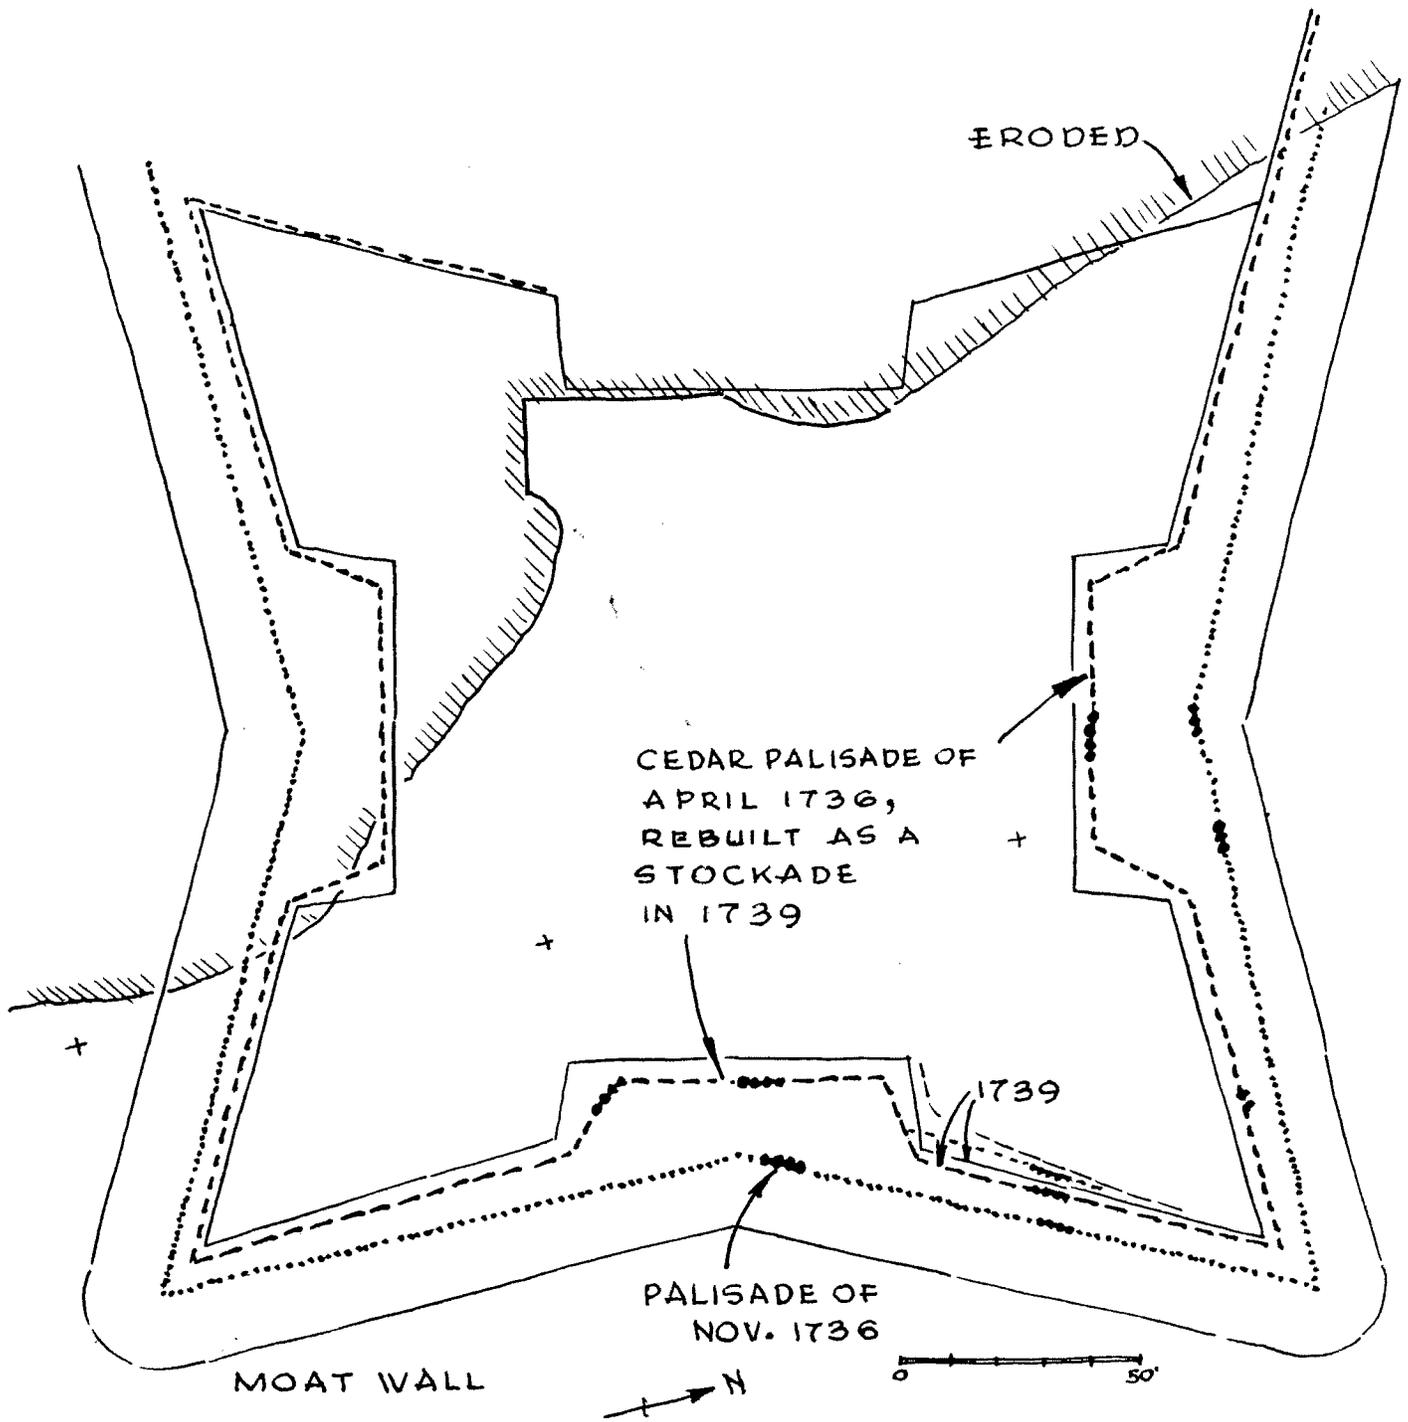
THE PALISADES

The inner palisade was, according to Moore, the first one to be built. We found it just outside the toe of the wall (Figure 19), precisely as shown on the 1736 map. Post molds were clear; in fact, below ground-water a number of post ends were still in place, rather well preserved. The workmen had split pine logs in half and trimmed the edges, leaving roughly squared timbers with one rounded face. This face was set away from the fort, toward the enemy. The posts averaged 9 inches in width and were from  $3\frac{1}{2}$  to 7 inches thick. They had been set vertically in a footing trench about 2 feet deep, and were spaced up to 3 inches apart.<sup>59</sup> Edge-trimming of the timbers suggests that the narrow split-offs were used as liners to fill the cracks between posts.<sup>60</sup> The palisade would have been

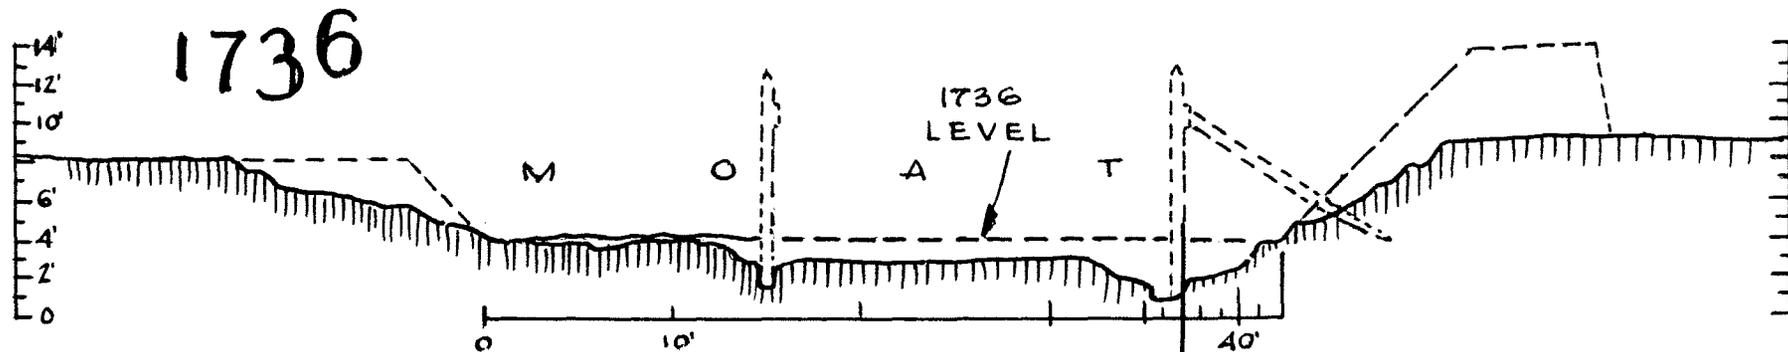
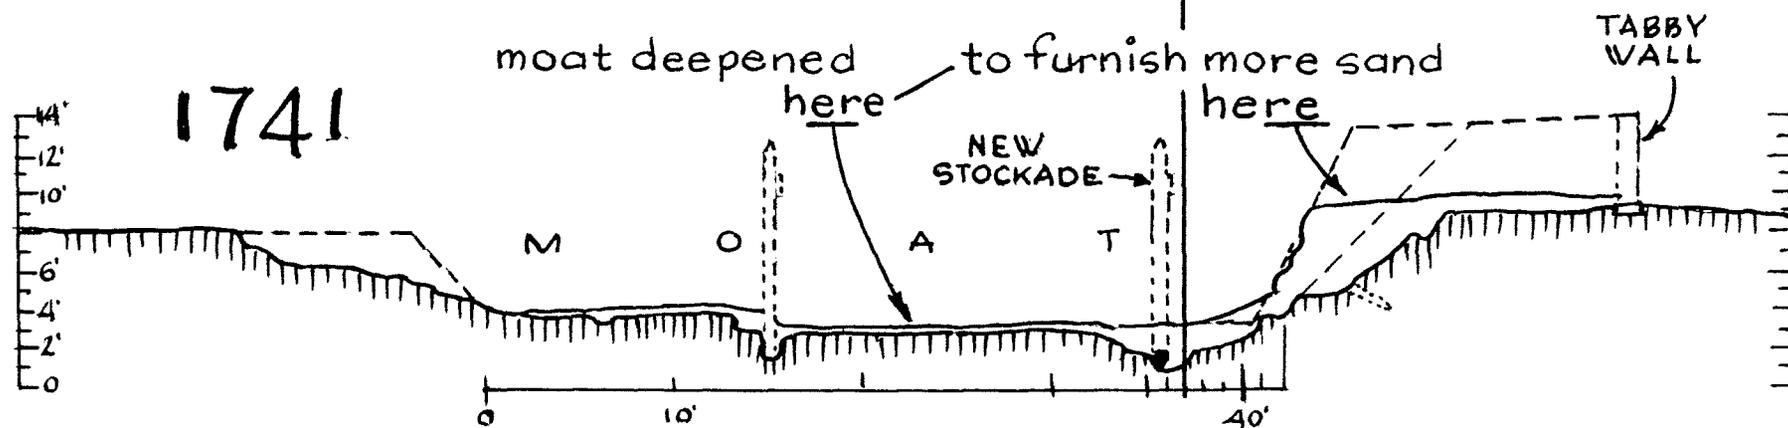
CROSS SECTION OF THE MOAT  
SHOWING STRUCTURAL CHANGES  
(NORTH FRONT)

Now, think again of the inner palisade at the foot of the fort wall. This palisade had to be moved anyway, in order to broaden the wall. The moat was now a foot deeper. If the old posts were sunk deeper, their tops would be too low for proper defense. So the original cedar posts had to be replaced by longer pine posts.

The proof of the change lay in the footing trench, which Fairbanks found to be considerably wider than average, with the post molds against its

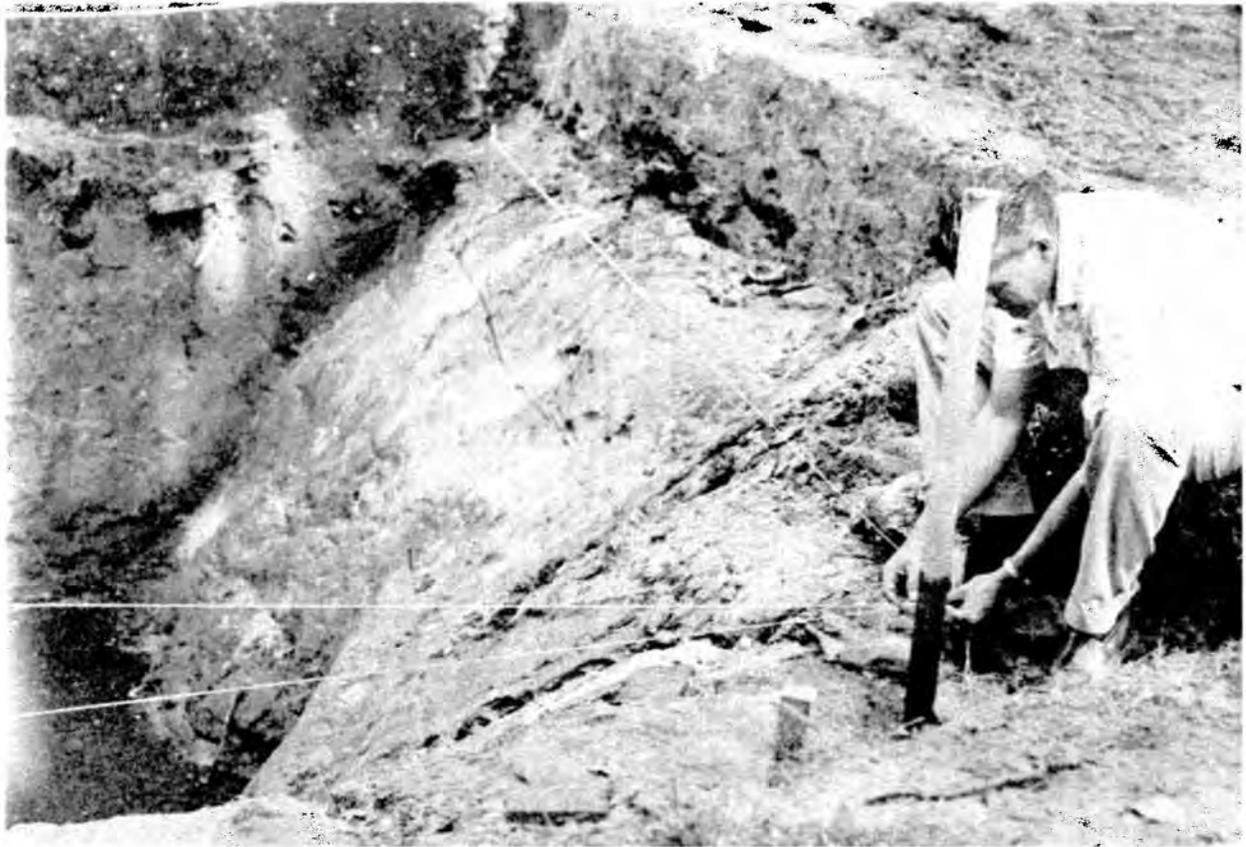
21. North Flank of the Southeast Bastion

Here Archeologist Shiner "peeled" the earth wall, exposing its well-preserved original slope, all the way down to the floor of the moat. The string at right shows the almost 90° angle at which the bastion juts out from the east wall of the fort.

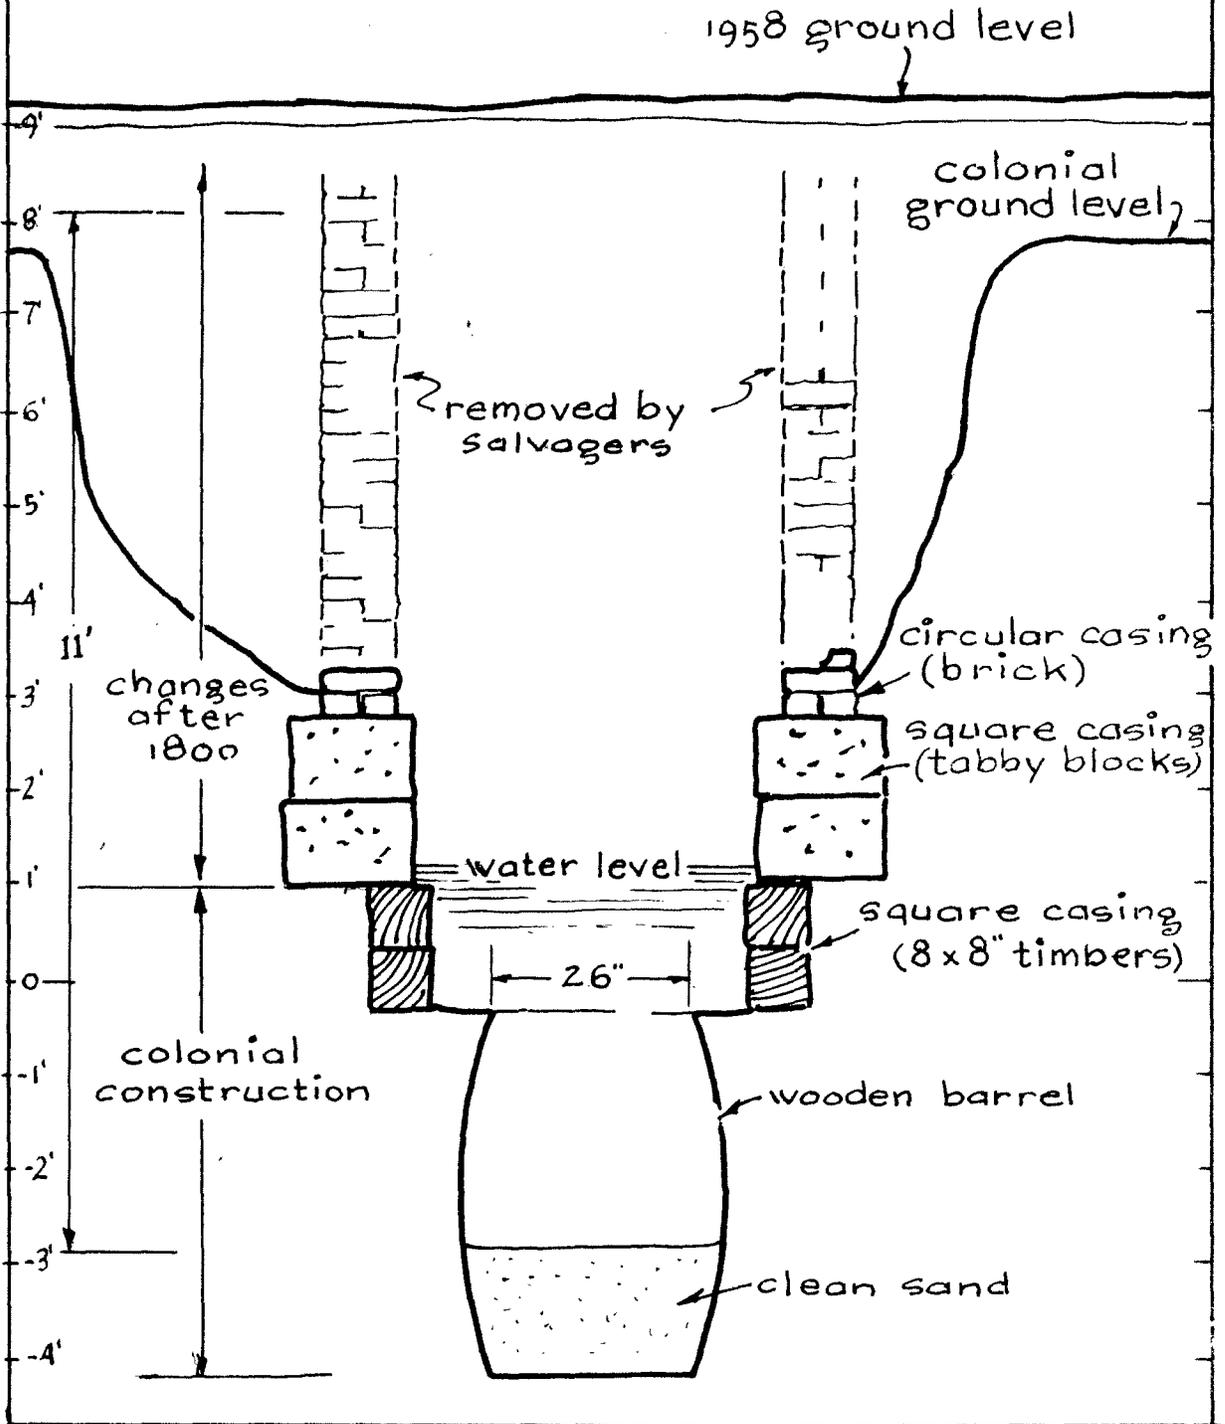
# THE WELL IN THE PARADE GROUND

The second well (Figure 23) was found beneath a slight depression in the center of the parade.<sup>69</sup> It was about 11 feet deep. The bottom of the casing was a wooden barrel 26 inches in diameter, excellently preserved. The clean sand at the bottom was  $2\frac{1}{2}$  feet below its rim. Above the barrel was a square casing, made by two layers of 8x8-inch timbers under two courses of 10-inch tabby blocks. The top section of the casing was built of brick, again cylindrical, and 4 feet in diameter. Salvagers had removed all but the two bottom courses.

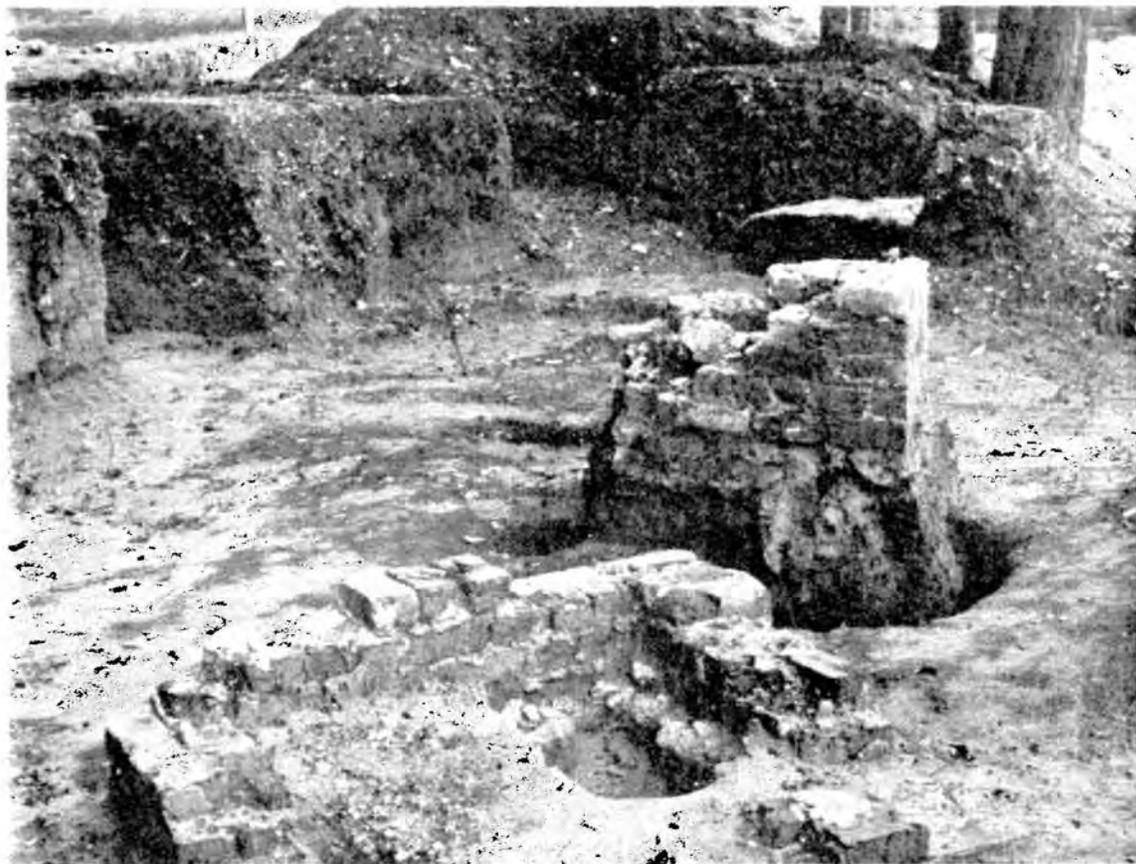
#### 24. The Forge Ruins

The 4x5-foot colonial forge is in the foreground. Back of it is a later hearth built on top of the colonial strata.

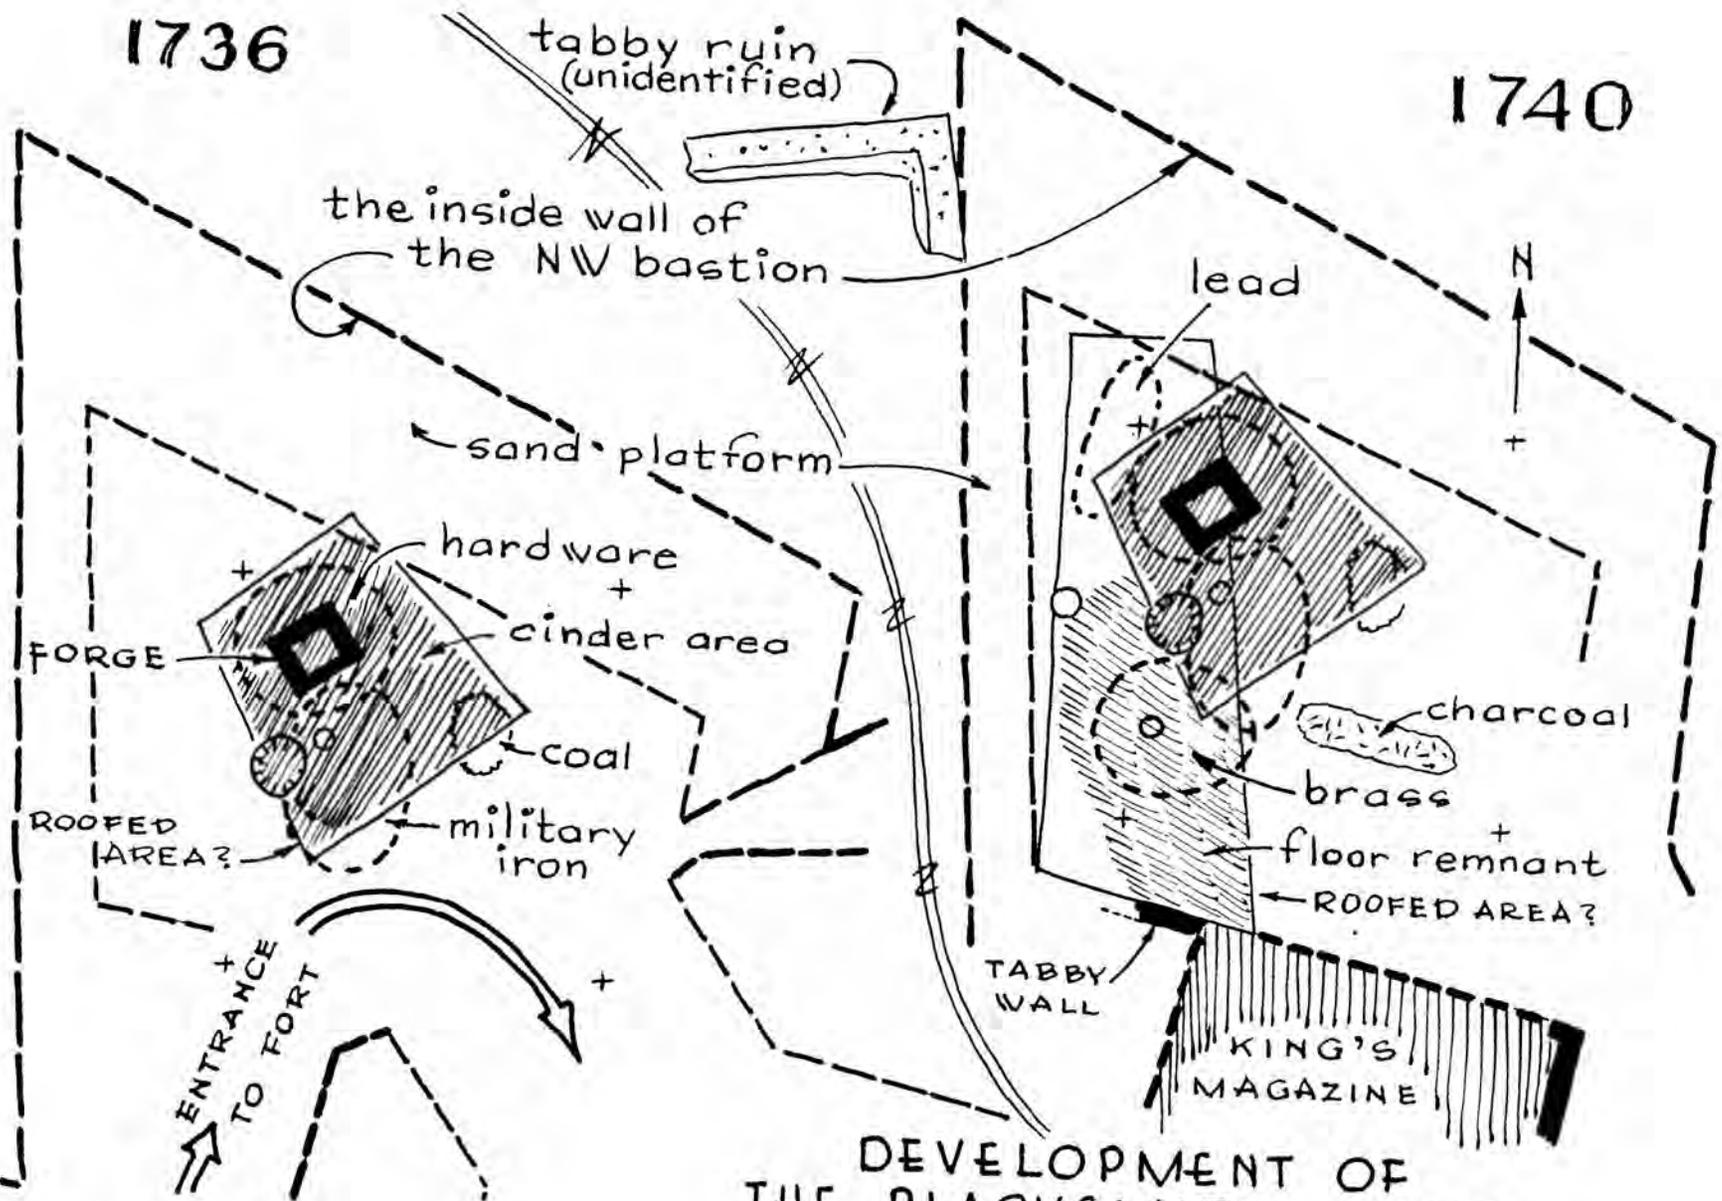
DEVELOPMENT OF THE BLACKSMITH SHOP

from the weather. Evidence of a shelter was not found, so it must have been an above-ground wooden structure. Inasmuch as the fort entrance at first seems to have been through the blacksmith's bastion, the smith's shelter could not have been large enough to obstruct this entrance. The shelter must have covered only the immediate area around the forge. Perhaps it was a tarred-roof shed, open to the southeast (Figure 27).

When the regiment came, the armorer's work area pushed outward, and most of the bastion was taken over by the shop. The condition suggests a greatly enlarged shed. The smith's bench would remain just north of the forge; the northwest corner became the location for molding musket balls. In the south half of the shop, the armorer set up one or two work benches. Perhaps the racks for the stocks of metal were on the long west wall.

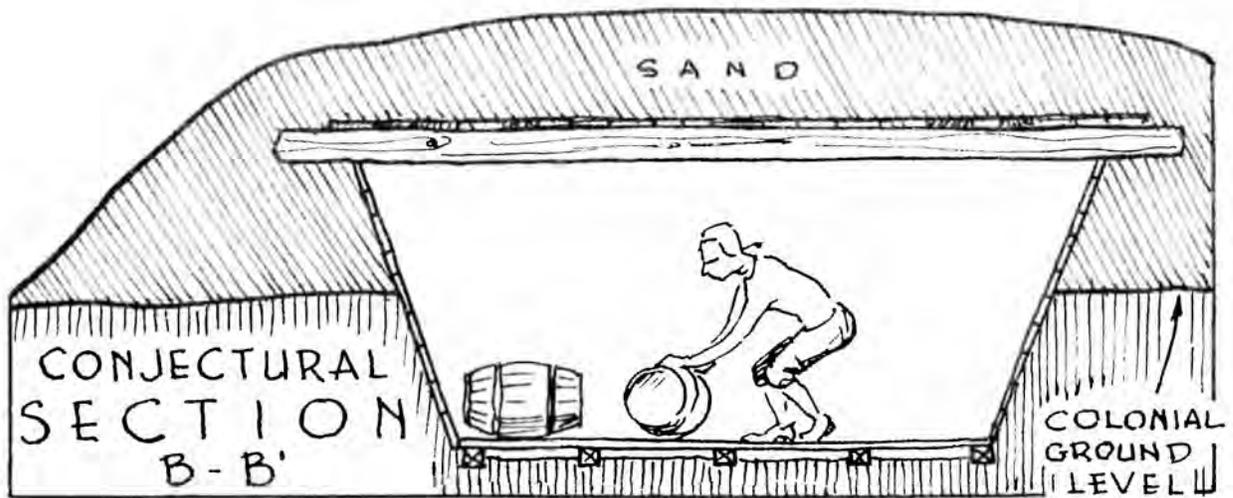
THE POWDER MAGAZINE OF 1736

In the center of the bastion  $3\frac{1}{2}$  feet below the colonial ground level, he found a nailed floor of 6- to 8-inch planks, covering a sizable portion of a sunken room 12 feet wide and perhaps 16 feet long. The exact length was indeterminate, due to intrusion of a tabby building which supplanted the wooden structure in later years. Toward the parade, the planks had been removed. The wood was badly decayed, but was probably 2-inch material.

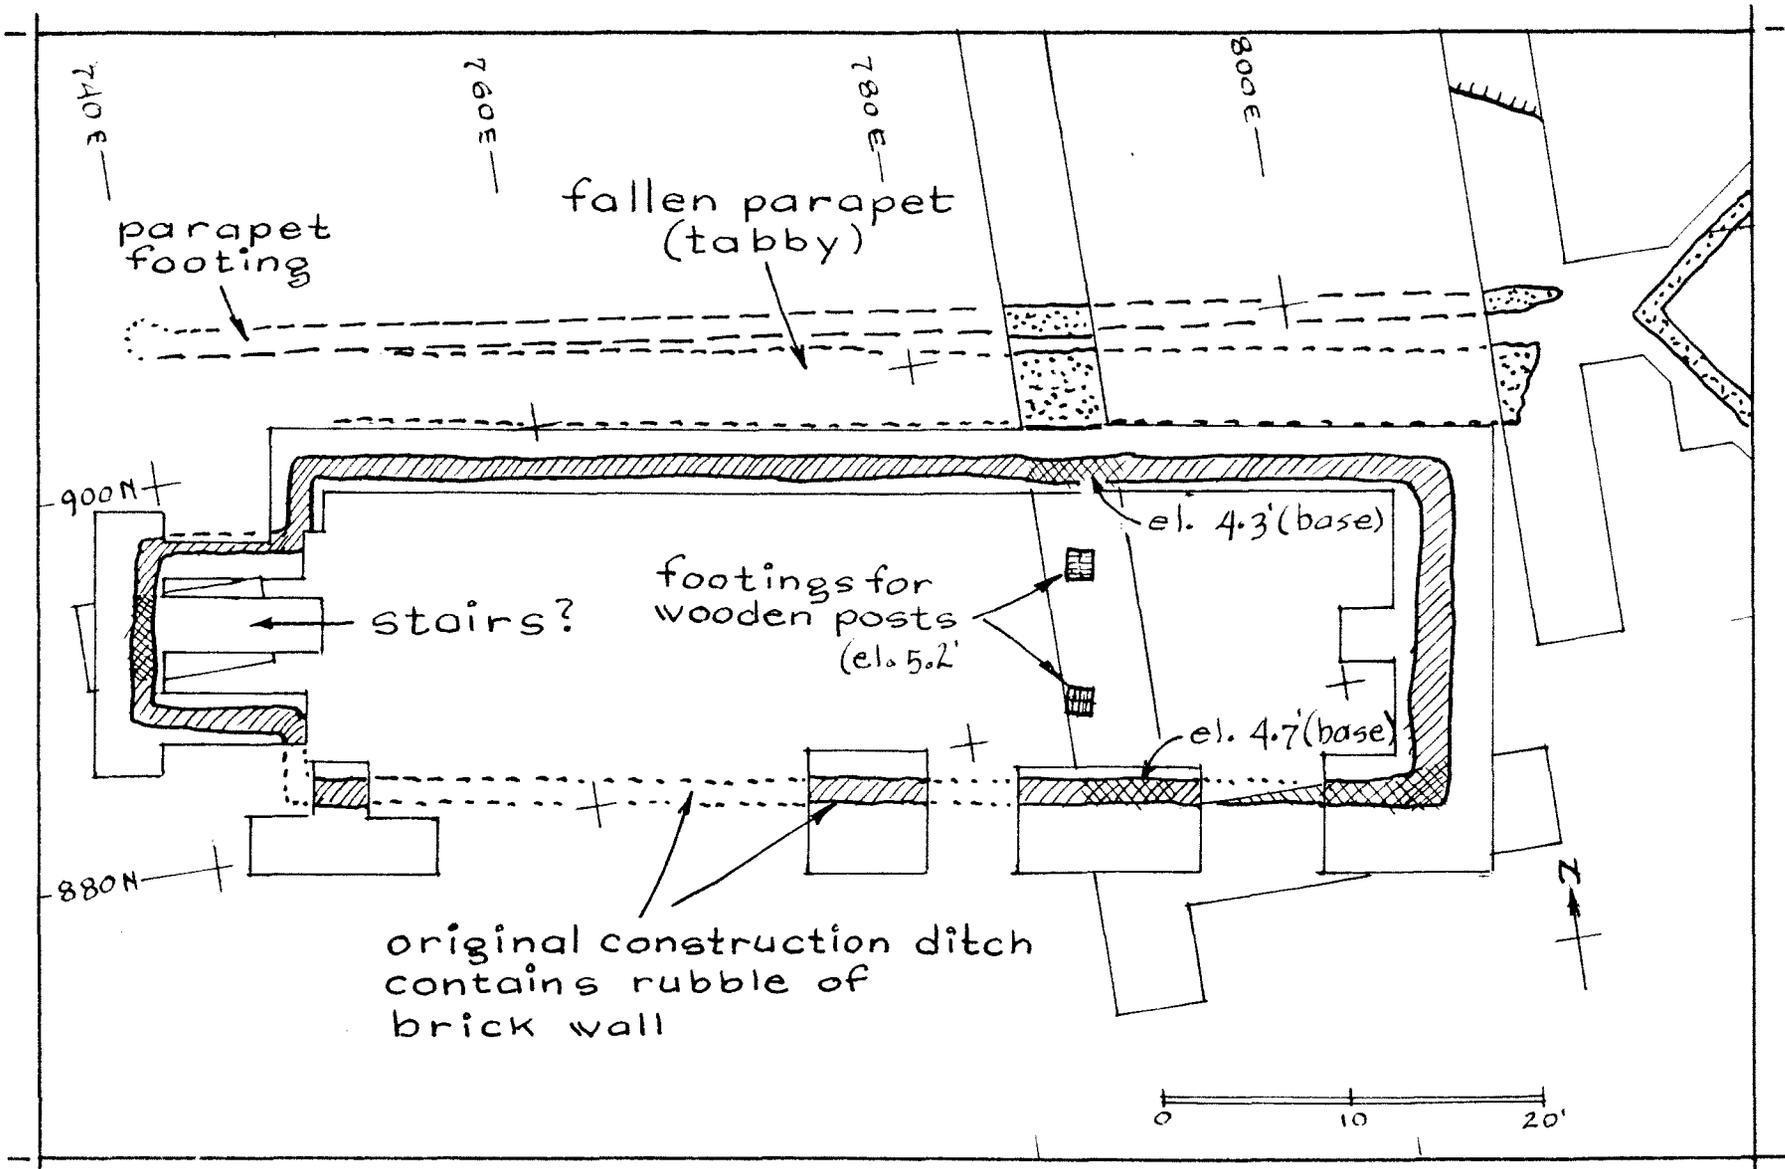
29 PLAN OF EXCAVATIONS AT NORTH STOREHOUSE

Its hard-packed sand floor lay nearly 4 feet below the parade level and was 3 feet deep with brick rubble -- rubble full of the strap-iron ties used in brickmasonry, a quantity of green bottle glass, Delftware sherds, unused gun flints, a grenade and numerous grenade and hollow shot fragments.

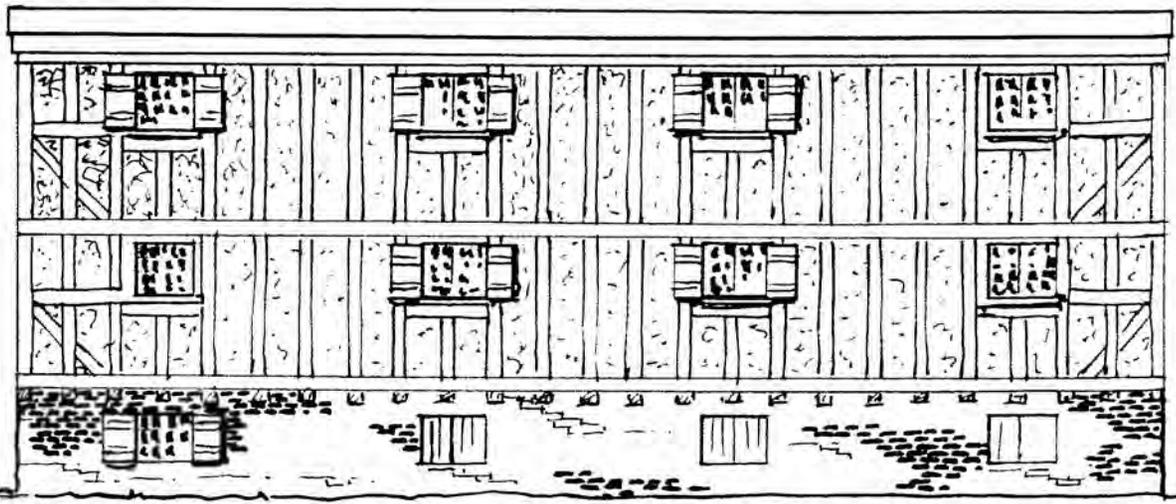
CONJECTURAL RECONSTRUCTIONS OF THE NORTH STOREHOUSE

The post foundations set 5 feet apart on the floor are a good clue to the interior construction.
