**The Fort at Frederica**  
**By**  
**Albert C. Manucy**

**The Department of Anthropology**  
**Notes in Anthropology, Vol. 5**

**The Florida State University**  
**Tallahassee, Florida; 1962**

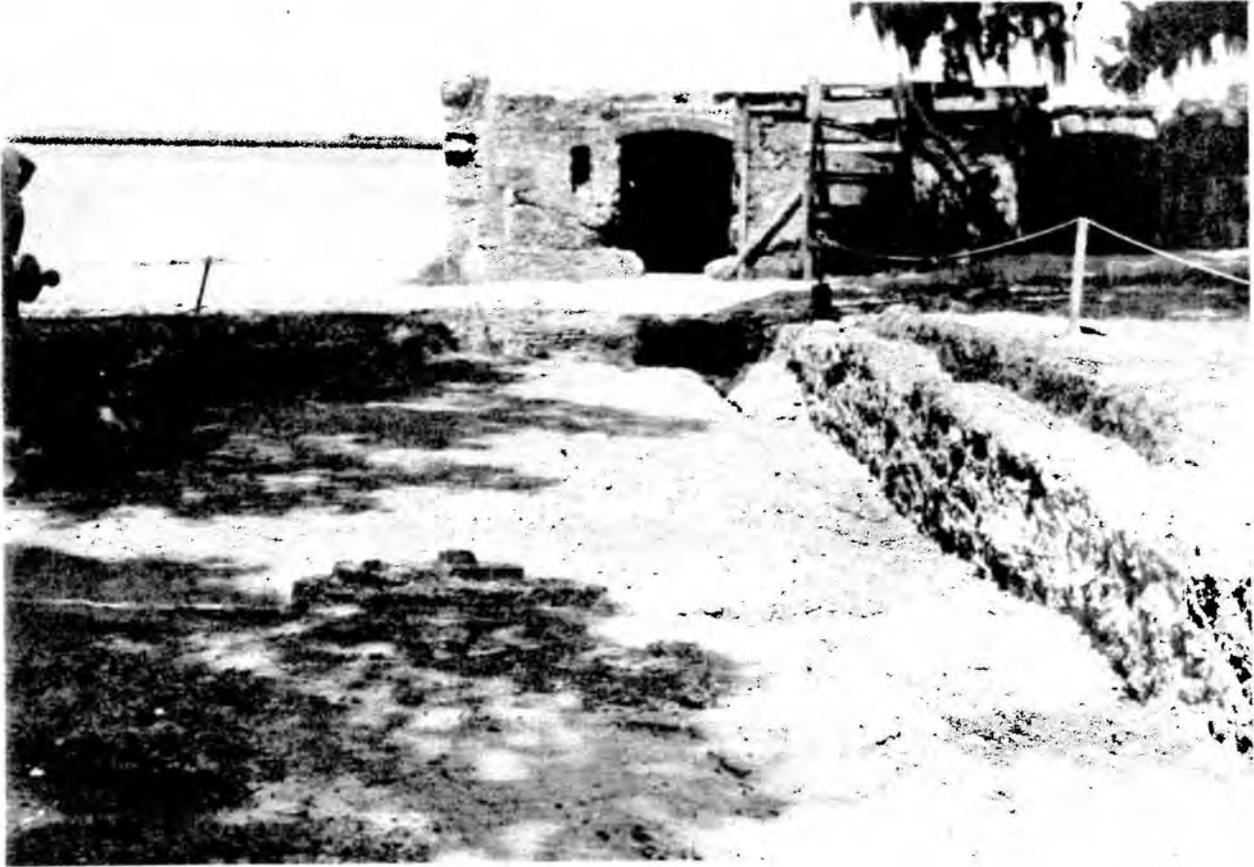
31. View of the Excavation at the South Storehouse

For three of the four exterior walls, much was still in place. It was plain to see how Oglethorpe's flint was used to economize on construction costs. The 24-inch-thick walls contained a core of flint-and-mortar, with brick veneer on each face. The salvagers had removed almost all the brick. The only solid brickwork was around the doorway in the center of the east wall.

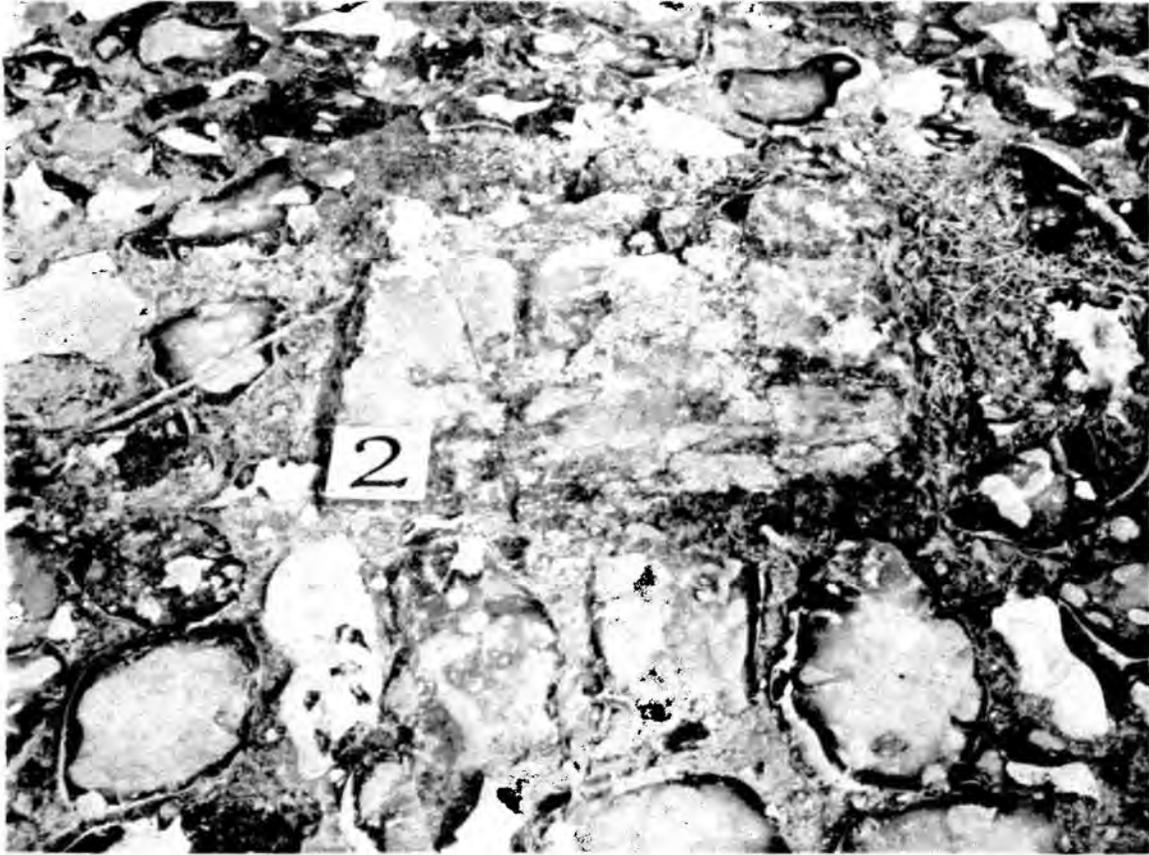
32. Closeup of the Flint Floor, South Storehouse

The number card is two inches square. Notice that the stones are laid flat side up in sand. The 12x12-inch brick pier at center has a thin spread of mortar which bears the butt imprint of the wooden post which helped support the upper floors. Oglethorpe's mention of "the Flints I brought over" helped establish the construction date of this storehouse (1739). Flint stones were also used, along with brick-bats, as aggregate in the masonry walls.

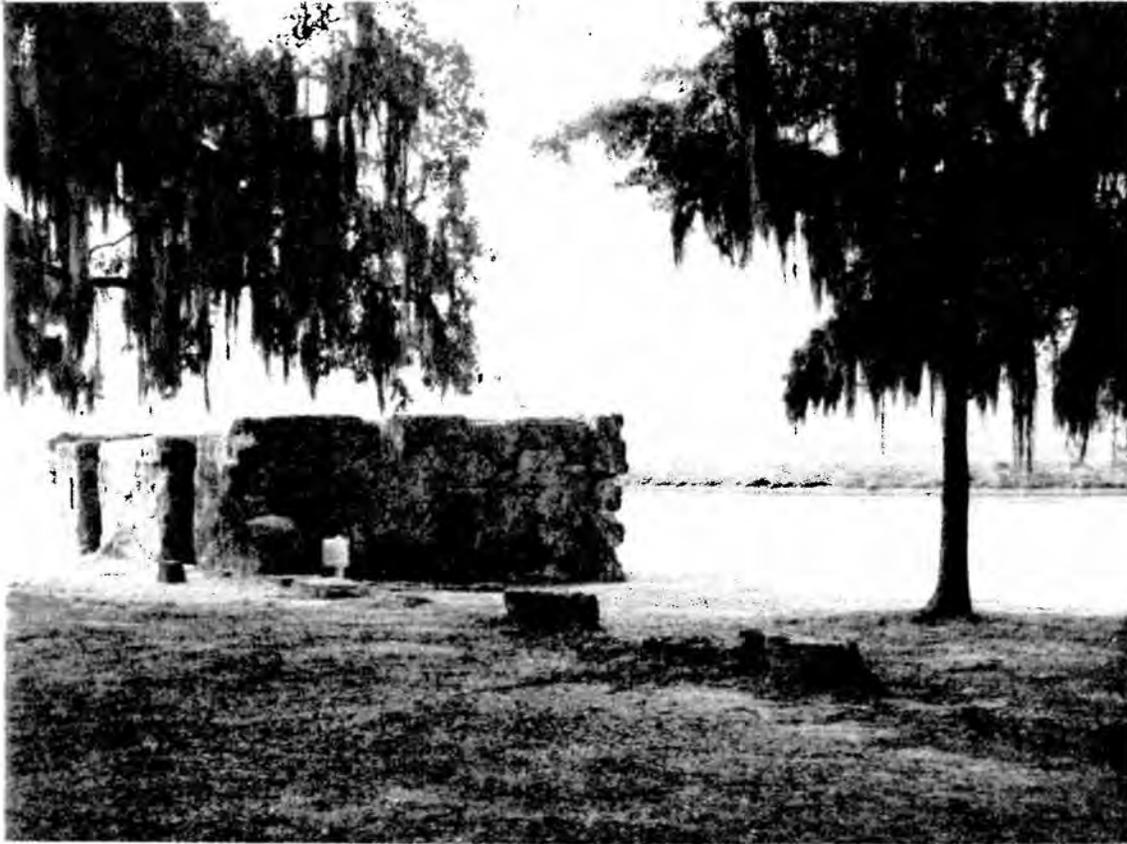
35. View of the King's Magazine

Originally this building was a symmetrical structure 96 feet long. The wall stubs in the foreground, uncovered by archeology, are the only remains of the northern half. In the south end, the massiveness of the construction helped to preserve the ruin.

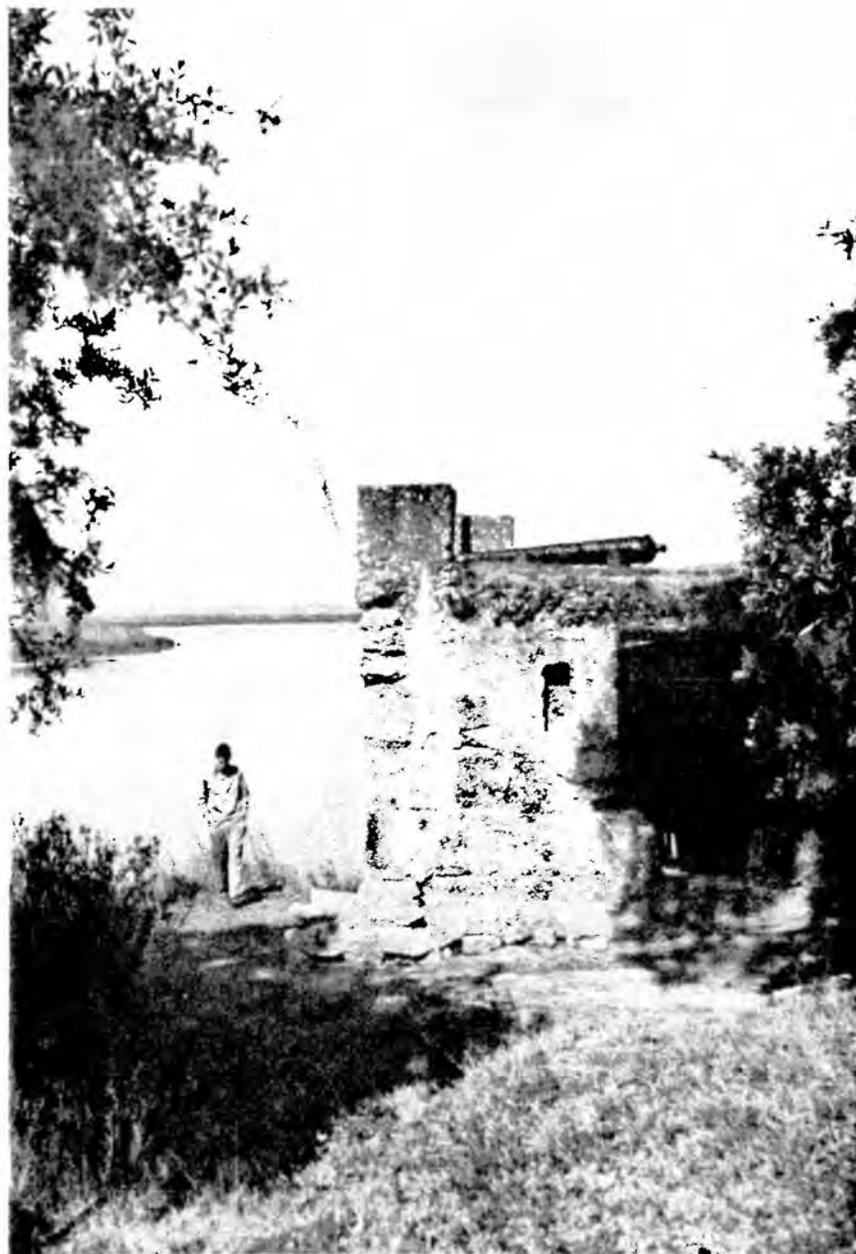
#### 45. Erosion Control

A--By 1950 the river had swept away Shoreline fill and exposed the masonry of the foundations. Tidewater, entering the magazine vaults, opened mortar joints.

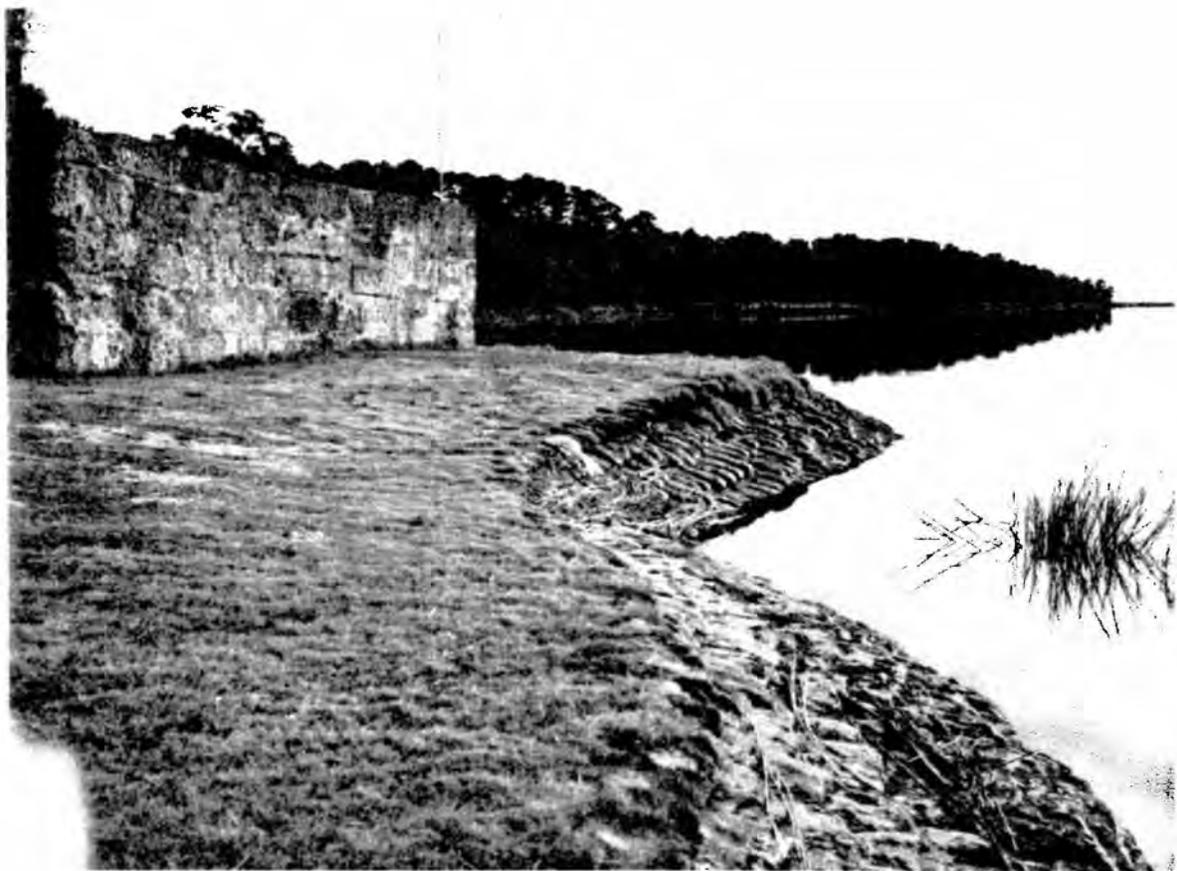
#### 45. Erosion Control

B--Earth and rubble fill pushed the river away from the ruin. The new shoreline was riprapped with bags of concrete mix which hardened in place.

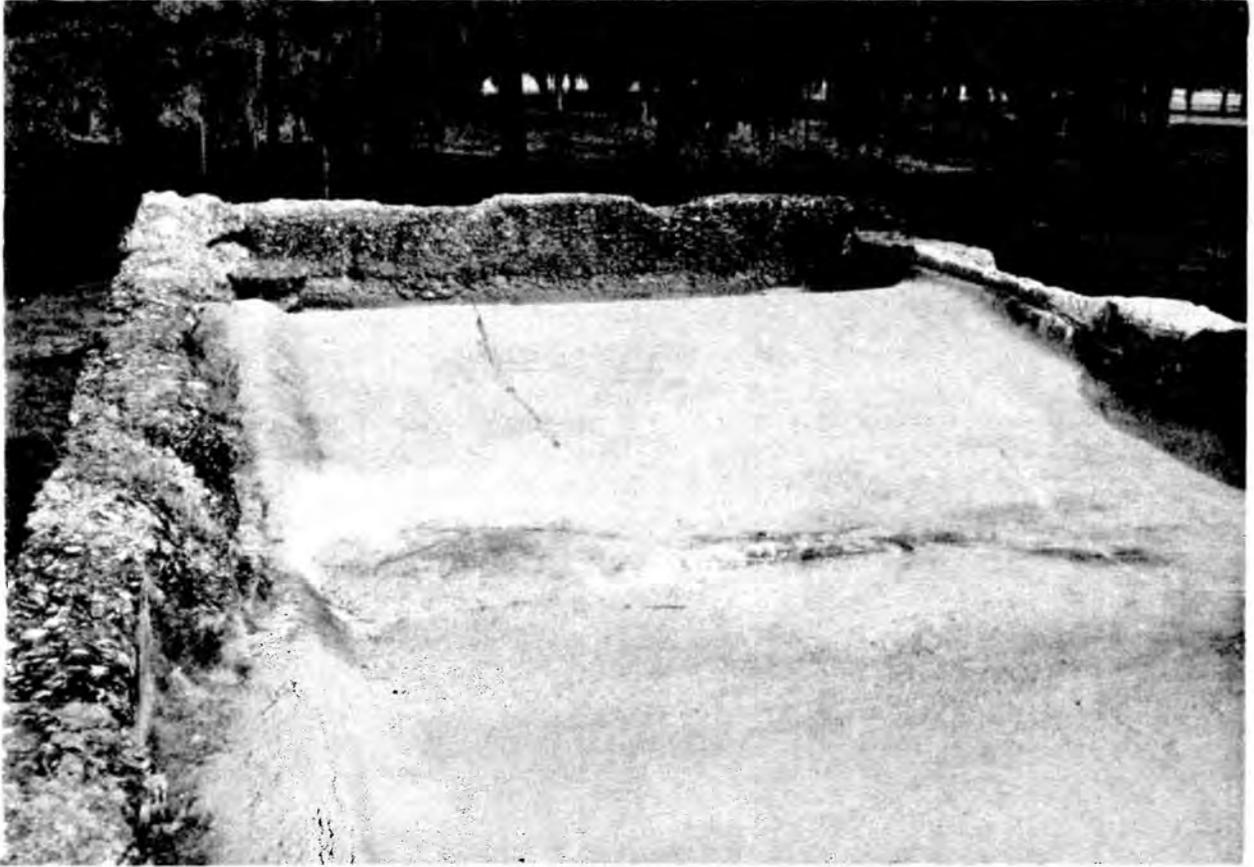
46. Waterproofing over the Arches

This view of the King's Magazine roof shows the 2-inch coating of reinforced concrete, applied by the pressure-gun method over the brick vaults. Between old brick and new concrete is a plastic waterproof membrane.

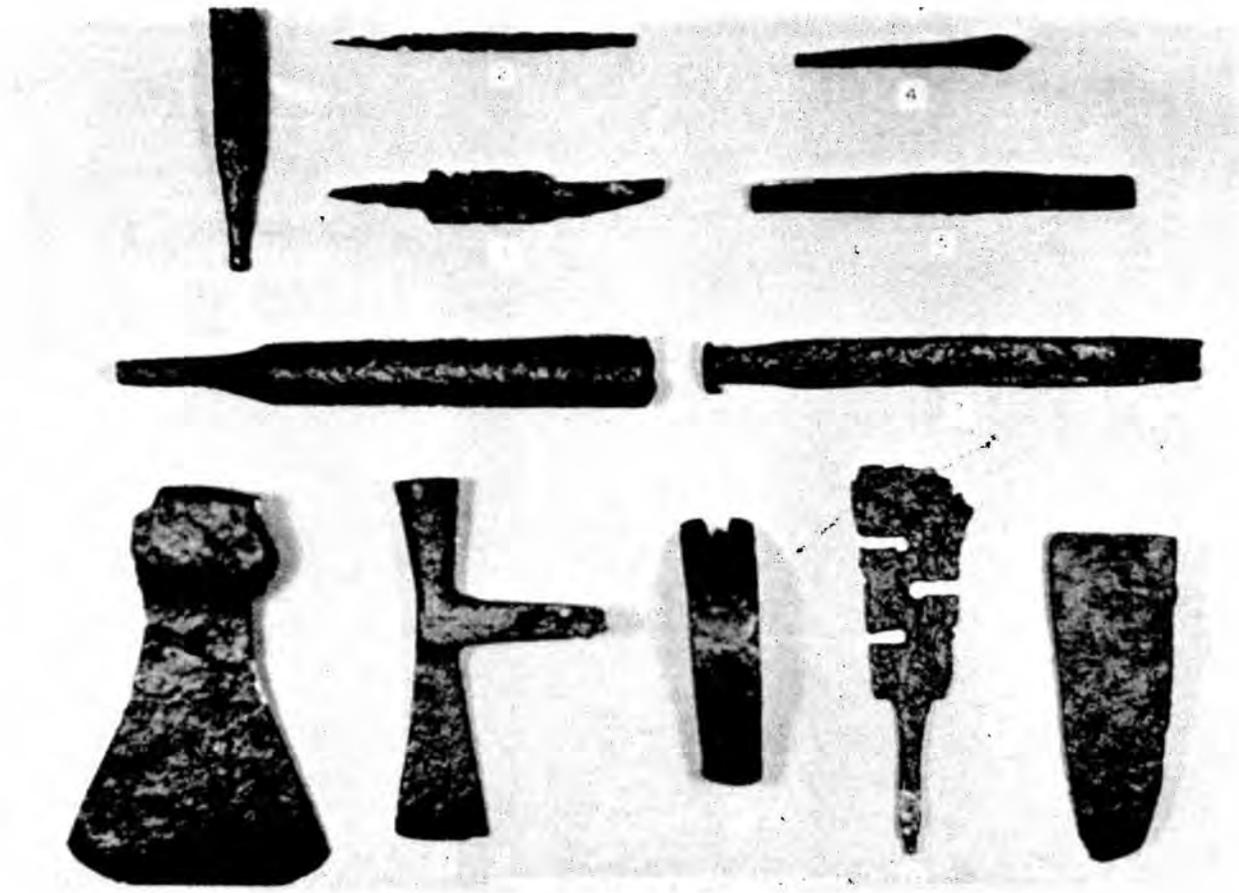
51. Tools Found in the Blacksmith Shop

The northeast section, including the forge area, was the smith's domain. Here he made and repaired hardware (nails, hinges, shutter hold-backs, hasps and staples, drawer pulls, knives and tools). The presence of scissors, roundhead dressmaking pins, buckles and an upholstery tack suggests that the smith was often helpful in household emergencies. Perhaps he even had a musical ear, since a jew's-harp was there too.
