HISTORIC STRUCTURES REPORT

PART I

SALEM CHURCH

**Fredericksburg and Spotsylvania
National Military Park
Fredericksburg, Virginia 22401**

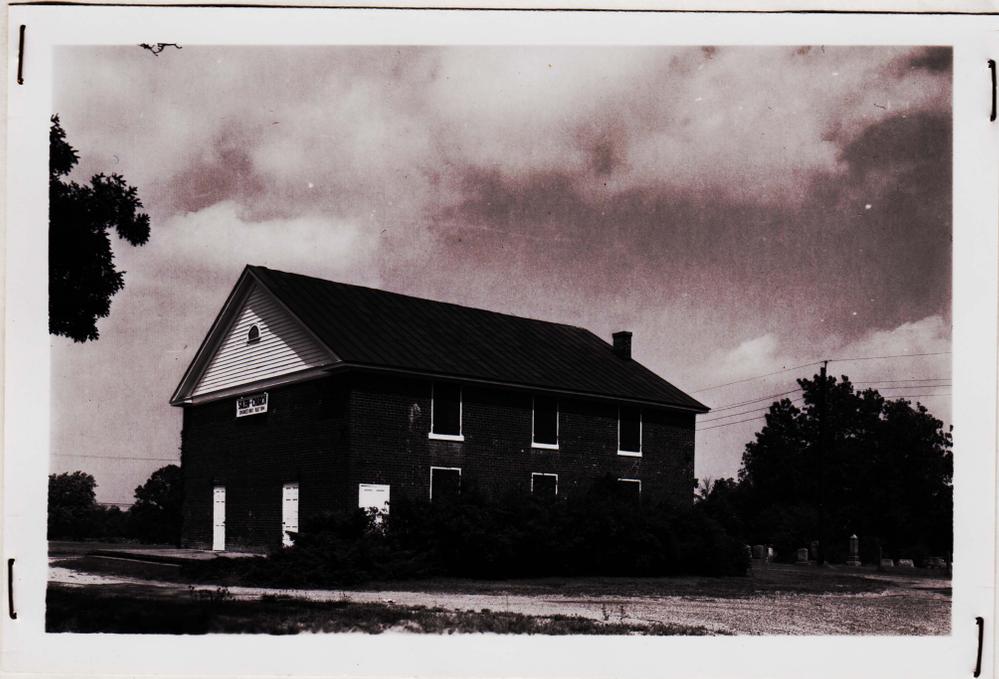
Old Salem Church, West End (Front) and South Side

Photograph by Ralph Happel, Summer 1965
