Wharf Treatment Recommendations

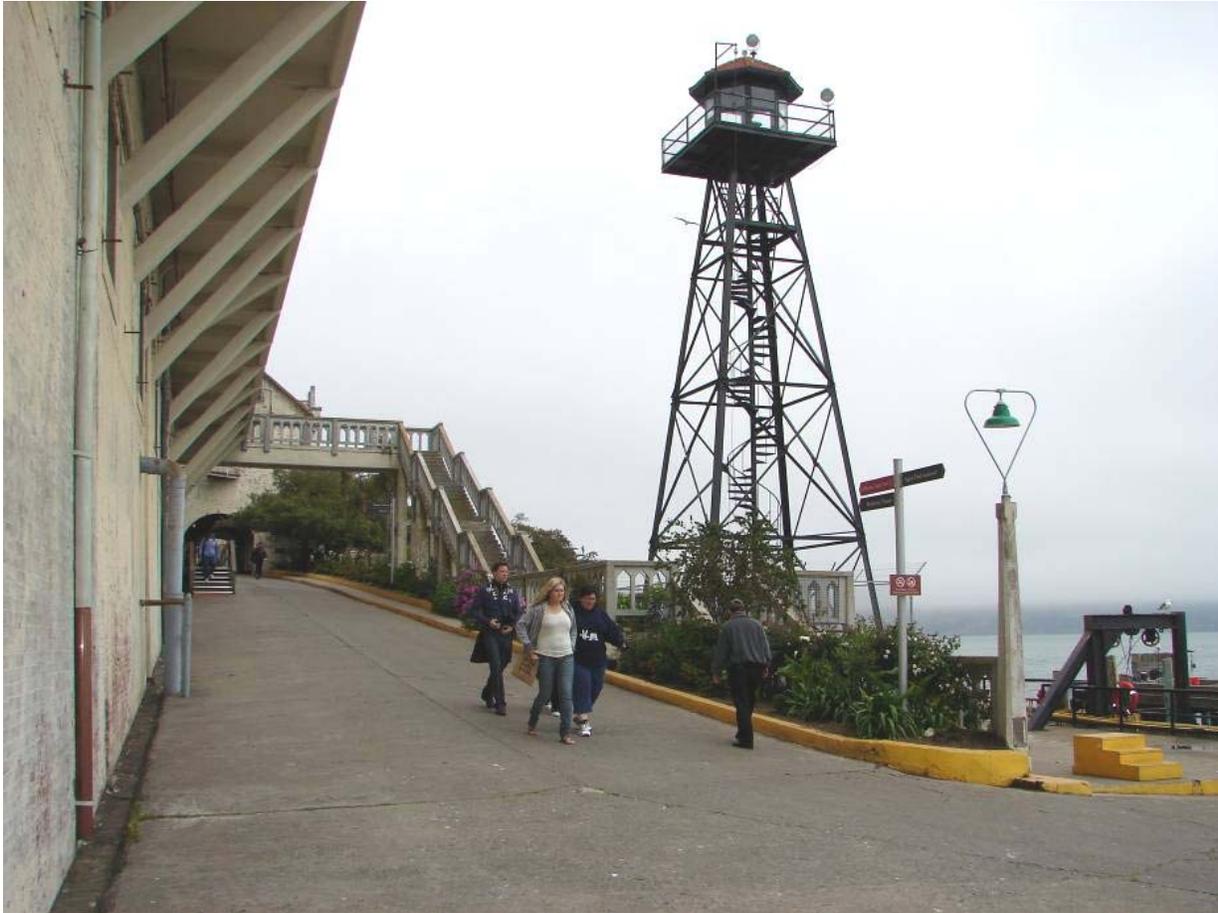
Figure 6 - 50. Maintain Dock Tower and fencing. (c 2009) (source: MBD); (DSC02454.JPG)

- Maintain the Dock Tower and its associated fencing (SF1). Allow for additional fencing if needed to facilitate visitor access to the Perimeter Sentry Walk.

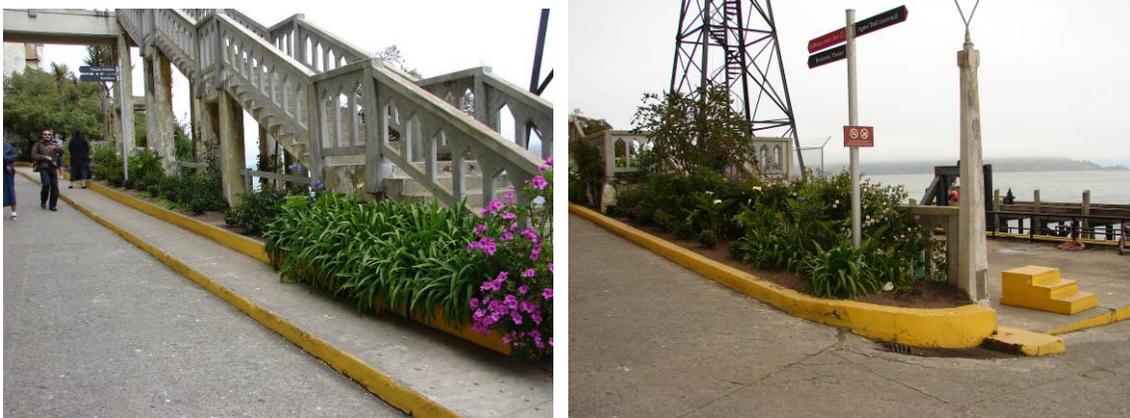
Figure 6 - 51. Maintain Sallyport Garden. (c 2009) (source: MBD); (DSC02483.JPG, DSC02456.JPG)

- Add new plantings in extant planter curb boxes on storage vault, ensure that new plantings reflect the historic character. Restore planter boxes as existed during Federal Penitentiary period.
- Maintain current historic Sallyport Garden plantings (*Fuchsia sp.*, *Pelargonium sp.*, *Rosa sp.*, *Watsonia sp.*, etc.). Continue to remove invasive species (*Hedera helix*, *Chasmanthe floribunda*, *Oxalis pes-caprae*).
- Remove green dracaena (#1, *Cordyline australis*) and Australian Tea Trees (#6, #7, *Leptospermum laevigatum*) trees in poor condition (north of Building 64). Plant new, smaller tree of the same species in the same location.
- Remove invasive vegetation (*Hedera helix*, *Oxalis pes-caprae*) from slope from the Wharf to the Perimeter Sentry Walk.

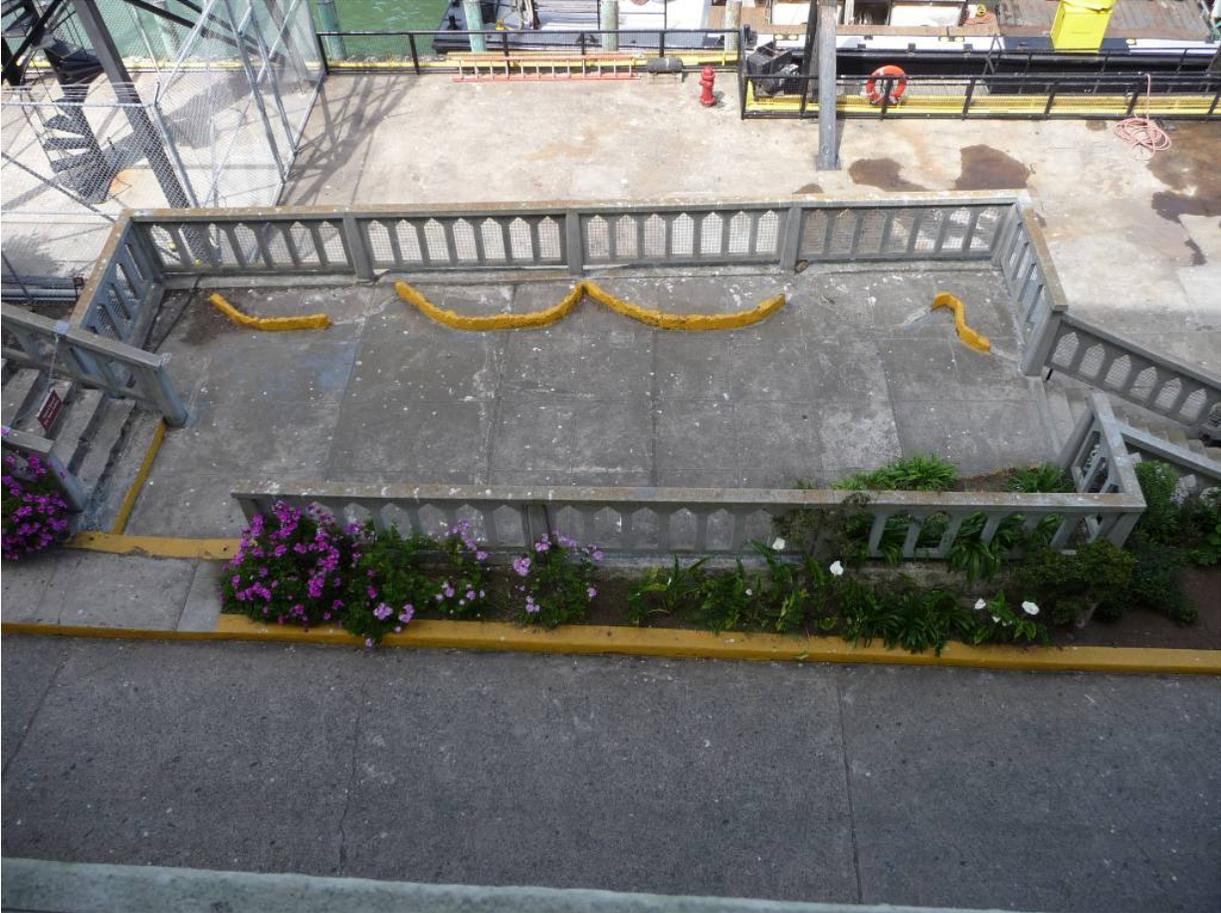
Figure 6 - 52. Restore planter boxes, and add plants using species present during the period of significance. (c 2009) (source: MBD); (WharfP1010183.JPG)

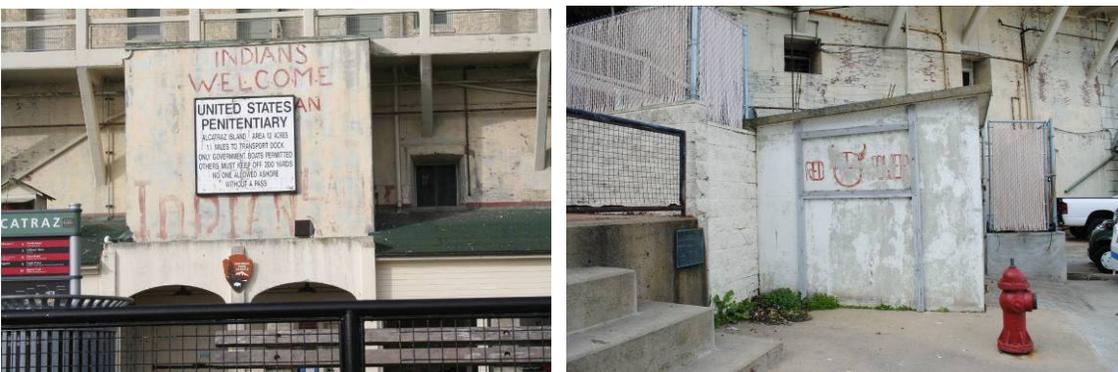
Figure 6 - 53. Restore U.S. Penitentiary Sign, 'Indians Welcome' and other Indian Occupation graffiti (c 2009, 2010) (source: MBD); (MBD IMG_2818.jpg, DSC_0416.JPG)

- Rehabilitate the terrace and all of its extant features on the building's west side. Repair metal ramps and staircases connecting the building with the terrace. Repair paving, curbs, walls and lights. Maintain decorative concrete railings. Maintain staircases and railings (MBSR28, MBSR29, MBSR30 and MBSR31), and security fencing (SR71, SR75 and SR76).
- Repair staircase from Building 64 to Road to Parade Ground (north of Building 64) and allow year round visitor access
- Maintain staircases and railings east of Building 64 and allow visitor access to Chinatown.
- Rehabilitate Building 64 and allow use for visitor services and administrative functions as recommended by the new GMP.
- Restore U.S. Penitentiary Sign and Indian Occupation graffiti "Indians Welcome" on Building 64 and 'Red Power' on Firebox #3.

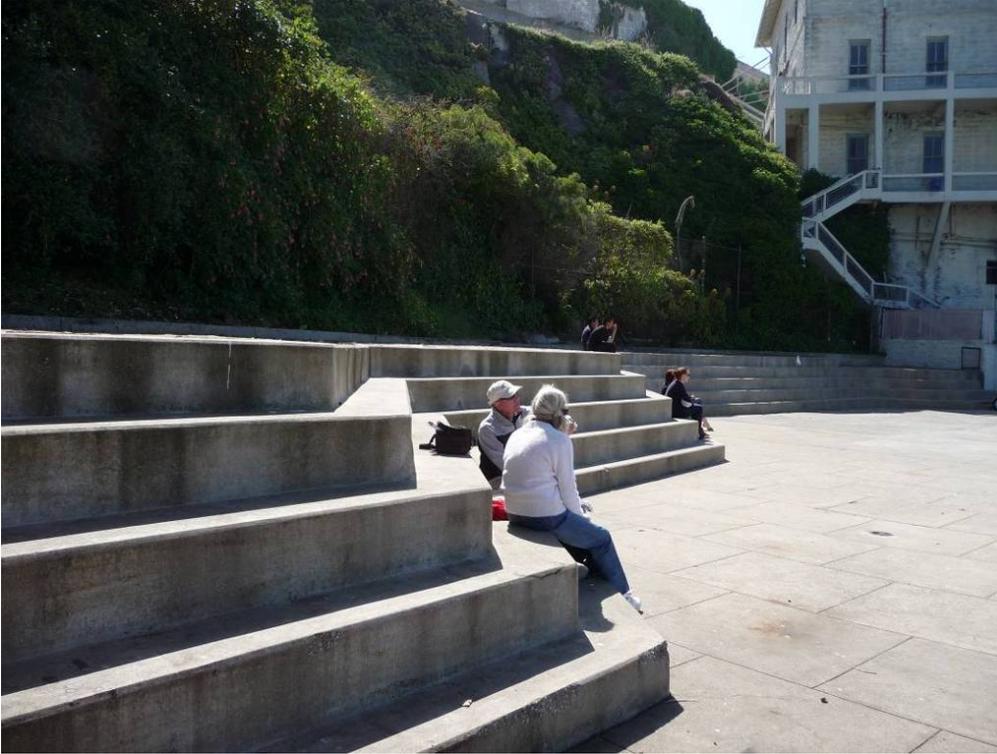
Figure 6 - 54. Remove amphitheater. Allow for addition of operations in this area. Remove invasive vegetation on slope and restore security fencing. (c 2009) (source: MBD); (P1000840.JPG)

- Remove non-contributing amphitheater, and allow for operations to be located in this area (similar to its historic use). Screen or otherwise integrate operations with visitor access to the Parade Ground and Agave Walk.

- Repair Federal Penitentiary period security fencing (SF2) at amphitheater and at south edge of Building 64.
- Repair painted line up markings (prisoner markings). Conduct additional research to determine extent and location of original markings.

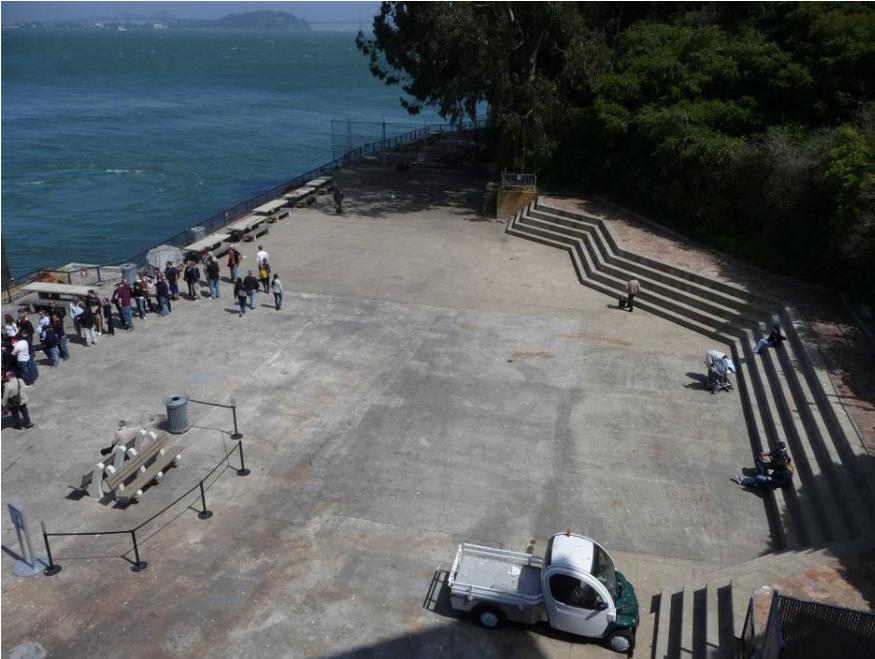
Figure 6 - 55. Restore prisoner line up markings on pavement. Allow for operations in this area, and new restroom building to replace existing non-contributing, non-compatible building. (c 2009) (source: MBD); (P1010156.JPG)

- Remove non-contributing restroom building and provide similar facilities in a new building designed of a mass, scale, and style similar to the historic buildings that once existed in the Wharf. Locate new building or buildings south of Building 64.

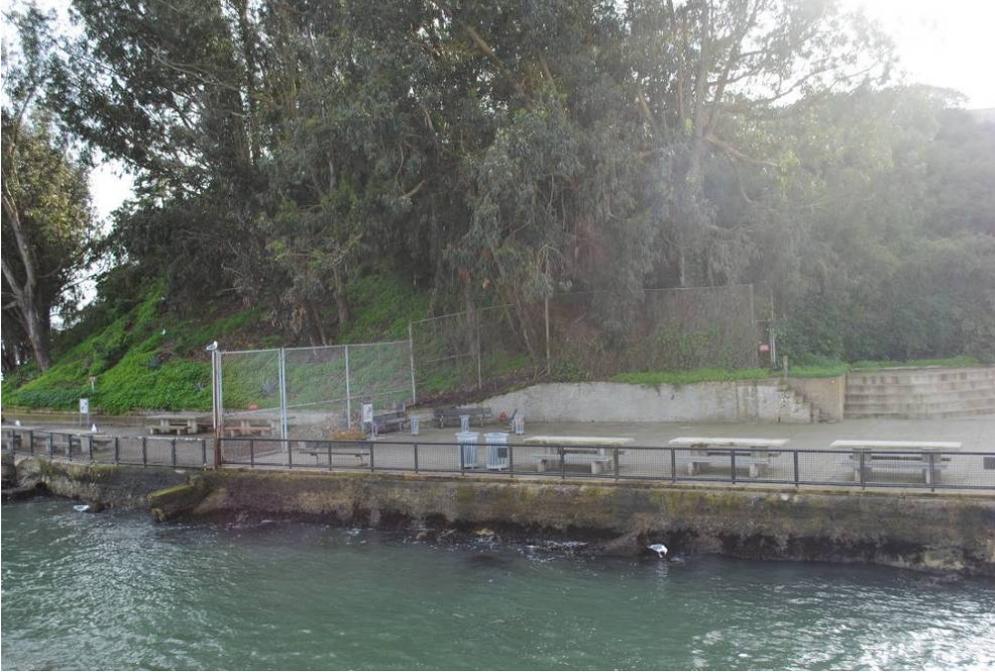
Figure 6 - 56. Stabilize seawall and shoreline. Remove non-contributing black metal railing and replace railing along dock to where it connects to the security fencing. (c 2010) (source: MBD); (DSC_0537.JPG)

- Maintain dock and all of its supporting structure. Maintain historic stone seawall (top of wall is visible on dock) and ensure that the top remains visible.

- Repair shoreline as needed, including seawall and shore protection.
- Repair staircase and railing from storage vault to Building 64 for year-round visitor access to the Parade Ground.

- Remove non-contributing railing (SR2) along seawall. Replace with railing that is compatible with the Wharf's historic character. New railing should extend along the dock from the Dock Tower to the security fencing (SF2).
- Repair staircase and railing at the south end of the existing amphitheater for use as seasonal access to Officers' Quarters 72 and 73.

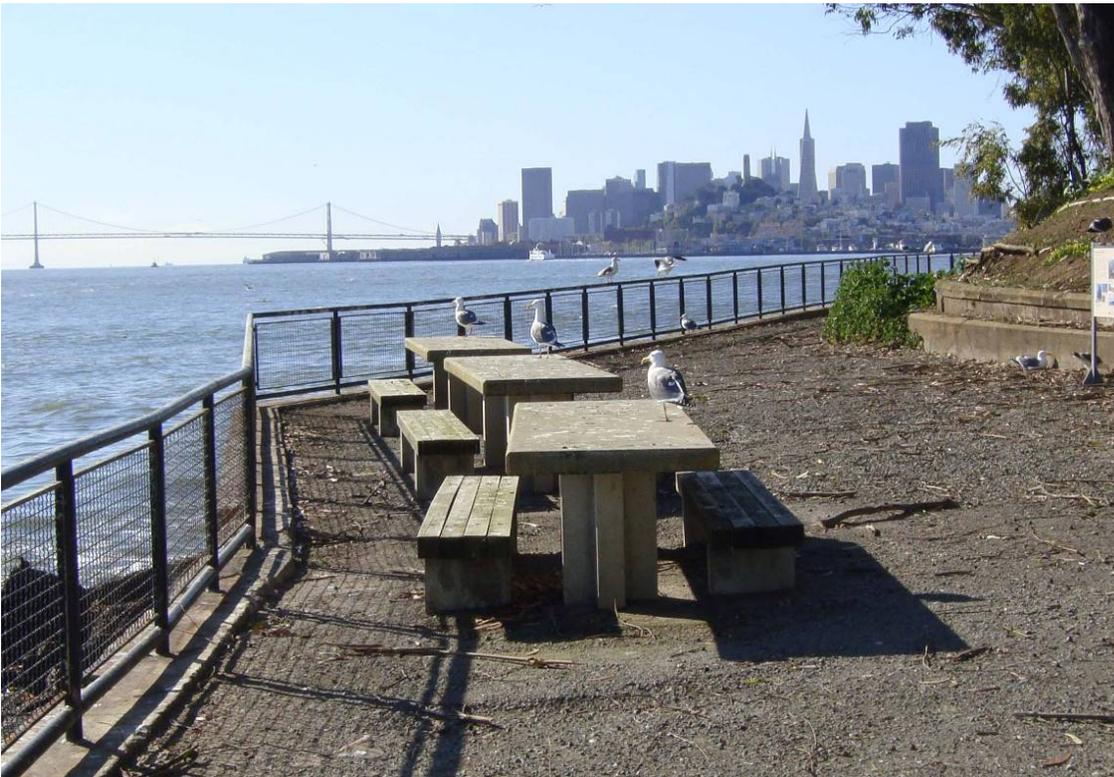
Figure 6 - 57. Remove non-contributing picnic benches. Remove non-contributing black metal railing (SR3). Maintain paving. (c 2009) (source: MBD); (DSC00181-Crop.jpg)

- Remove non-contributing picnic tables and replace furnishings that are compatible with the Wharf's historic character.

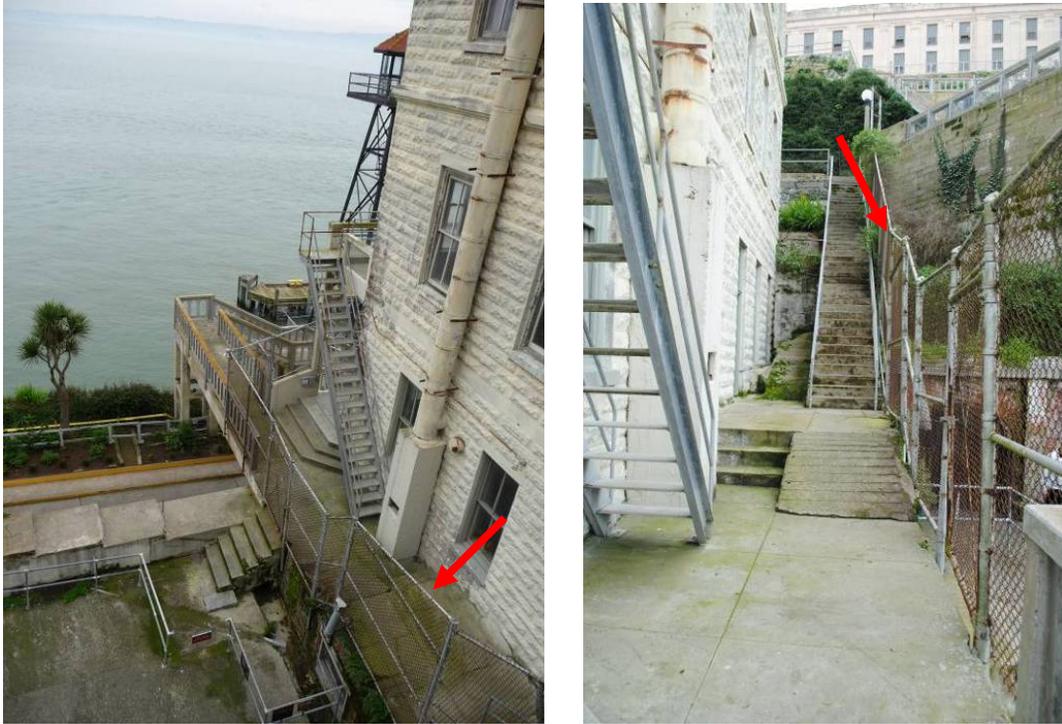
Figure 6 - 58. Maintain security fence (SR 72), concrete staircase and metal railing. (c 2010) (source: MBD); (P1030757.JPG, DSC_0375.JPG)

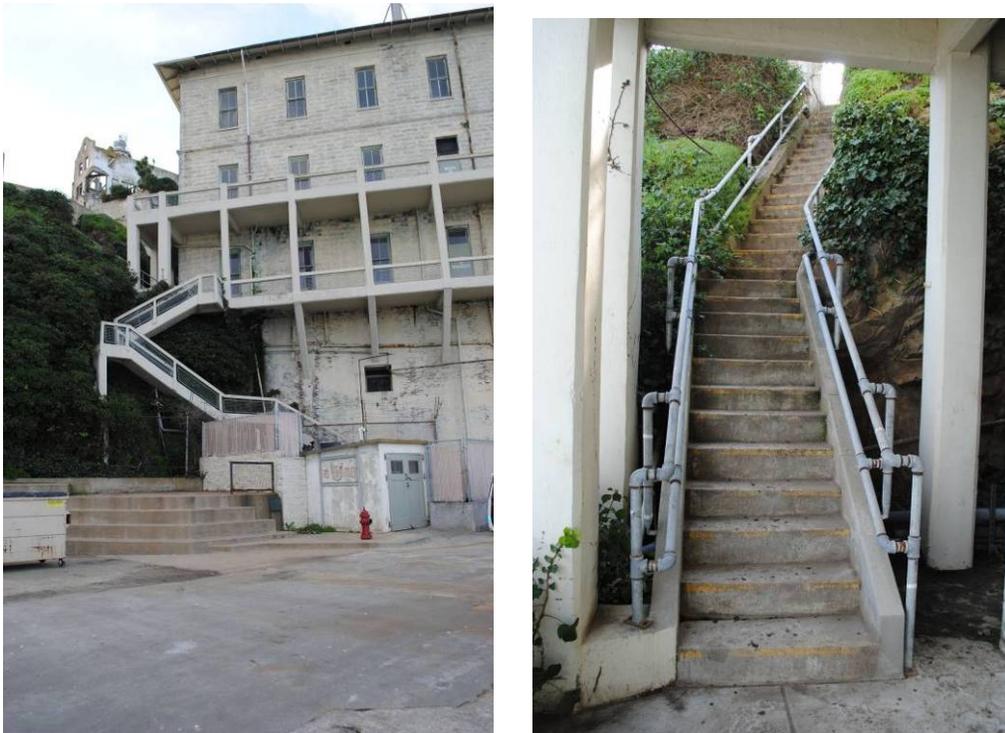
Figure 6 - 59. Maintain staircases and railings from Wharf to Parade Ground at Building 64. Repair staircase and railing at top. Allow year round visitor access to Parade Ground via these staircases. (c 2010) (source: MBD); (DSC_0412.JPG, DSC_0446.JPG)

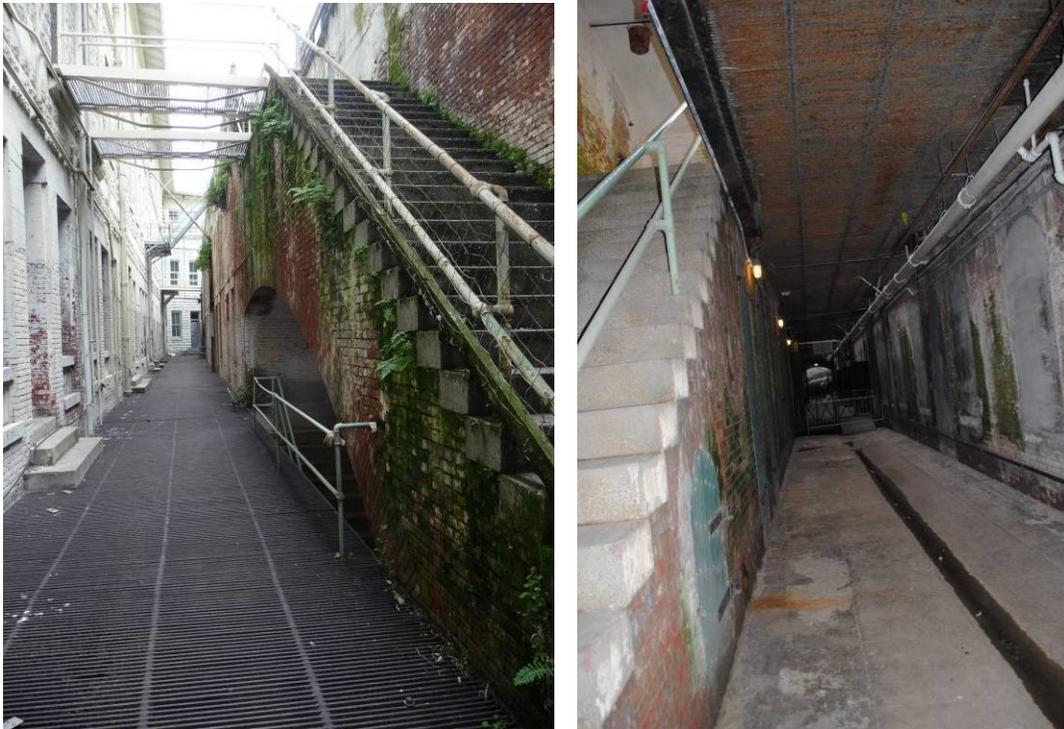
Figure 6 - 60. Maintain staircases, and railings on west side of Building 64 in Chinatown. (c 2010) (source: MBD); (DSC_0412.JPG, DSC_0446.JPG)

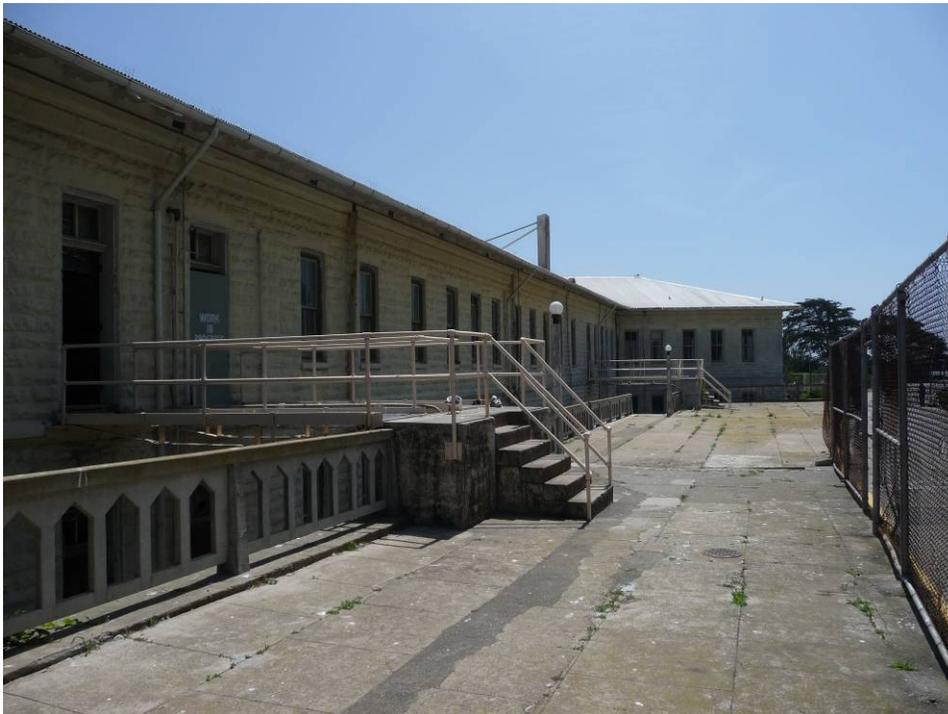
Figure 6 - 61. Repair paving, curbs, walls and lights. Maintain staircases and railings. Maintain decorative concrete railings. Maintain Federal Penitentiary period security fencing. (c 2009) (source: MBD); (P1020897, DSC_0357.JPG)
