# Main Road - East Treatment Recommendations

### *Officers' Row*

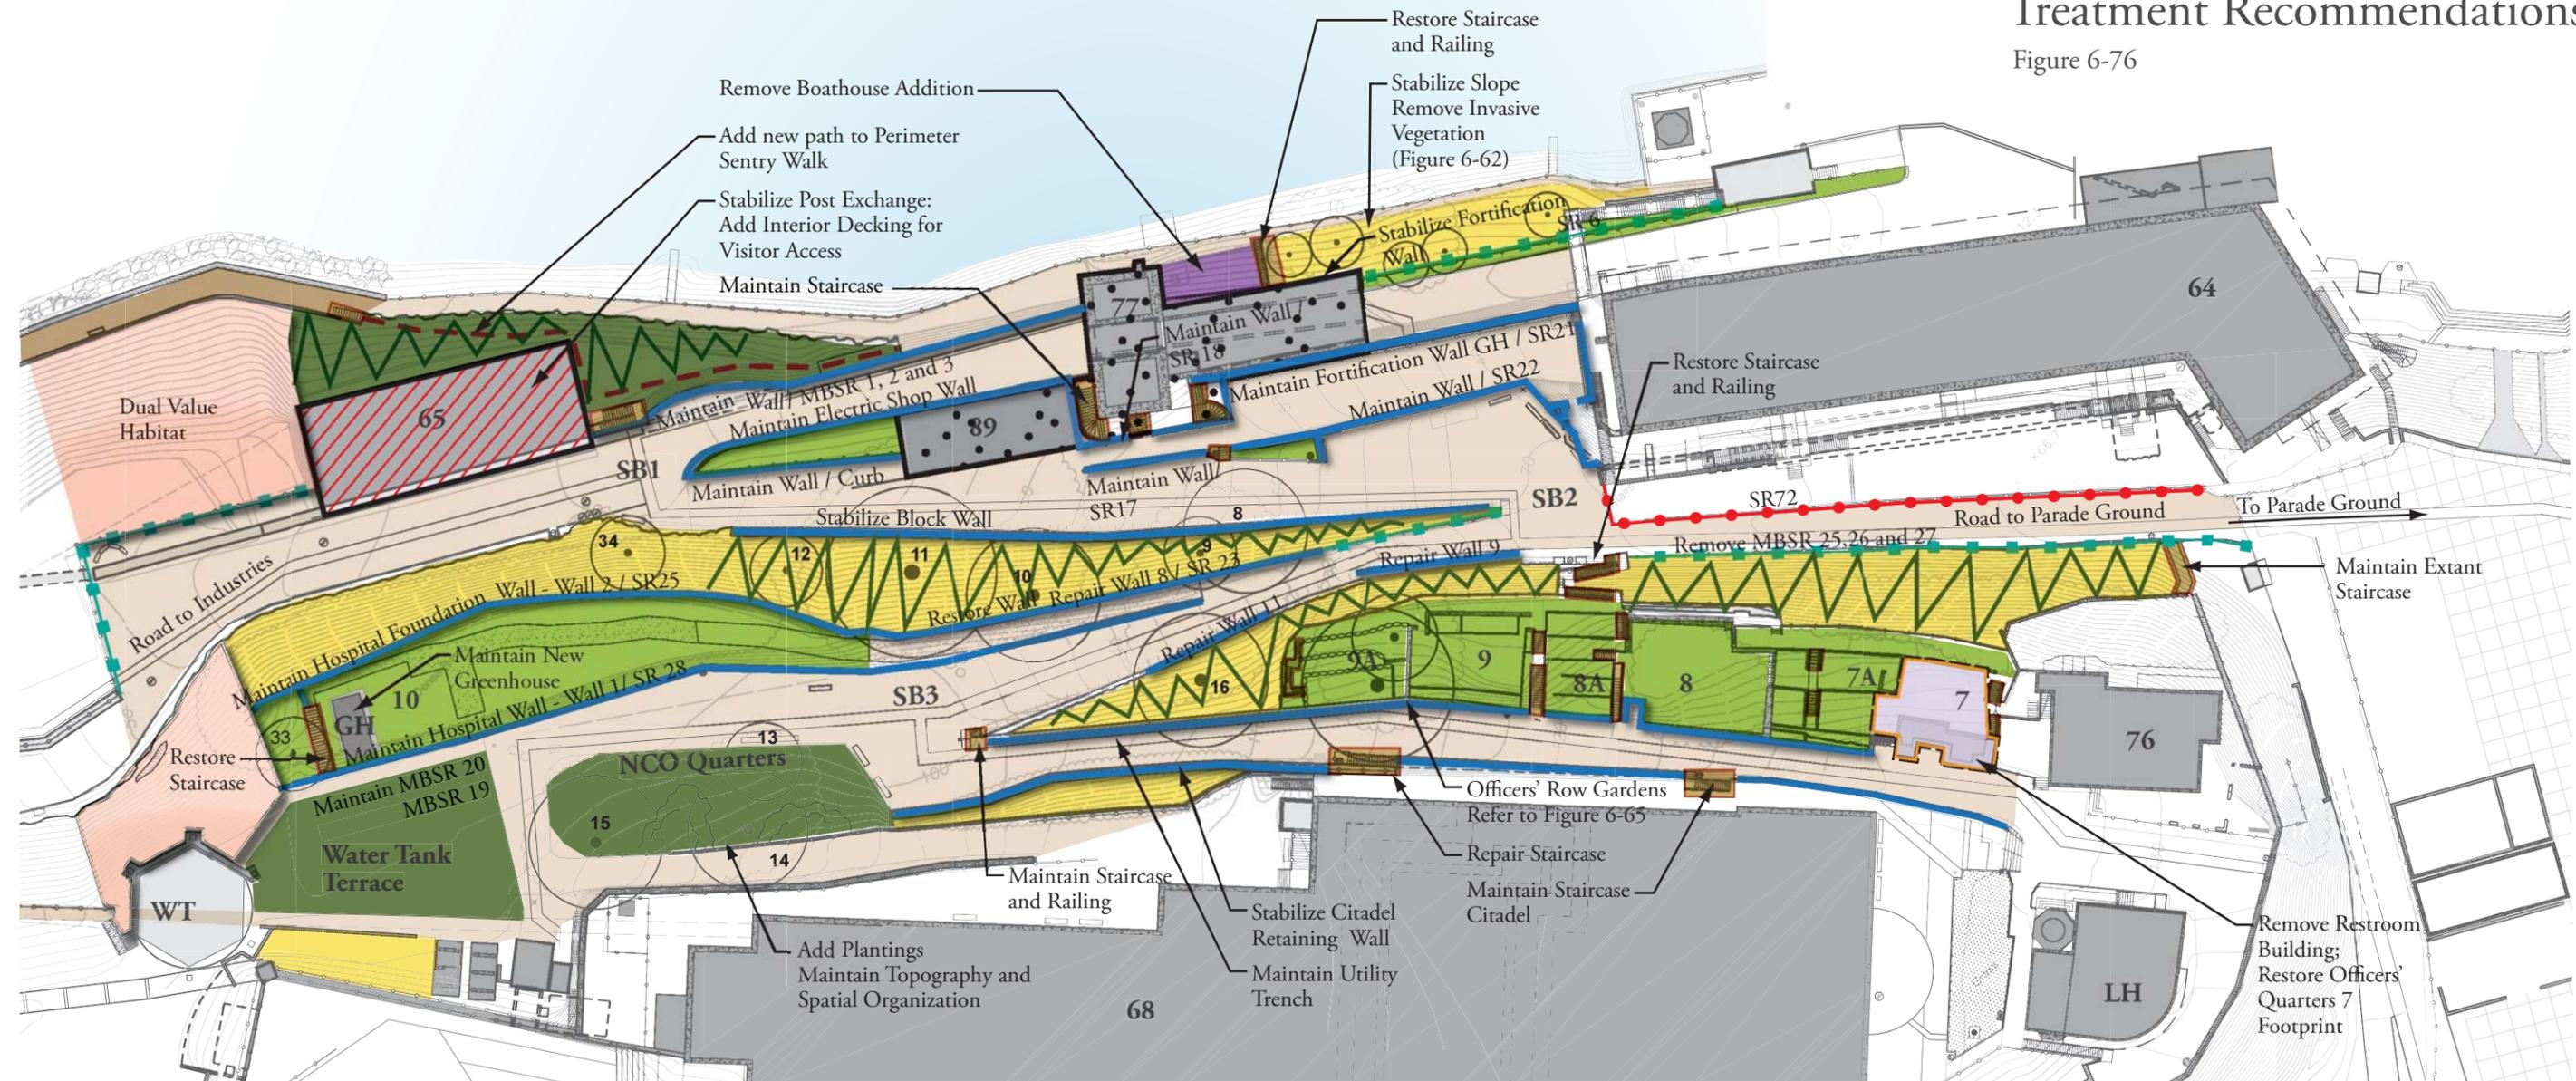
Figure 6-76

- **Maintain, stabilize or repair all extant contributing features associated with the Main Road – East.**
- **Maintain the historic form, topography and arrangement of the Main Road.**
- **Allow for non-contributing compatible features to remain and be stabilized.**

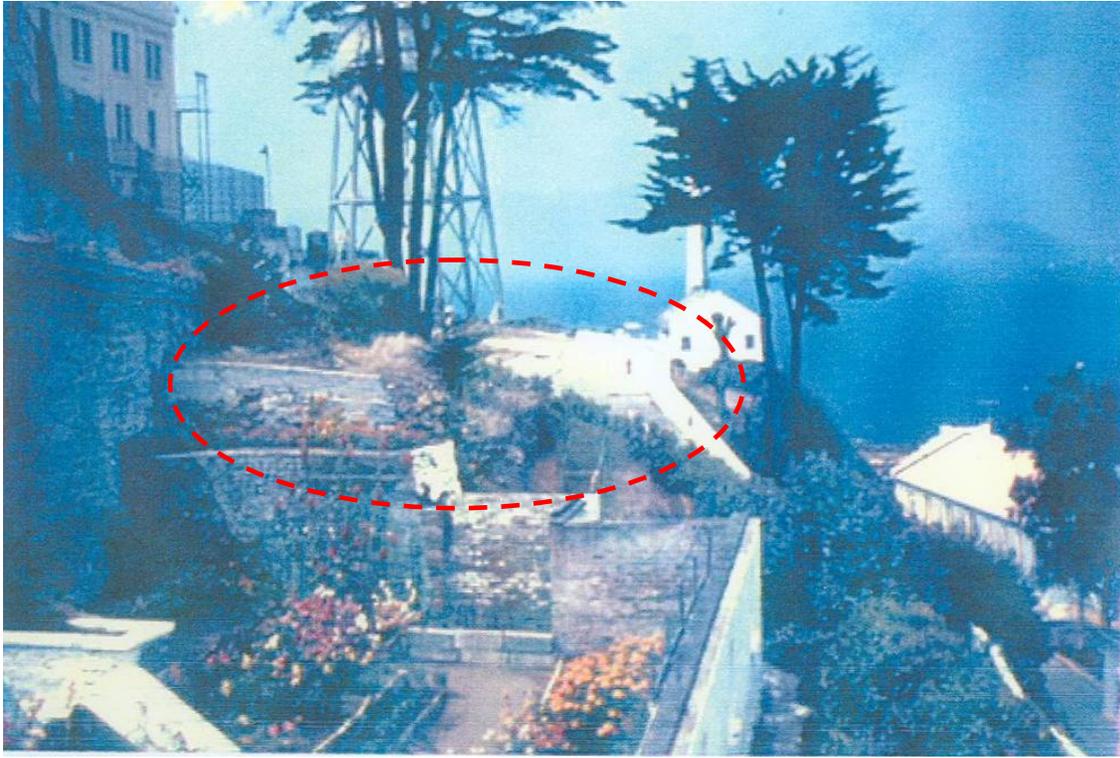
**Figure 6 - 77.** Restore Garden Terrace 9a plantings to reflect “wild” character of 1940s and 1950s. Remove Monterey Cypress trees and replace with new trees in same location: (c 1961) (source: Parks Conservancy) (N foundation 1961.jpg)

- Remove all English, Algerian and cape ivy from existing vegetation
- Repair dry stack stone walls.
- Restore staircases and decorative concrete railing SR24 at north edge of garden.
- Restore plantings to reflect the “wild” character of this garden terrace during the 1940s and 1950s.
- Remove Monterey Cypress trees (#17, #18) and stumps. Plant new, smaller trees of same species in the same location. Prune early in the tree’s lifespan to remove lower horizontal branches.

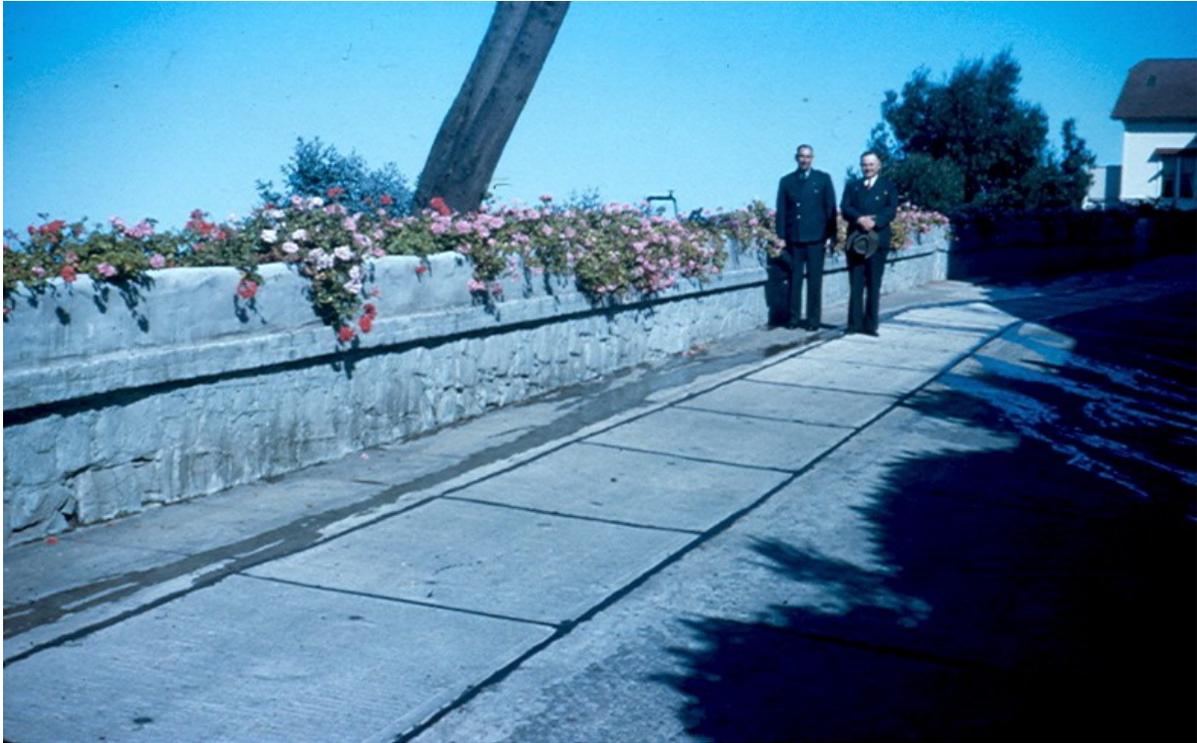
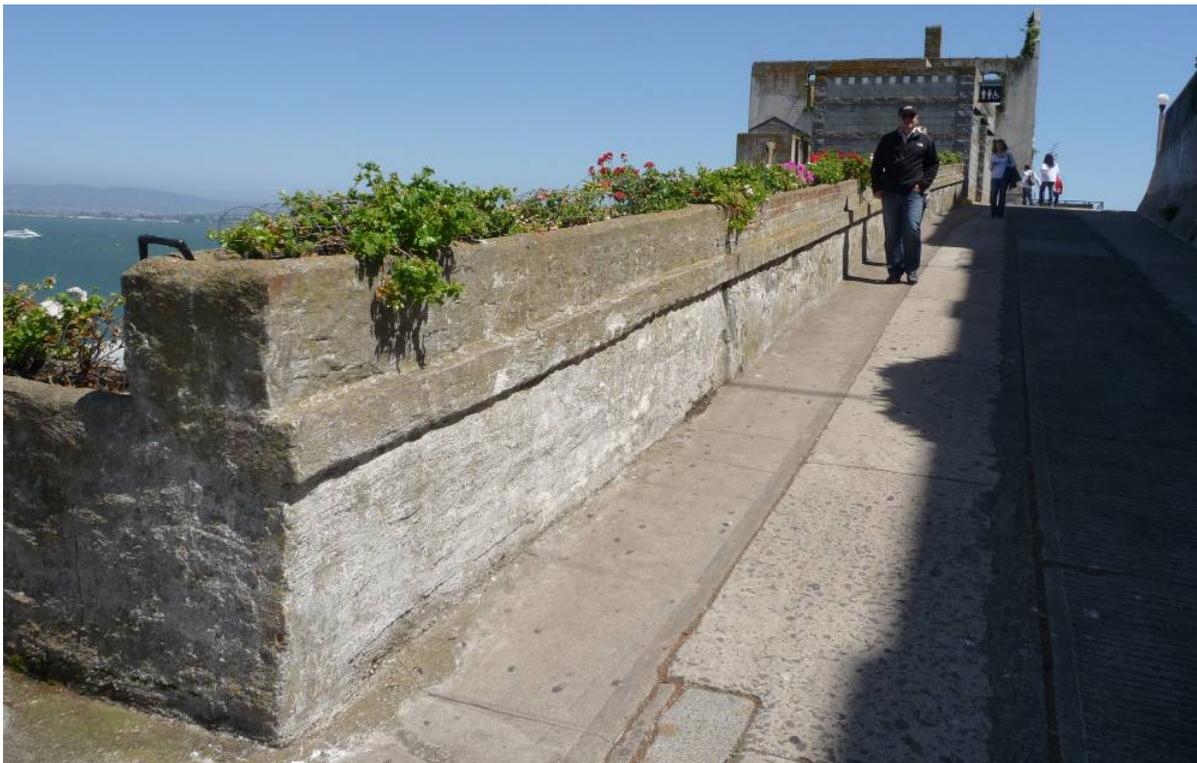
**Figure 6 - 78.** Maintain the Trough Wall adjacent to Officers' Quarters 8 and Garden Terraces 8a and 7a to reflect the character of the wall during the Federal Penitentiary period: top, (c Federal Penitentiary period 1934-1963) (source: Parks Conservancy) (main road planter (simpson-03).jpg); bottom, (c2010) (MBD P1000421.JPG)

- Stabilize East Retaining Wall where needed. Repair historic railing, SR24, and maintain the restored portions of SR24 along the top of wall.
- Restore the staircase and decorative concrete railing SR74 that connects to the Main Road.
- Stabilize the Trough Wall at Officers' Quarters 9 and Garden Terrace 9a. Maintain the Trough Wall at Officers' Quarters 8, and Garden Terraces 8a and 7a. Ensure that the Trough Wall continues to reflect its historic appearance during the Federal Penitentiary period.

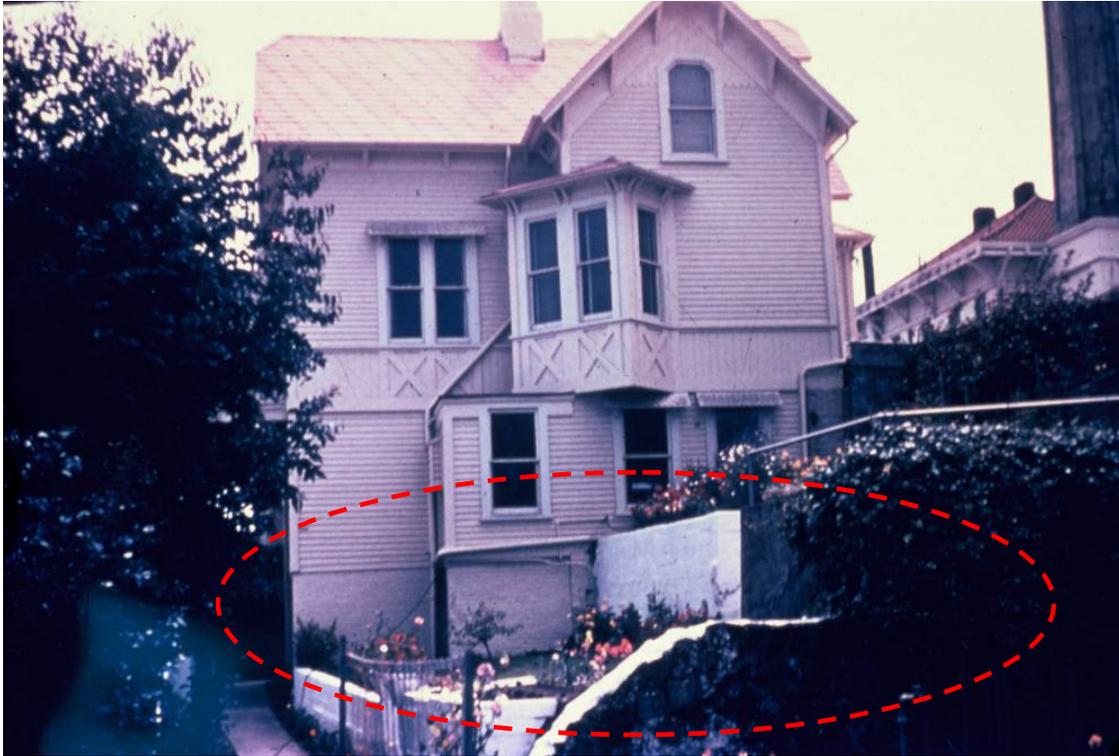
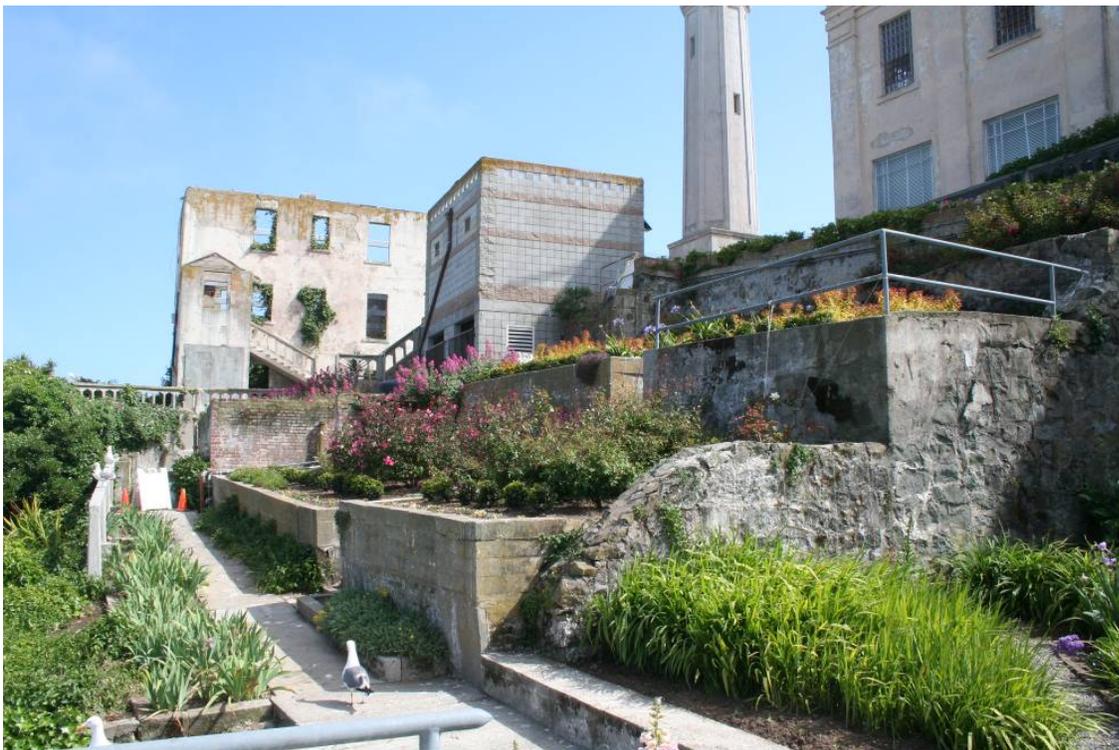
**Figure 6 - 79.** Stabilize Remaining Area of Officers' Quarters 7 Footprint. Maintain Plantings of Garden Terrace 7a: top, (c1960-62) (source: Parks Conservancy) (Bldg 7 c1960-62 (Don Bowden 6831503-R1-E024).jpg); bottom, (c 2009) (source: MBD); (IMG\_2863.JPG)

- Remove non-contributing restroom building, leaving all extant historic materials intact including building and site walls. Maintain extant building wall and foundation of Officers' Quarters 7. Restore the spatial organization of the historic building space. Add gravel paving to the level surfaces and do not plant. Plants and gardens did not exist during the period of significance.

- Maintain extant plantings and configuration of planting beds.
- Repair building foundation walls, and allow for whitewashing walls as was done historically during the 1940s, 1950s and early 1960s.
- Repair paving.
- Stabilize all site walls and curbs.
- Restore staircase and repair railing SR24
- Maintain restored railings.

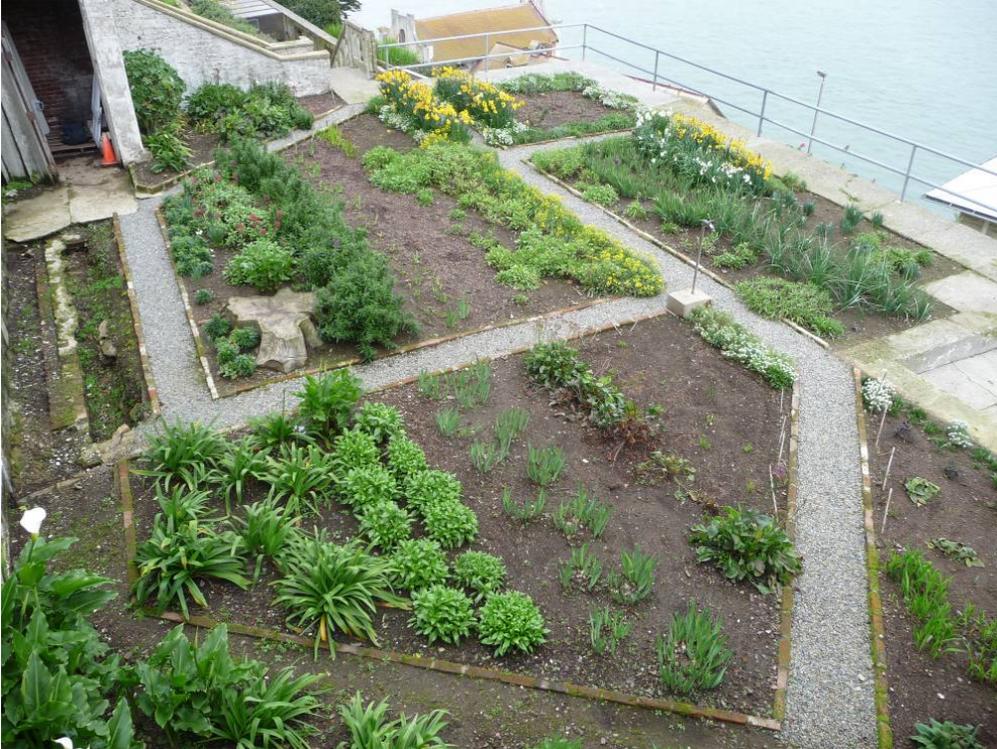
**Figure 6 - 80.** Maintain Plantings of Officers' Quarters 8. (c 2010) (source: MBD); (P1030866.JPG)

- Maintain extant plantings and configuration of planting beds.
- Repair building foundation wall defining the west edge of the garden. Allow for whitewashing the wall as was done historically during the 1940s, 1950s, and early 1960s.
- Repair paving.
- Maintain restored Pipe Railing SR11.
- Maintain curb at southeast corner of garden
- Stabilize Coal Shed/Garden Storage.
- Maintain graffiti marker – “May 1, 19xx” (Figure 3-194b).

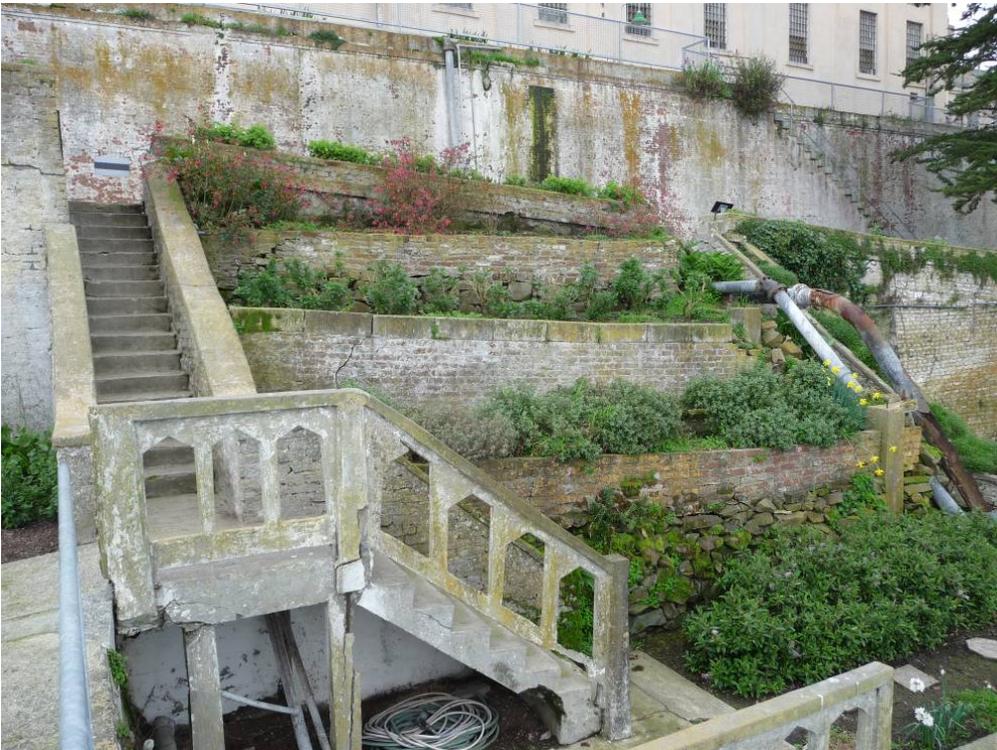
**Figure 6 - 81.** Maintain Plantings of Garden Terrace 8a. Repair Site Walls, Staircases, and decorative concrete railing (c 2009) (source: MBD); (P1030838.JPG)

- Maintain extant plantings and configuration of planting beds.
- Stabilize staircases and railings on the north and south edges of the garden. Repair staircases and decorative concrete railing SR24. Maintain restored decorative concrete railing.
- Repair four site walls and stabilize east wall adjacent to path.
- Maintain extant utility pipes.

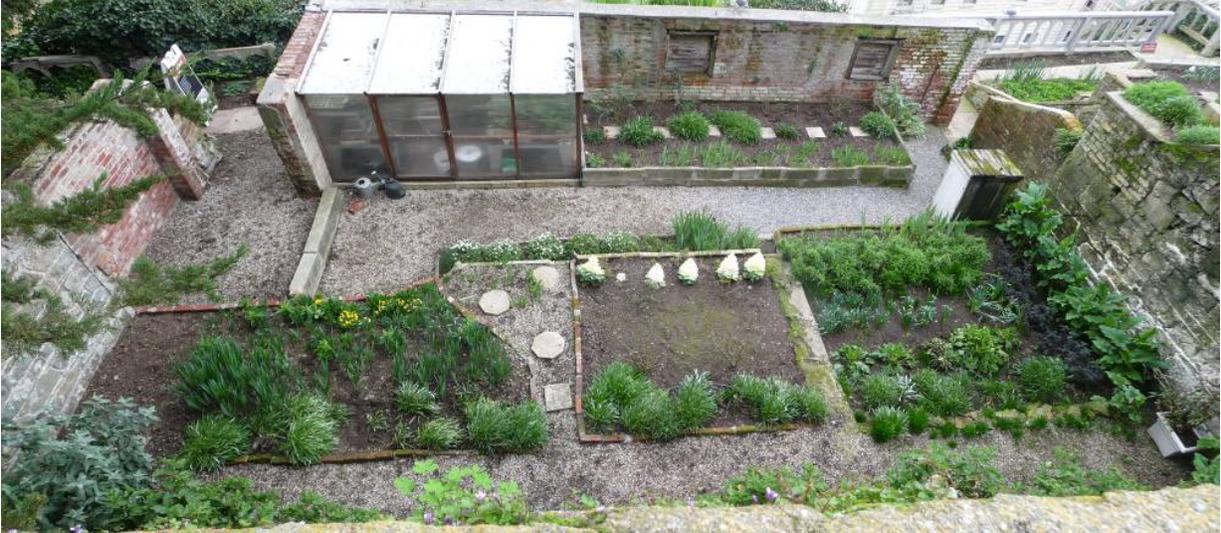
**Figure 6 - 82.** Maintain Plantings of Officers' Quarters 9 and maintain reconstructed Hothouse. (c 2010) (source: MBD); (Building 9 Panorama.JPG)

- Maintain extant plantings and configuration of planting beds.
- Stabilize building foundation walls at the north and east edges of Officers' Quarters 9. Allow for whitewashing the wall as was done historically during the 1940s, 1950s, and early 1960s.
- Maintain new non-contributing, compatible Hothouse (built by Alcatraz Historic Garden Project in August 2007).
- Stabilize concrete curb.
- Maintain white box. Maintain graffiti marker - “Tippy” (Figure 3-194a).

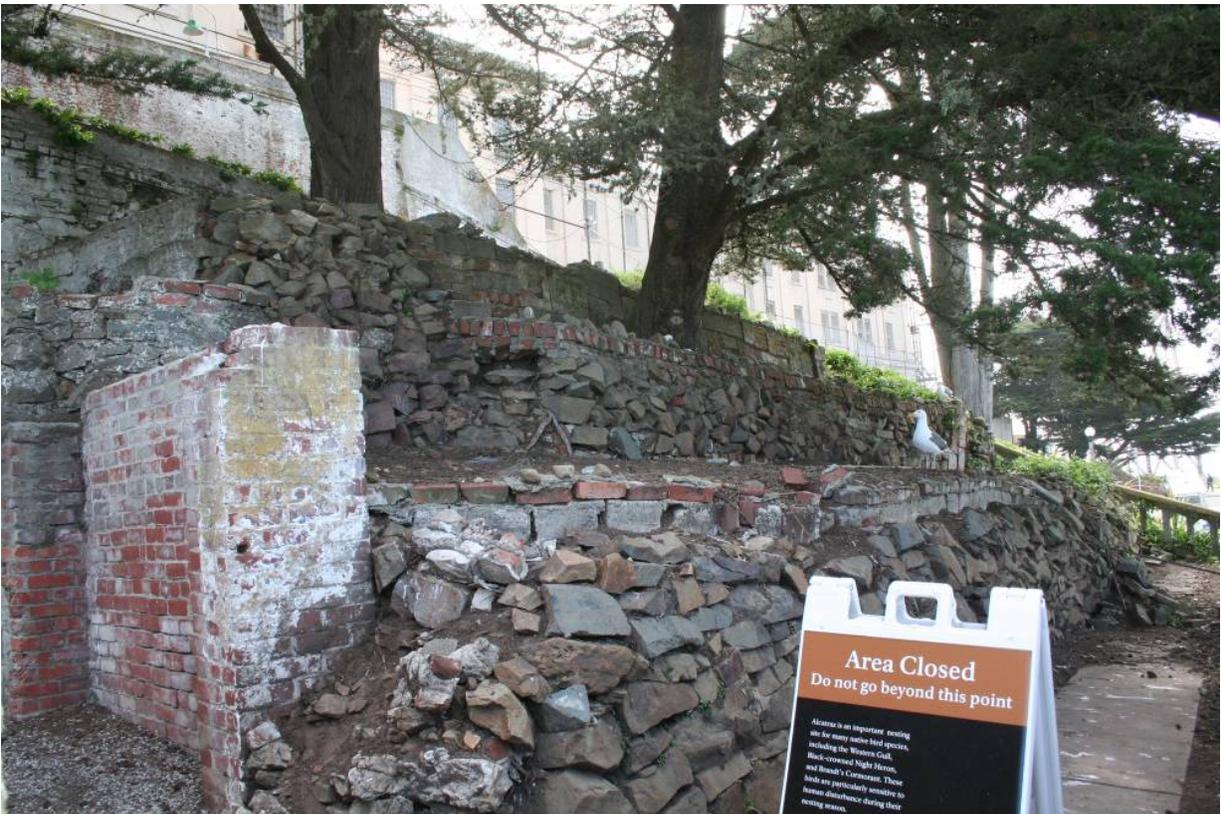
**Figure 6 - 83.** Repair Garden Terrace 9a Site Walls. Remove Monterey Cypress trees and plant new smaller trees in the same location. (c 2009) (source: MBD); (IMG\_2842.JPG)

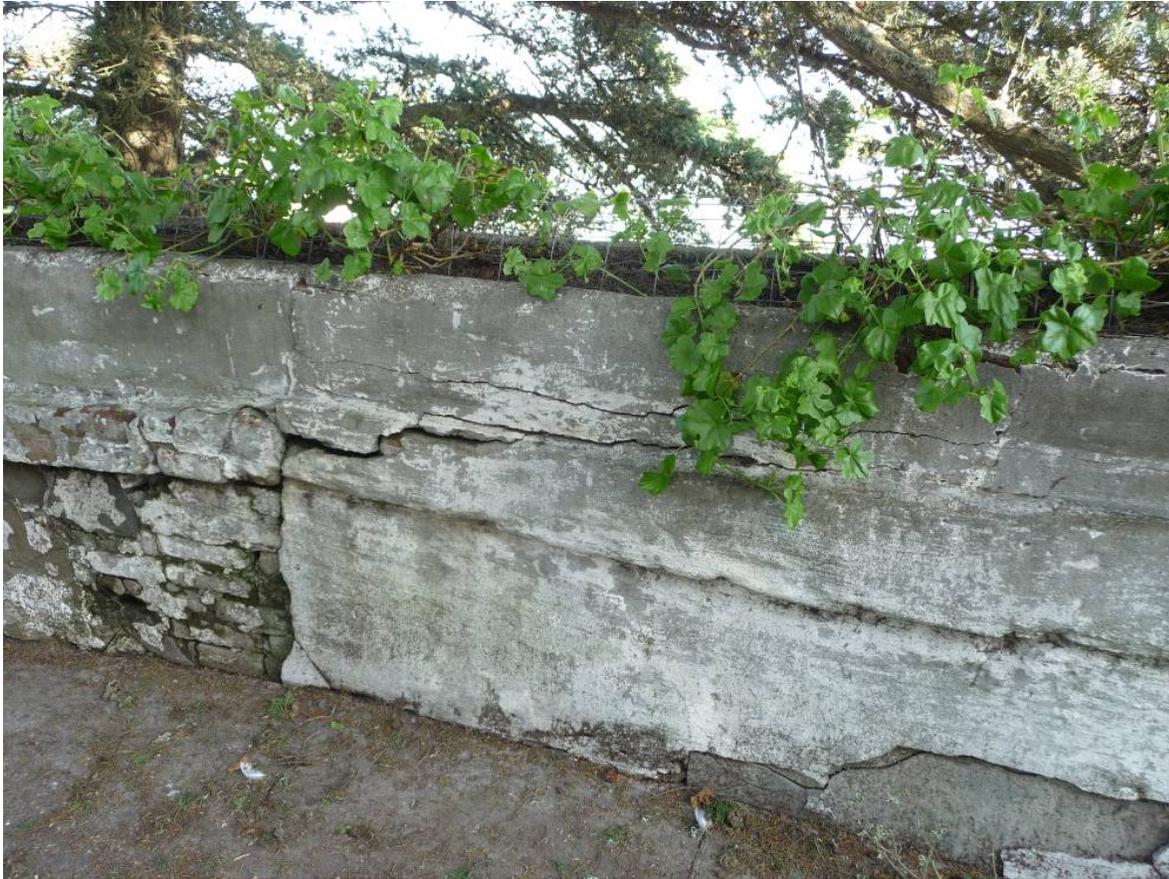
**Figure 6 - 84.** Stabilize Trough Wall adjacent to Officers' Quarters 9 and Garden Terrace 9a to reflect the character of the wall during the Federal Penitentiary period. (c 2010) (MBD P1040122.JPG)
