## Physical History

### **Origins of the Fort Point Lifeboat Station (1886-1915)**

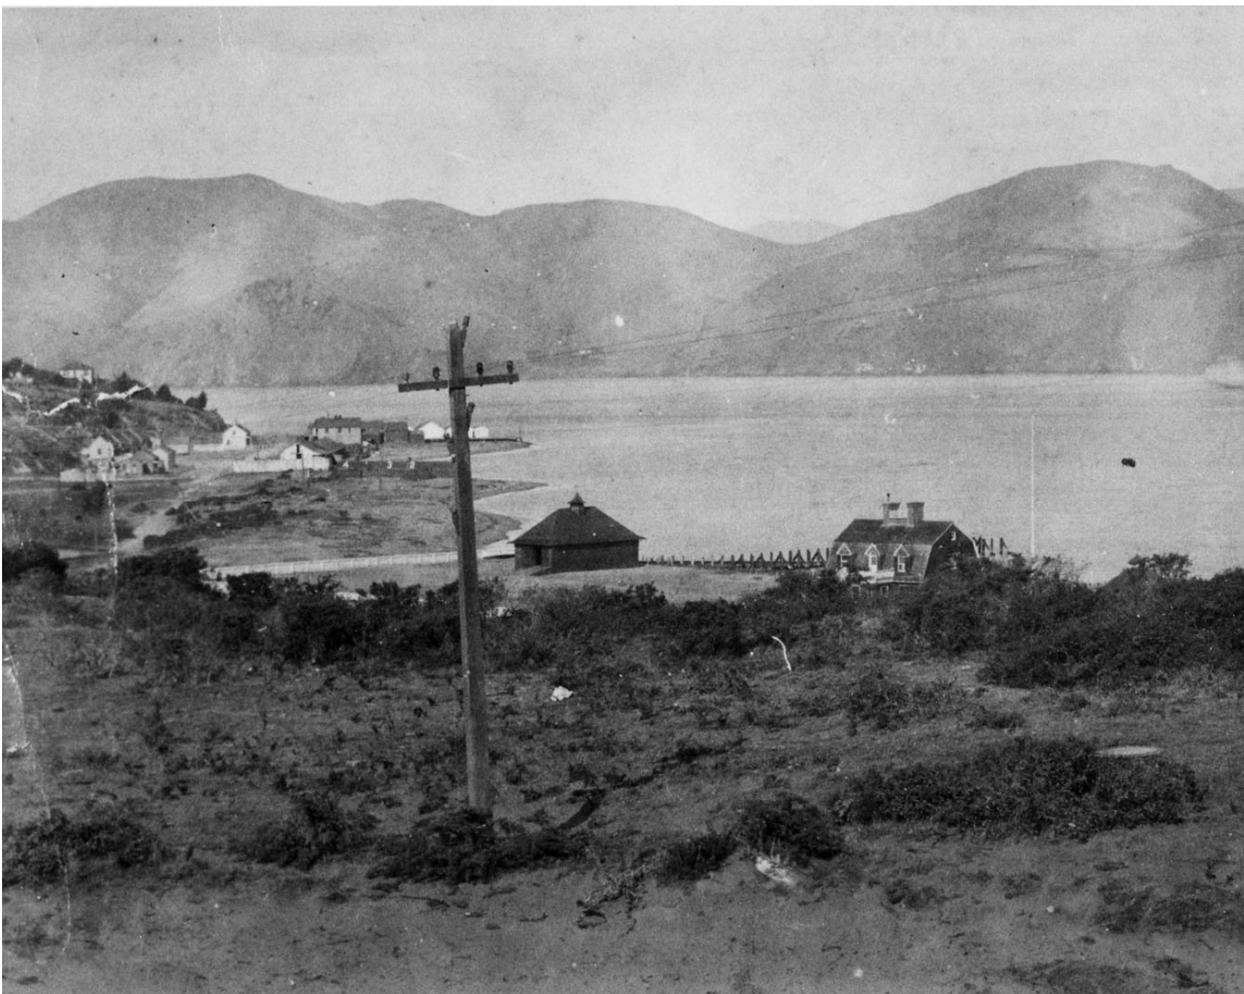
*History figure 1. This photograph was taken shortly after the station was completed in 1890. The photographer is looking northwest toward the Golden Gate. [10]*

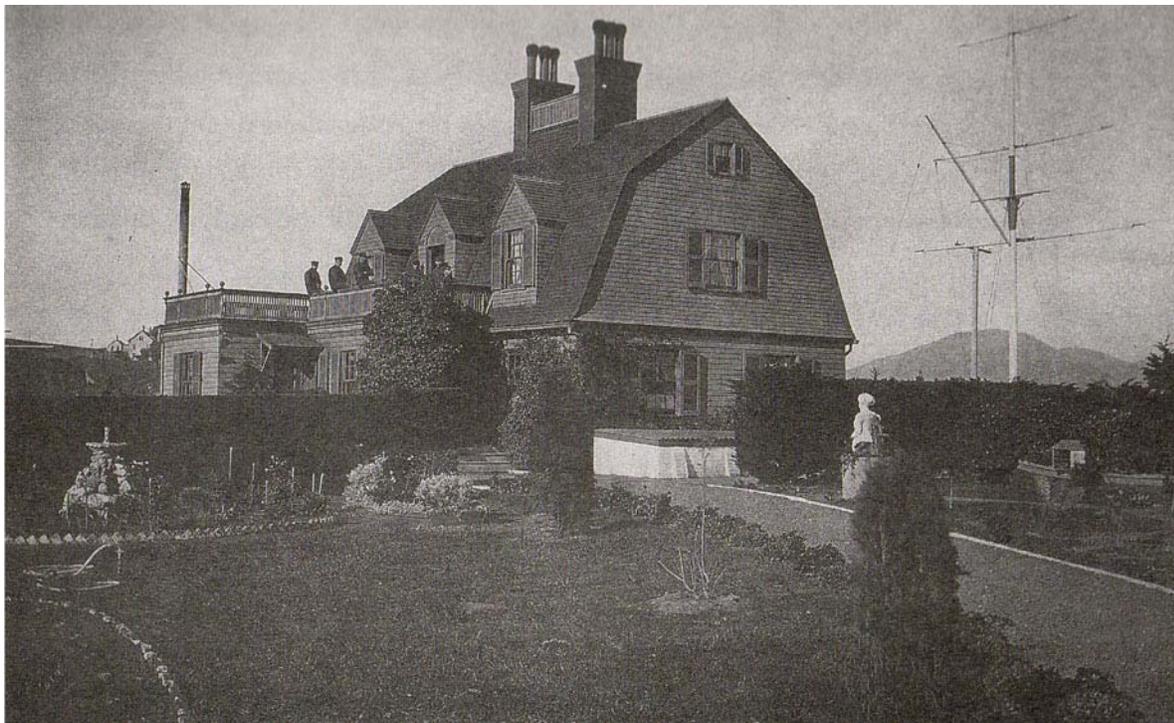
*History figure 2. Photograph of the Keeper's Quarters (bldg. PE 1902) from about 1900. Note the established vegetation and garden ornaments. A hose bib is also visible, indicating the existence of an underground water main. [12]*

landscaping was already lush (see *history figure 2*). It also reveals at least one fountain and several hose bibs, which demonstrate that permanent, subterranean plumbing had been installed by this date.

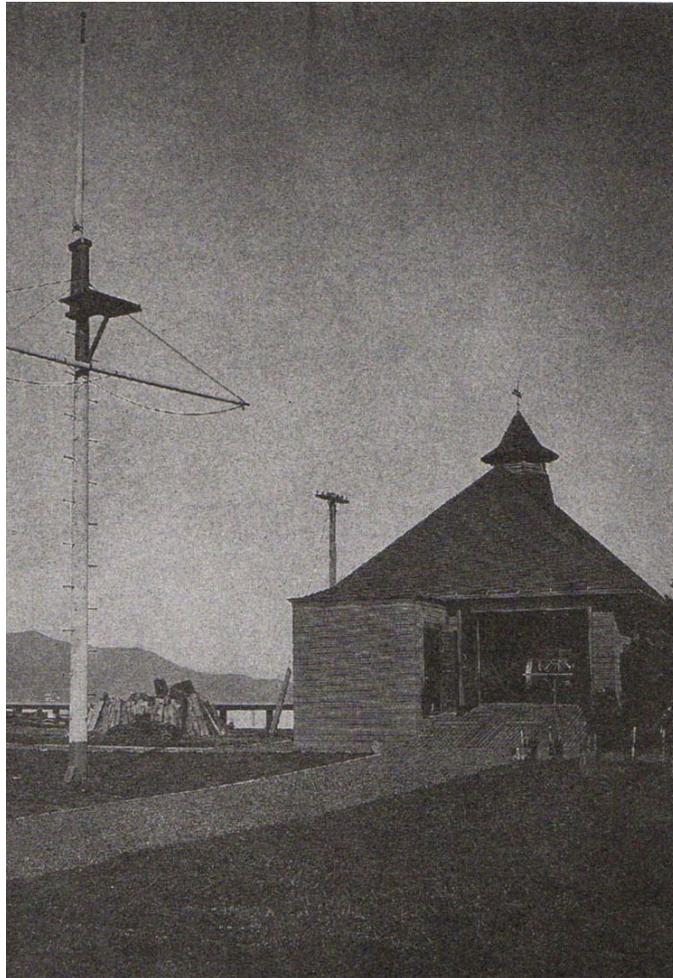
*History figure 3. Photograph of the boathouse (bldg. PE 1902) from about 1900, looking north. Note the beach apparatus wagon just inside the open door. The winch room is just to the left of it. [16]*

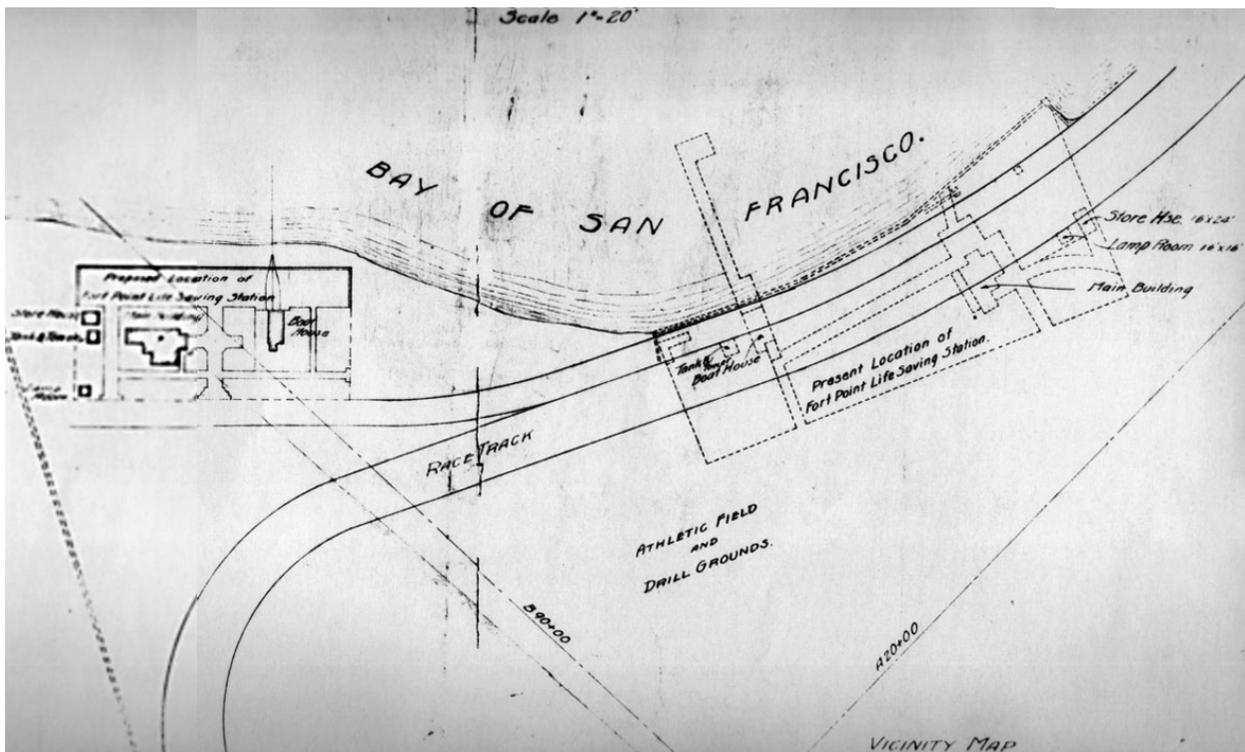
History figure 4. Map from 1914 showing proposed relocation of Fort Point Lifeboat Station 700 feet west of original site to make room for Exposition racetrack. [23]

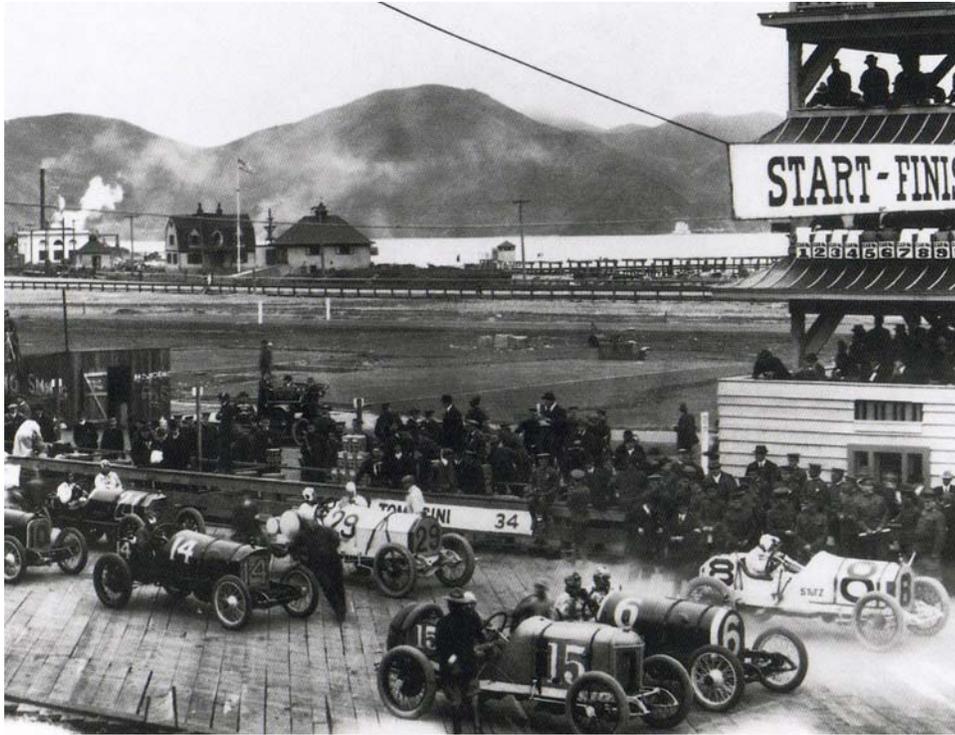
*History figure 5. Photograph of start of Grand Prix on February 27, 1915. Fort Point Coast Guard Station in its new location is visible in background. The new boathouse has not yet been built. The exposition incinerator is just visible in the upper left corner. [29]*

A photograph (*history figure 5*) of the opening of the 1915 Grand Prix auto race, the event for which the Exposition's wooden racetrack was built, shows the Fort Point Coast Guard Station in the background. [26] The race was held on February 27, one week after the Exposition opened, so work on the relocated Coast Guard Station must have only just been completed. The old boathouse can clearly be seen occupying the space intended for Fourchy's larger boathouse. The Exposition's large garbage incinerator is visible in the background to the west of the station. Like most of the Exposition structures, this building would have been demolished or removed shortly after the event closed, probably sometime in 1916. Its presence helps confirm the date of another photograph taken sometime later in which the new boathouse appears. This demonstrates that the new boathouse was completed within a year of the station's relocation. This same photograph shows that a few other deviations from Fourchy's 1914 plan also occurred. Rather than build a new structure for a proposed garage at the west side of the facility, the original boathouse was moved to the center of the western driveway and reoriented so that its main boat doors opened to the south onto Marina Drive. It now became the garage for the O-in-C Quarters. This configuration eliminated the small plaza which had been proposed in Fourchy's plan. The water tower was placed directly behind the old boathouse, and just beyond it was a fuel shed. This was probably the old 16 by 24-foot storage shed which had been moved from the original site by the Exposition. The hen house proposed in Fourchy's plan can be seen just west of the water tower. The smaller lamp room was either never relocated or had been demolished by this date. Despite the completion of the new boathouse and dormitory, the O-in-C Quarters were not immediately remodeled. The large kitchen extension appears in photographs as late as 1926 and probably remained until about 1932. Photographs from the early 1920s show other minor deviations from the Fourchy plan. Just east of the marine railway, for instance, a single, large maintenance shed was built instead of the two smaller ones proposed. This building was a simple gable-roofed structure oriented with its major axis perpendicular to the shoreline. [28] The proposed spur from the launchway to this shed was never built. Another minor deviation was the location of the wreck pole. The smaller of the two original poles was retained in 1915 as Fourchy intended, but it was installed on the beach *outside* the western boundary of the seawall rather than within it. This may have been done to increase the amount of space available for drilling with the beach apparatus. Inadequate practice space would always be a problem for the Fort Point crew after they were confined to their new location.

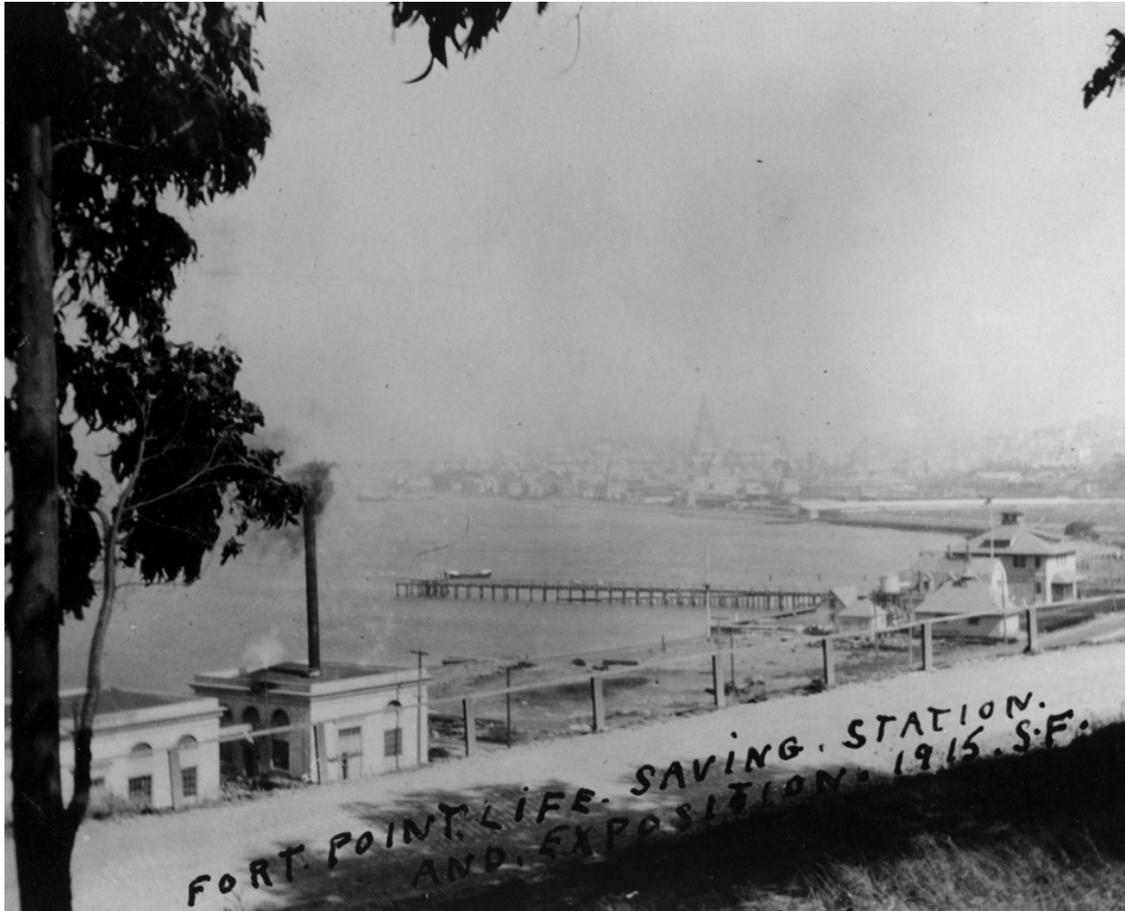
*History figure 6. Photograph of Fort Point Coast Guard Station from late 1915. The new boathouse (bldg. PE 1903) is visible in background. This is the earliest known image of the new boathouse. Old boathouse (bldg. PE 1902) has been moved to present location and converted to a garage. Exposition garbage incinerator visible in left foreground. [30]*

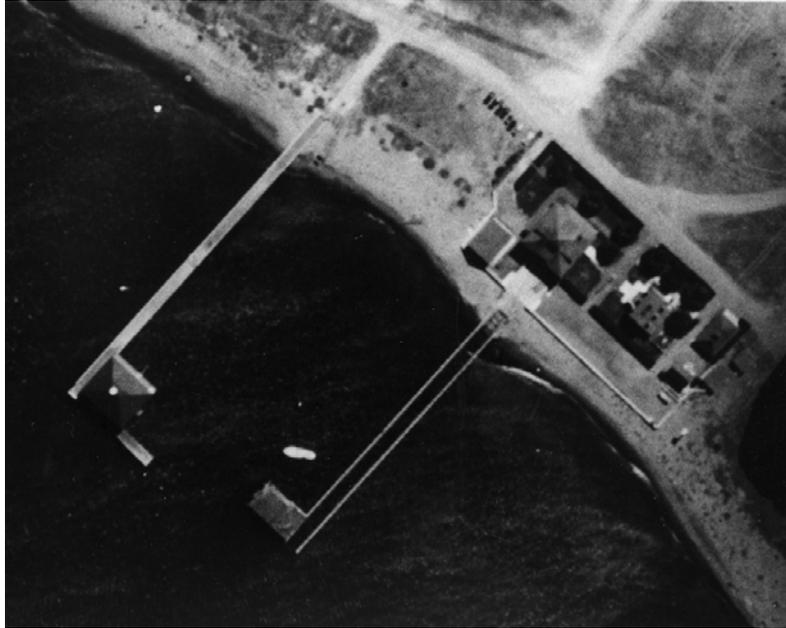
*History figure 7. Aerial photograph from about 1938. This view corresponds closely with the site plan drawn up that year. Note that old boathouse (PE 1902) has not yet been aligned with buildings PE 1901 and PE 1903. Maintenance shop (PE 1907) at head of marine railway shows original north-south orientation of roof. [34]*

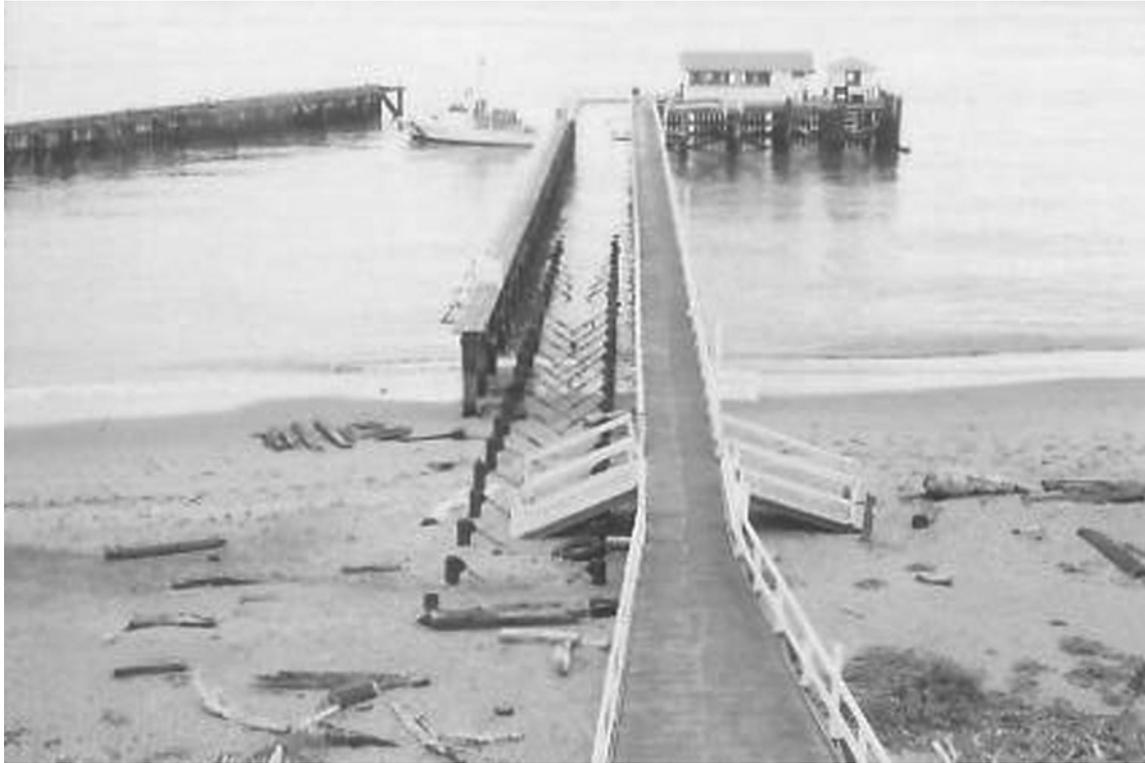
*History figure 9. Photograph of deteriorated marine railway in 1978 shortly before its complete demolition. Photograph taken by Gordon Chappell—PWR Historian. [45]*

The marine railway has not been used for over 15 years. It is in an advanced state of deterioration. All that is left of the railway itself are the pile bents. Only the easterly catwalk, which is in fair condition, is still required as access to the search and rescue boat dock. [44]

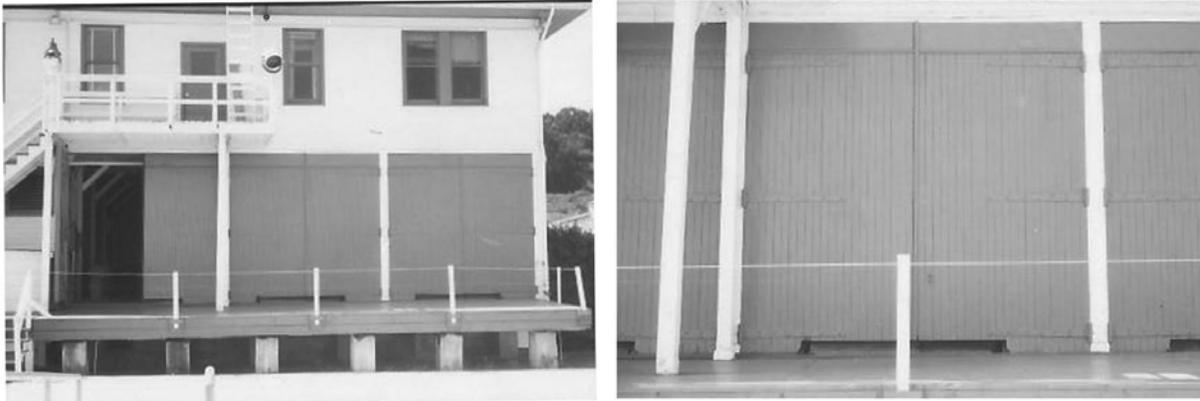
History figure 10. Photograph of main boat doors with detail, taken in 1978 shortly before their removal. Photograph taken by Gordon Chappell—PWR Historian. [48]

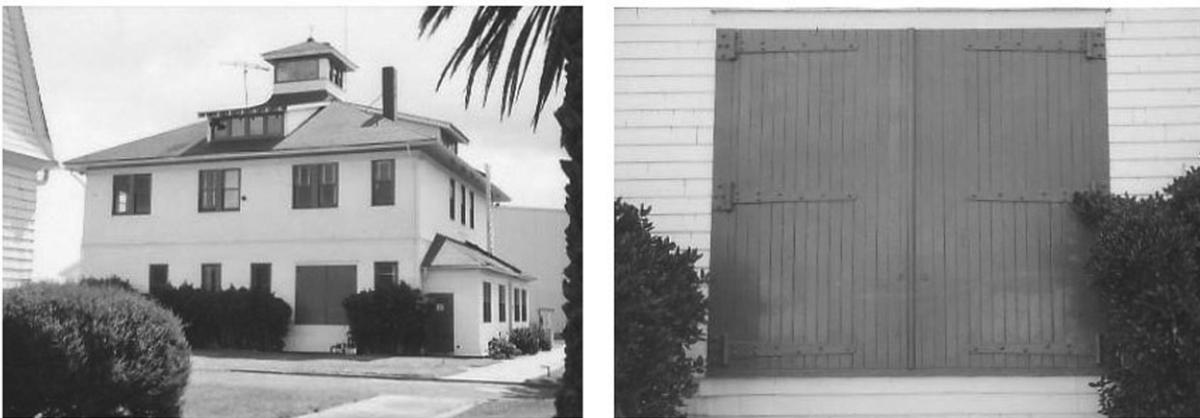
History figure 11. Photograph of beach apparatus door with detail, taken in 1978 shortly before its removal. Photograph taken by Gordon Chappell—PWR Historian. [49]
