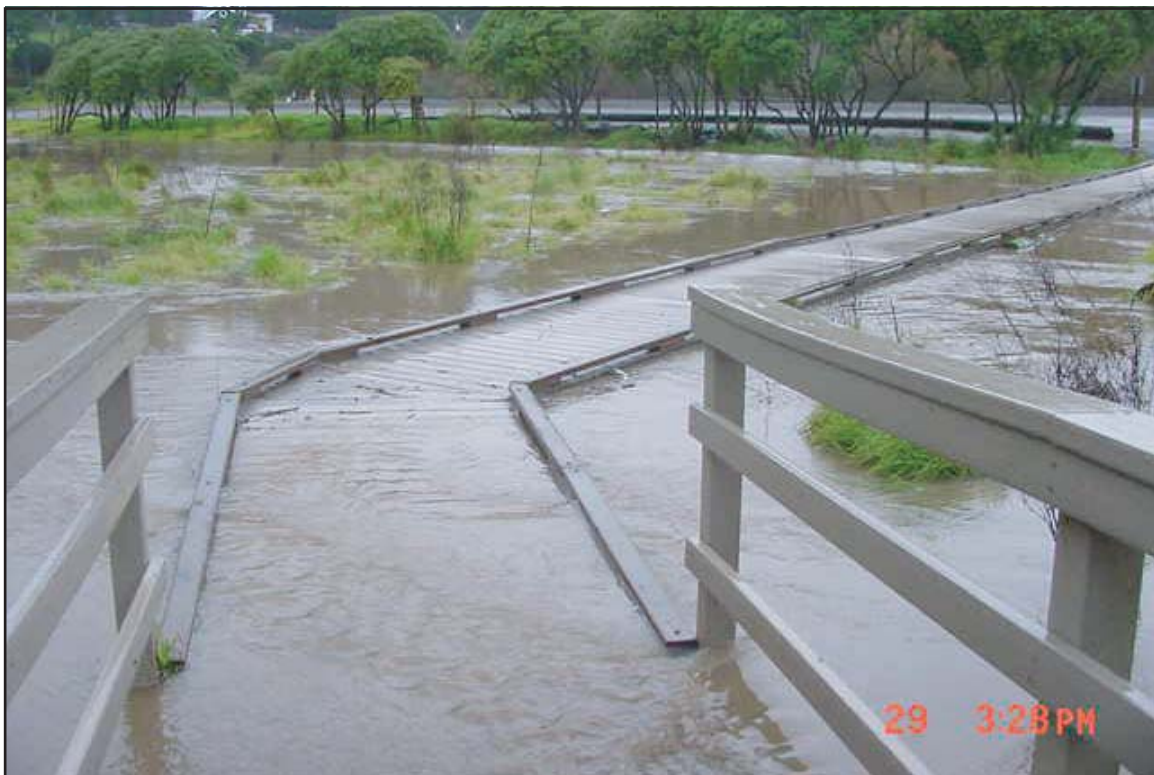
View of Muir Beach parking lot from pedestrian bridge to beach

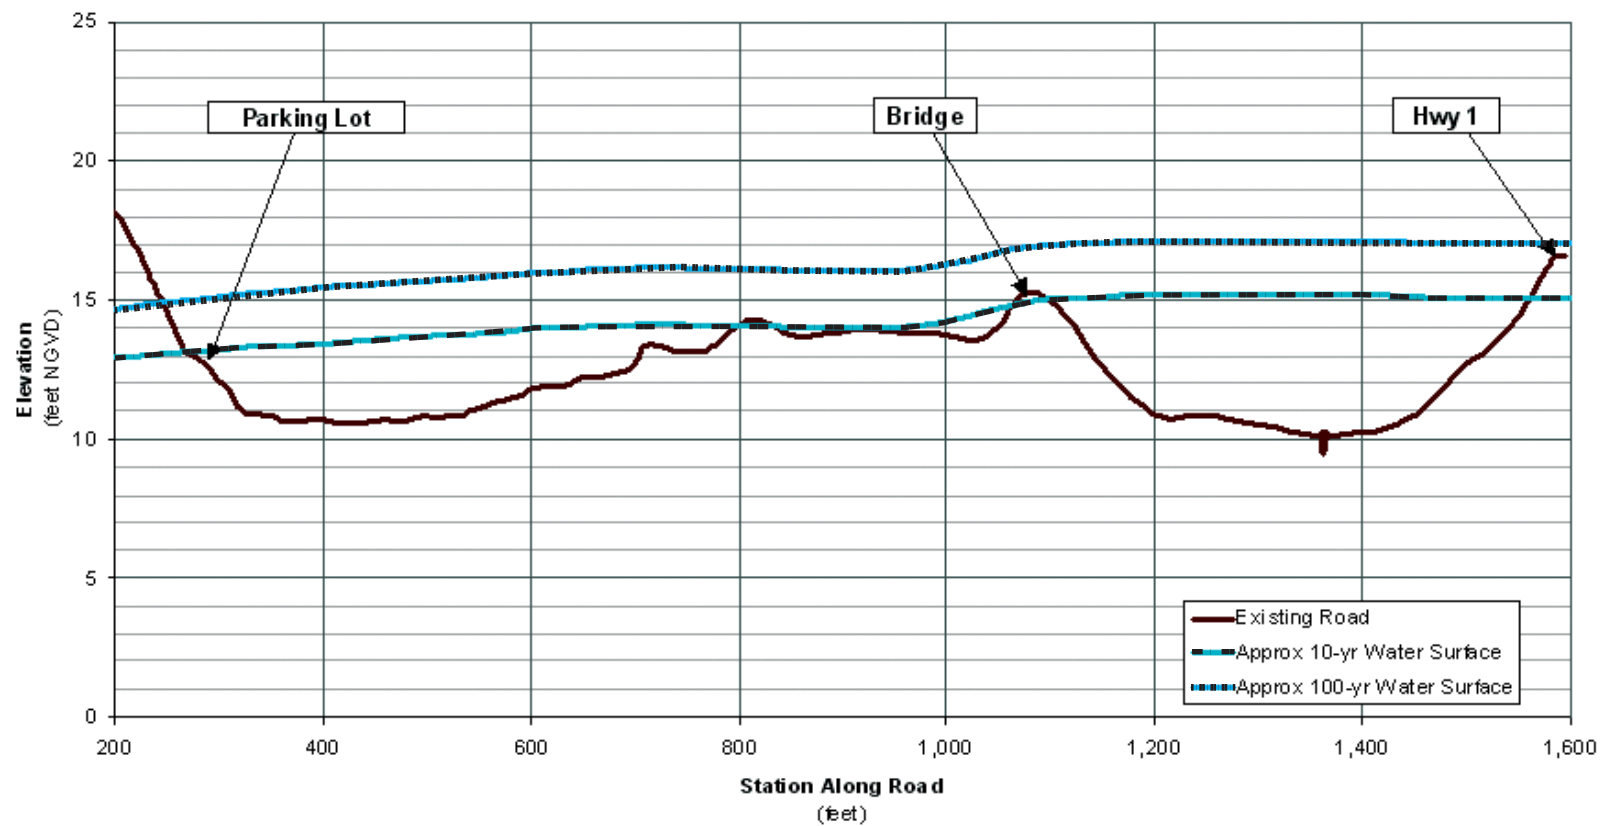
Existing Road Profile Compared to Approx 10-yr and 100-yr Water Surface Elevations for Existing Conditions
