## Wetland Statement of Findings

### Marin Headlands and Fort Baker Transportation Infrastructure and Management Plan

Marin County, California

March 2009

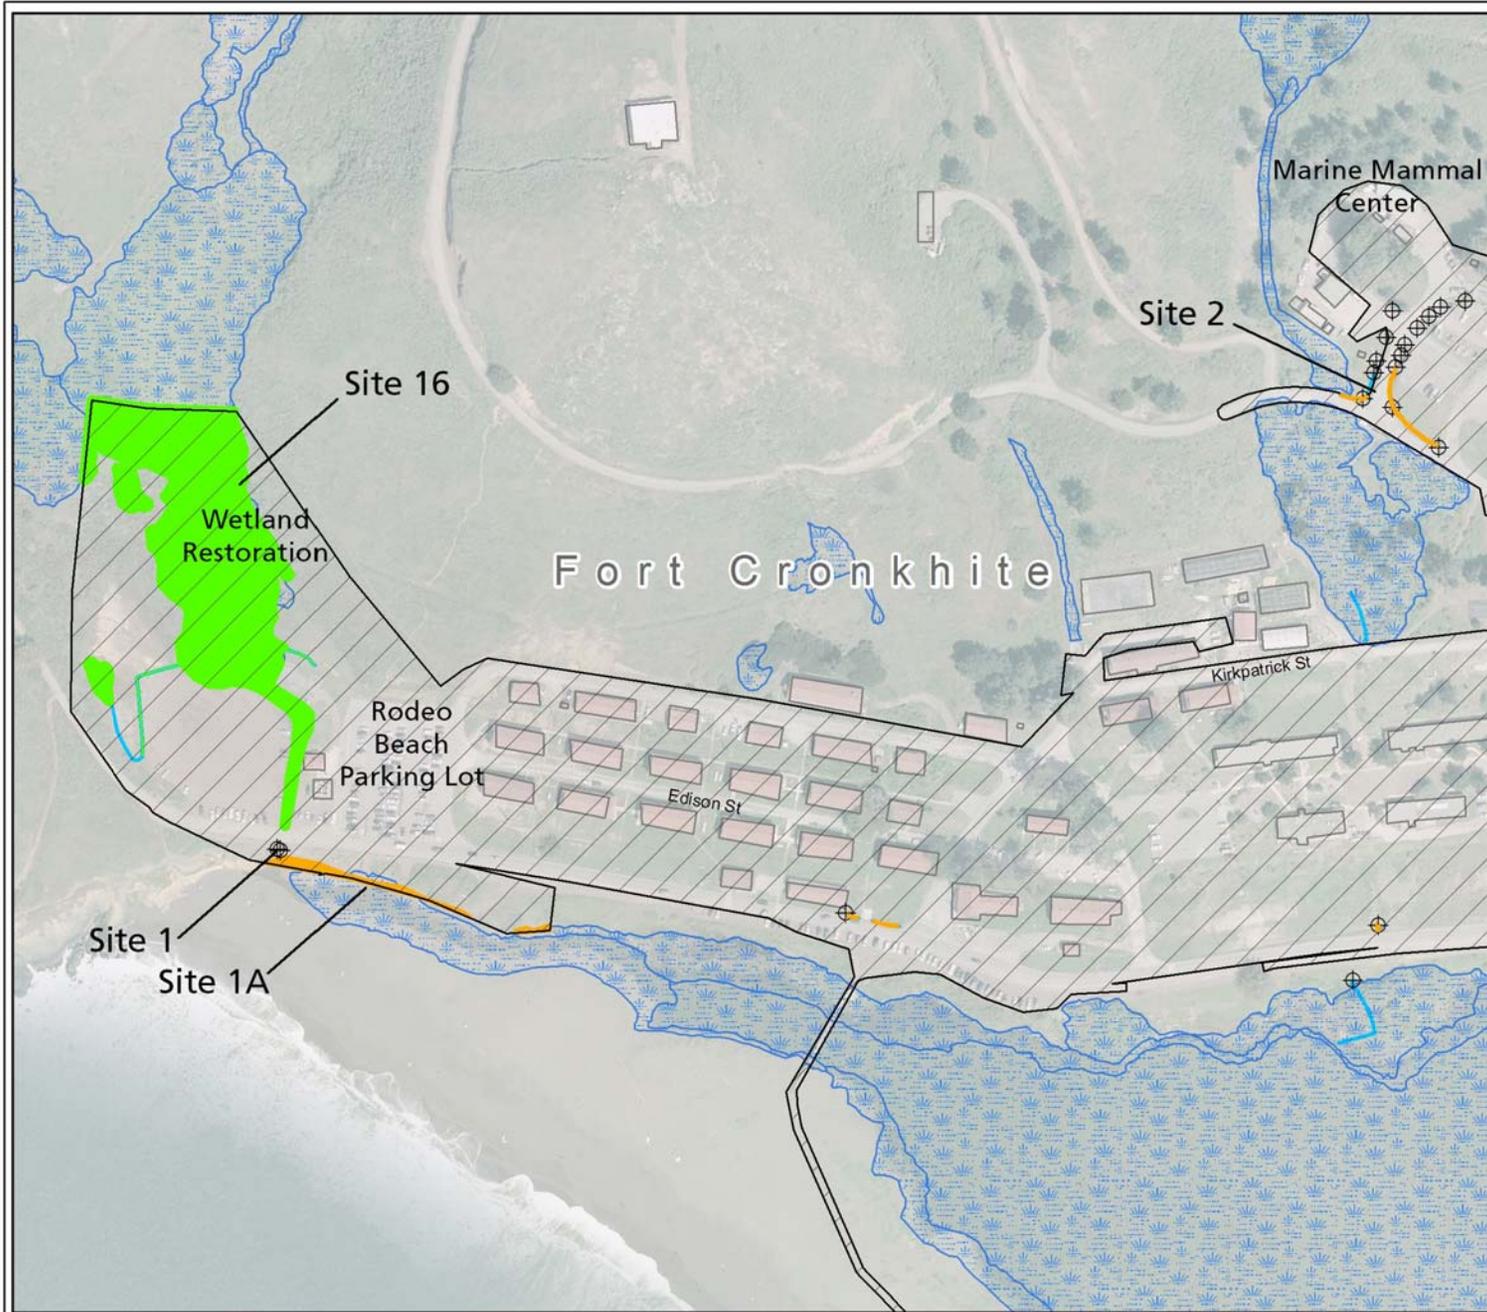
Figure 2, Fort Cronkhite West

Proposed Action: Replace the existing pair of culverts that connect the wetland at the north end of the Rodeo Beach parking lot under Mitchell Road, with Rodeo Lagoon. The design of the new culvert will be determined as the design for the wetland restoration of this area progresses. Most likely, the new culvert will be larger in diameter than the two existing, and will arch to span natural substrate along the bottom. Alternatively, Mitchell Road may span the channel on a railroad car bridge or similar structure. Under either scenario, the aquatic substrate will be substantially enhanced and restored as a habitat for aquatic organisms.

Site #	Figure #	Acres	Cowardin Class	Description of Activity
Site 1A	Figure 2	no fill	EUB - C	Install a stair pathway from Mitchell Road to Rodeo Beach
Site 1	Figure 2	0.002	PEM-B	Replace two 12-inch culverts with either a span or large arching open-bottom culvert under Mitchell Road
Site 2	Figure 2	0.008	PEM - B	Marine Mammal Center - Center curbing and gutter
Site 3	Figure 3	0.002	PEM - F	Widen pavement along Bunker Road and replace 2 culverts
Site 4	Figure 4	<b>0.038</b>	PEM - B	Remove trail crossing Rodeo Creek corridor
Site 5	Figure 4	0.145	PEM - B	Smith Road parking lot
Site 6	Figure 4	0.049	PEM-B	Construct new crossing of Rodeo Creek at Smith Road Construct 60- foot long foot/bike/horse bridge, 12 feet wide
Site 7	Figure 5	<b>0.053</b>	PEM-B	Remove crossing of Rodeo Creek corridor at Rifle Range
Site 8	Figure 5	0.004	PEM-Bd	Drainage ditch along Julian Road by Rifle Range
Site 9	Figure 5	<b>0.027</b>	PEM-B	Fisherman's Trail removed and rehabilitated.

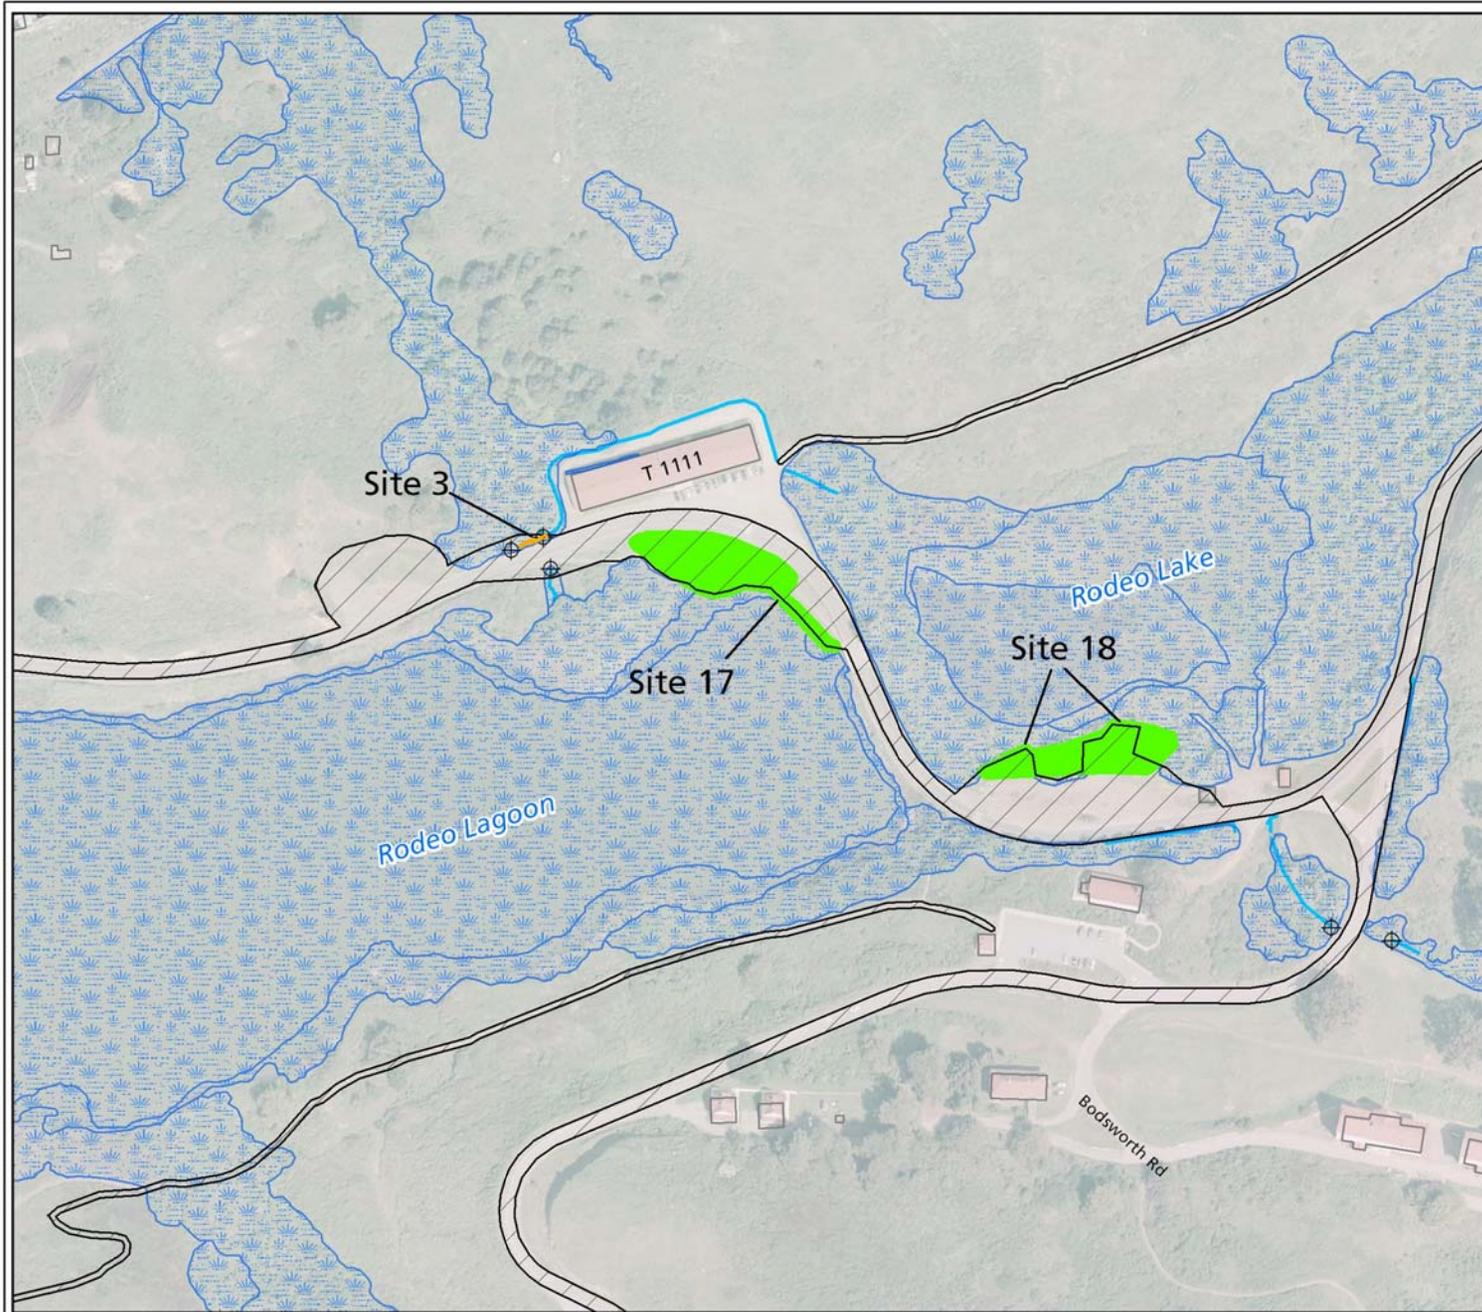
Figure 3, Rodeo Lagoon and Lake

# Wetlands Statement of Findings Sites 3, 17 and 18

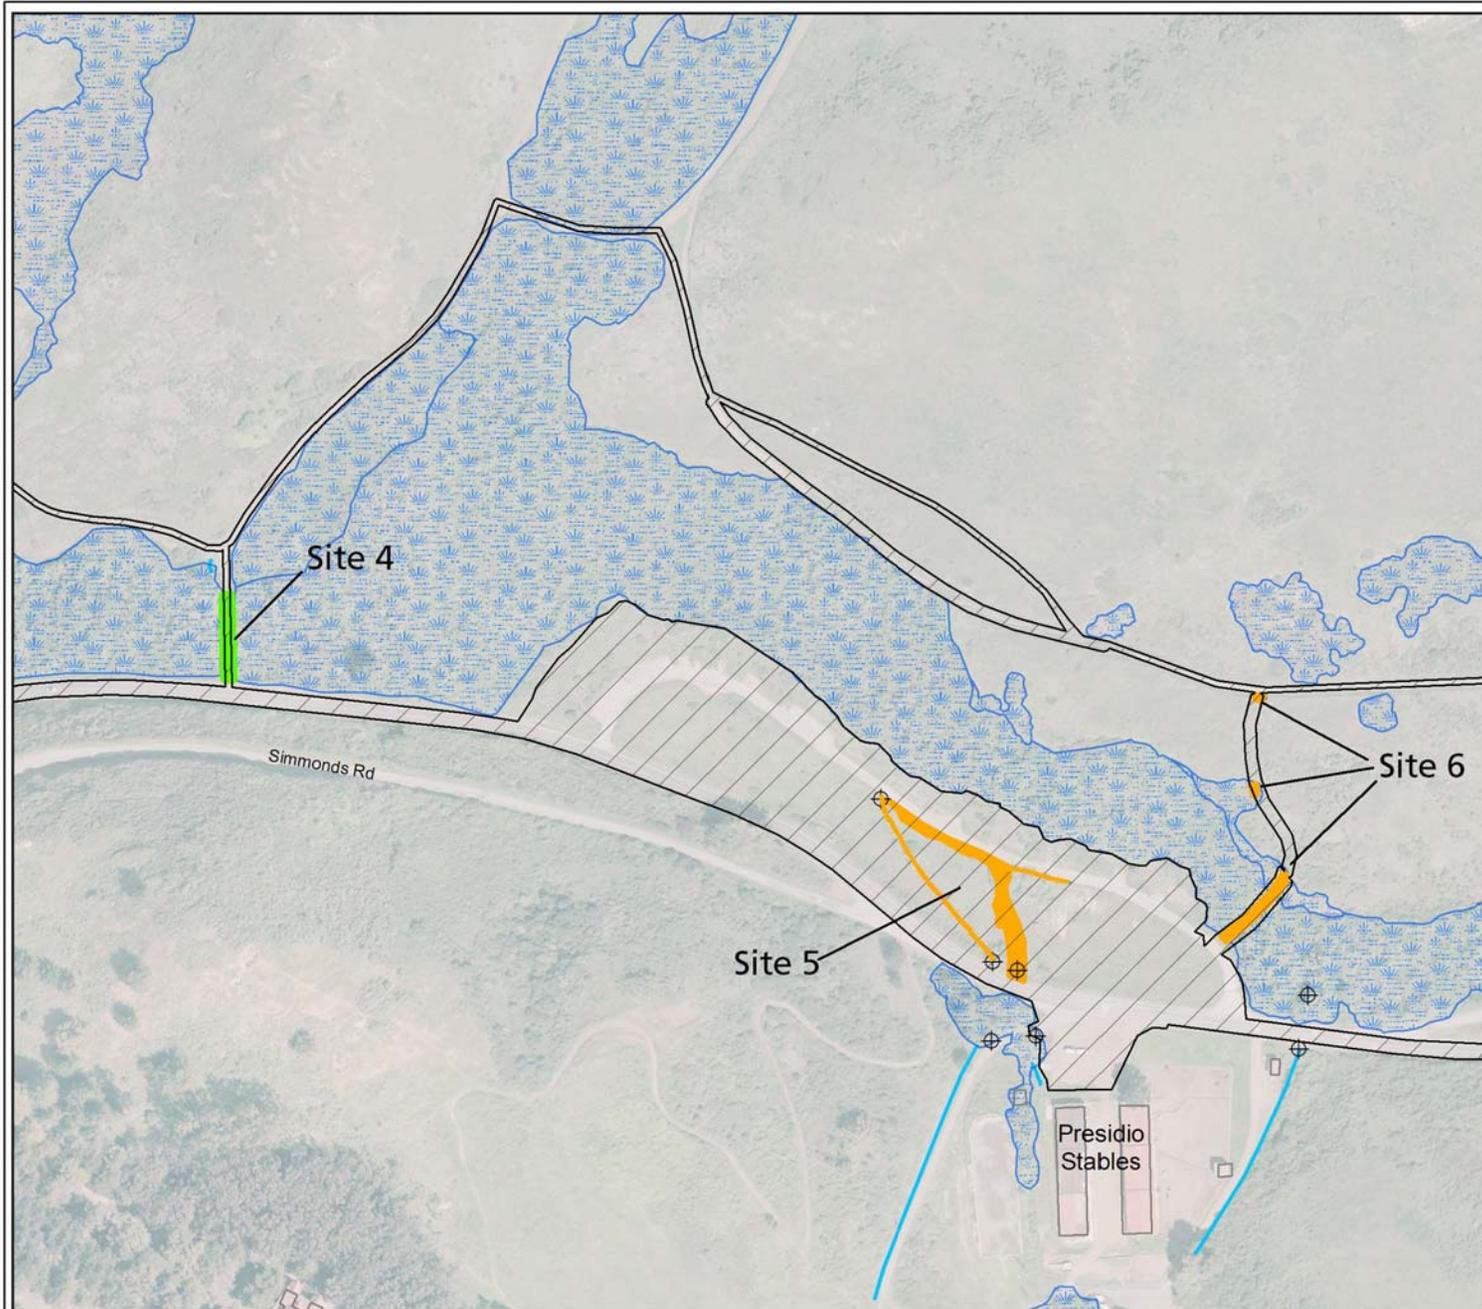
Figure 4, Smith Road

**Site 4, Figure 4:** The 6-foot wide trail and foot bridge that crosses the lower Rodeo Creek floodplain and creek channel west of Smith Road will be removed and rehabilitated to natural conditions. The trail connects Bunker Road on the south side of the creek with the Rodeo Valley and Miwok trails to the north. The existing fill comprising the trail tread will be removed so the surface will be returned to grade and the corridor restored as riparian wetland. Approximately 150 linear feet of the trail is within the mapped riparian wetland corridor. Approximate area of wetland restoration is 0.038 acre.

Proposed action: The culverts conducting runoff under Bunker Road from the channelized water courses (ditches) that drain the west side of the Rodeo Valley Stables will be replaced and reconfigured. The discharge openings on the other side of Bunker Road, which would drain on to the proposed parking lot by Smith Road, would likely be redirected slightly into either a new ditch that directed the water along the periphery of the parking lot, or diverted toward the open, unimproved portion of the site, where palustrine emergent wetlands will be enhanced/restored. Area of affected wetland is estimated at about 0.004 acre.

Wetland resource: These ditches convey the runoff that would otherwise flow through the Rodeo Valley Stables area. There is a luxuriant willow canopy in the portion of the ditch just above the culverts, a palustrine scrub-shrub wetland dominated by *Salix lasiolepis* (FACW) and *Juncus balticus* (FACW+). Ideally, the wetland vegetation will not be affected by the culvert replacement. The willows and emergent vegetation provide wildlife habitat, and take up nutrients from the runoff.

# Wetlands Statement of Findings Sites 4, 5, 6 and 19

Historic photographs of this area reveal that there was substantial moisture draining northward from the hills through the location the balloon hangar and Presidio Riding Club stables occupy today, and sustained a broad wetland and riparian corridor feeding Rodeo Creek. Built and used as a motor pool by the Army during the Second World War, today, runoff is channeled away from the developed area in two to three drainage ditches that empty into culverts under Bunker Road. The western two culverts discharge onto Site 5, and the water flows through the large ditch or contributes to sheet flow across the site descending toward the lower ditch at Smith Road. The eastern portion of the site has more sparse vegetation probably because of both poor soil quality (chert gravel fill material) and poorer hydrologic conditions, although patches of *Juncus effusus* (FACW) are scattered throughout.

The emergent wetland on this site was not previously captured as part of the Cowardin wetland mapping of the Rodeo Valley (2006). It plays an important water quality function based on its location. Being situated below the horse stables, it captures some of the sediment that washes across and under the roadway, recycles nutrients, and keeps them out of Rodeo Creek. Sheet flow across the site is retarded by the vegetation, infiltrates, and recharges the water table. At the base of the slope, at Smith Road, there is a mature willow canopy, providing shade and high quality habitat for wildlife and birds. The site offers a rare opportunity for restoration and enhancement of the wet meadow. Fill material could be removed, and the upstream culverts modified to redistribute stormwater over more of the site, and away from the drainage ditches, which could be filled in and plugged to not drain the site as they currently do. However, given the shortage of suitable parking areas available, successfully avoiding wetland encroachment at the site is probably not practicable, and thus enhancement would also be infeasible.

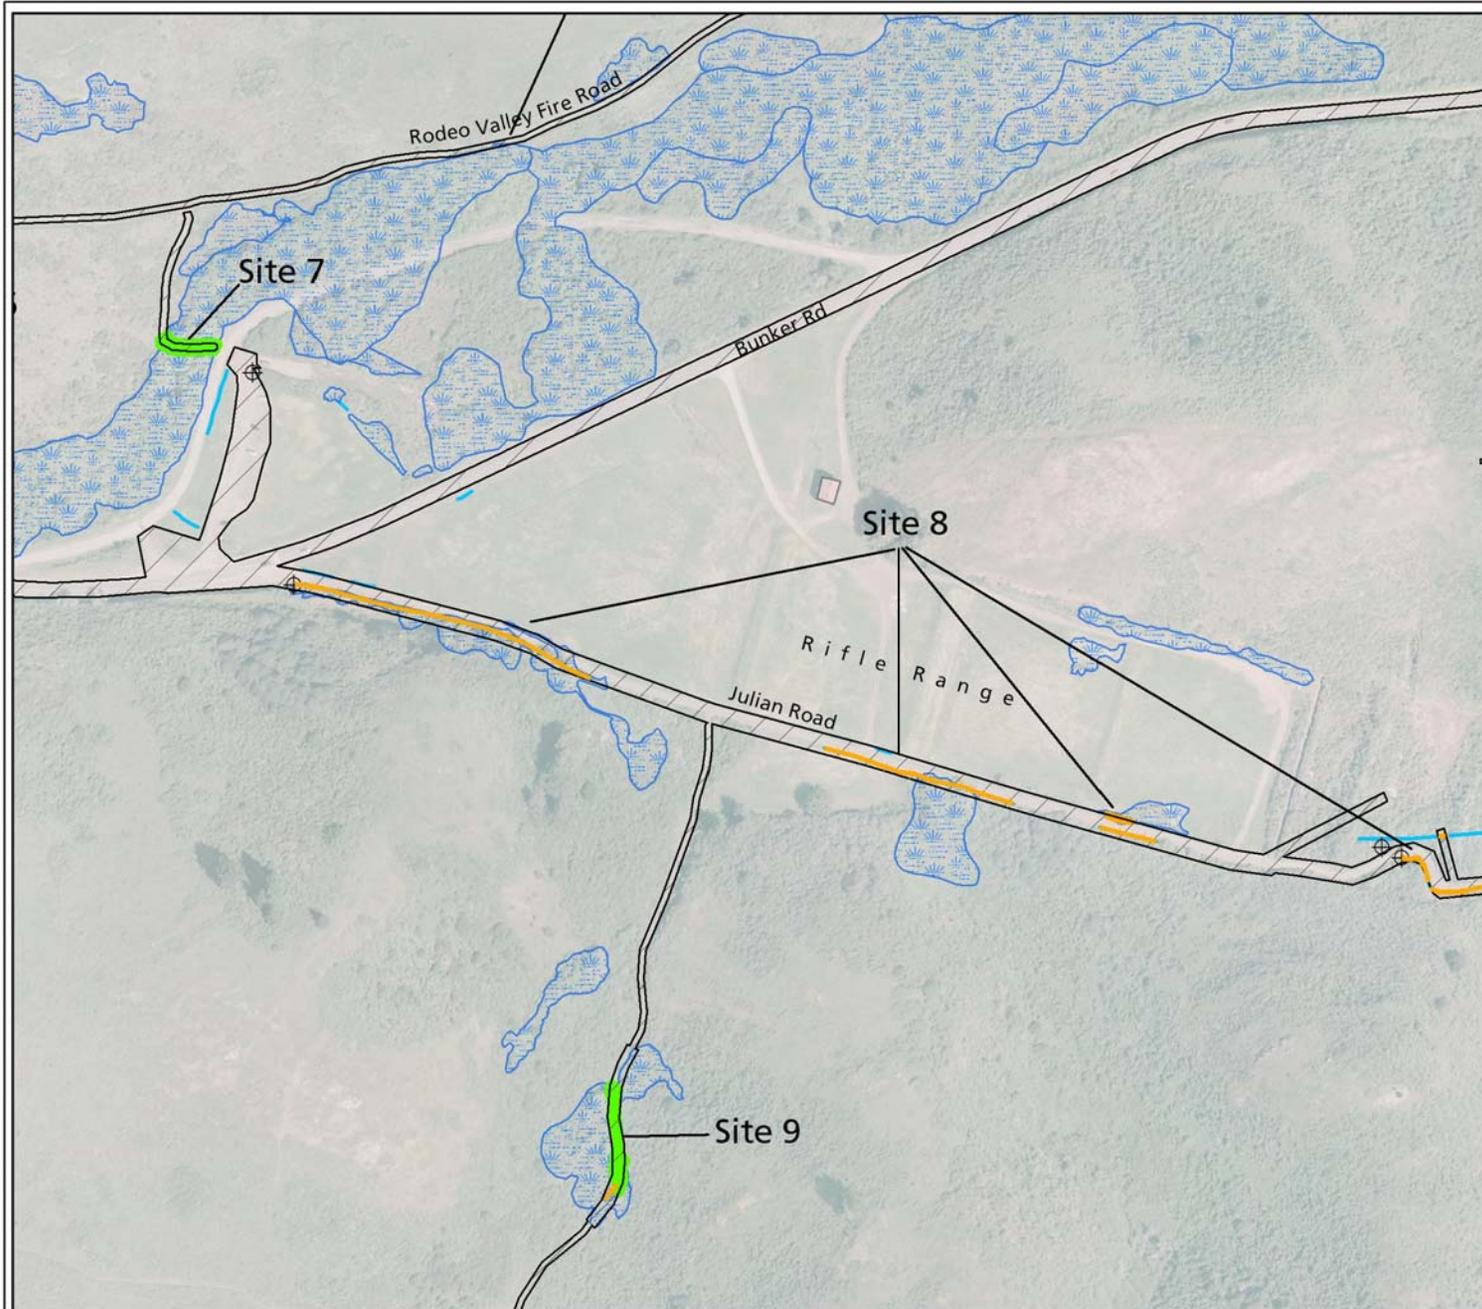
Figure 5, Rifle Range

The plan is to re-establish the inboard drainage ditch and install a new storm drain culvert under Julian Road to replace the collapsed drain. Work also includes installing a new 24-inch ditch relief culvert and inlet basin, re-establishing the inboard ditch, replacing a 36-inch drainage-crossing culvert, and installing ditch relief culverts with above-ground 15-inch down drains and energy dissipaters along the trail. Farther up the trail, there is a small hillside seep at an "s" crease in trail; one of the seeps draining toward Capehart Housing below. The proposal is to address the wet area with drainage rock and geoweb as needed. The tread would be 6 feet wide at most. The total area of wetlands affected along Julian Trail is 0.004 acre, most of which would be the conversion of a vegetated open ditch to subsurface culvert.

Wetland Resource: The drainage ditch along this road includes both vegetated and un-vegetated stretches. Dominant wetland species include slough sedge, soft sedge, and patches of arroyo willow and California blackberry. The drainage ditch serves to collect runoff from Julian Road and also likely intercepts and replaces some natural small drainages from both the slope to the south and east, and that which come off the rifle range itself, portions of which are clearly palustrine emergent wetlands themselves. Rehabilitating the culverts on Julian Road will likely

# Wetlands Statement of Findings Sites 7, 8 and 9

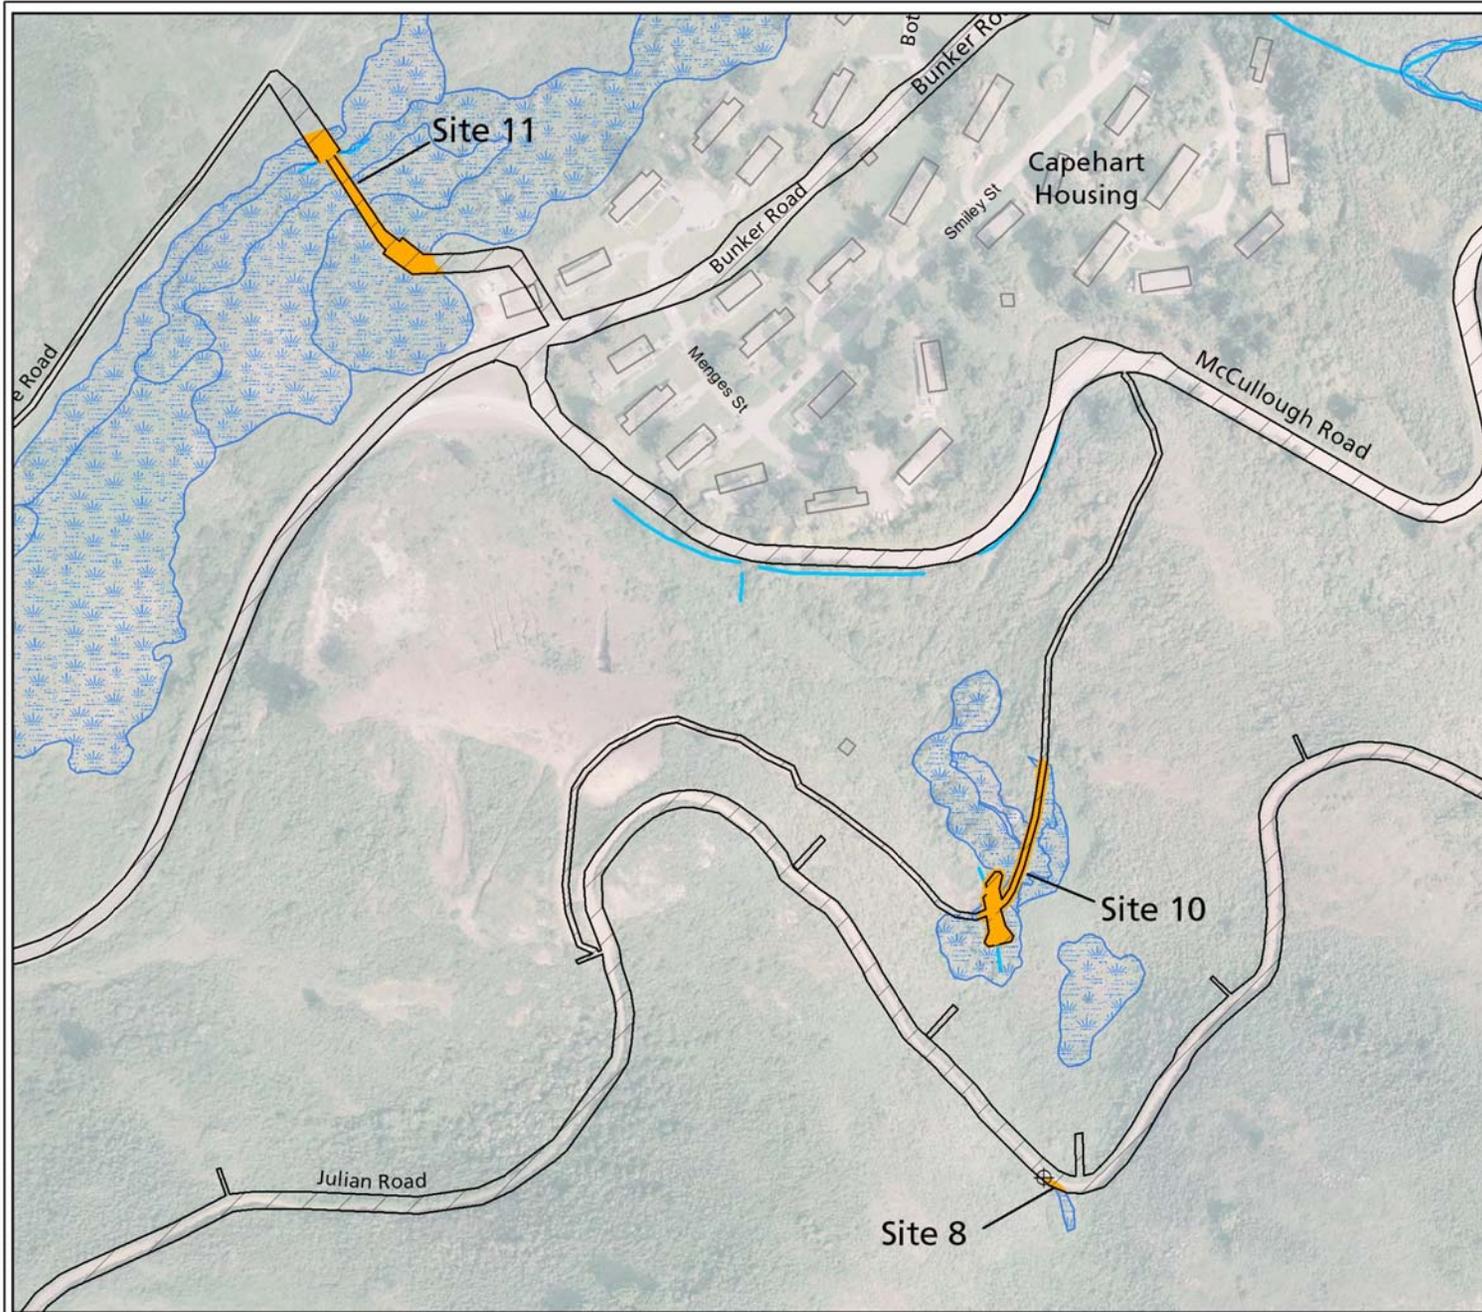
Figure 6, Capehart Housing

# Wetlands Statement of Findings Sites 8, 10 and 11

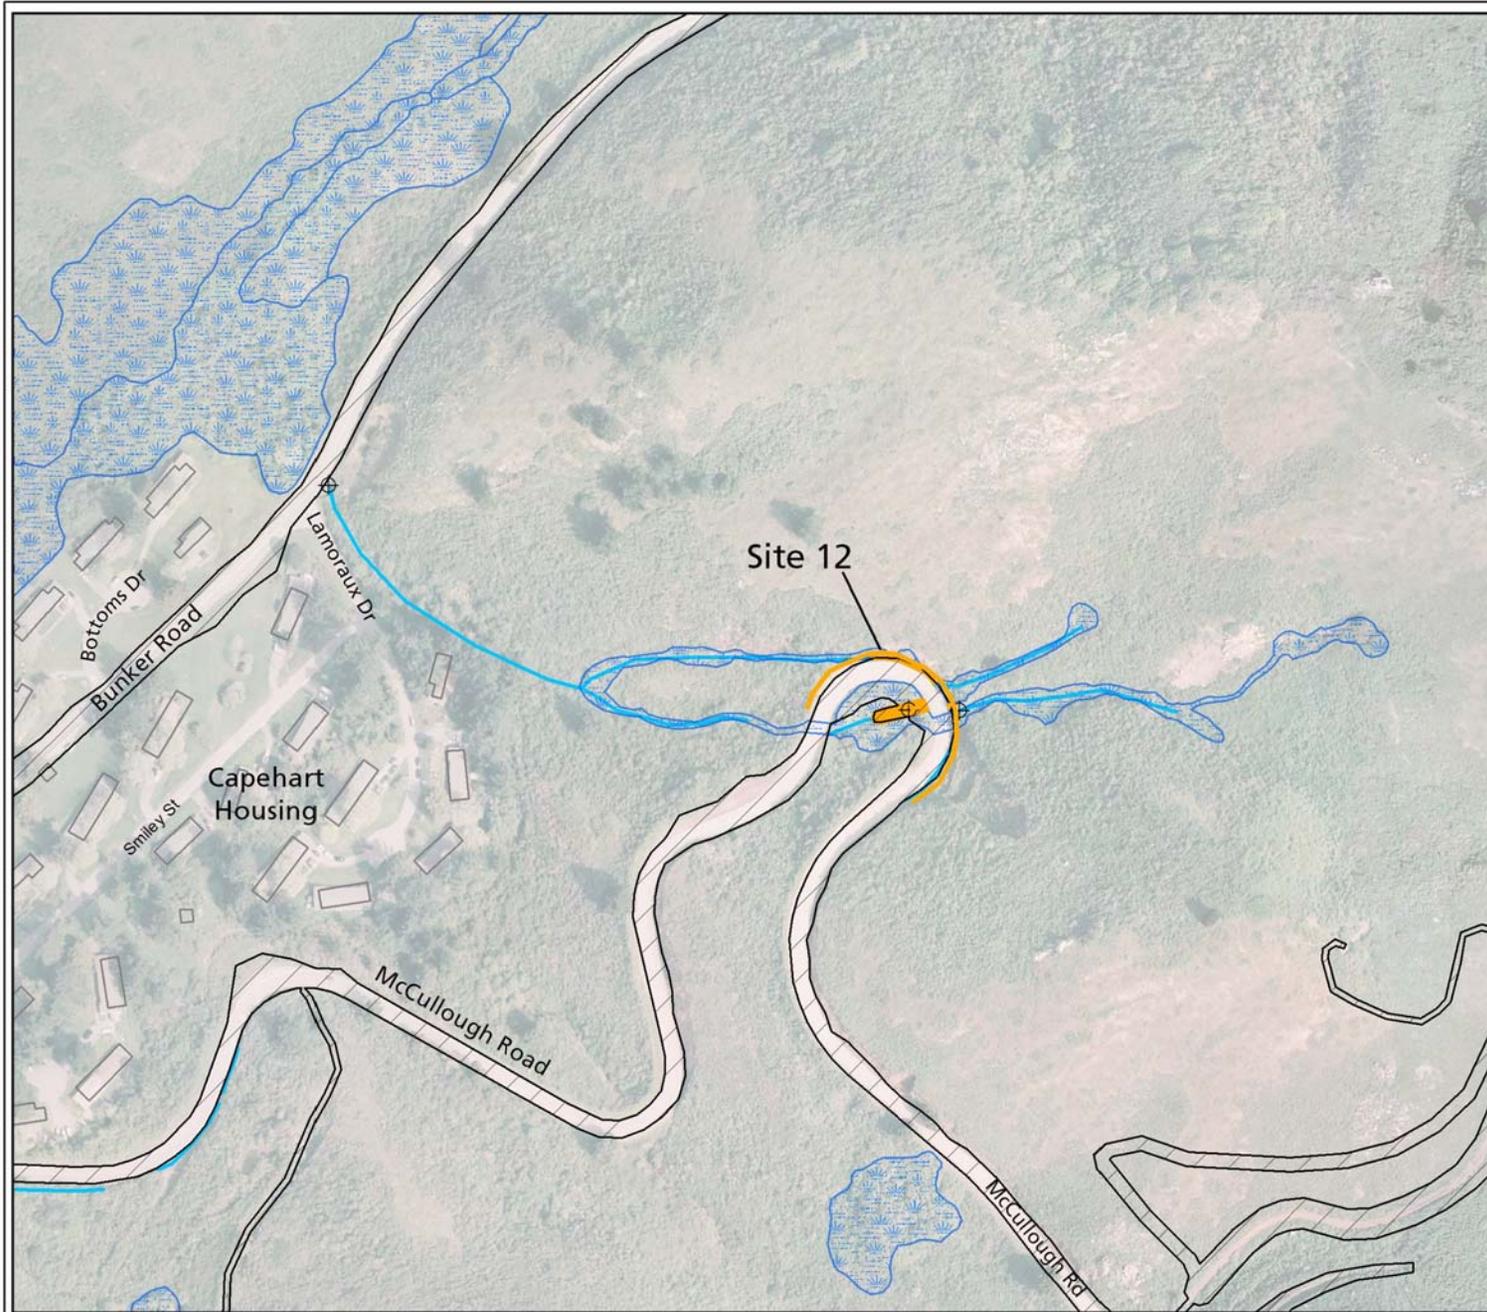
Figure 7, McCullough Road

Proposed Action: McCullough Road pavement will be widened by 1 foot on each side of centerline for bicycle safety, from 22 feet wide to 24 feet, except on the switchback corner where the pavement would be further widened to accommodate large vehicles such as buses in their respective lanes. FHWA drawings indicate the curve will be widening a total of about 7 feet and cleared and graded to improve line of sight, 40 feet from centerline. Wetland ditches on the outside of the road will be deepened and redefined. The culverts under the road will be replaced. The berm in the center of the curve will be removed for sight distance and to improve drainage. It appears that the willow canopy in the center of the curve will also be substantially cut back, and not allowed to re-attain its current density. There will need to be continued thinning in this area to keep the vegetative cover low, especially given the amount of moisture passing into this area that supports the current thicket. The earthwork in the center of the curve will impact the ravine in the center of the curve. The wetland channels/ditches on the outer edge of the curve will also be regraded and probably realigned slightly but left open so the vegetation can reestablish. The area of affected wetlands is difficult to estimate but will likely be about 0.011 acre.

Wetland resource: The hairpin curve was cut through the complex of two drainages with associated palustrine vegetation when it was constructed. This wetland complex continues downslope to Capehart Housing where it is diverted through a series of ditches and culverts before emptying into Rodeo Creek. The small channels foster semi-permanent flows and palustrine scrub-shrub emergent wetland. Dominant vegetation includes arroyo willow (especially in the center of the road curve), Pacific small-reedgrass (*Calamagrostis nutkaensis*, FACW), coyote brush, California blackberry and giant vetch. Groundwater seeps from shallow bedrock supply the semi-perennial flows, with much of the water diverted to a swale along the outside of the curve. One of the two small channels flows through a culvert under the road and into the center of the curve, supporting the luxuriant willow canopy that obstructs the line of sight of motorists around the curve.

# Wetlands Statement of Findings Site 12

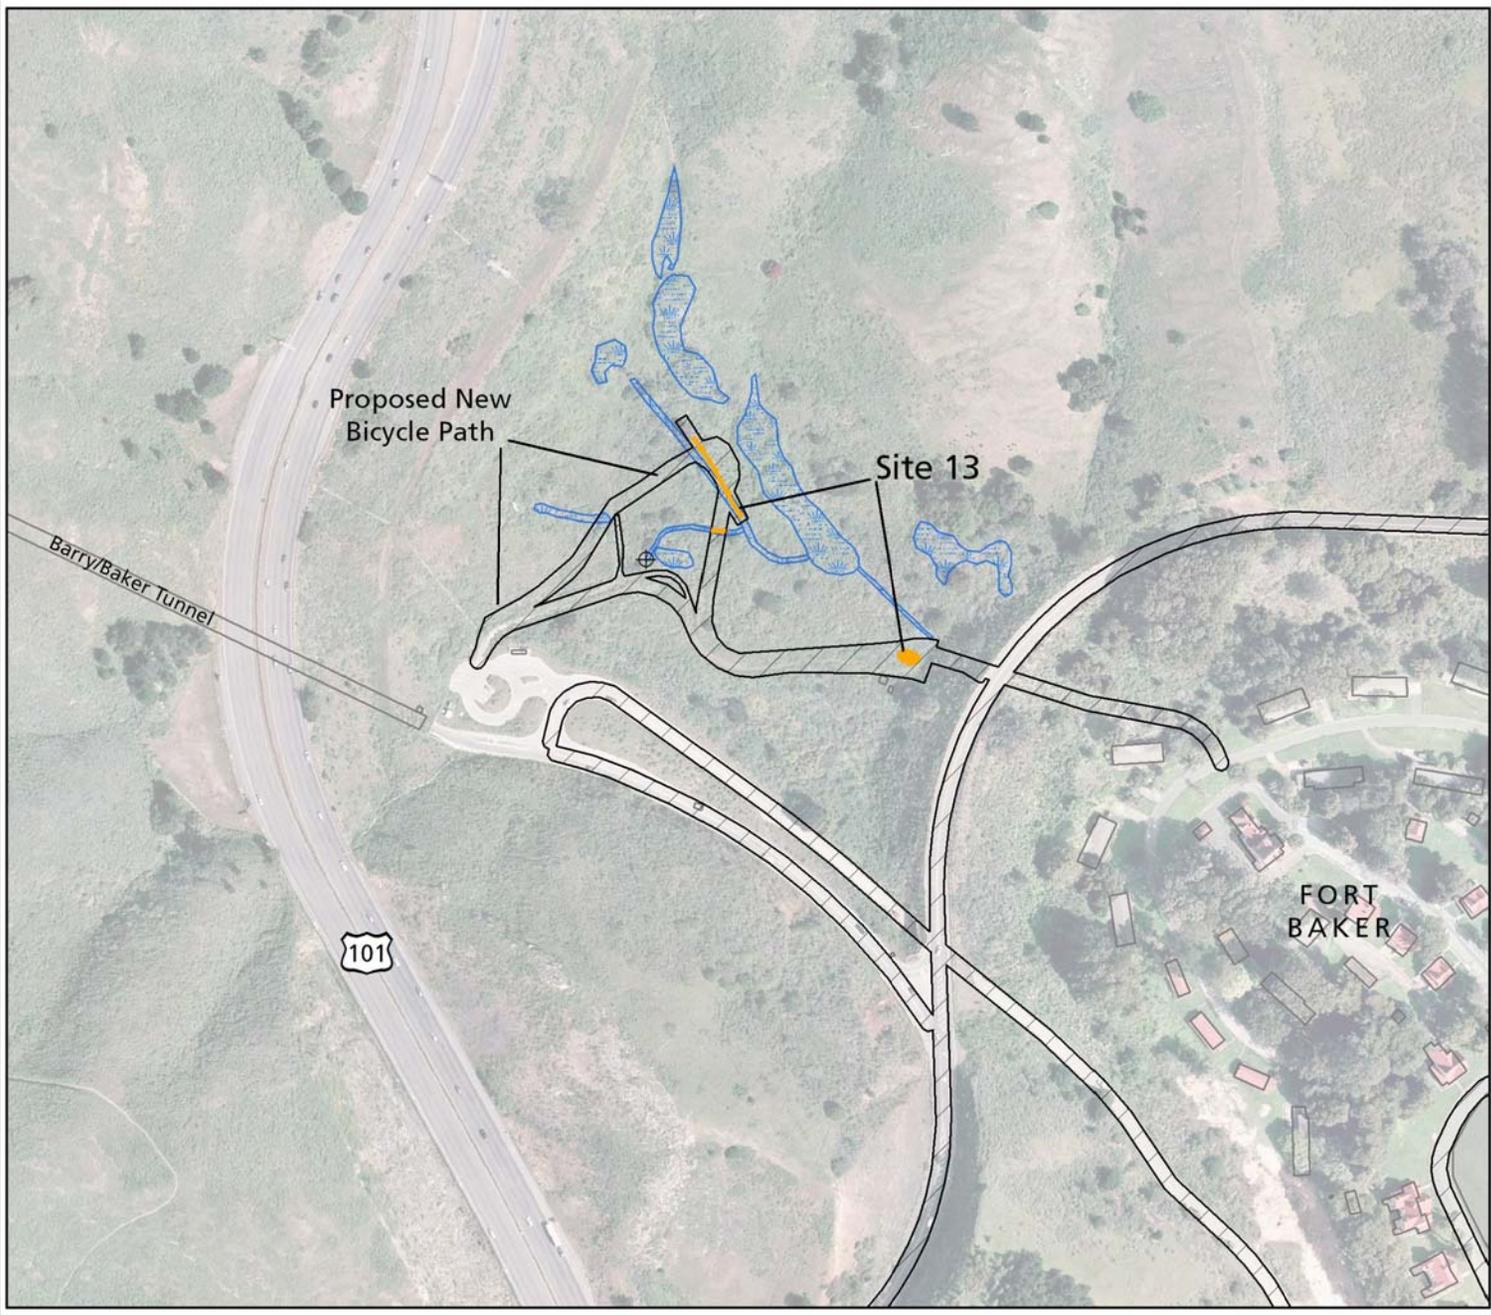
Figure 8, Fort Baker Bike Path

# Wetlands Statement of Findings Site 13

- Potentially Impacted Wetland
- Restored Wetland
- Project Study Area
- Cowardin Wetland (Outside of Study Area)
- Culvert

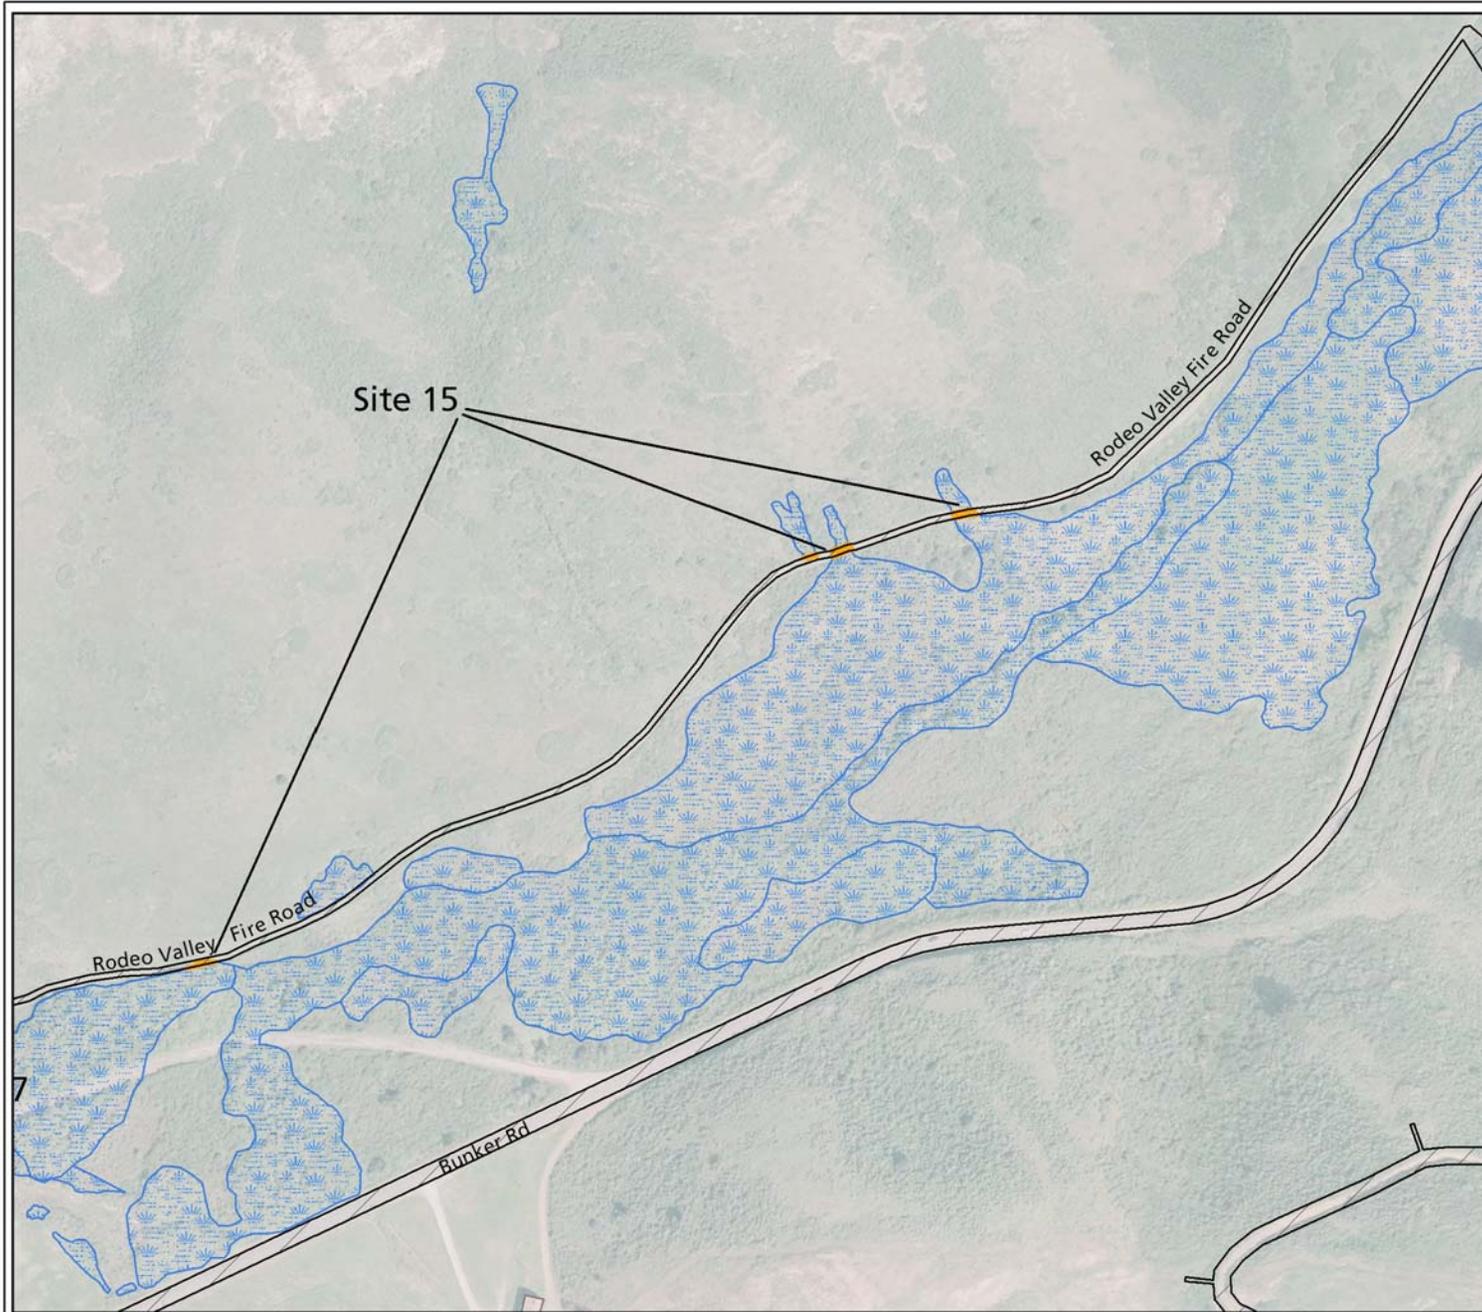
Figure 10, Rodeo Valley Fire Road

# Wetlands Statement of Findings Site 15

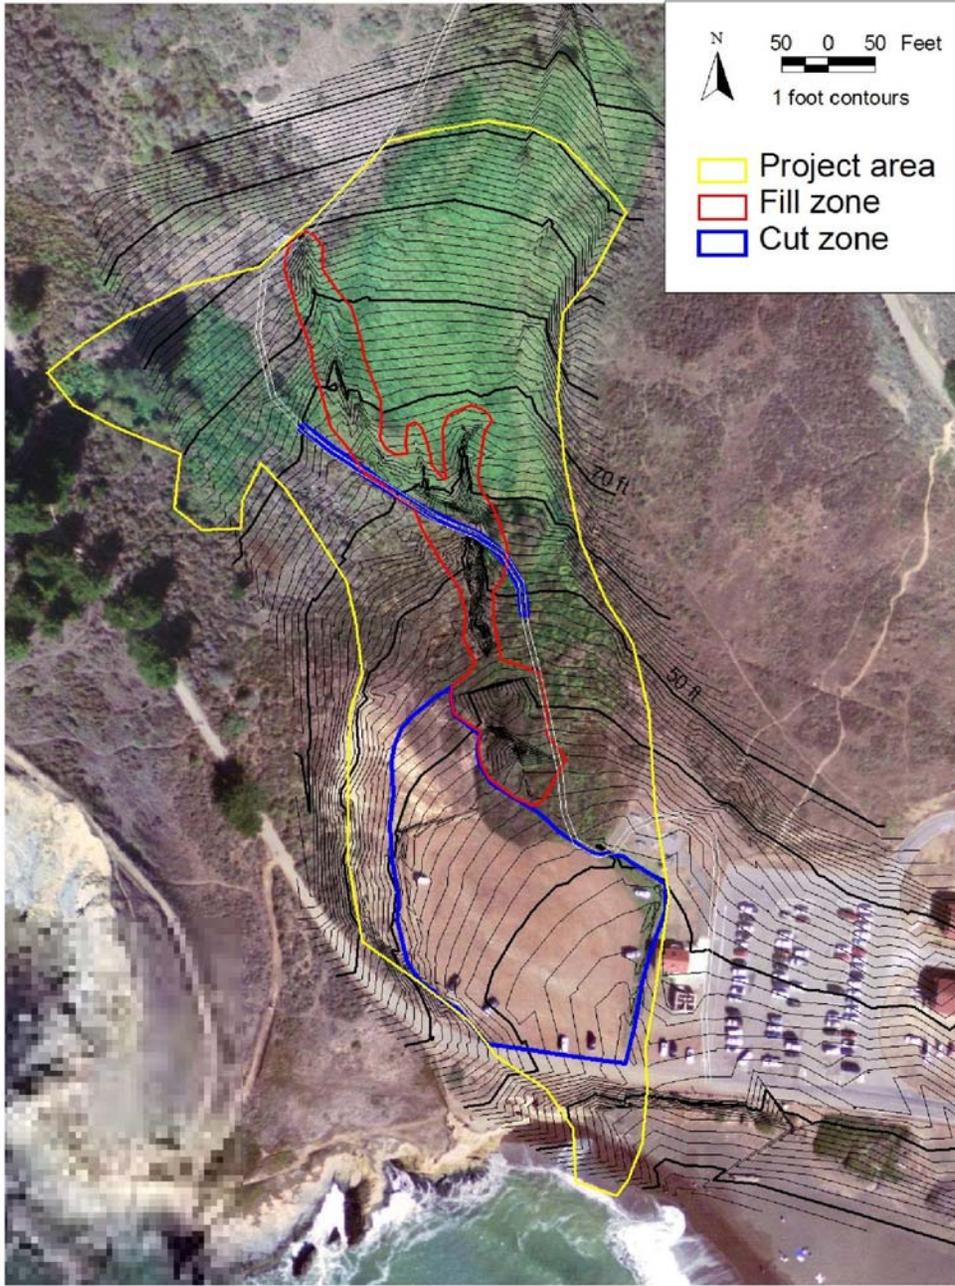
Figure 11, Rodeo Beach

Figure 11 shows the restoration project area in yellow which covers about 8.5 acres altogether. The design of this restoration project is in progress so all acreage estimates are very approximate. Essentially, about 0.9 acre of wetland, shown in red, will be filled with suitable substrate to negate the substantial gullies and surface irregularities caused by past site human alternations (0.74 acre of these are currently wetland). The area to be filled is shown in red, and the 1.6 acres to be excavated are shown in blue. All of the filled or excavated areas will be restored as wetlands, though some will shift from shrub to emergent. About 1.3 wetland acres from what is now upland parking lot will be converted back to wetland. As of October 2008, it is projected that NPS would replant about 3.8 acres of wetlands from above the farm road down the slope to underneath Mitchell Road, which will span the newly recreated wetland.

### Proposed Wetland Restoration Rodeo Beach Parking Lot

Essentially, potential restoration sites within the Rodeo watershed were evaluated in the past, and the restoration of the Rodeo Beach parking lot (Site 16, Figure 2) appears to provide the greatest opportunity for wetland restoration with the fewest constraints (Shaw 2005). The NPS recently arranged to have a conceptual wetland restoration design and guidelines developed for the Rodeo Beach parking lot by a team of wetland scientists from Colorado State University, in cooperation with GGNRA specialists. The goal is to recreate the natural conditions which were present prior to the Army's filling of wetlands for roads and parking,

Under current conditions, Mitchell Road forms an impervious, static barrier between Rodeo Beach and upslope areas. Historic Coast Geodetic Survey maps from the 1850's show dunes extending into the lower portion of the unpaved parking lot. It is doubtful that these "dunes" were from wind-derived materials given the coarse materials present on Rodeo Beach. The natural condition of the shoreline would likely have been an alternation between active scarps in relict washover terrace deposits or alluvial fan deposits, and partially infilled, re-vegetated scarps (Baye 2006).

Replacement of existing road fill and culverts with a free-spanning structure at Mitchell Road will result in long-term, moderate benefits depending upon the length of the free-spanning structure. Beneficial impacts could include the development of dynamic banks cut into temporarily stabilized washover terraces formed by storm events. Aesthetic improvements will also result from the removal of road fill in this shoreline area, affording visitors a visual connection with the Pacific Ocean, beach, and upslope wetlands.
