Hunter Hereford Completion Report

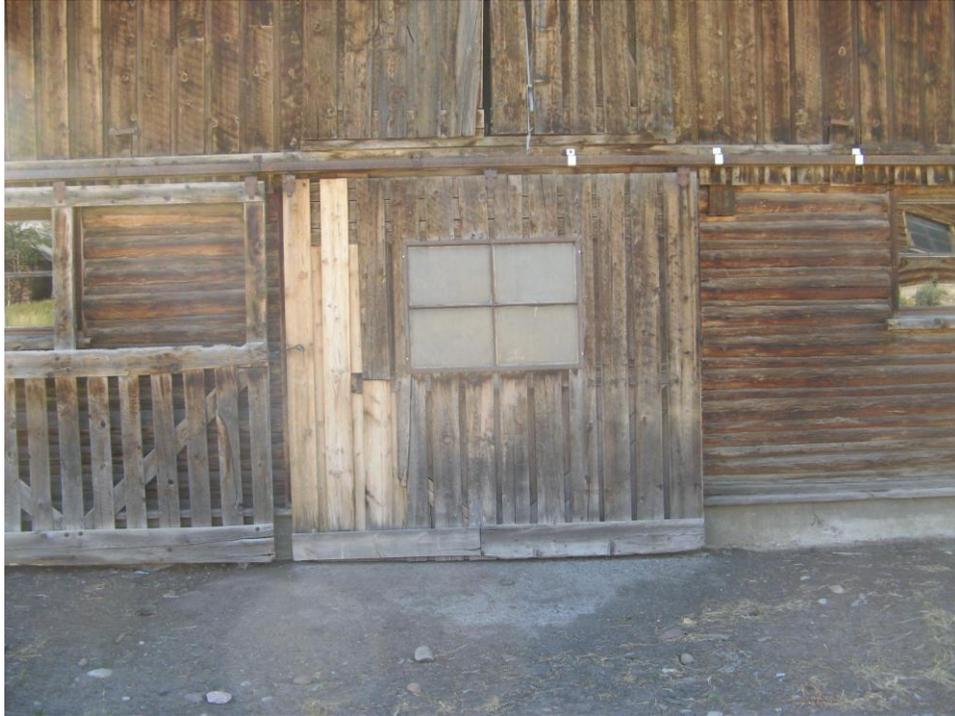
Repaired winter door on front side of Barn

- the front winter door of the Barn was repaired and realigned on the sliding track
- the front summer door was secured on the sliding track to the side of the winter door
- the upper door on the front side of the Barn was repaired
- glass was replaced and glazed where missing on the Barn windows
- roofing felt and rolled roofing were replaced on the loafing shed on the south side of the Barn
- the gate on the east side of the loafing shed was re-erected and repaired

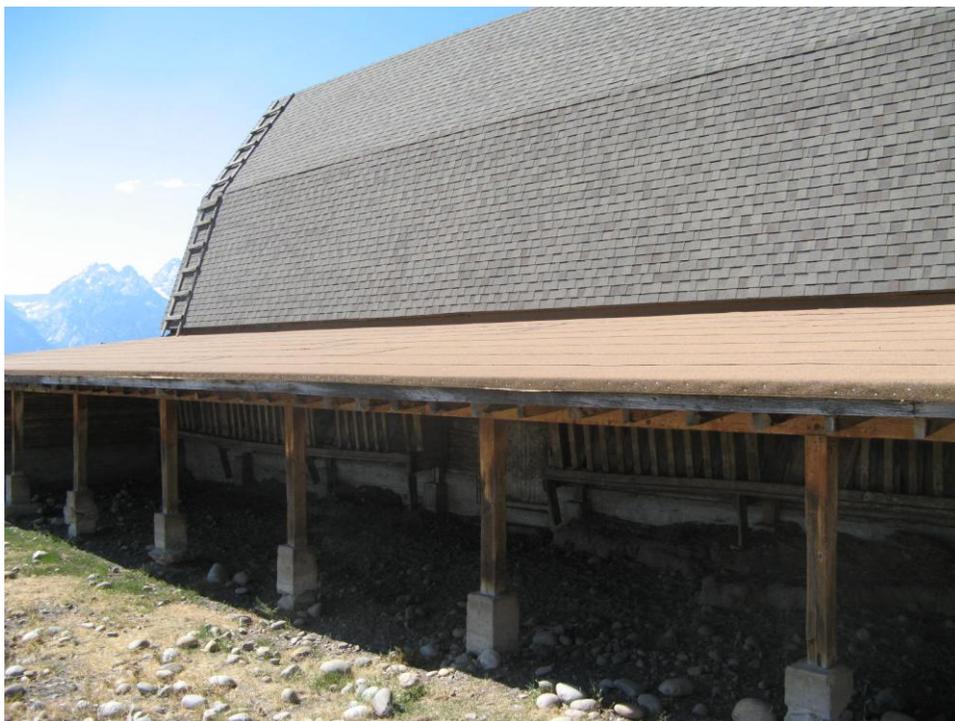
New rolled roofing on loading shed

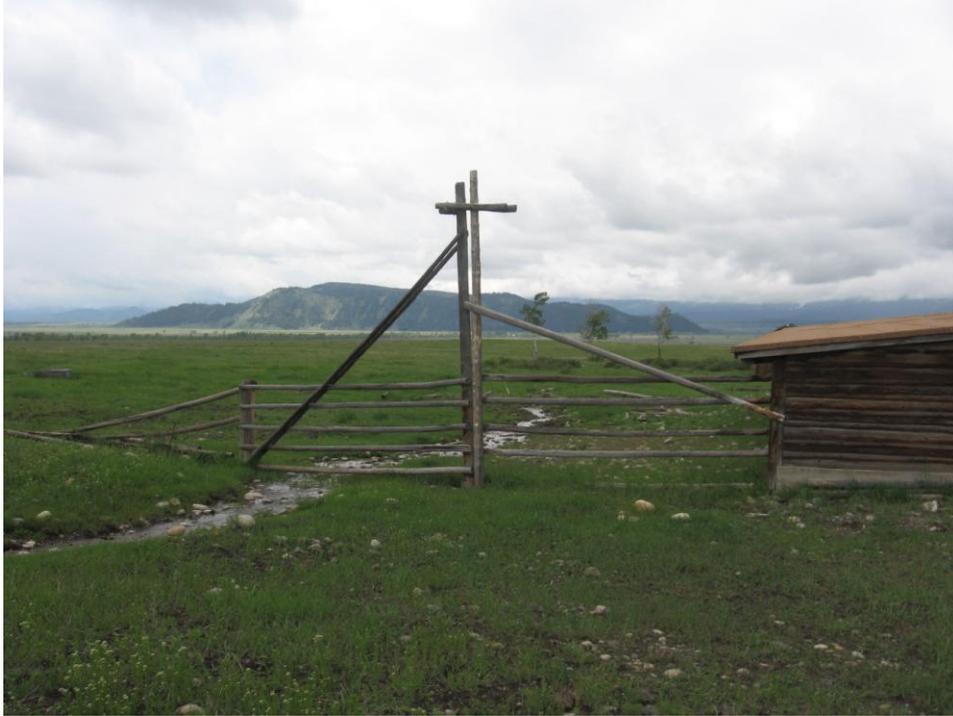
Repaired gate on east side of loafing shed

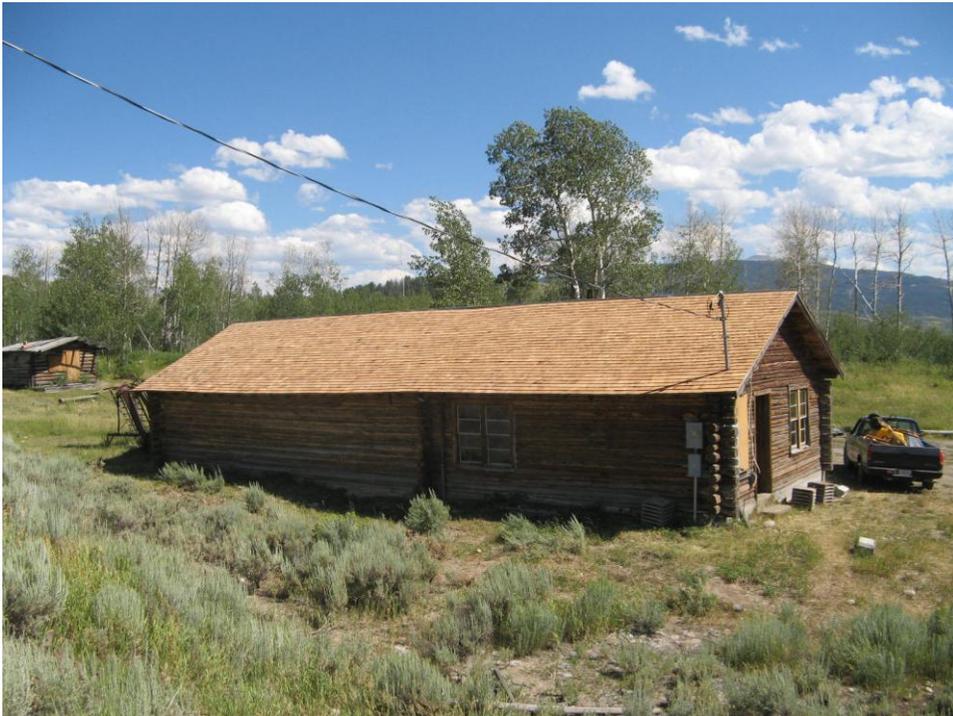
New shingle roofing on Garage north elevation

- the north elevation was re-shingled with #1 Chemco treated (fire retardant) 16" wood shingles
- a new ridge cap was installed

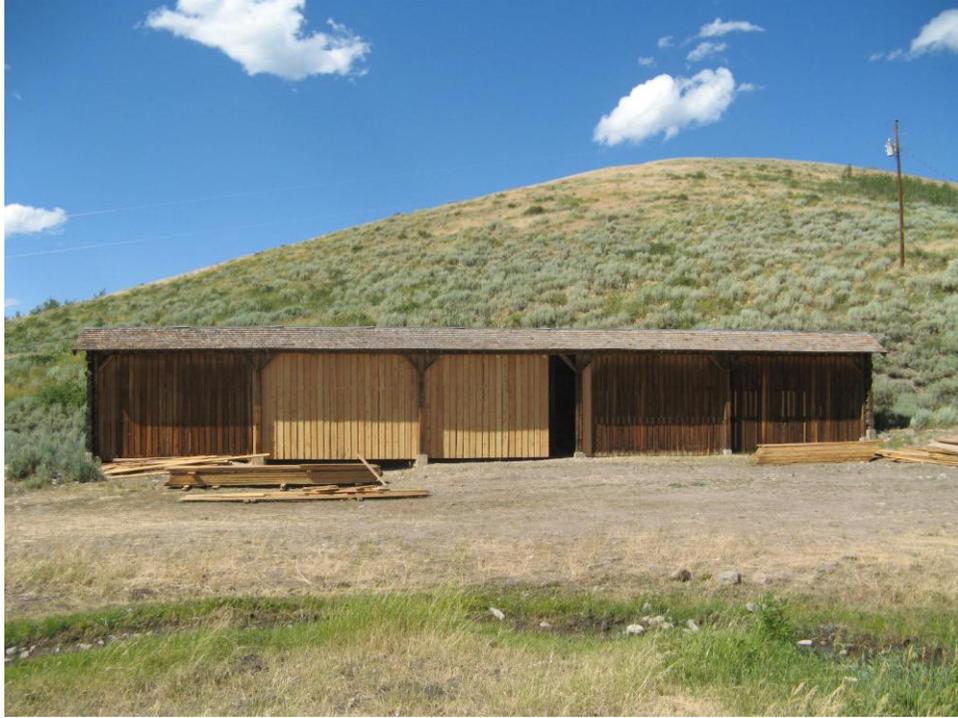
New and repaired sliding doors on Equipment Shed

- two of the five sliding doors were replaced in-kind
- the remaining three doors were repaired
- the sliding track was repaired
- a new concrete pier was poured to support the post separating the third and fourth doors from the left

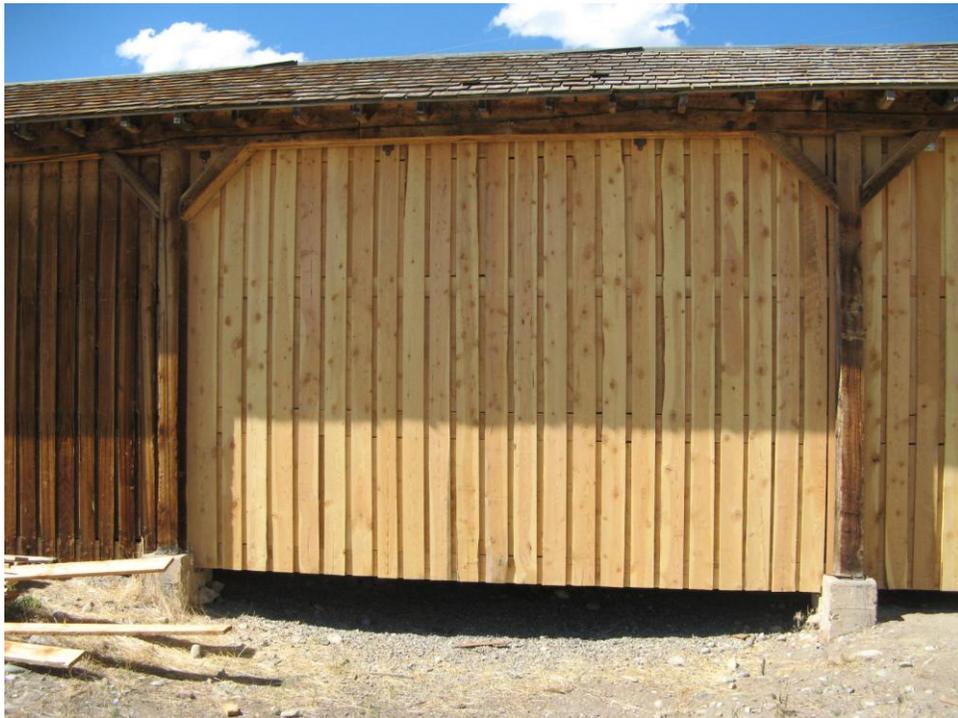
New door on Equipment Shed

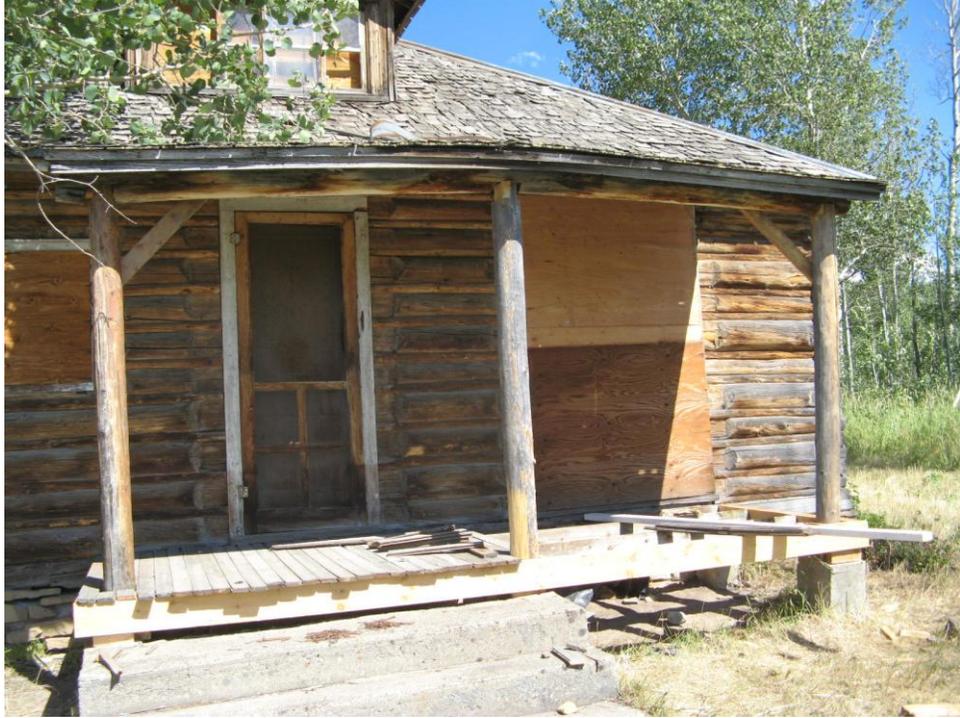
Partial stabilization of Foreman's Residence porch

- porch stabilization was initiated (but not completed)

On the Foreman's Residence the porch posts and floor frame were repaired, but the porch decking was only partially reinstalled. The remainder of the porch flooring needs to be reinstalled or replaced in-kind. After the volunteer project was completed, the WCHP patched and repaired roofing in the southeast corner of the Foreman's Residence to help stabilize the building. However, roof material was not replaced in-kind. The current rolled roofing needs to be removed and replaced with wood shingle. The roofing material on the northern side of the same gable is in need of repair/replacement. Several building sill and wall logs need replacement.
