Buildings and Structures

U.S. Grant Memorial

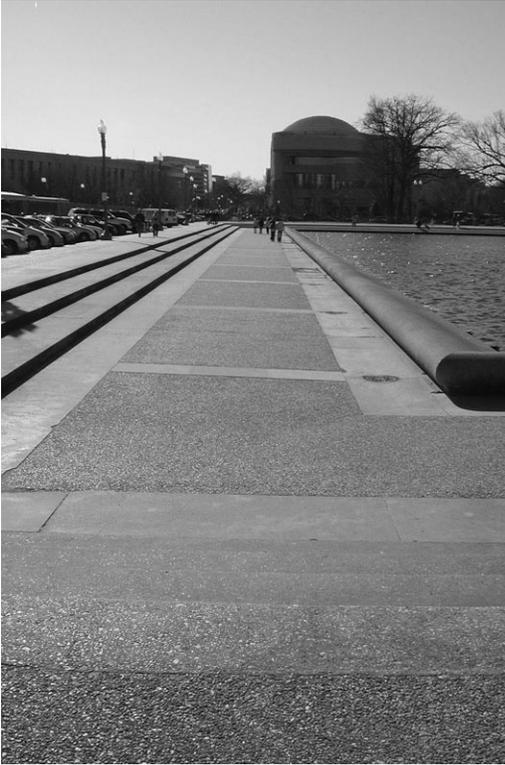
Paving composed of limestone and concrete, contrasting in color and texture, articulates the wide sunken walk surrounding the reflecting pool. View looking west. (CLP file "plaza and walk along S side pool" Feb. 24 2006)

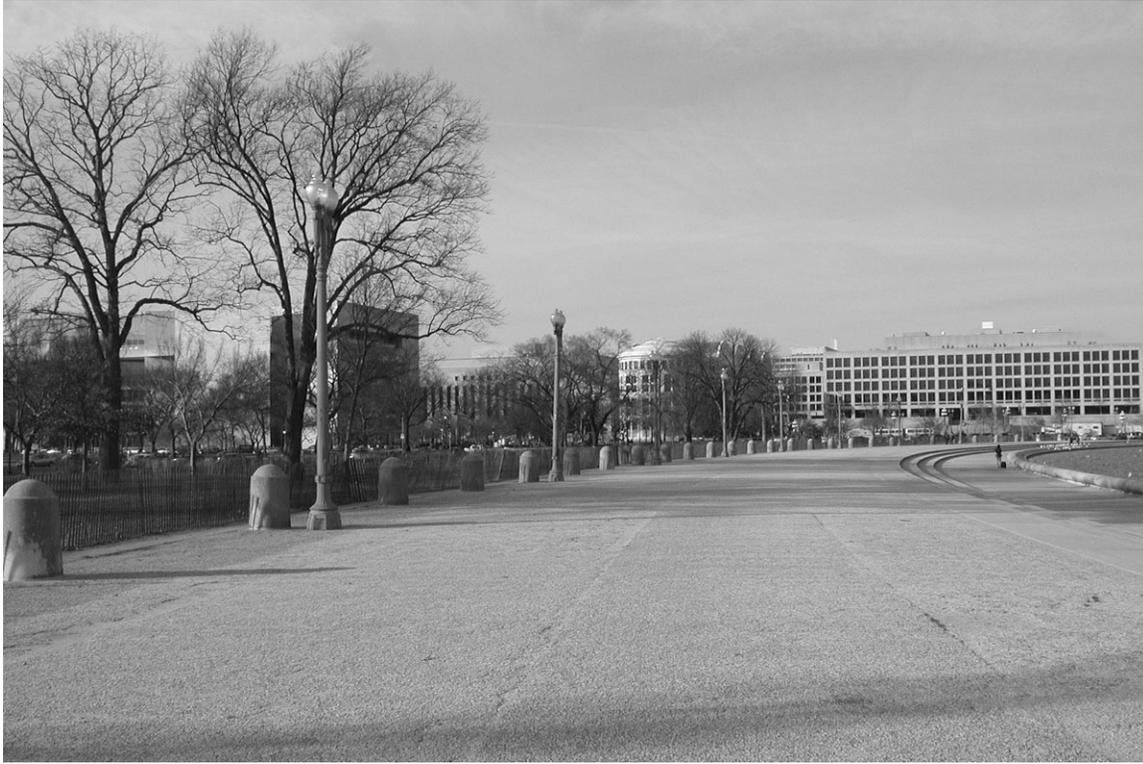
A concrete plaza extends west of the Capitol Reflecting Pool. View looking north. (CLP file "plaza west of pool" Feb. 10 2006)

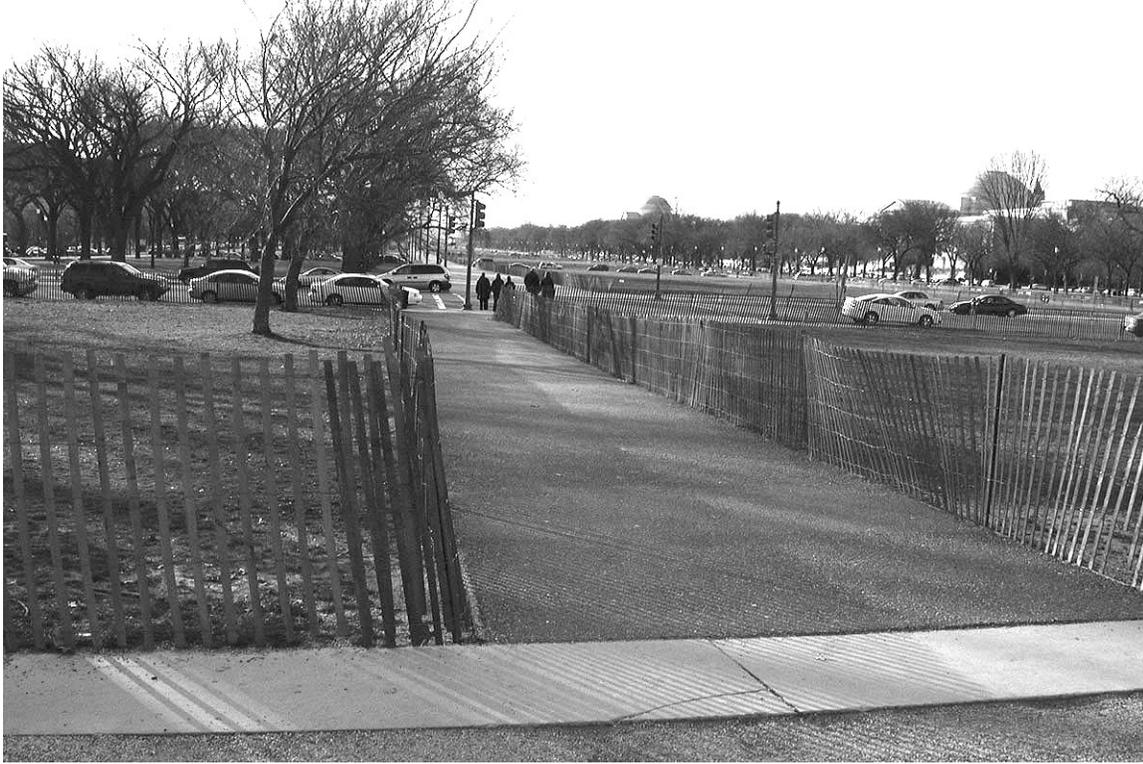
Two asphalt walks lead across the lawn in Union Square, ending at 3rd Street, just off the alignment of the Mall walks. View looking west. (CLP file "US walk looking W 3 BW adjusted" Feb. 10 2006)

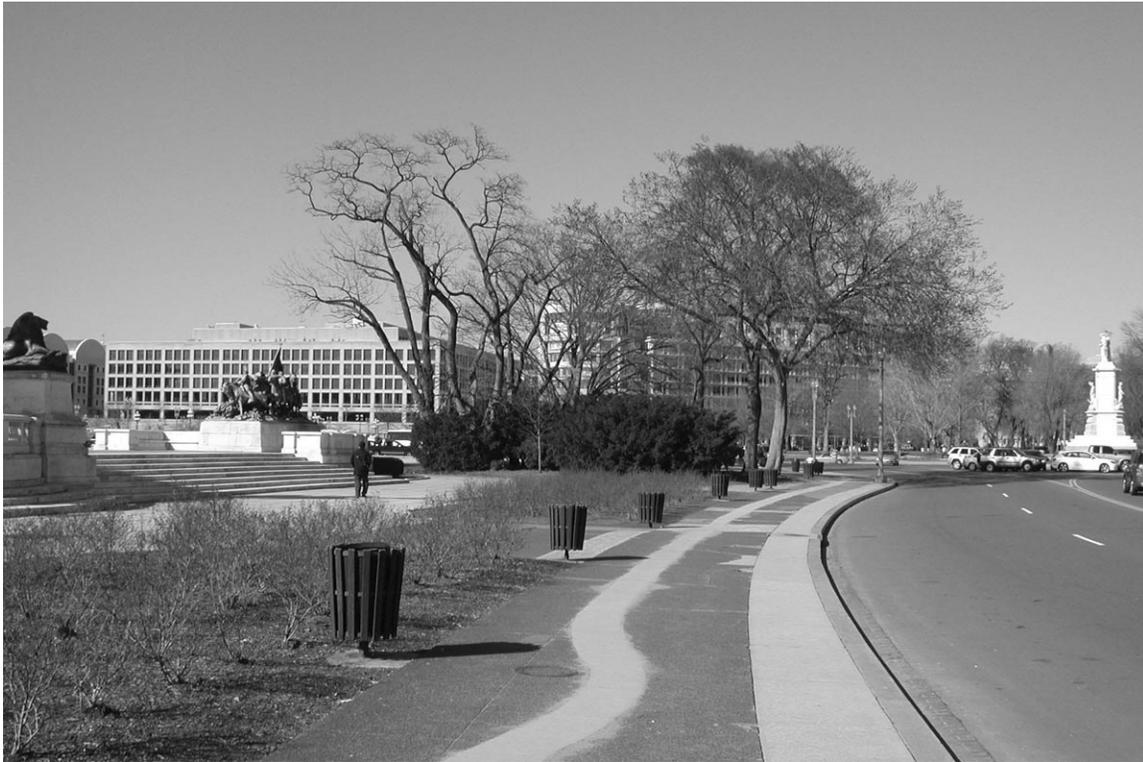
The irregularly patched sidewalk along 1st Street contrasts with the dignity and formality of the entrance to the Grant Memorial. The Architect of the Capitol will be resurfacing it. (CLP file "GM entrance view along 1st St." Feb. 24 2006)

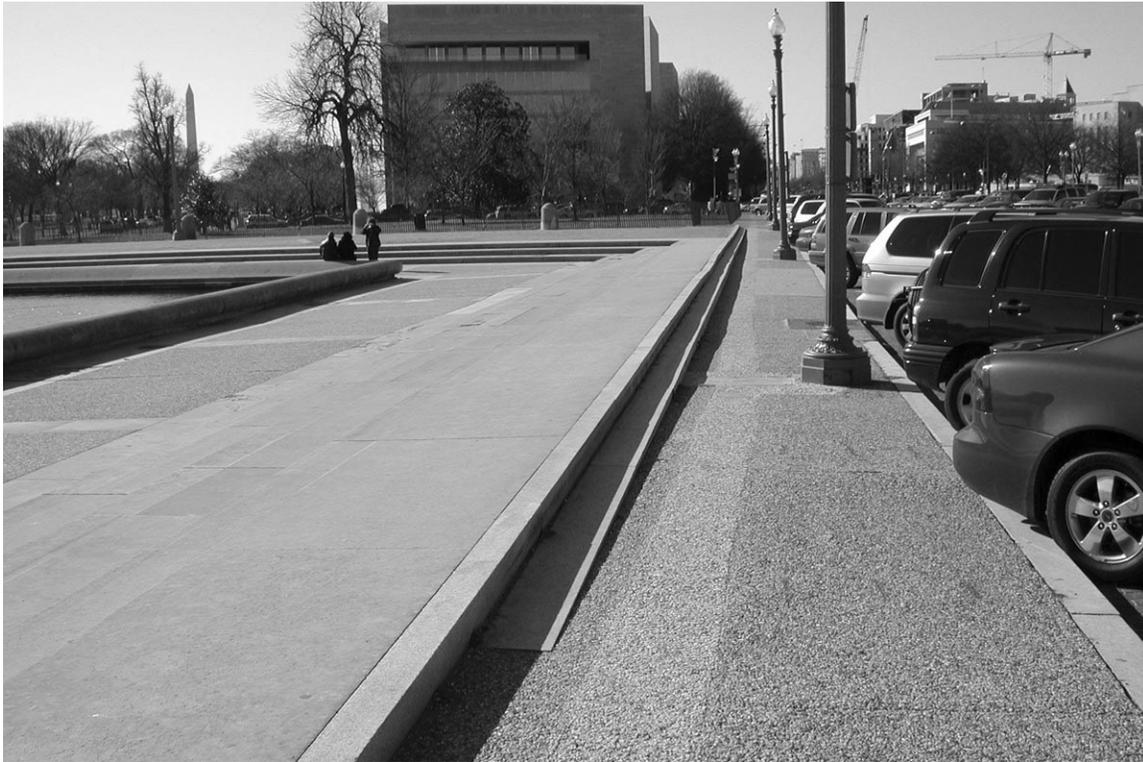
Two odd steps are located next to the sidewalk northwest of the pool. View looking west. (CLP file "granite step along N edge pool plaza, slope" Feb. 24 2006)

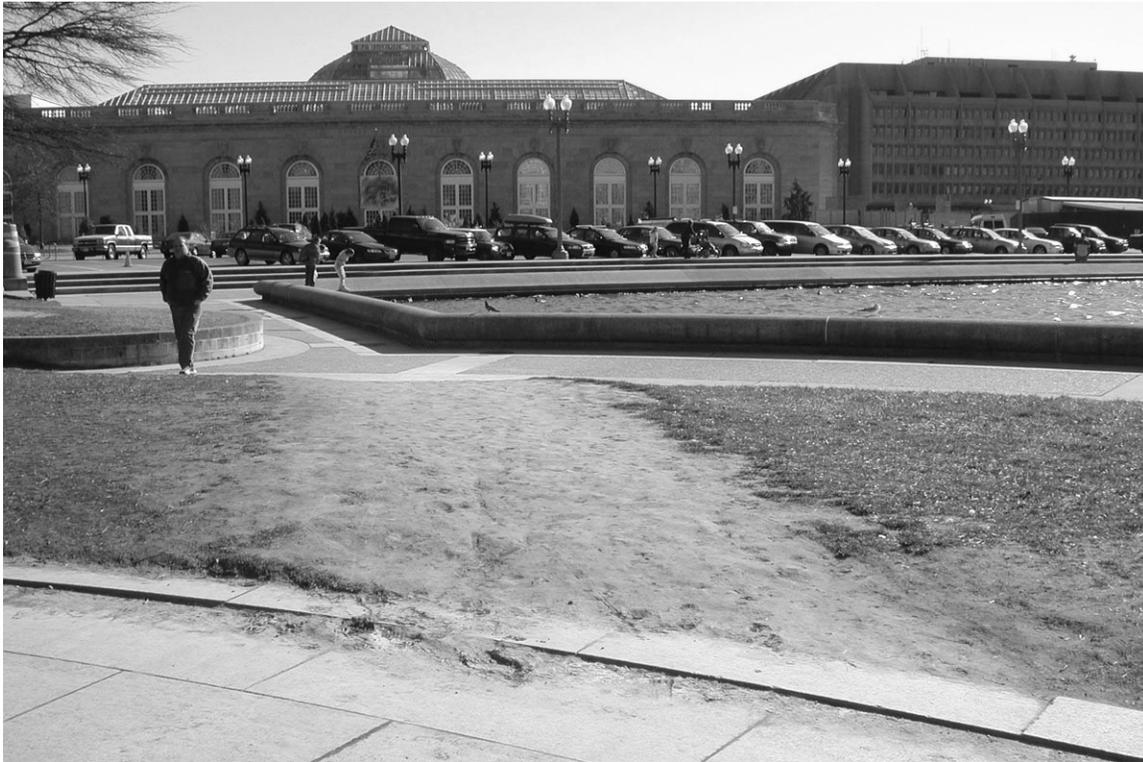
Social trails have been worn into each of the grass panels flanking the west plaza in front of the Grant Memorial. View south to the Botanic Garden on left; Health and Human Services building is behind on right. (CLP file "social trail to S" Feb. 24 2006)

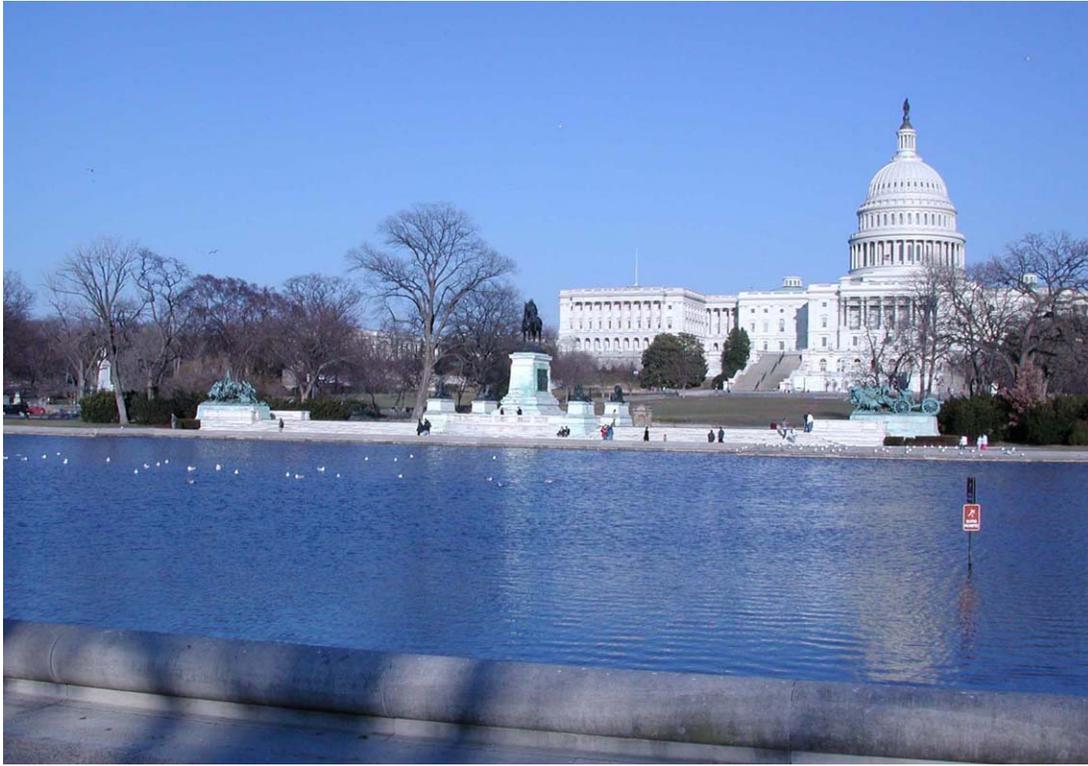
The Grant Memorial creates a dramatic foreground for views of the Capitol. (CLP file "Union Square from across pool" March 6 2005)
