# NATIONAL HISTORIC LANDMARK NOMINATION

## EYRE HALL

Historic Name: Eyre Hall

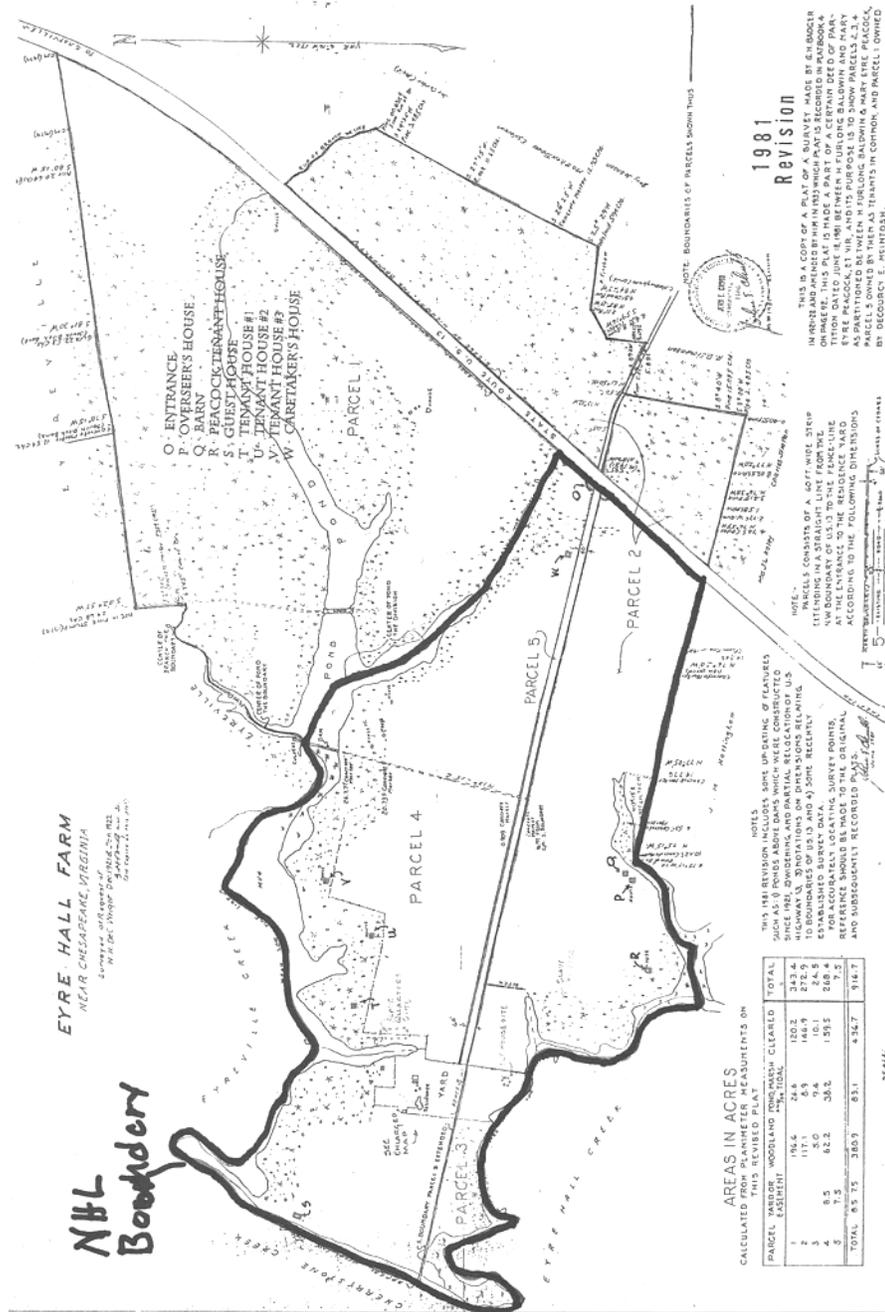
## Site Plan

Eyre Hall, site plan and NHL boundary  
Marilyn Harper, 2008

Eyre Hall plantation is located in Northampton County, Virginia, approximately 3.2 miles south of the county seat of Eastville. The property lies on the bayside of the Eastern Shore of Virginia, generally bounded by the waters of Cherrystone Creek on the west; Eyreville Creek on the north; and Eyre Hall Creek on the south. U.S. Route 13 forms the eastern boundary of the nominated property. The 467-acre tract includes eight significant contributing resources, most of which are located in the immediate vicinity of the main house, and include: a large Georgian-era frame house with Federal and twentieth-century additions, three historic outbuildings, a historic family cemetery, a large well-preserved eighteenth-century garden, and a largely intact eighteenth-century landscape, all set in an unaltered context of water and wetlands. Most of the non-contributing resources are positioned singly or in small groups at various locations around the edges of the district boundary.

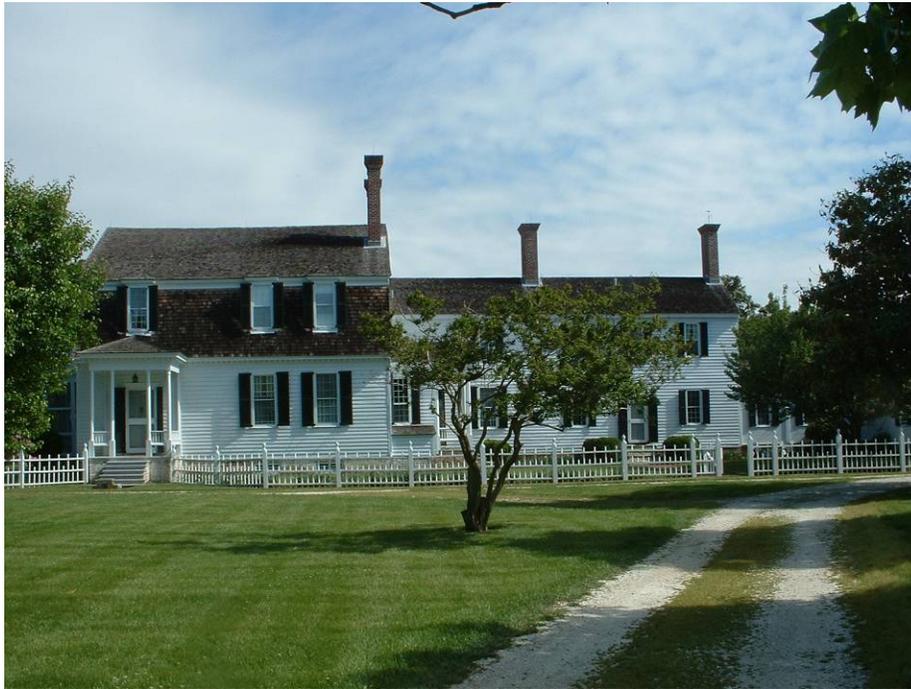
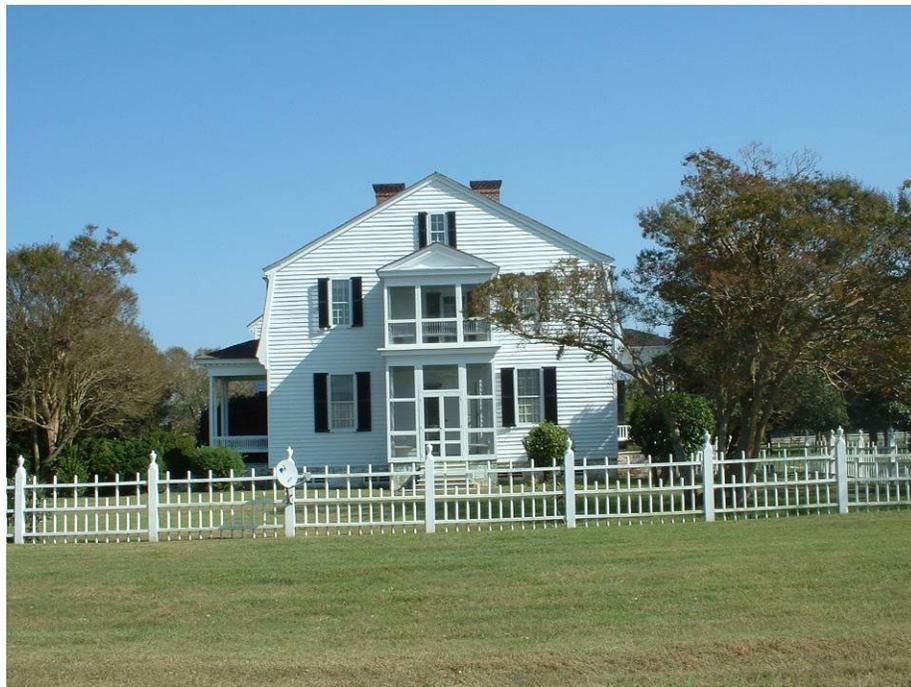
Eyre Hall, south elevation (top) and west elevation (bottom) of house Michael Bourne, 2006 and 2005

The **front (south) elevation** of the main block is divided into three bays. On the first floor the westernmost bay contains the main entrance under a one story hipped roof porch; large 9/9 sash windows fill the two bays to the east. The three bays on the second floor, set within the lower slope of the gambrel roof, contain shallow hipped roof dormers with smaller 9/9 sash windows. The cornice of the dormers is a continuation of the upper roof cornice. The entrance consists of a very large eight-panel door set into a massive frame. The lion-headed brass doorknocker was brought here in 1870 from Old Castle, the home of Margaret Parker Eyre, the second wife of Severn Eyre III.<sup>5</sup> The door is protected with a recent storm/screen door. The door and the window frames are original. As is the case for most of the windows in the main block, the original Georgian window sash, with wide 1¼" muntins, was replaced with the present Federal-style sash, with slender ¾" muntins, by John Eyre in the early nineteenth century. Louvered blinds protect all openings on the first and second floor. Windows with original iron bars fill the two eastern bays in the brick foundation.

The **west elevation** is divided into three bays. The two end bays contain 9/9 light Federal windows. The doors in the middle bays on the first and second floors are slightly off-center, but this asymmetry is disguised by the symmetrical placement of the two-story portico. Because the west elevation is a gable, it rises a full two and one-half stories high. The sash of the single small attic window at the third floor level was not replaced in the early nineteenth century and retains the original wide muntins. Very boldly shaped bargeboards cover the eaves of the lower slope of the roof and the ends of the cornices. The foundations, weatherboard, and windows have the same details as the south façade. Four original cellar windows are symmetrically placed in the foundation. The west portico is supported on a brick half vault that differs from the foundations of the other porches and appears to date to the original construction. The west portico resembles the south porch in materials and details; the second floor columns are considerably shorter than the first, reflecting the lower ceiling heights of the second story inside the house. Full cornices are located between the first and second floor of the portico and define the pedimented gable; the tympanum is filled with beaded shiplap boards.

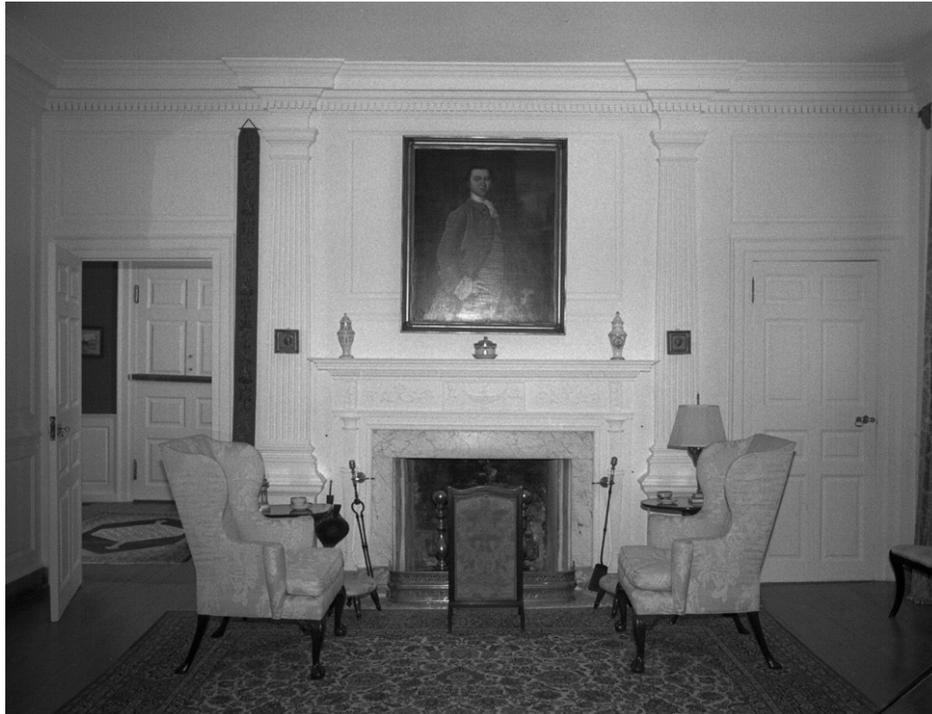
Parlor, east wall  
Michael Bourne, 2000

Like the entry, the **parlor** is fully paneled. All four walls are covered with bold fielded paneling, but the moldings of the parlor are slightly less elaborate than those in the entry. Pairs of classical fluted pilasters flank the door to the entry on the west wall and the fireplace on the east wall. Like the entry, the deep six-part cornice breaks out above the pilasters. Three eight-panel doors match the moldings of the panels. The west door leads to the entry. The other two doors flank the fireplace on the east wall. The door to the right of the fireplace opens into a small closet; the door to the left probably provided access to a small service lobby originally. It now leads to the "porch room" created in 1807 to provide interior access to the east wing. The elaborate brass hardware on the doors is probably original. The two windows on the south wall have Federal period sash. Here, too, the baseboard retains its original dark grey marbleizing.

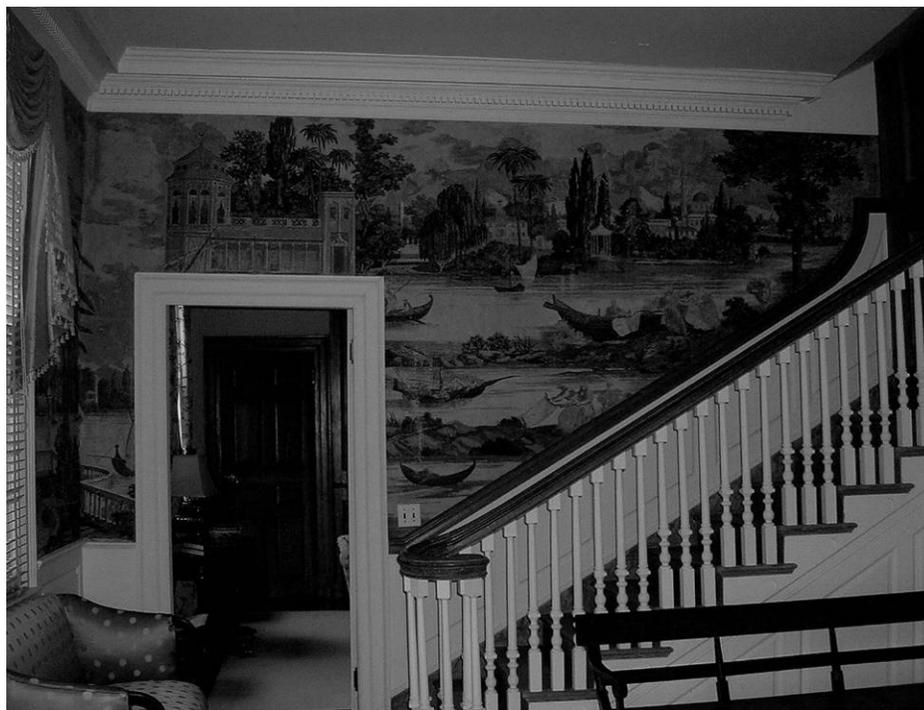
Stair hall, east wall  
Michael Bourne, 2004

The open string stair rises along the east wall to a landing then turns and ascends to the second story within the depth of the arch. The balustrade has three turned balusters per step and ends with a bold single-revolution volute. The profile of the handrail is typical of the pre-Revolutionary period and ramps up before terminating into the south wall. A half rail on the east wall mirrors the handrail; the dado beneath the half rail is paneled. The spandrel beneath the balustrade and the walls of the landing and upper flight are also paneled.

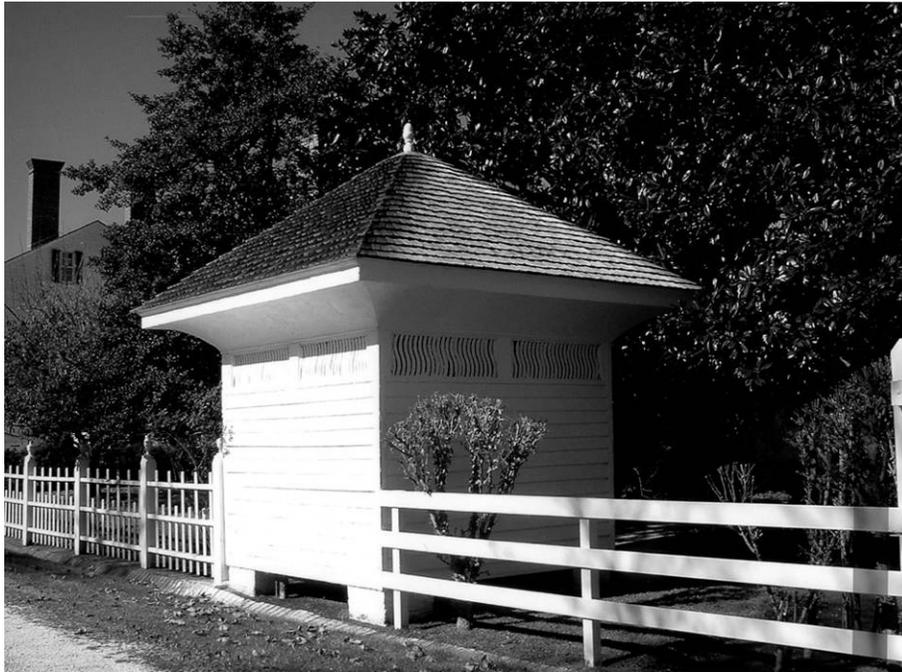
Dairy, looking northwest  
Michael Bourne, 2004

Dendrochronology suggests that the frame dairy, measuring 10' square, was built ca. 1759 and moved to its present location ca. 1807.<sup>17</sup> The north (front) elevation stands on a continuous brick foundation, while brick piers support the back of the building. Beaded weatherboard covers the lower part of the walls. Vents with vertical closely-set strigil-shaped slats fill the area between the weatherboard and the plaster cove cornice. There is a turned finial at the center of the hipped roof. A millstone step on the north side leads to a reproduction paneled door, dating from the 1930s but set in the original frame and hung on original cross garnet hinges.

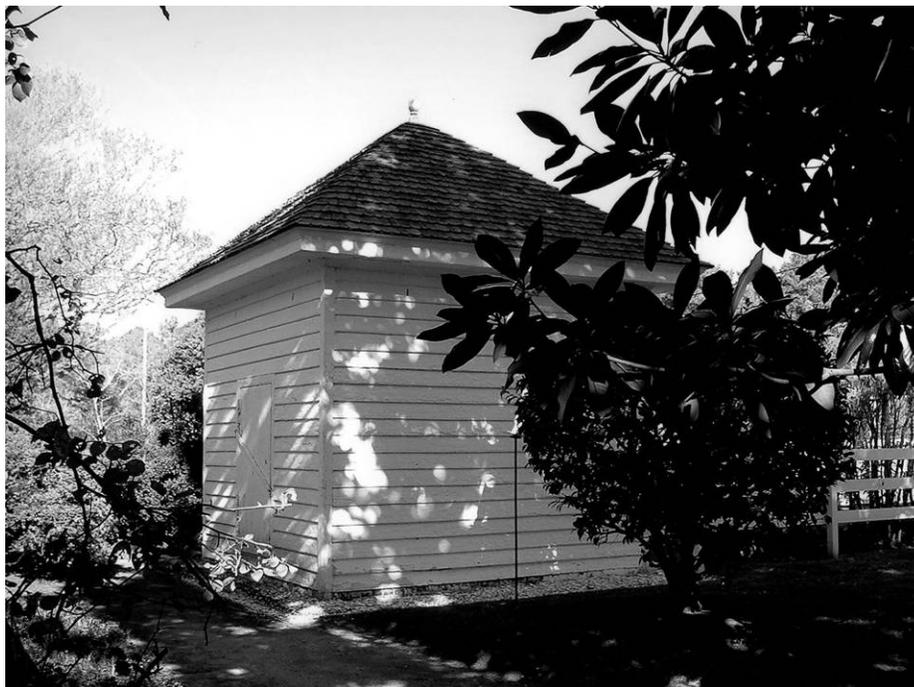
Smoke house, looking northeast  
Michael Bourne, 2004

The frame smokehouse stands about 58' to the north of the dairy, with which it is aligned. According to the dendrochronology report, this building dates to 1807; it is identified on the insurance policy of that year as a “pantry.” It measures about 12' square and stands on a low brick foundation. The walls are beaded weatherboard, but many coats of whitewash have obscured the detail. A wide board-and-batten door centered on the west elevation is secured inside by a wood box lock and outside by a diagonal iron bar and staple. Slits cut into the soffit and the second weatherboard below the cornice allowed smoke to escape. The roof, like that of the dairy, is pyramidal.

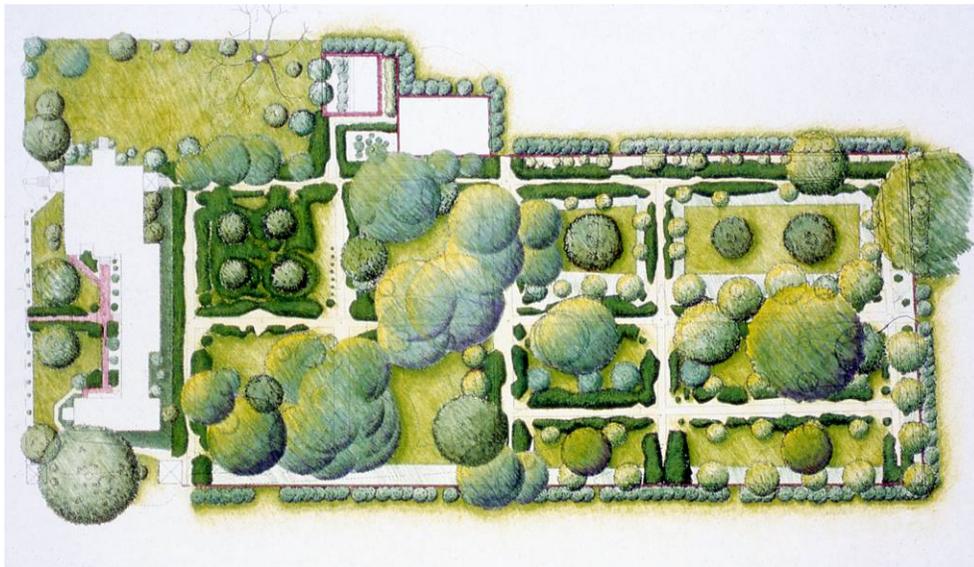
Eyre Hall gardens, schematic plan  
Darrin R. Alfred for the Garden Club of Virginia, 1997
