**NATIONAL REGISTER OF HISTORIC PLACES
REGISTRATION FORM**

historic name: Red Rocks Park, Mount Morrison Civilian Conservation District,
other names/site number: Morrison Park District 5JF.442

Red Rocks - Mount Morrison

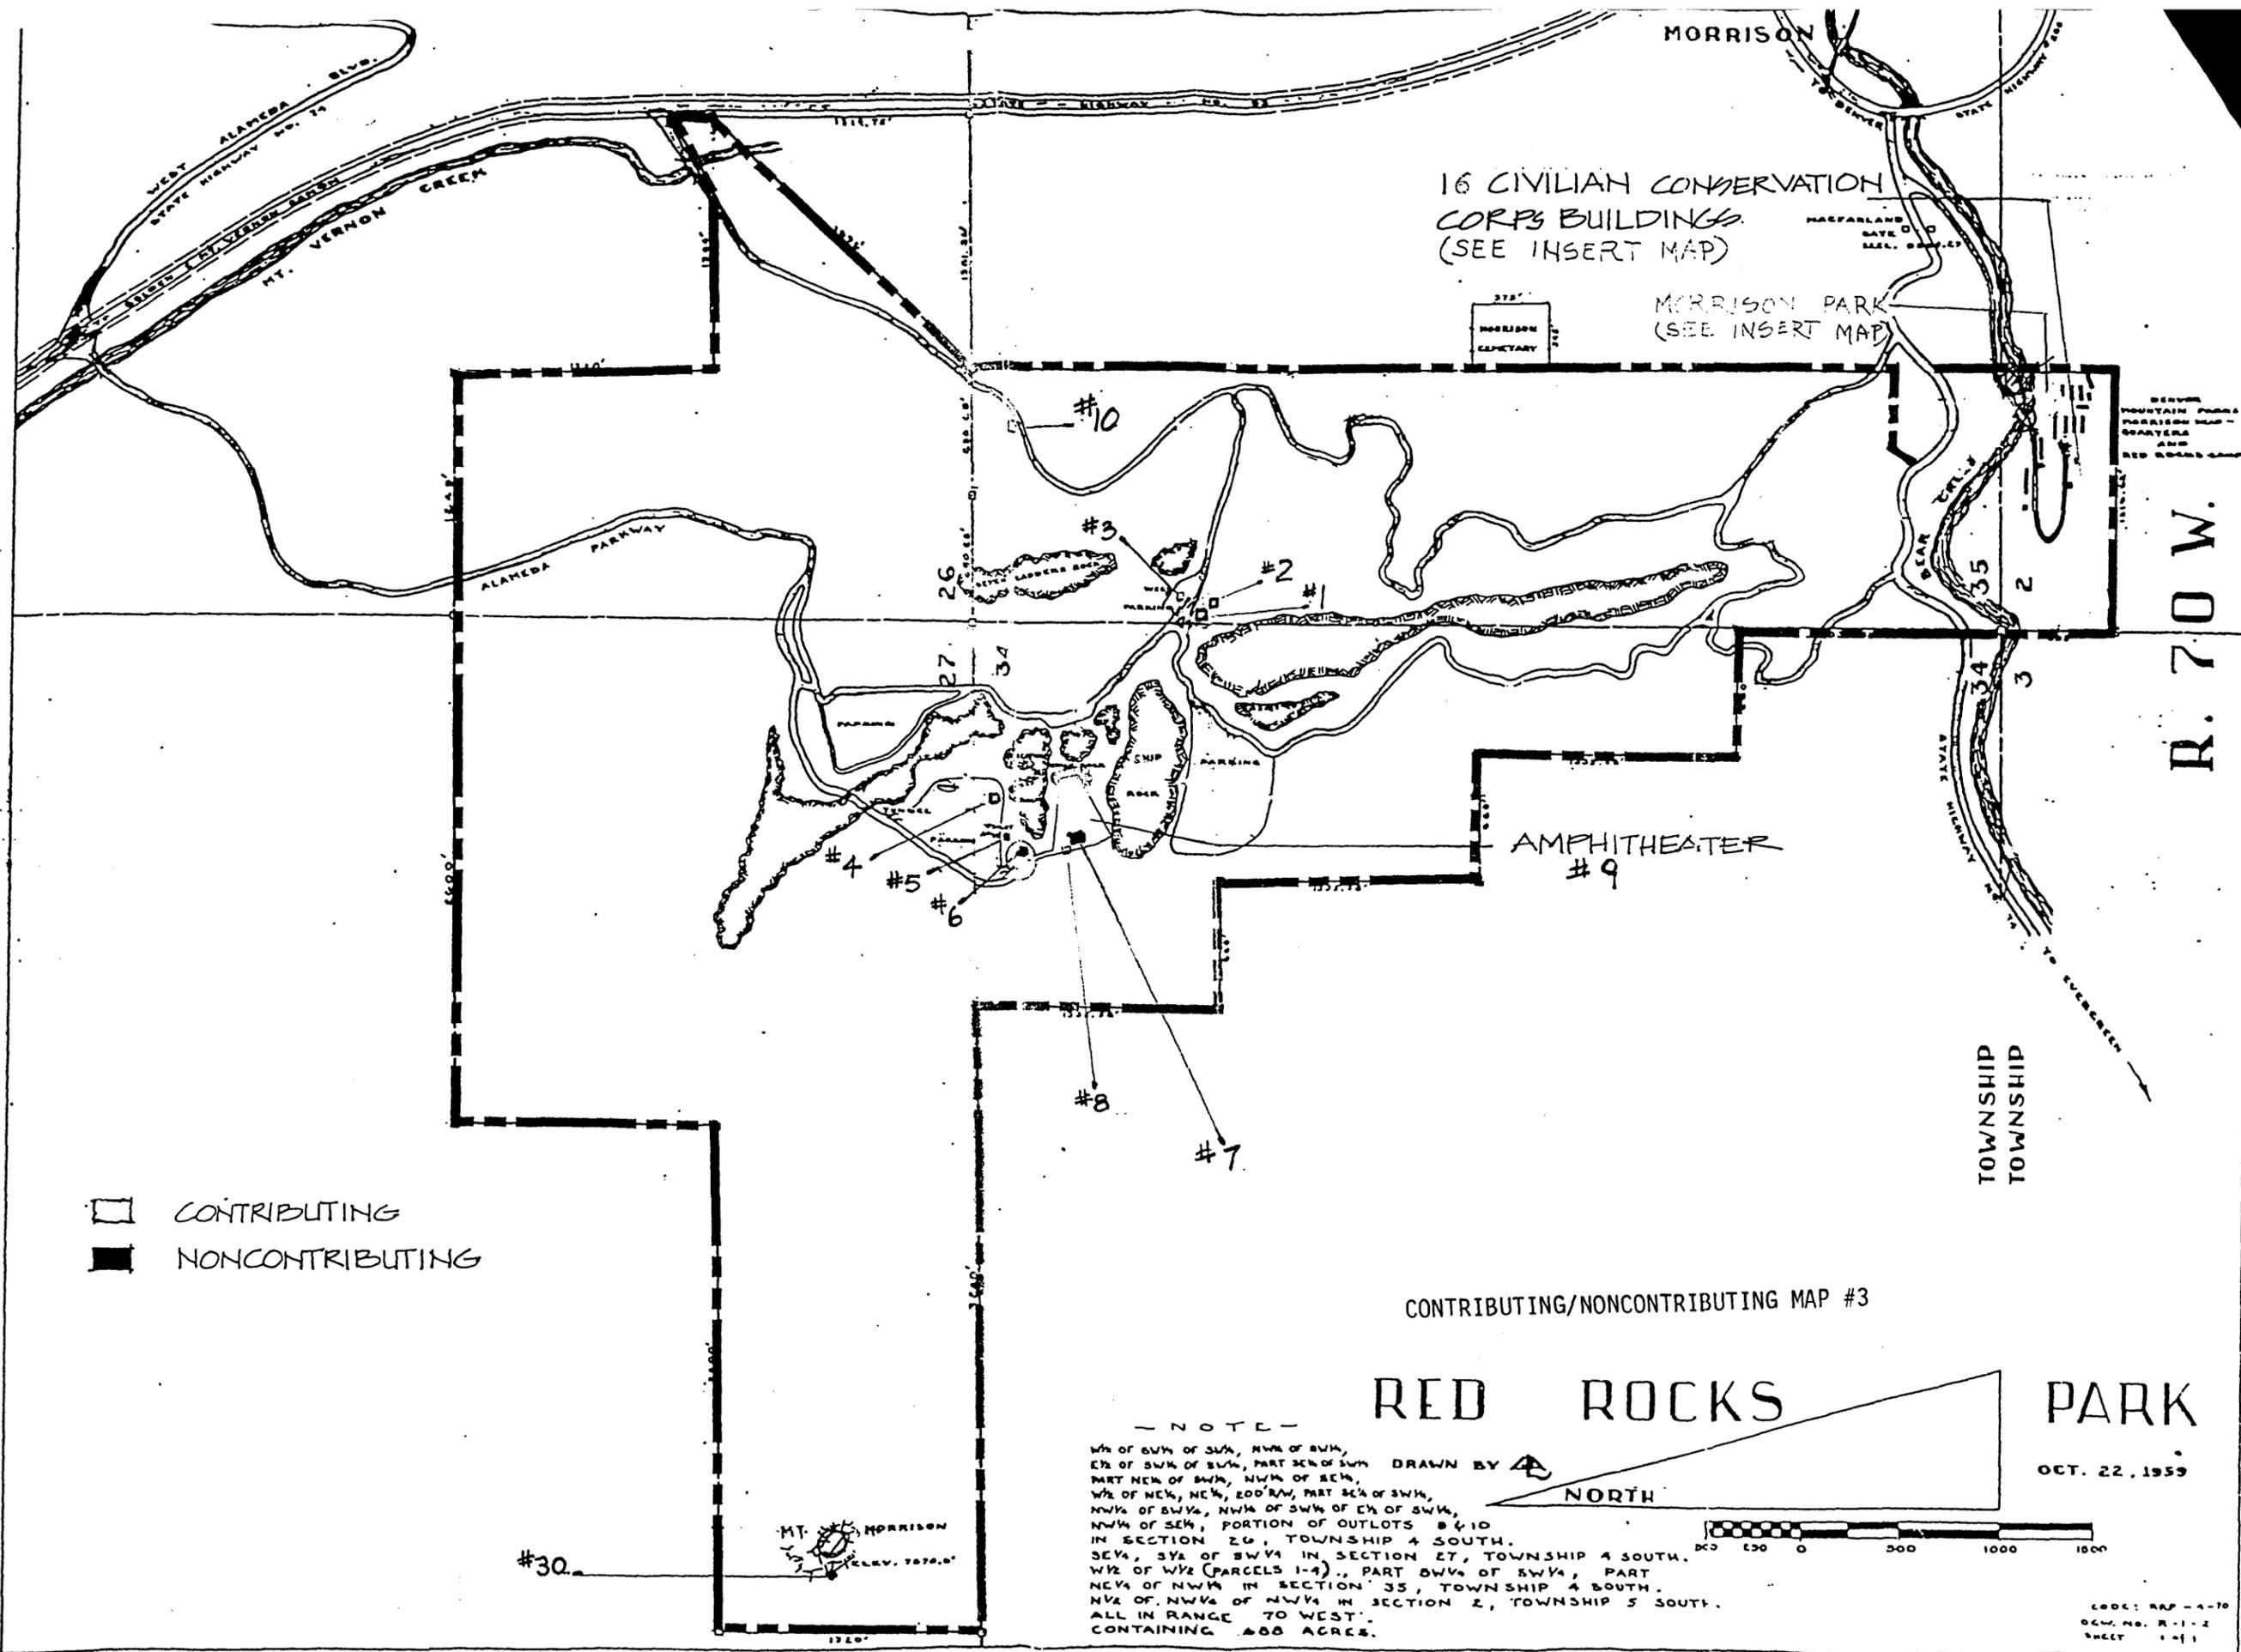
CONTRIBUTING/NONCONTRIBUTING MAP #3

- CONTRIBUTING
- NONCONTRIBUTING

1. Red Rocks Pueblo (1931): "Indian Concession House" Pueblo Revival Style Architecture, earth colored smooth stucco. (map 3)
2. Red Rocks Pueblo Secondary Building (map 3)
3. Red Rocks Picnic Shelter (map 3)
4. Utility Building (map 3)
8. Ticket Booth (map 3)
9. Amphitheater (1936 - 1941) Three Mammoth Flat Sandstone Rocks, native stone, curvilinear seating. [see site plans] (map 3)
10. Ticket Booth (map 3)
11. CCC dining hall: 190' long, front gabled roof (map 5)
12. CCC recreational building: 1 1/2 story, stage, hand-painted mural (map 5)
- 13-18 CCC barracks: long and narrow (map 5)
19. CCC bathroom / laundry: side gabled (map 5)
20. CCC Officers' housing (map 5)
21. CCC infirmary / Officers' offices (map 5)

- 22. CCC blacksmith shop: square, unpainted and rustic (map 5)
- 23. CCC machine shop: long, rectangular (map 5)
- 24. CCC carpenter shop: long, rectangular (map 5)
- 25. CCC equipment shed (map 5)
- 26. Mountain Park Offices: long and rectangular (map 5)

- 5. Ticket Booth (map 3)
- 6. Amphitheater Consession Stand (1948) (map 3)
- 7. Restroom (1946) (map 3)
- 28. Waterworks Building (map 5)
- 29. Morrison Park restroom (map 5)

- 27. Water tank (map 5)
- 30. Mt. Morrison Antennae (map 3)

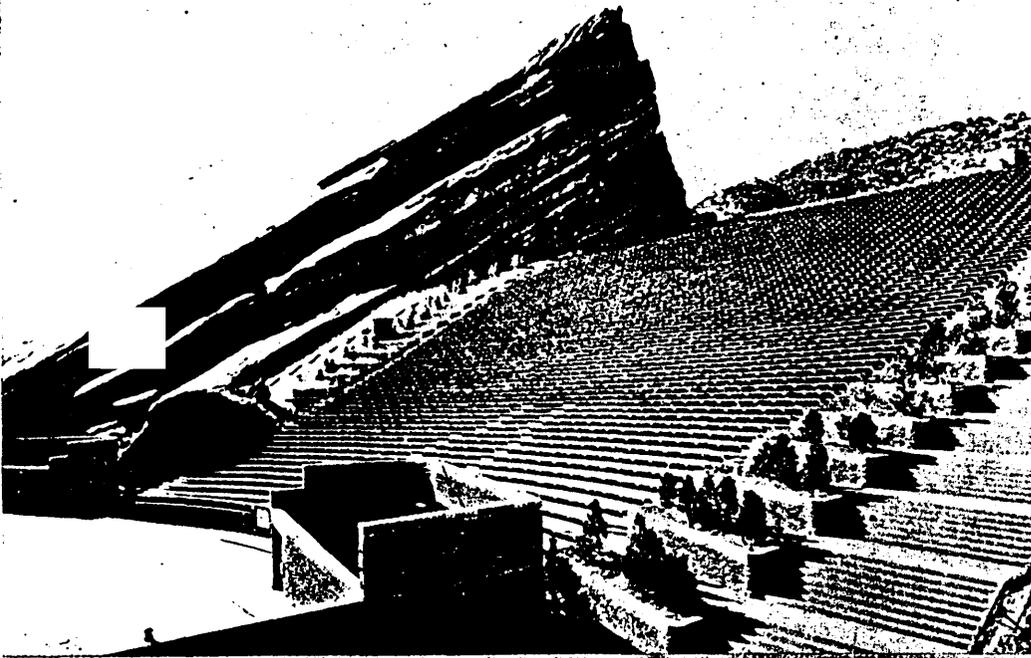
Natural acoustics of wind-shaped stone clearly project voices and sounds to listeners in the back row. Skillful blending of old and new has retained the natural beauty.

The theater is located at an altitude of 6,000 feet, amongst a huge cluster of red rocks. These rocks are the result of geologic formations composed of some 10,000 feet of sandstone that has slowly lifted up and tilted on end to form gigantic rocks of prismatic red color. These events occurred during the Triassic Age some 250 million years ago. Exposed to the wind, water, and heat, the outcrops formed into strange shapes with tunnels, caverns, and holes throughout. The walls of the Red Rocks Amphitheater were formed by two mammoth, flat sandstone rocks; the Ship Rock and Creation Rock, set on edge. These are accompanied by a third rock that forms a sounding board, giving the site uncanny acoustical properties. The theater is open at the rear, reducing the occurrence of an echo.

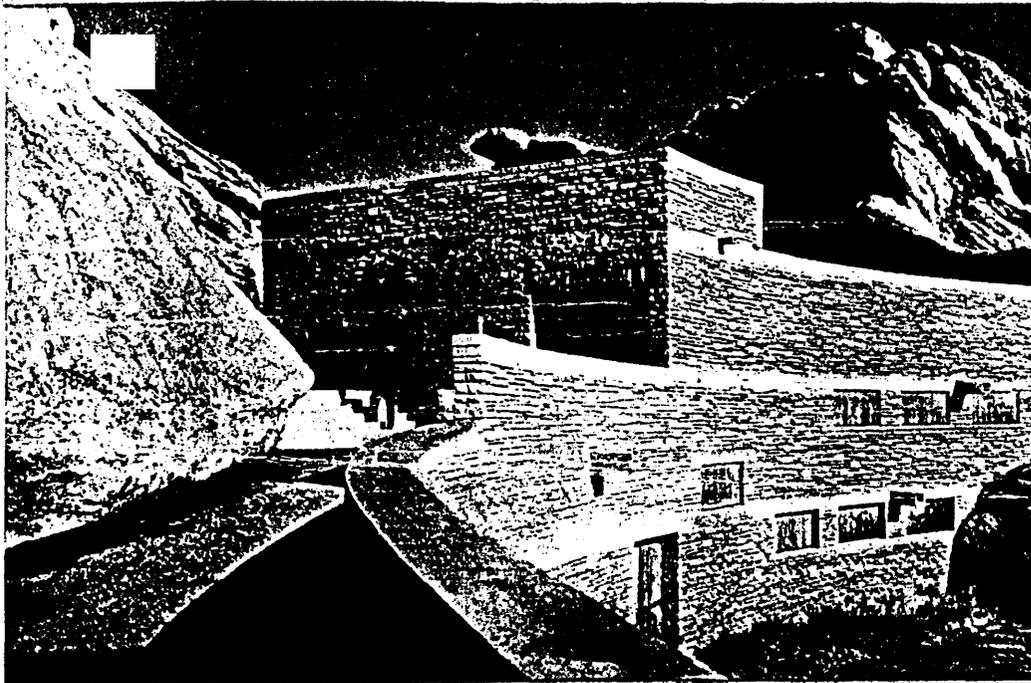
Graceful rock hollow forms the backbone of stairways that were later clothed in stone in a dramatic union of modern architecture with sculpturing of wind, rain, sun.
