National Register of Historic Places Registration Form

historic name Colman Automotive Building
other names/site number _____

street & number 401 East Pine Street not for publication
city or town Seattle vicinity
state Washington code WA county King code 033 zip code 98122

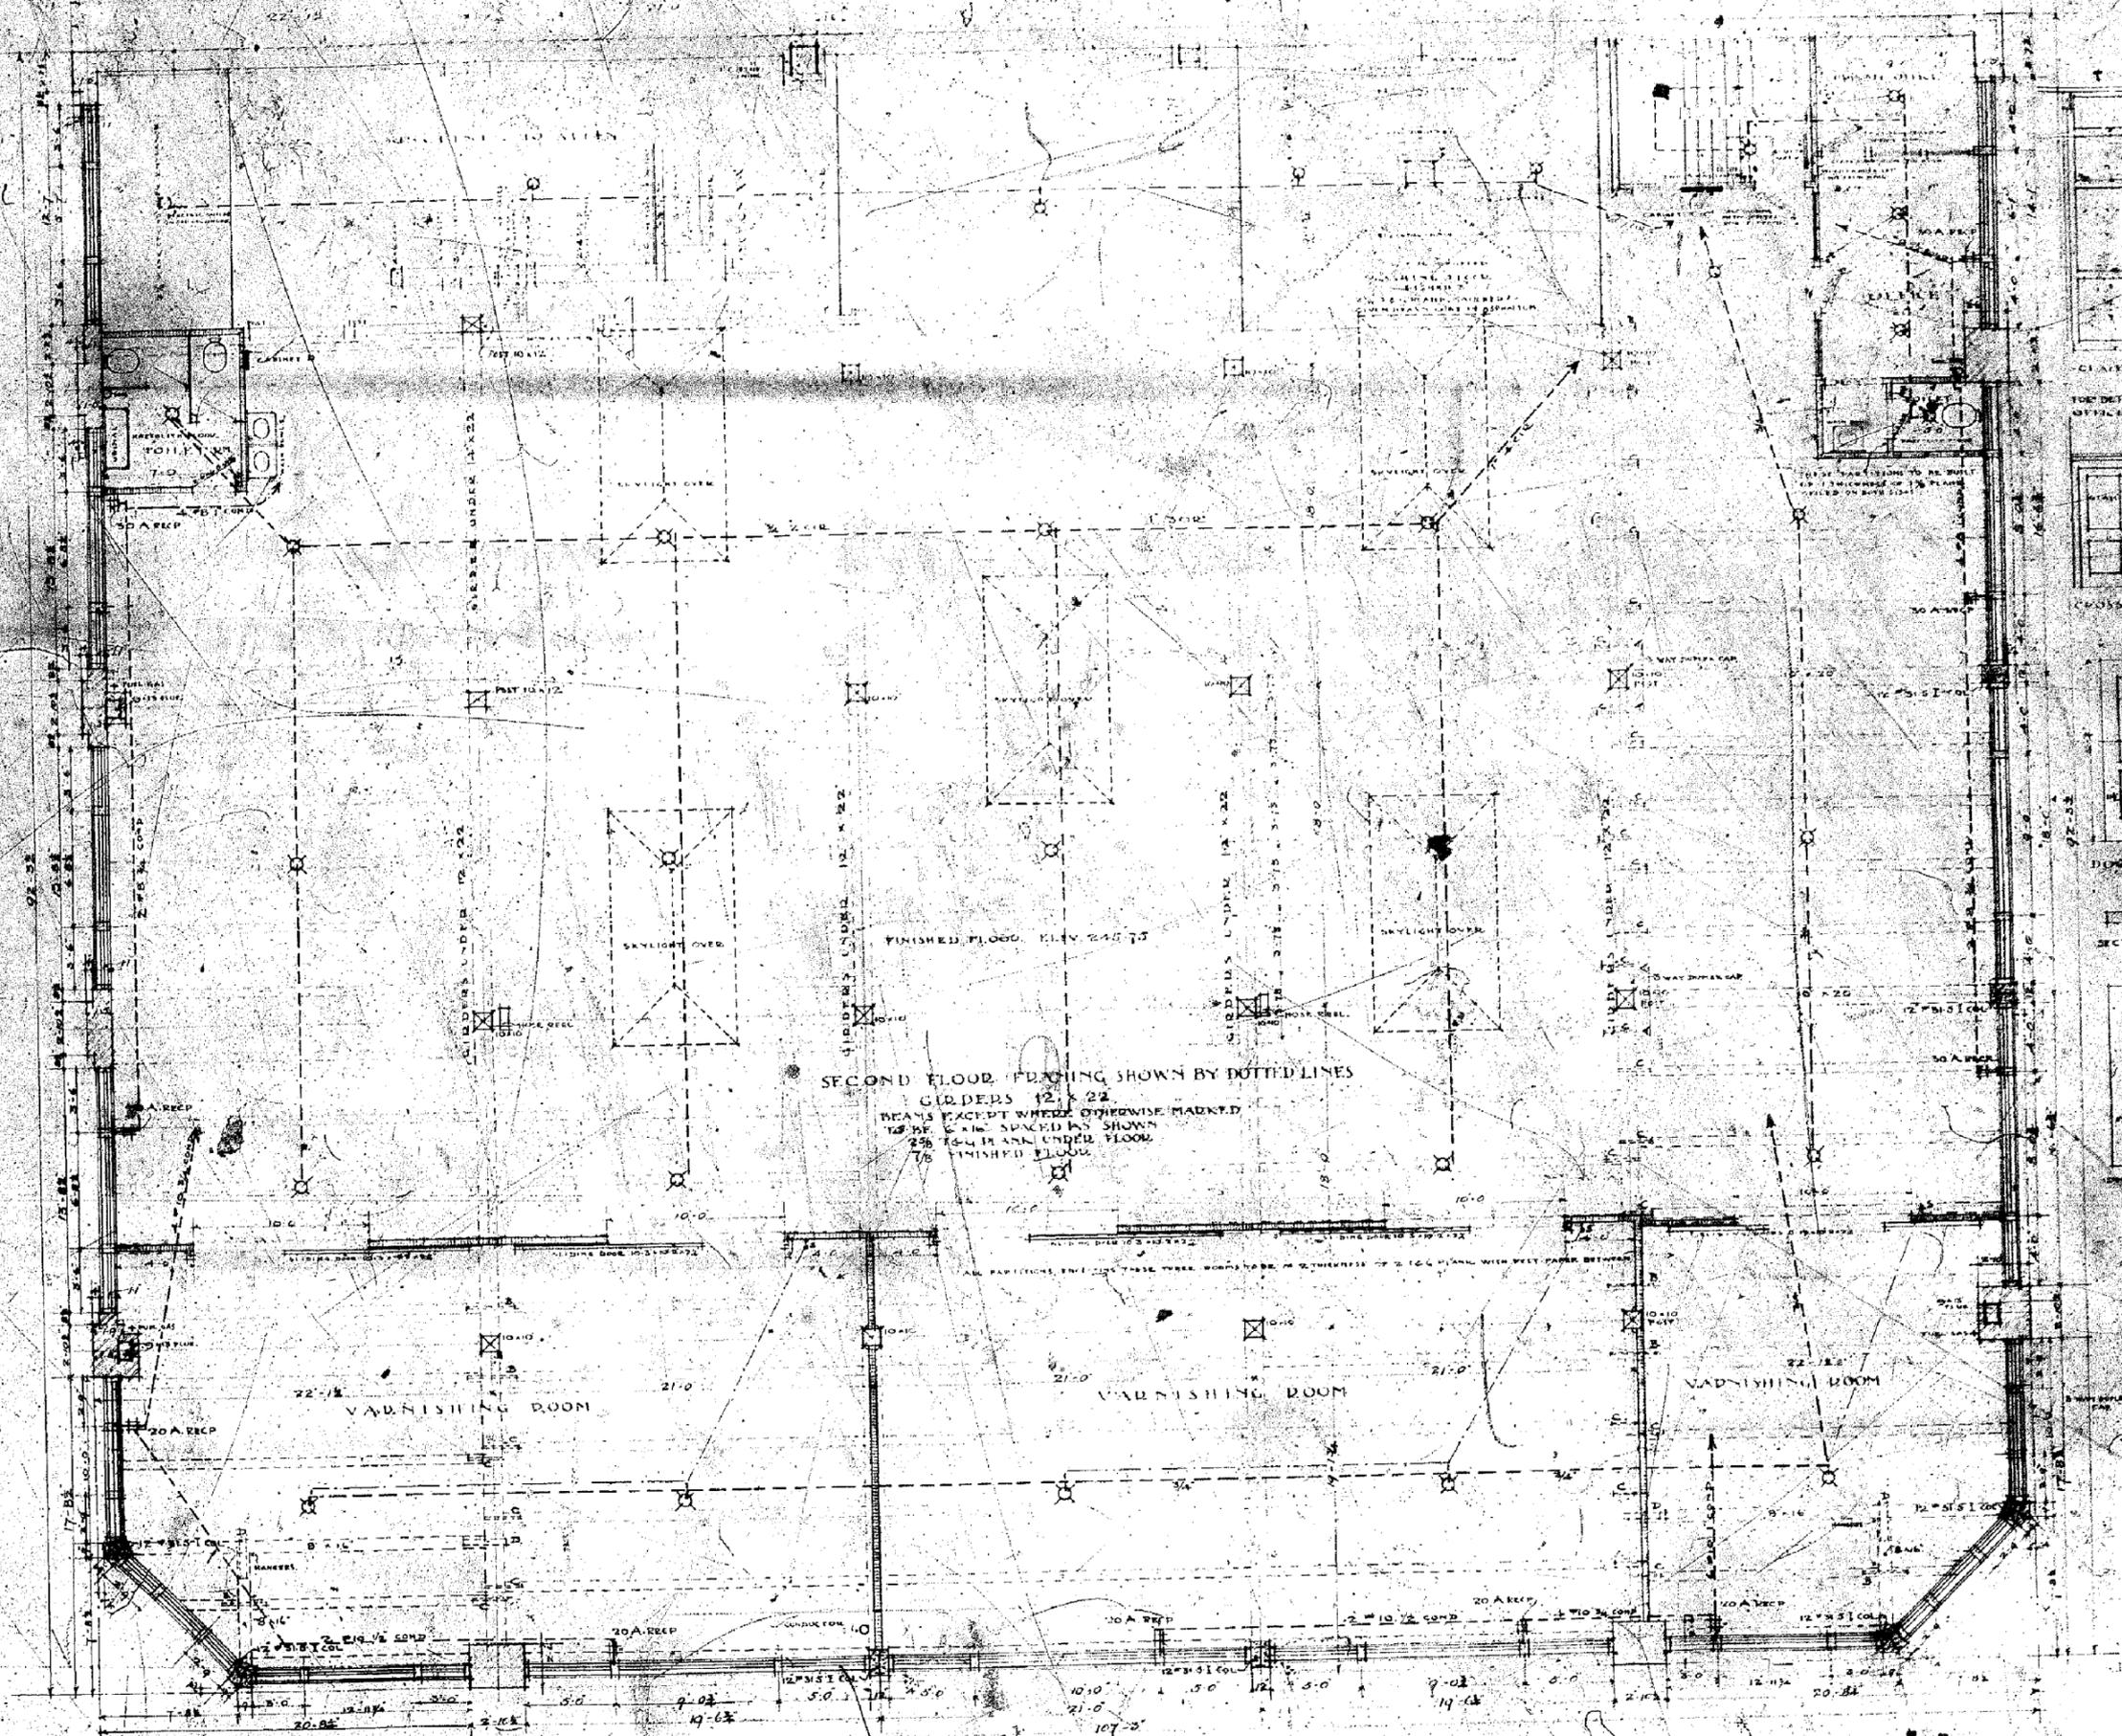
SECOND FLOOR PLAN
 SCALE 1/4" = 1'-0"

SECOND FLOOR FRAMING SHOWN BY DOTTED LINES
 GIRDERS 12" x 24"
 BEAMS EXCEPT WHERE OTHERWISE MARKED
 12" x 6" x 16" SPACED AS SHOWN
 2" x 4" PLANK UNDER FLOOR
 7/8" FINISHED FLOOR

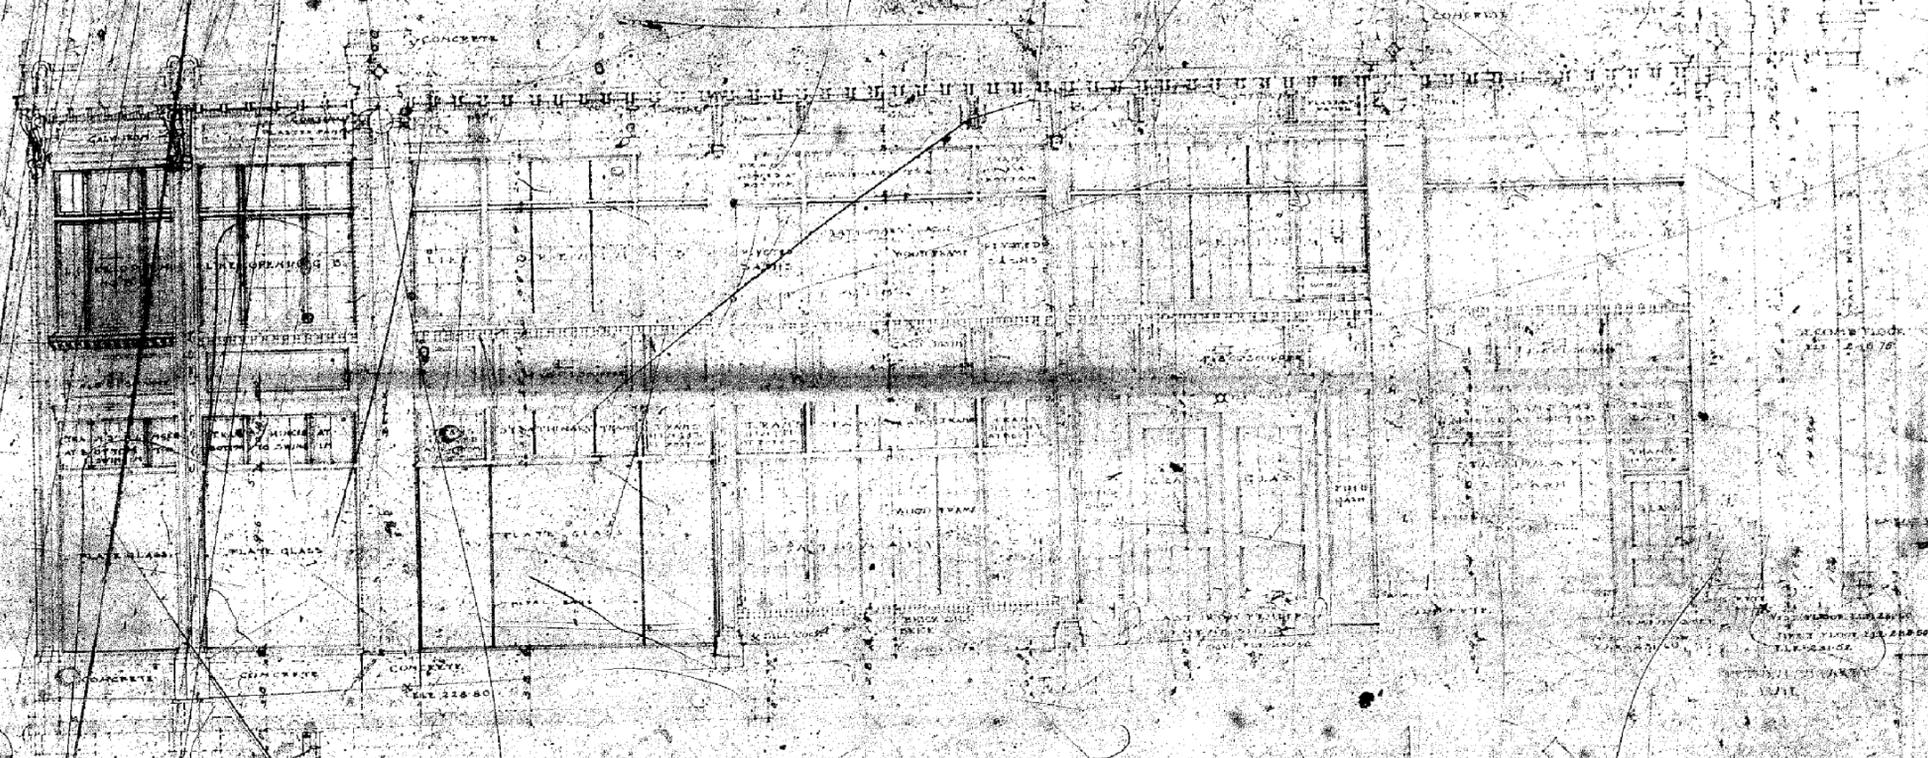
BELLEVUE AVENUE ELEVATION
SCALE 1/4" = 1'-0"

NOTE ON BELLEVUE AVE. SIDE
BRICK WALL TO BE SET BACK
SO THAT TOP OF WALL IS NOT
LESS THAN 18" ABOVE FOOT

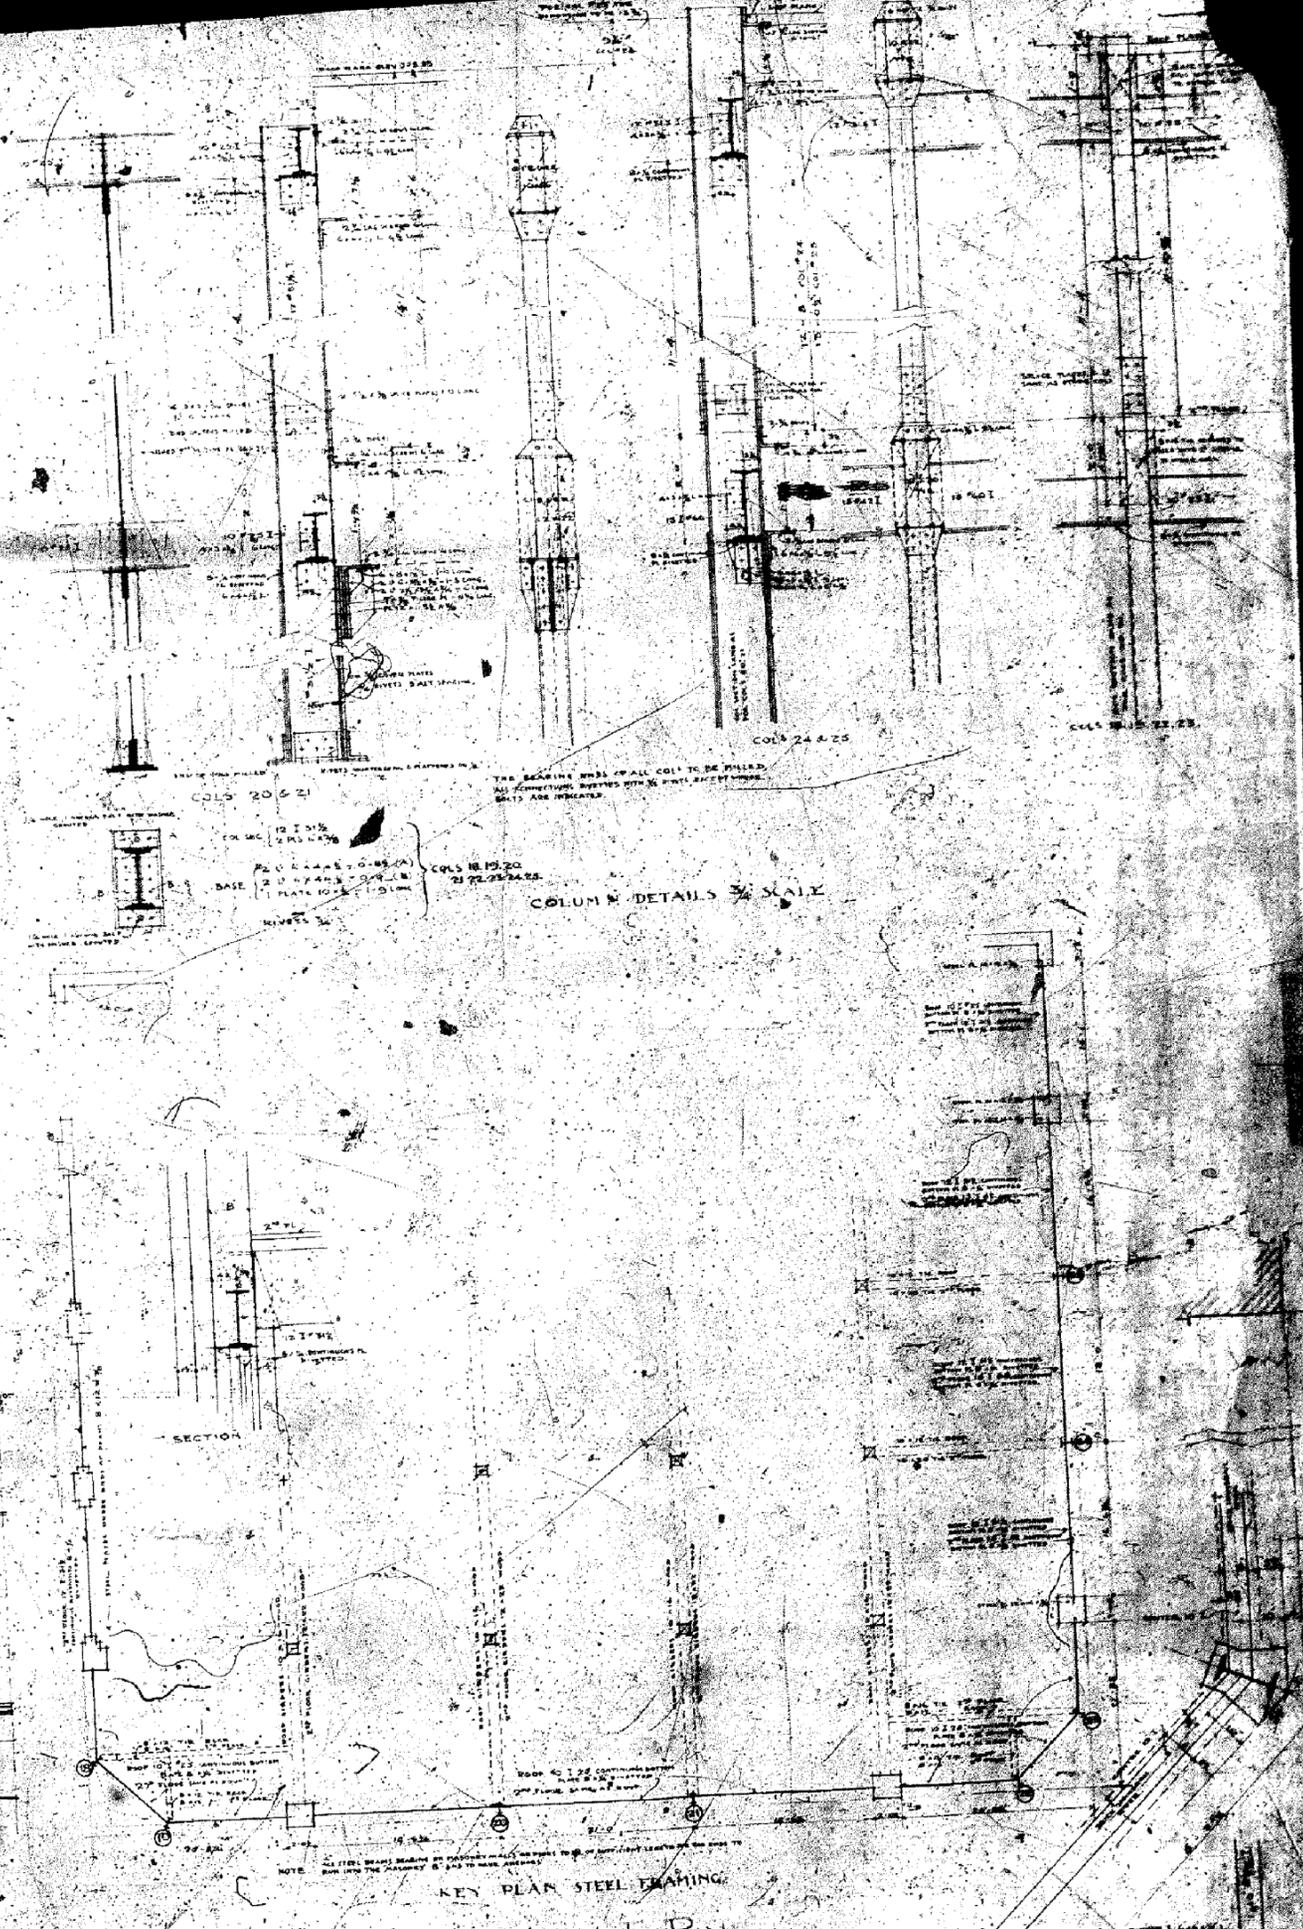
COLUMN DETAILS 3/4" SCALE

KEY PLAN STEEL FRAMING
