National Register of Historic Places Registration Form

Historic name: Mager Mortgage Company Building
Other names/site number: Women's Clinic of Oklahoma City
Name of related multiple property listing: _____

Street & number: 231 Northwest 10th St.
City or town: Oklahoma City State: OK County: Oklahoma
Not For Publication: Vicinity:

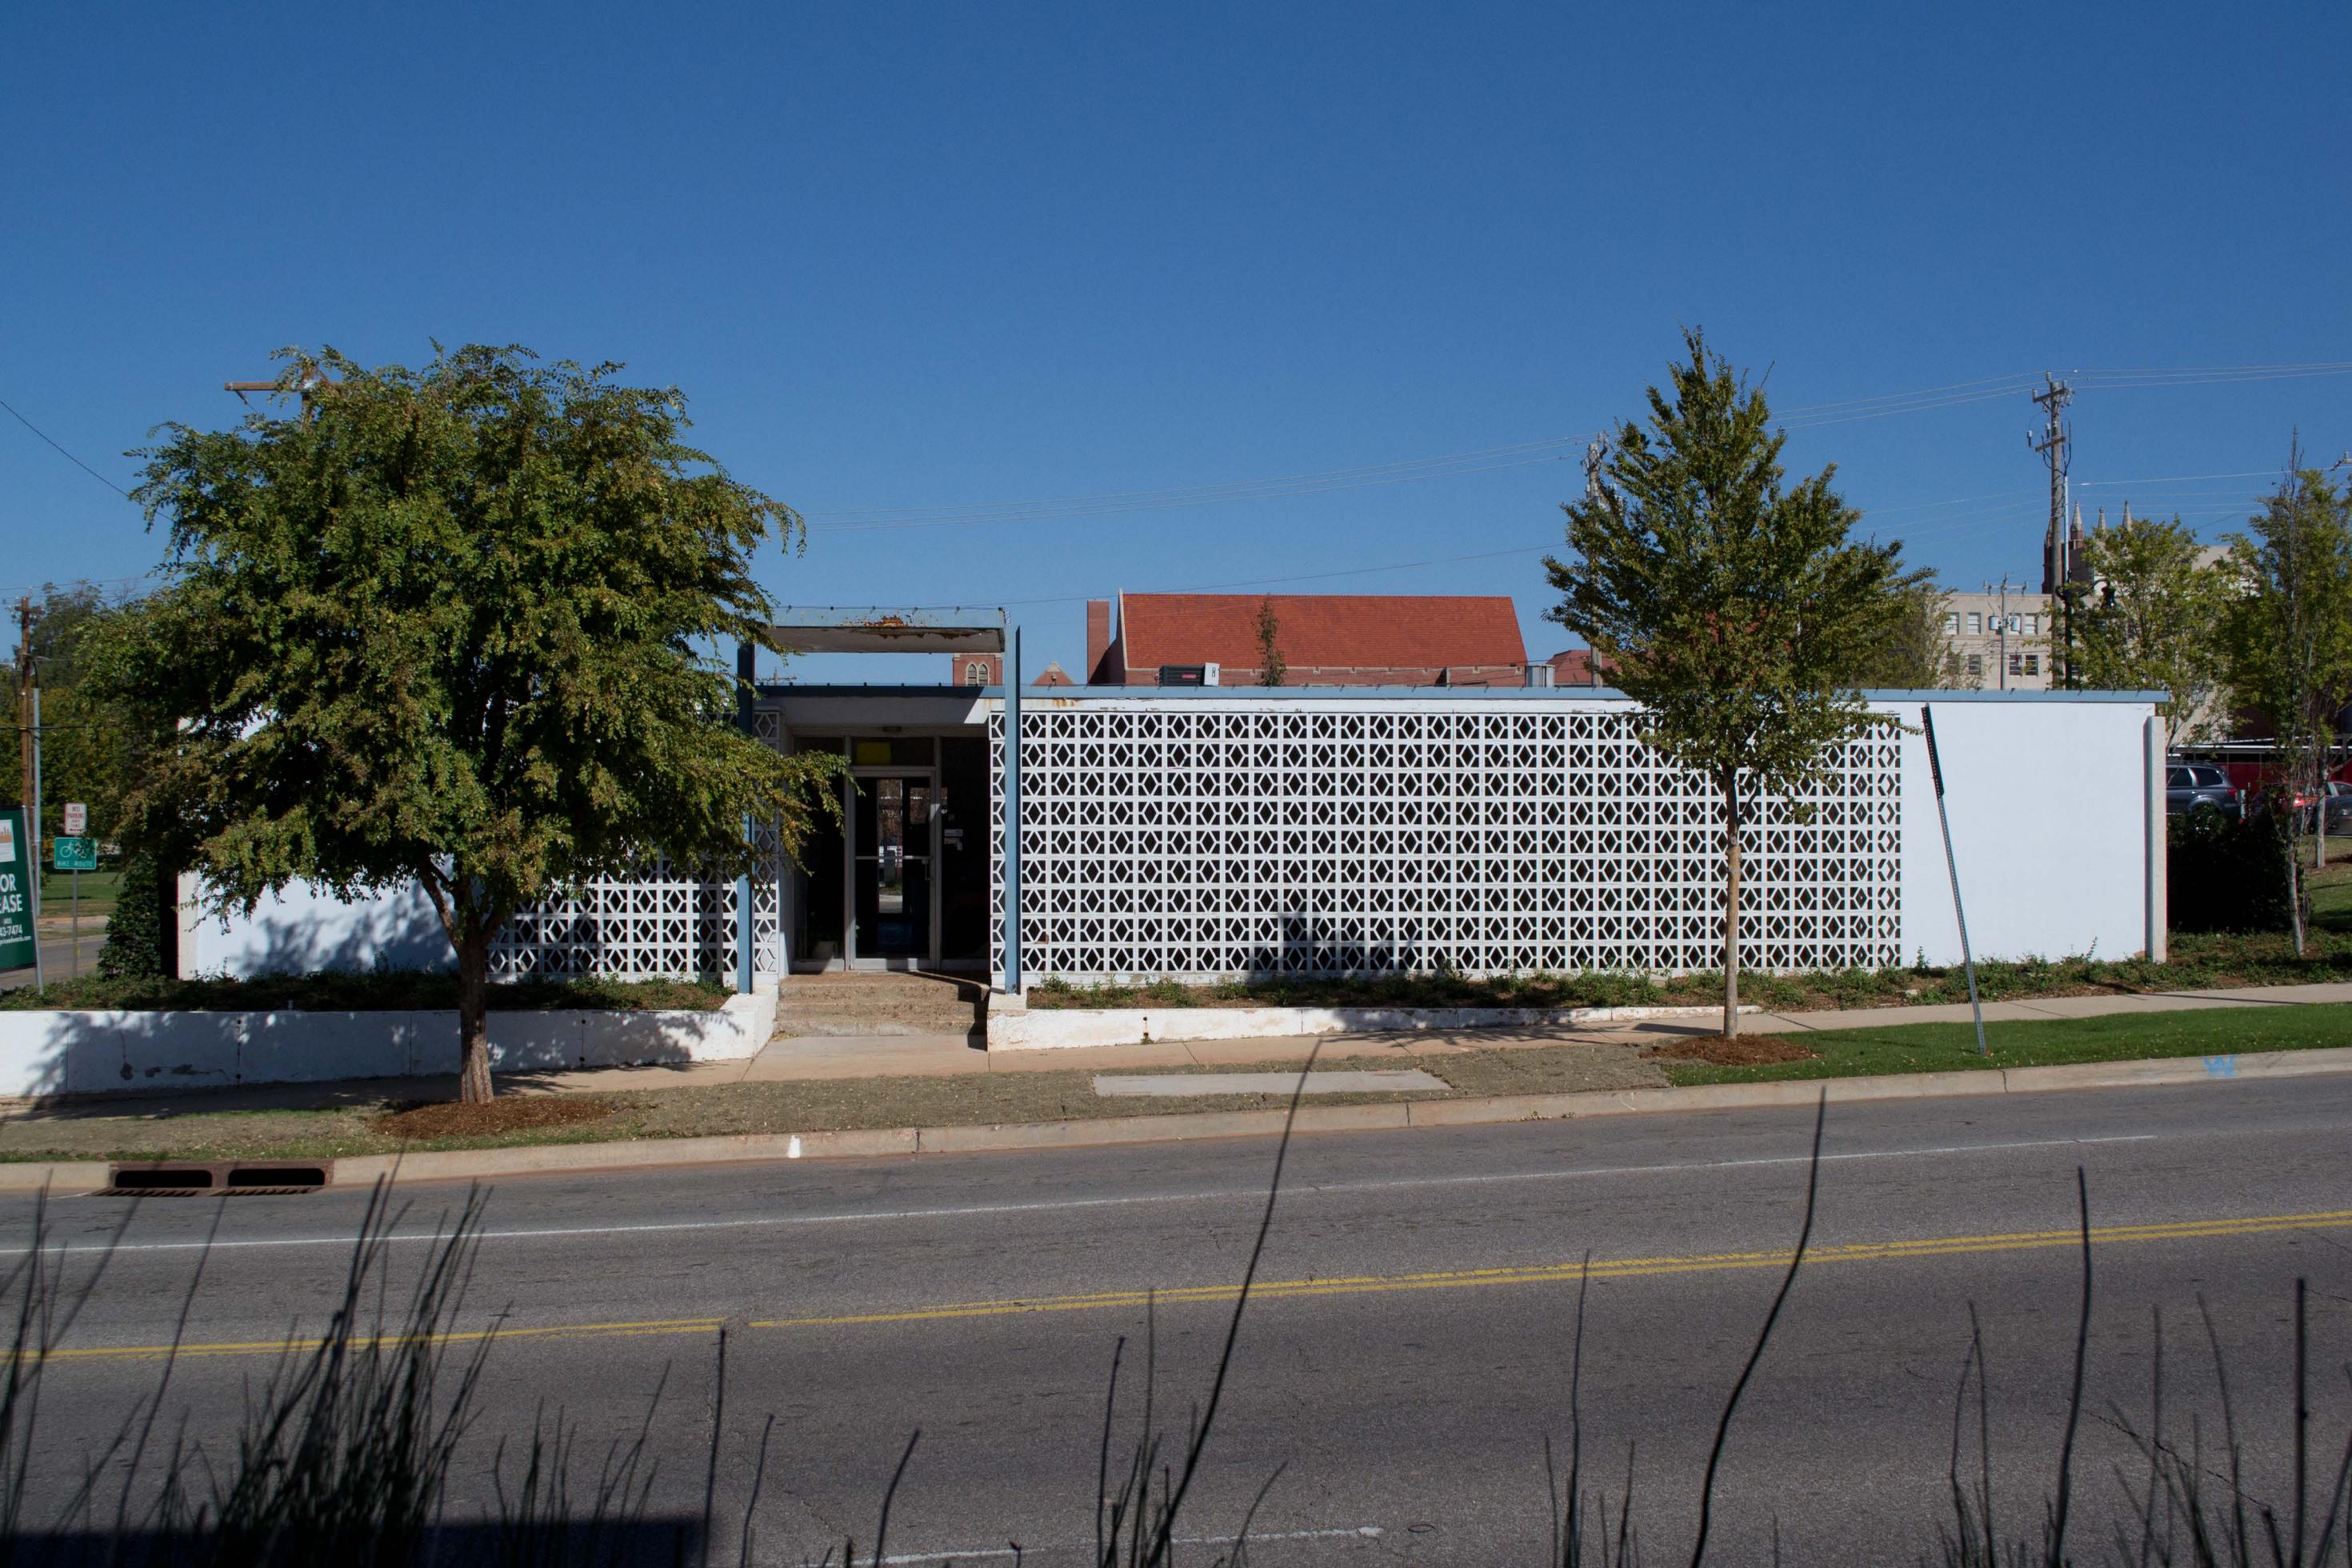
Photo 0001 South elevation, camera facing north

This description will proceed from the south (main) elevation and around the west, north, and east elevations, respectively. The asymmetrical south elevation has a recessed entry with an aluminum-frame glass door with a fixed transom above and flanked by full-height side lights. On either side of the entry, the walls are primarily comprised of full-height windows. These are concealed on both sides of the entry, by a decorative concrete-block "solar screen," set out from the building wall about twelve inches. Each block is approximately twelve inches square and is cut-out in a diamond pattern. The solar screens are the same height as the building. A metal canopy, or awning, marks the entrance. The canopy is two feet higher than the roofline, projecting slightly back over the roof and outward six feet past it. The canopy is supported by six-inch-by-six-inch vertical I-beams set eight feet apart on the walkway. There are three steps up from the walk to the entry.

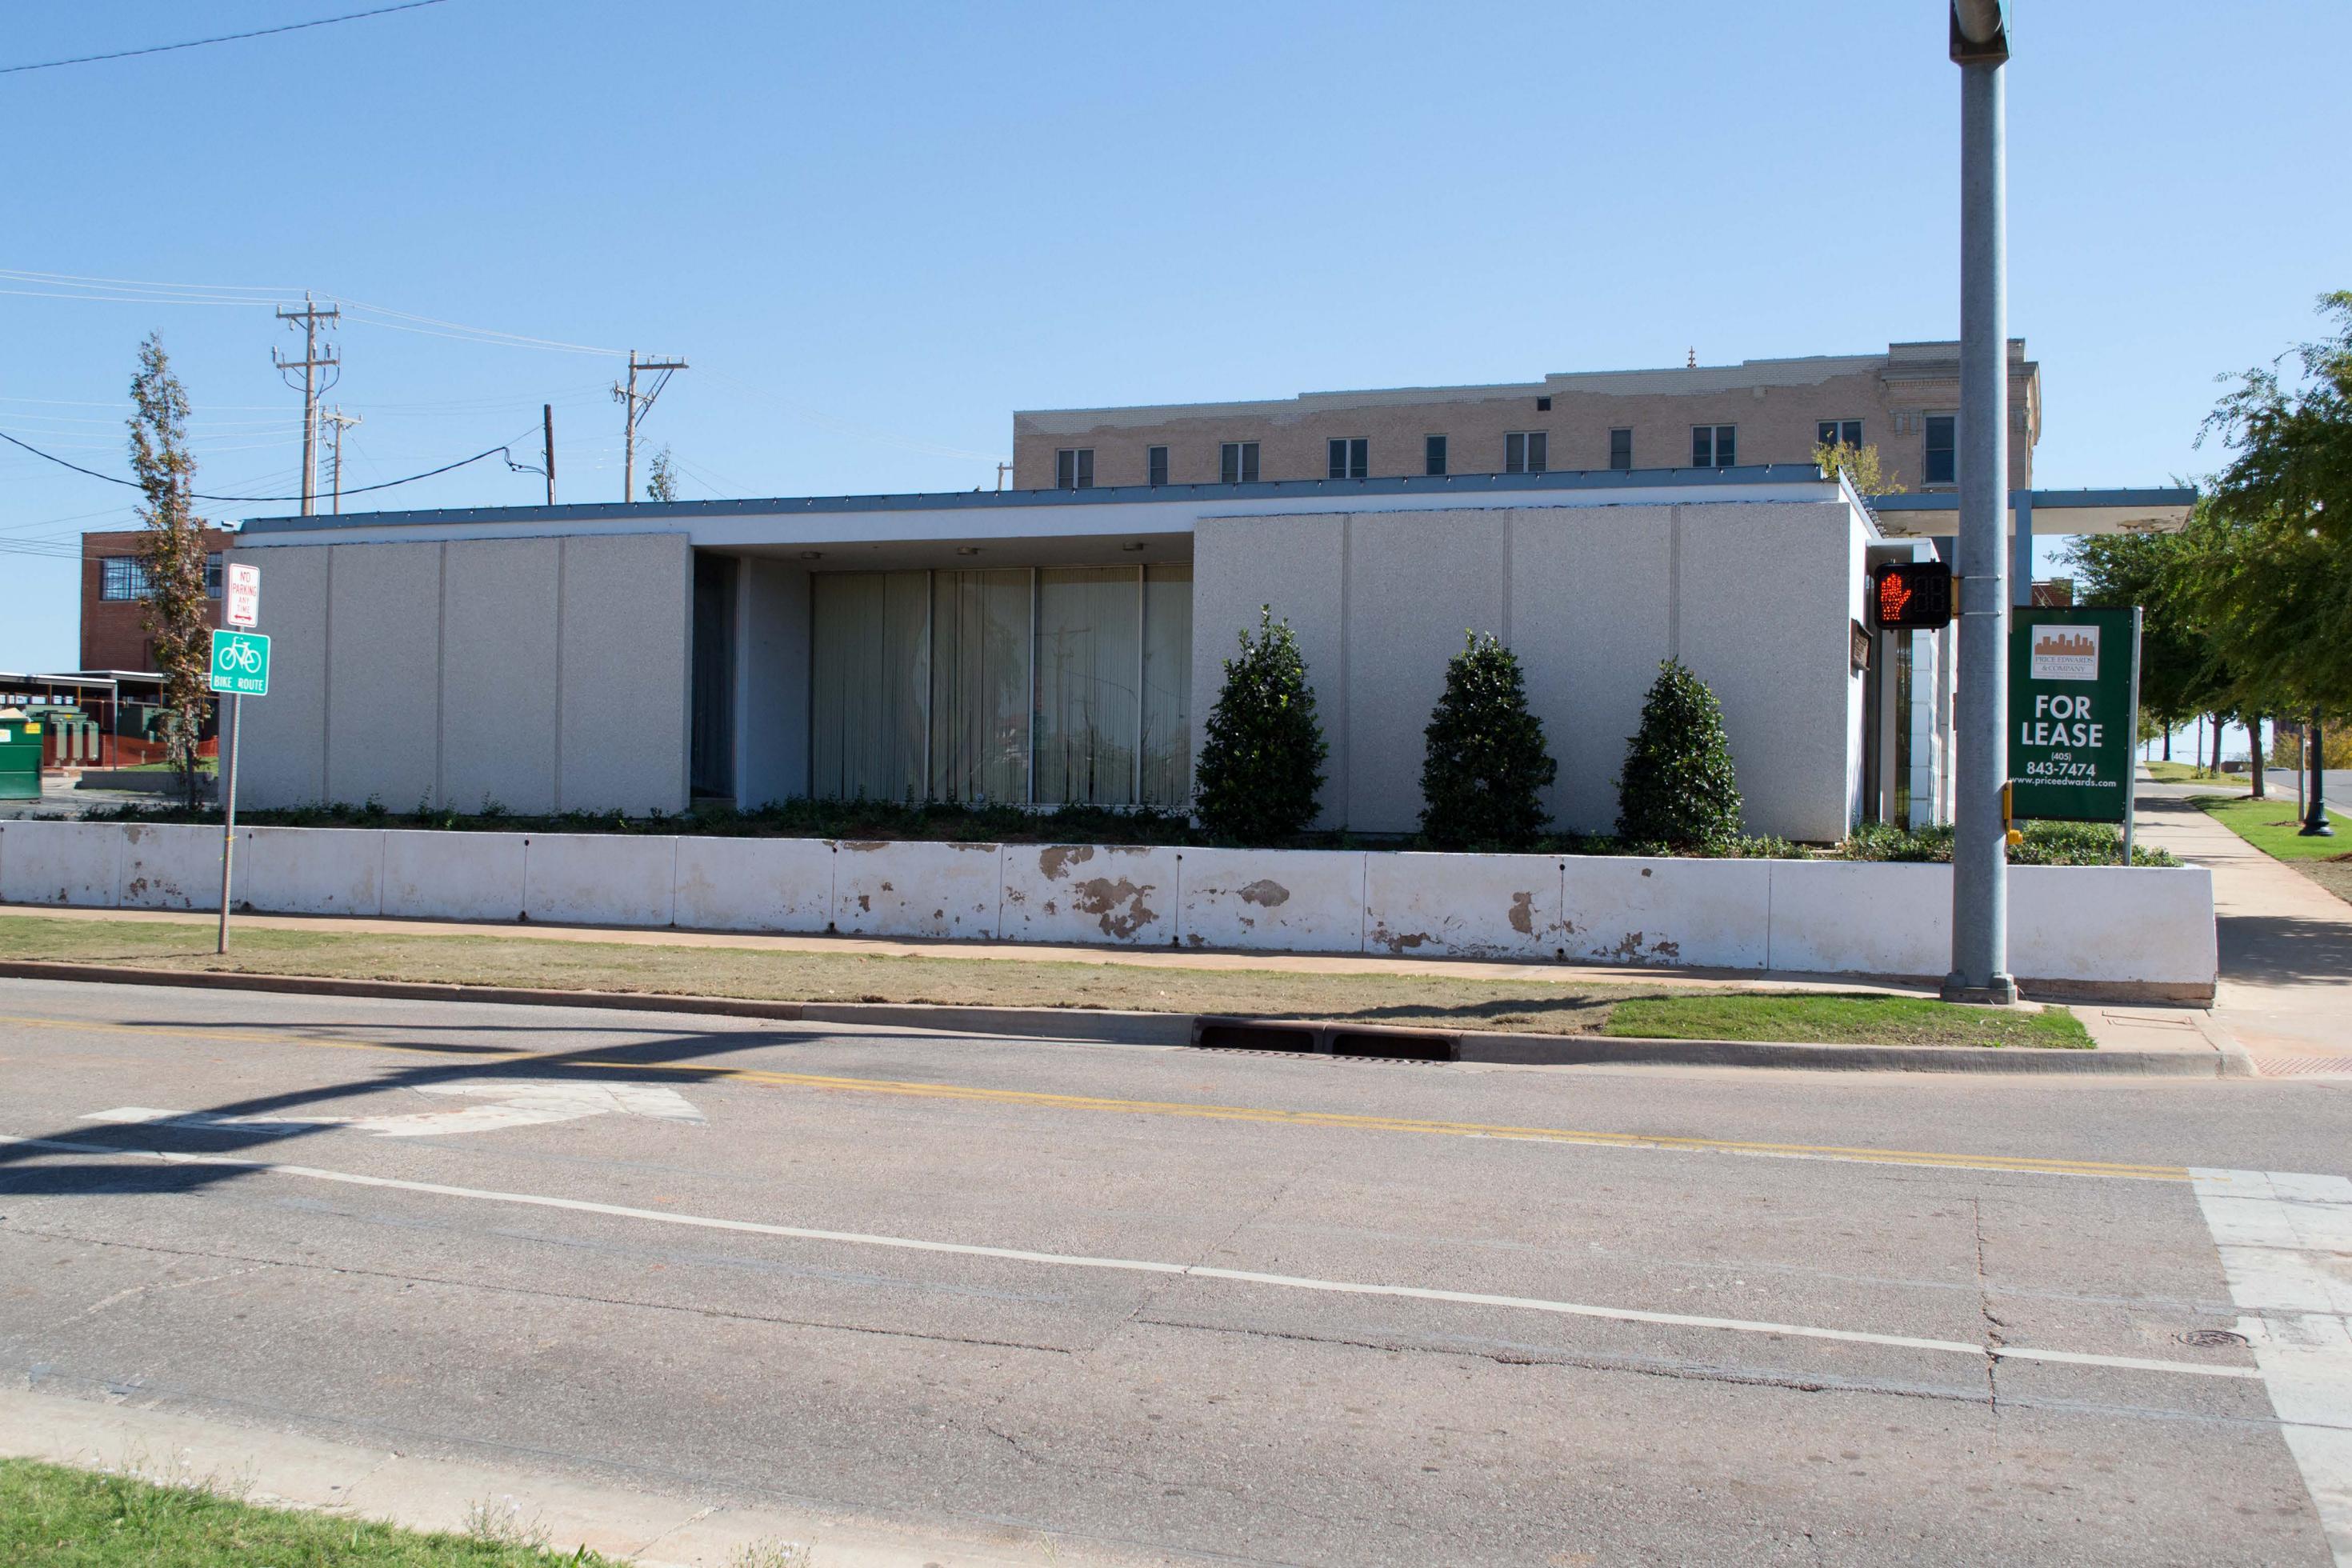
Photo 0002 West elevation, camera facing east

The symmetrical west elevation is in three approximately equal sections. There are four pre-cast aggregate/concrete panels on each side of a recessed window area (no door). Shallow reveals separate the panels. The windowed area has four units facing west and one each on the north and east sides. Inner walls of poured concrete provide support.

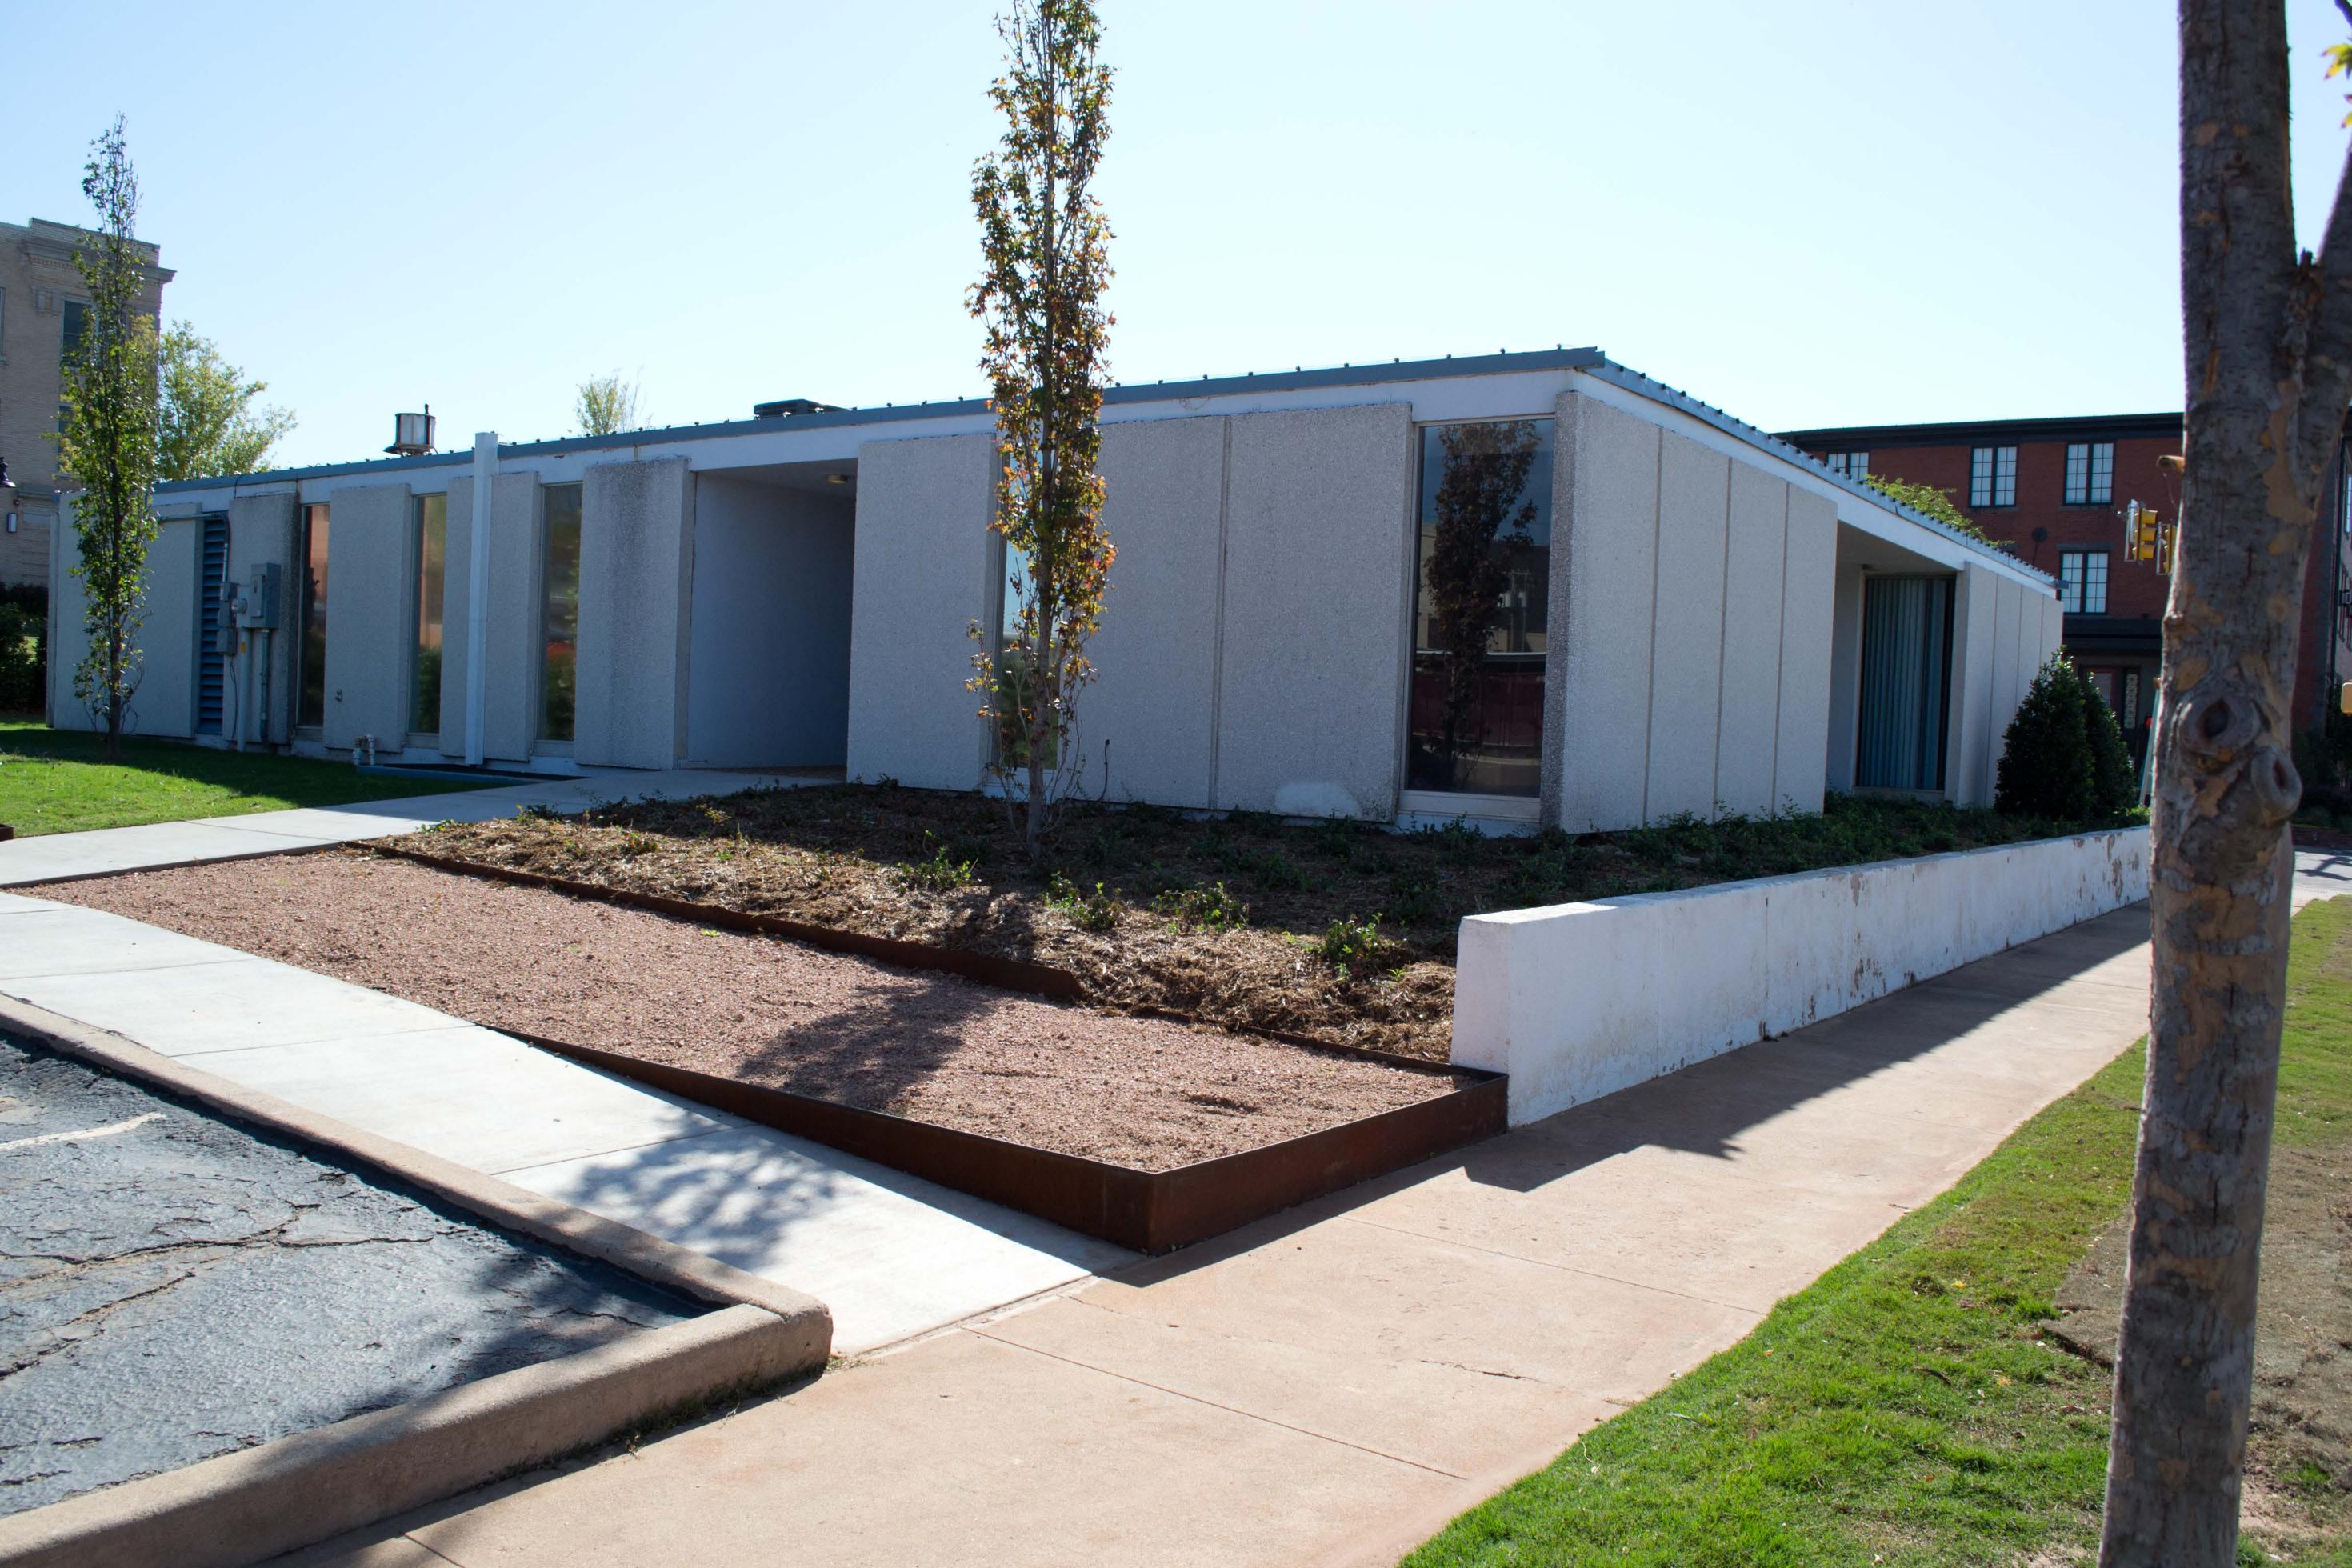
Photo 0003 North elevation (left), West elevation (right), camera facing southeast

The asymmetrical north elevation has a recessed entry set slightly to the west. The entryway has a door with a fixed transom, and flanking windows. To the left of the door are three of the pre-cast panels and two windows. To the left of the door are five pre-cast panels separated by three windows and a louvered opening. The west end of this elevation has been altered by the removal of two windows, replaced at an unknown date by a stuccoed wall. A large downspout is placed against the north wall.

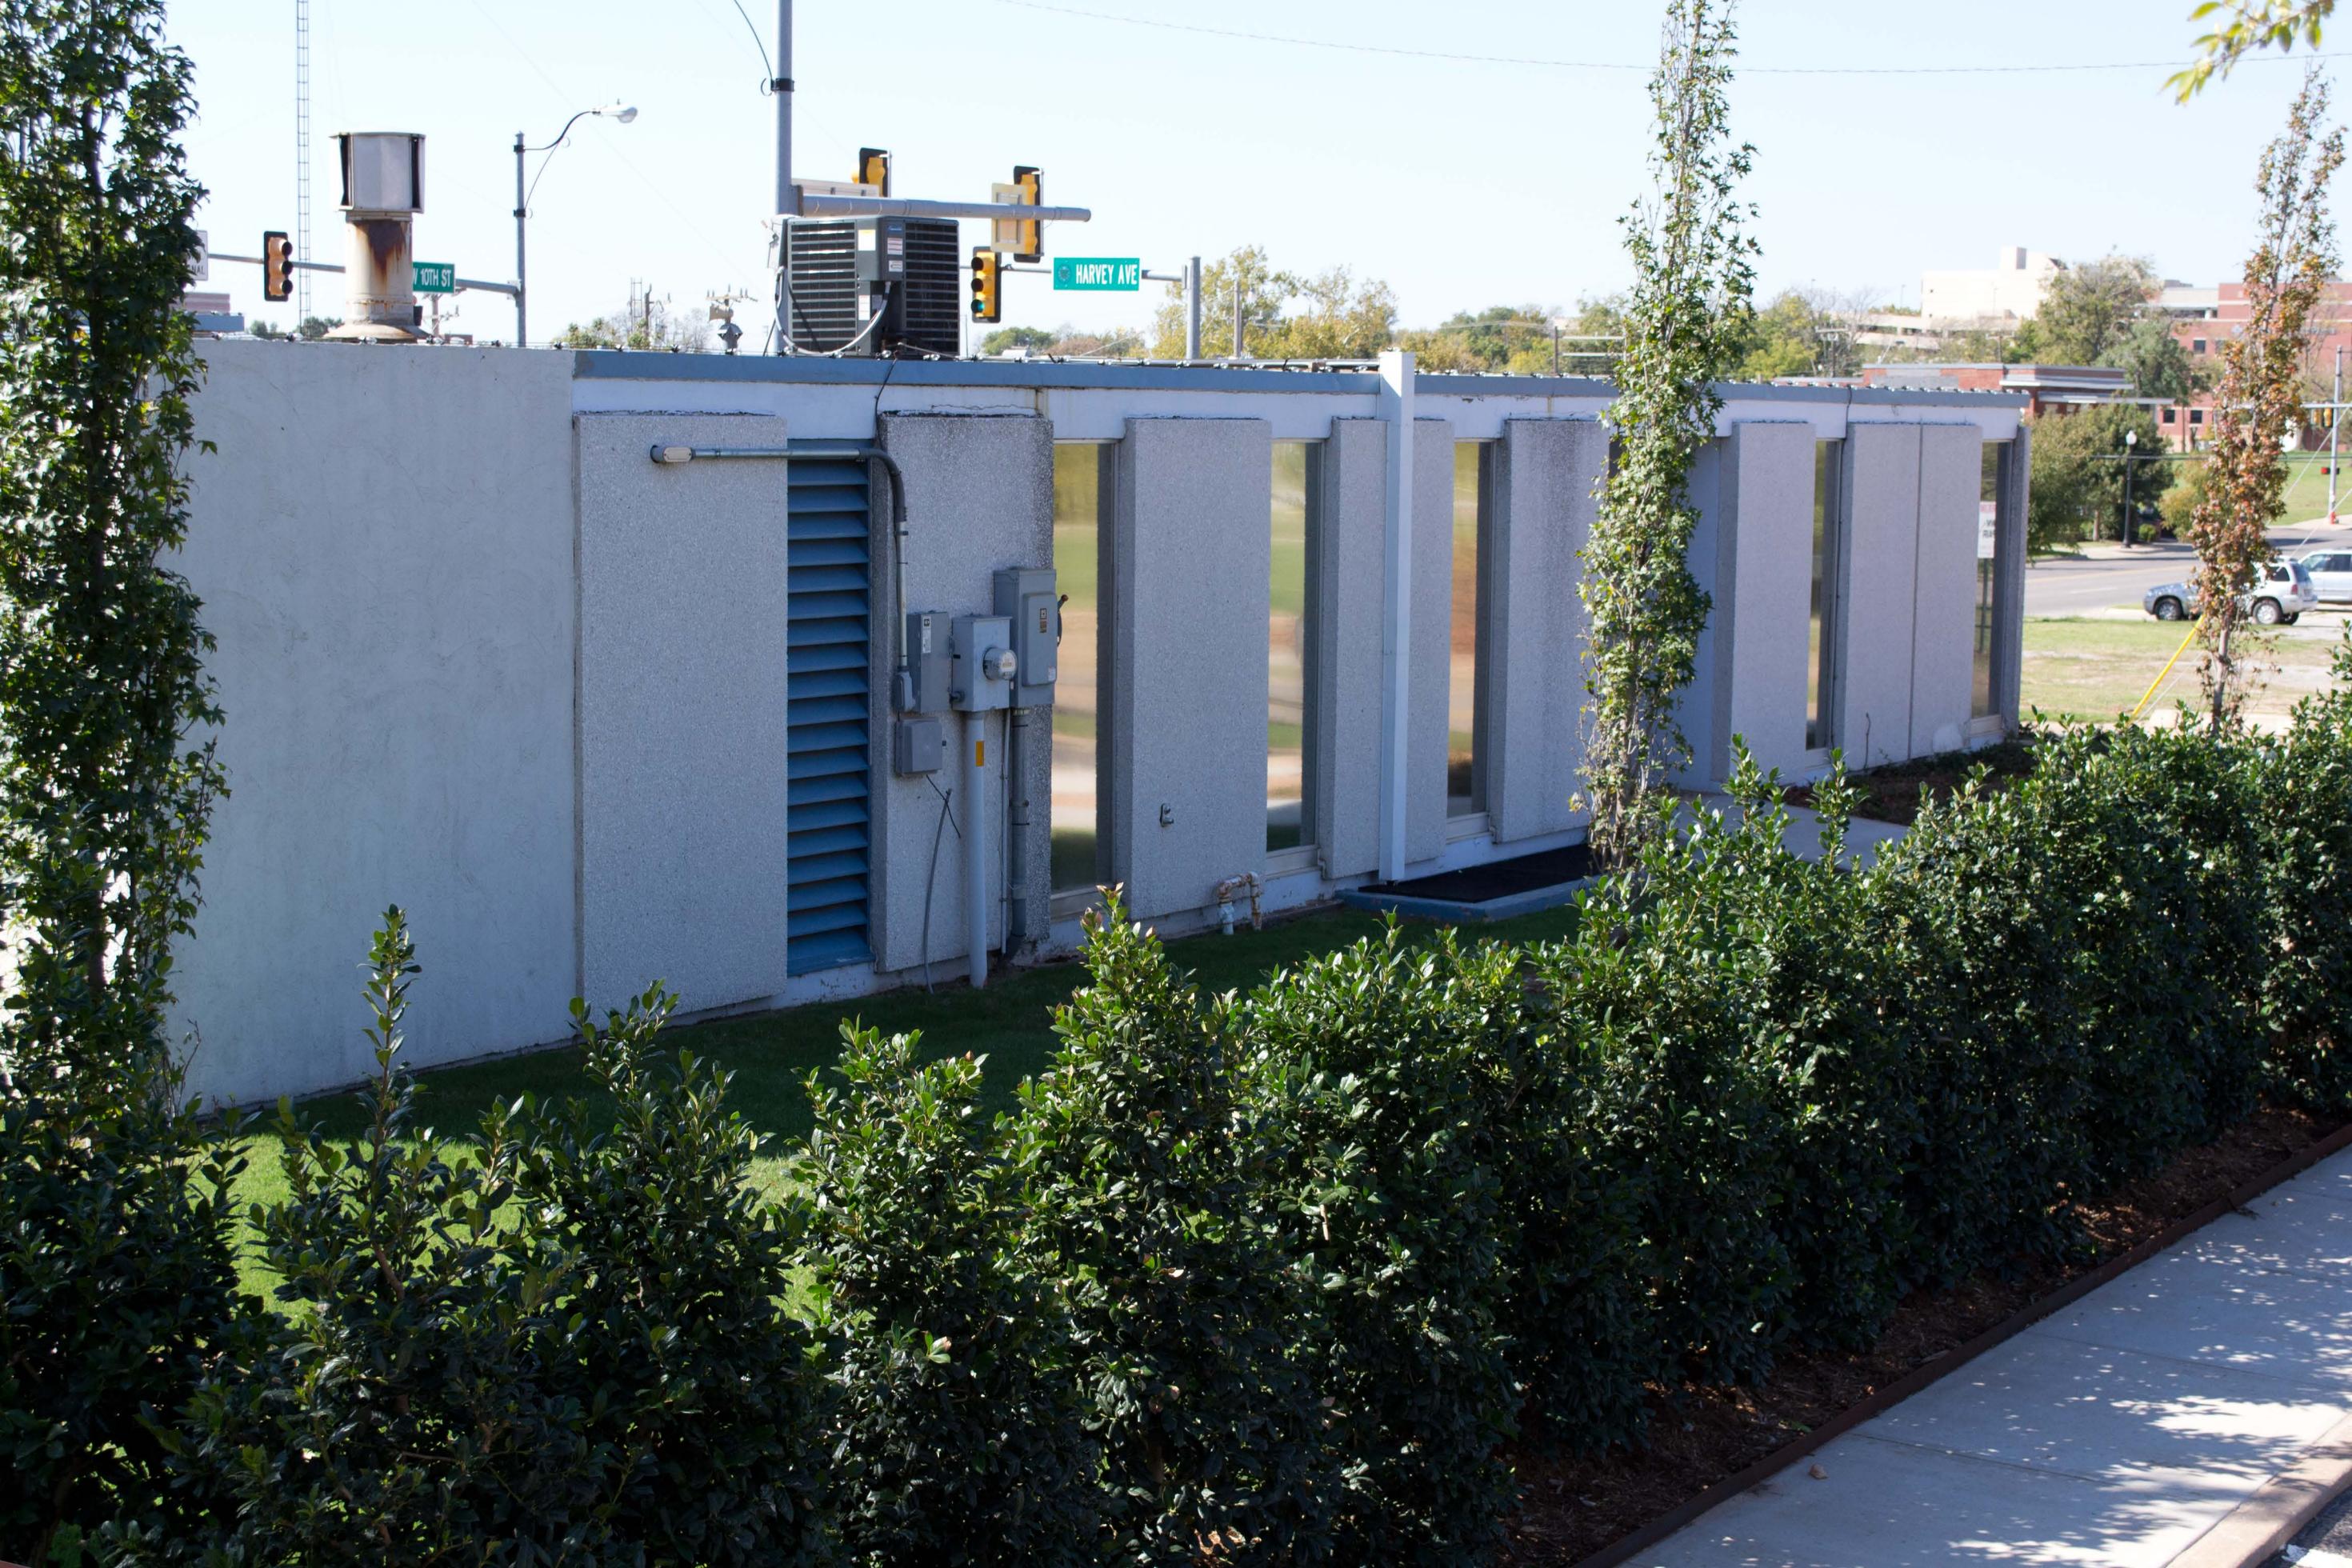
Photo 0004 North elevation, camera facing southwest

On the east part of the north elevation, two windows were removed circa 1975 or later, when the building's occupant became a medical clinic. They were replaced with a wall of unknown material that is faced with stucco. The room behind that section of wall was altered in order to create an X-ray area. Interior rooms have seen a considerable change from the original floor plan. On the exterior, the Mager Mortgage Company Building retains a very high degree of architectural integrity and is an excellent example of basic Modern Movement visual characteristics applied to a small commercial building.

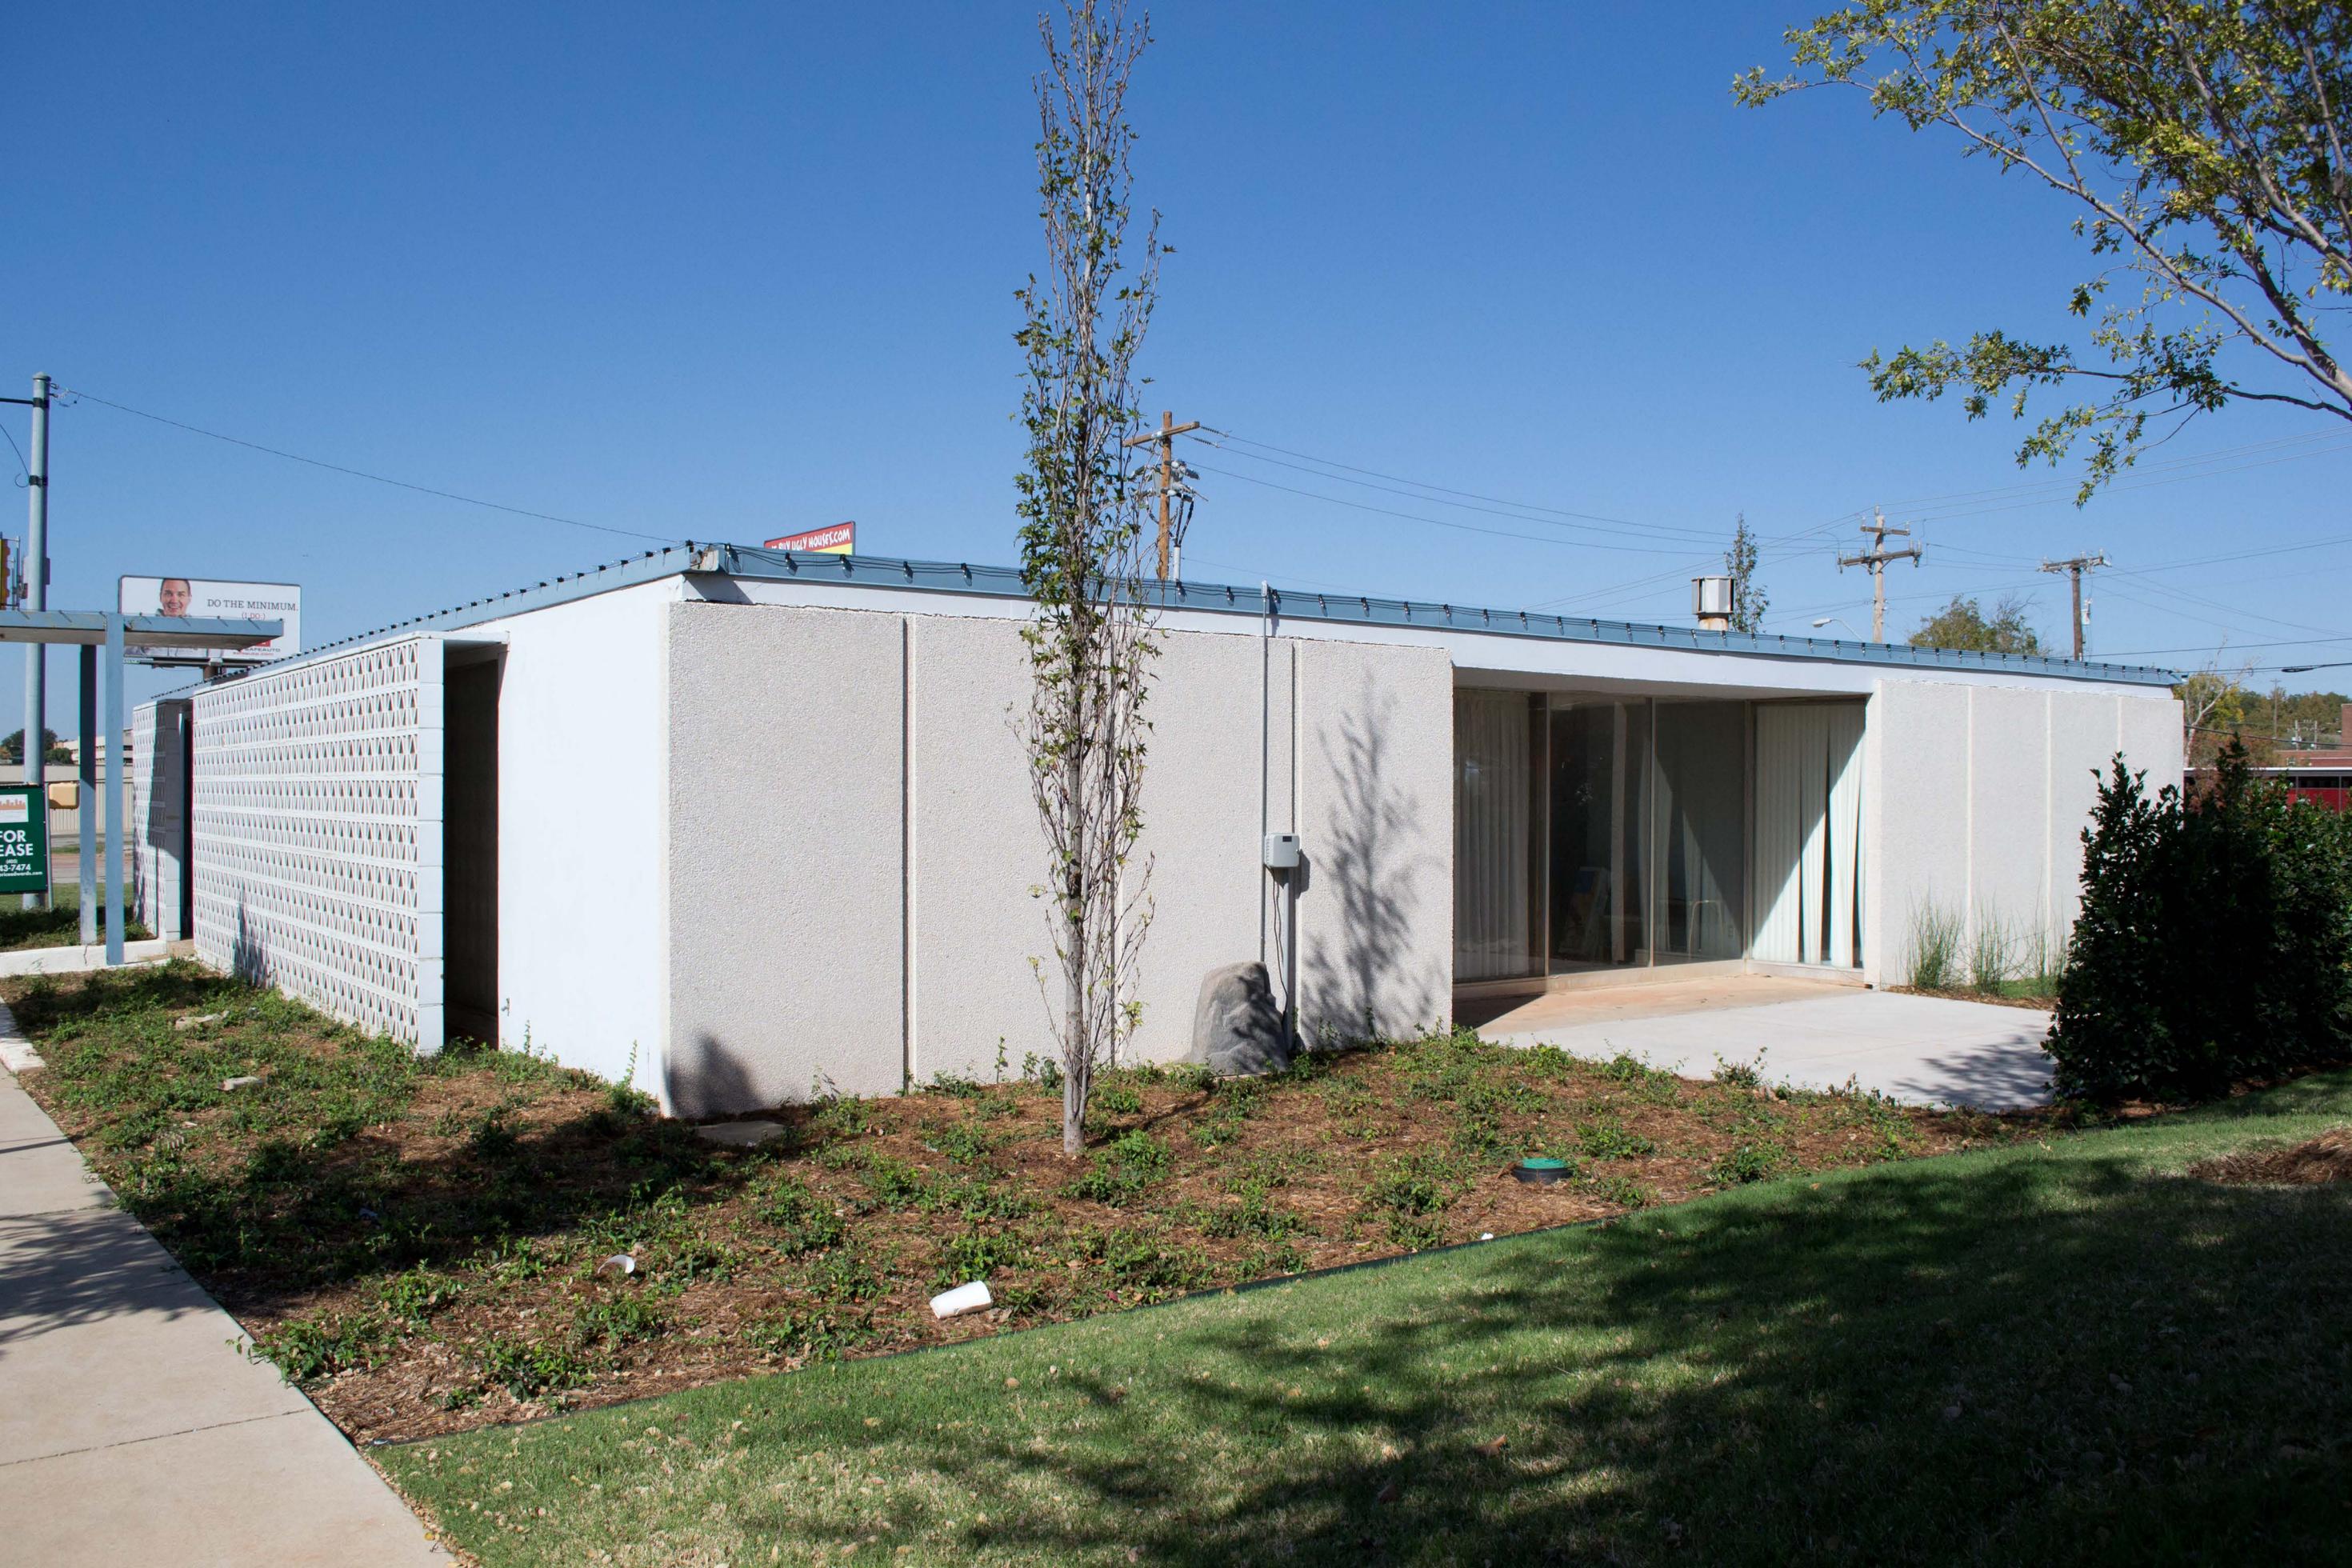
Photo 0005 South elevation (left), East elevation (right), camera facing northwest

The symmetrical east elevation has three approximately equal sections, two of which comprise four pre-cast panels with reveals; the central section is similar to that on the west side, with the addition of a glass door and side light on the south end and a full window on the north, instead of a concrete wall.
