National Register of Historic Places Registration Form

Historic name: Mount San Jacinto State Park Historic District

Street & number: 25905 Highway 243

City or town: Idyllwild State: CA County: Riverside

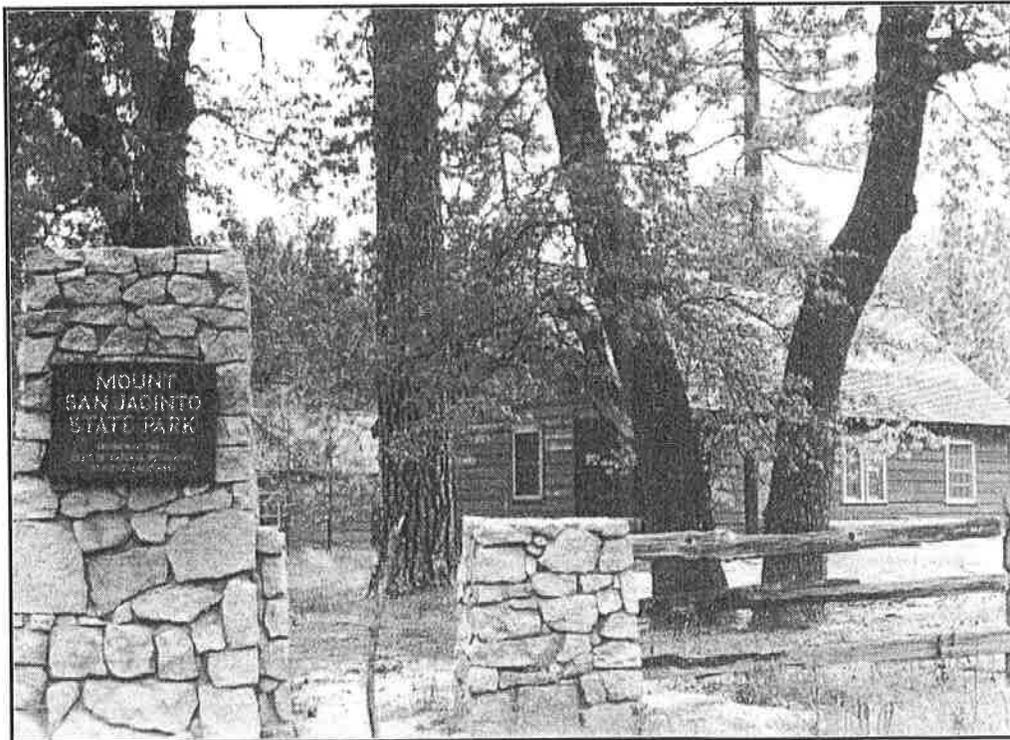
Photograph # HP2
Looking North at Stone
Masonry Column, Pier,
and Residence #1 (right)
Date: 1936 May
Source:
CA State Museum
Accession # 090-23396

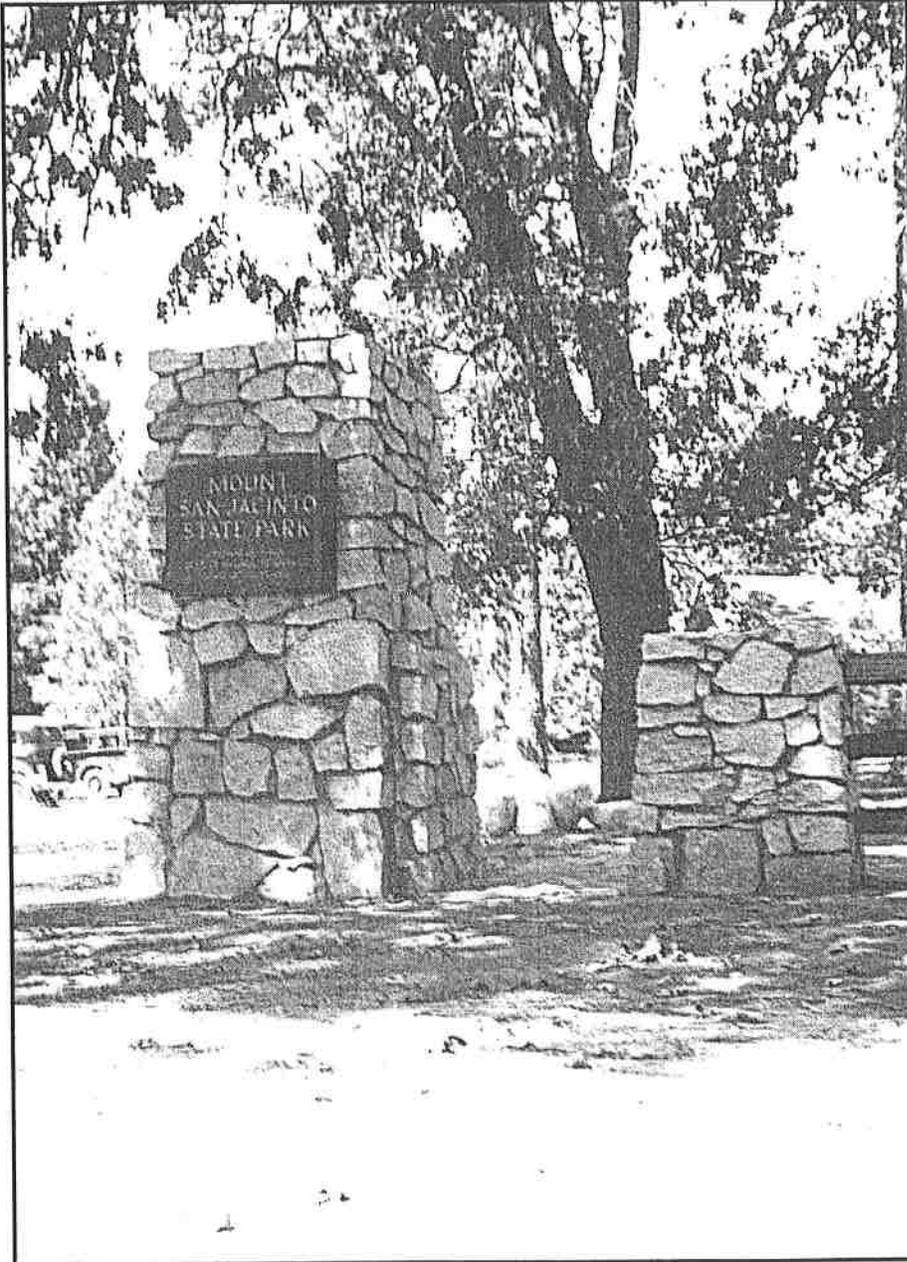
Photograph # HP3

Looking Northwest at
Stone Masonry Column,
Pier, and Visitor Parking
Area (left)

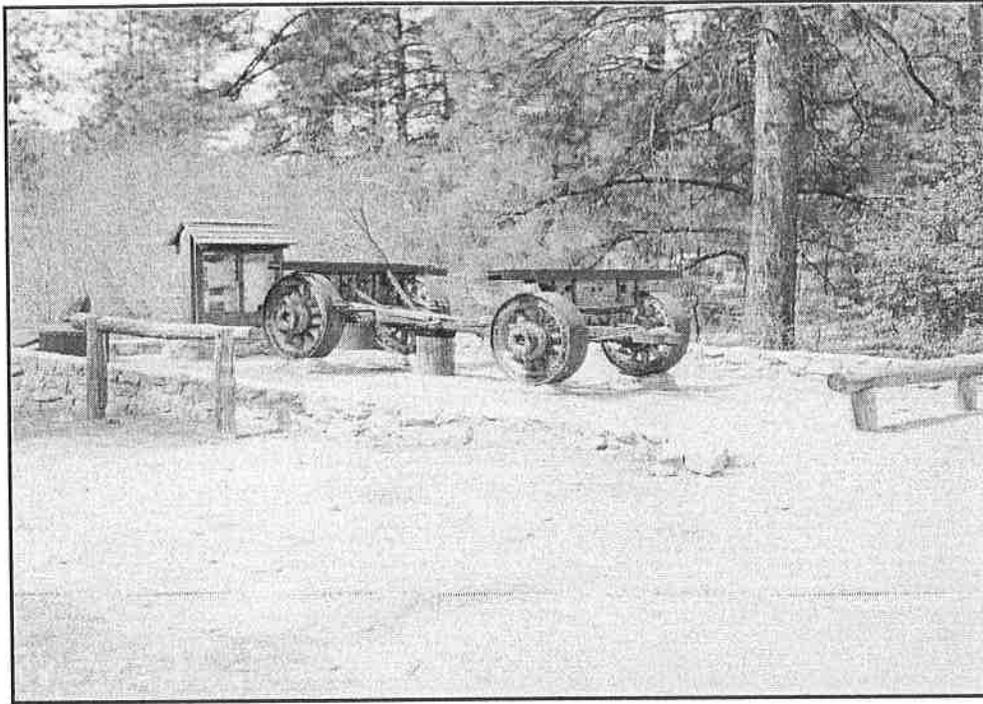
Photograph # HP4

Looking Southwest at
Log Hauling Wagon
Display Platform and
Visitor Parking Area

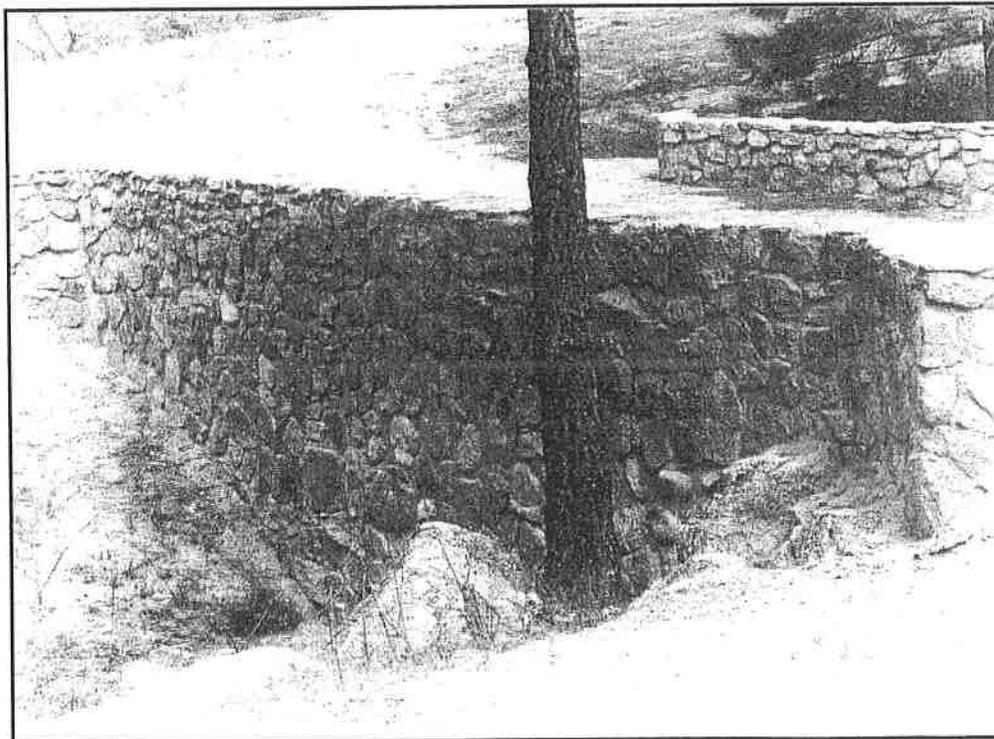
Photograph # HP5

Looking North at Stone
Masonry Bridge

This 1936-built 20-foot by 20-foot stone rubble masonry and earthen fill bridge conveys vehicular traffic across the 6.5-foot-deep creek bed dividing the Idyllwild Headquarters area from the adjacent campground. The bridge's simple, yet solid construction, utilizing irregular courses of cement-mortared dressed quarry rubble stones, fieldstones, and riprap, typifies the NPS/CCC-era Park Rustic style. An approximately 3-foot-high solid cement-mortared stone balustrade, capped by a single course of dressed flat-topped granite rocks, runs along either side of the bridge's compressed earth crown deck. Water-born debris and sediment periodically constricts the flow of the creek through the bridge's 30-inch-diameter corrugated galvanized iron culvert and flanking weep holes. Twin riprap aprons in front of the culvert's north and south openings prevent the water from undermining the bridge. A non-historic layer of asphaltic cement road pavement now covers the bridge's original 4-inch-thick decomposed granite crown deck.²⁰

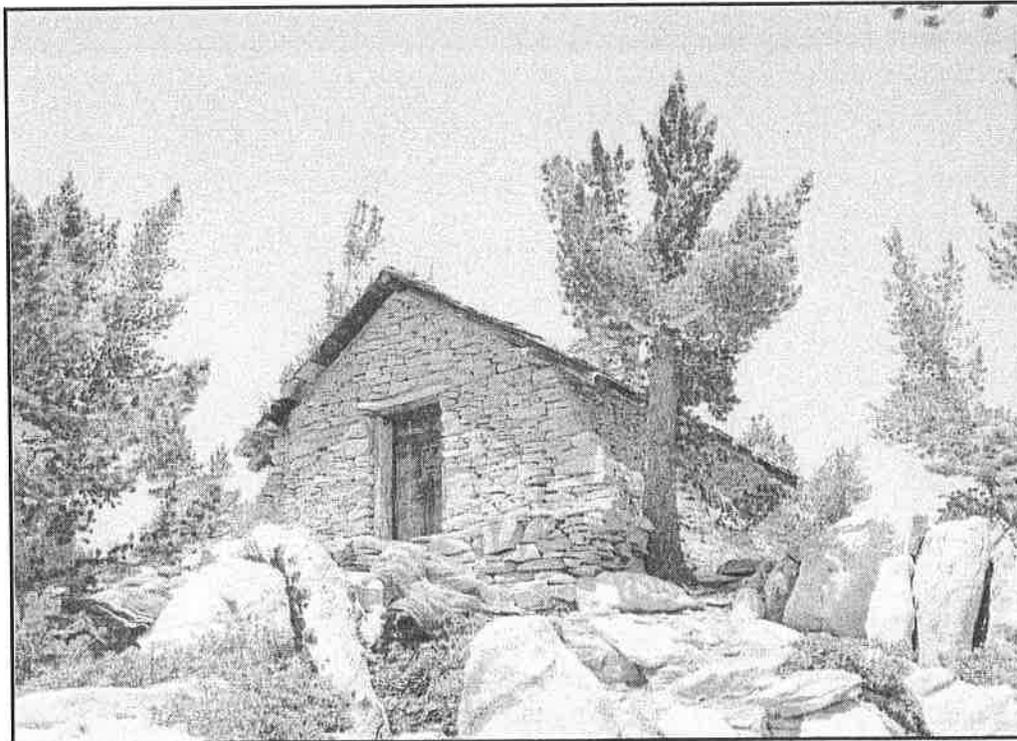
Photograph # HP8
Looking Northwest at
San Jacinto Peak Shelter
Date: 1952 August
Source:
CA State Museum
Accession # 090-23415

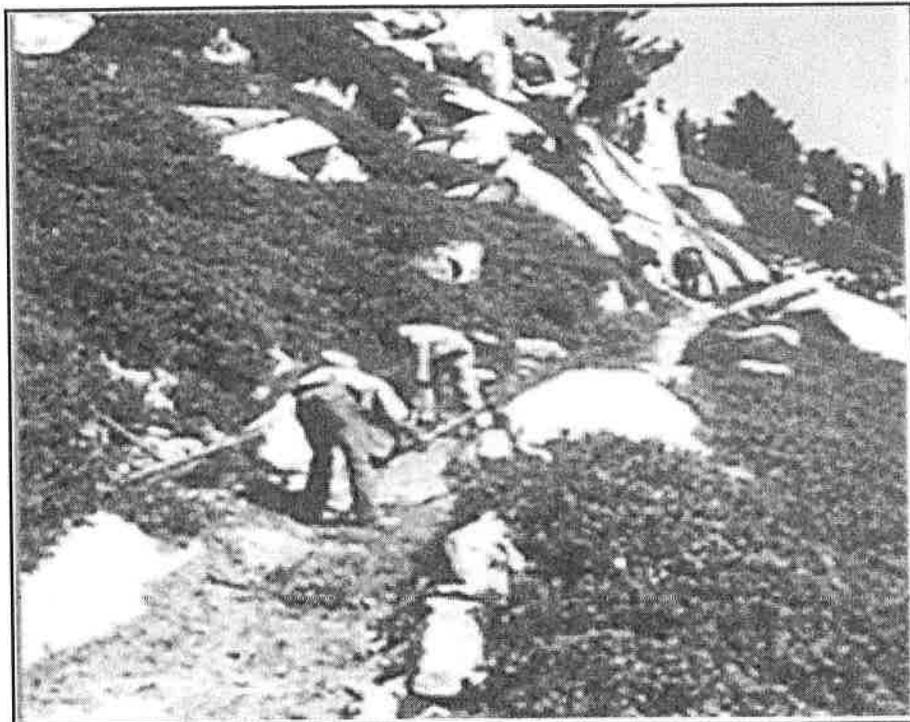
Photograph # HP9
Looking Northeast at Trail
Repair Work
Date: 1957 August 8
Source:
CA State Museum
Accession # 090-23933

along the way. Blast scars, drill holes, and pick marks can still be observed in cleaved boulders and rockwork alongside compacted earthen trails conforming to the contours of the natural forested landscapes through which they travel. Rehabilitated after World War II, from 1949 to 1965, the trails still maintain these unique Park Rustic style design characteristics.²⁹

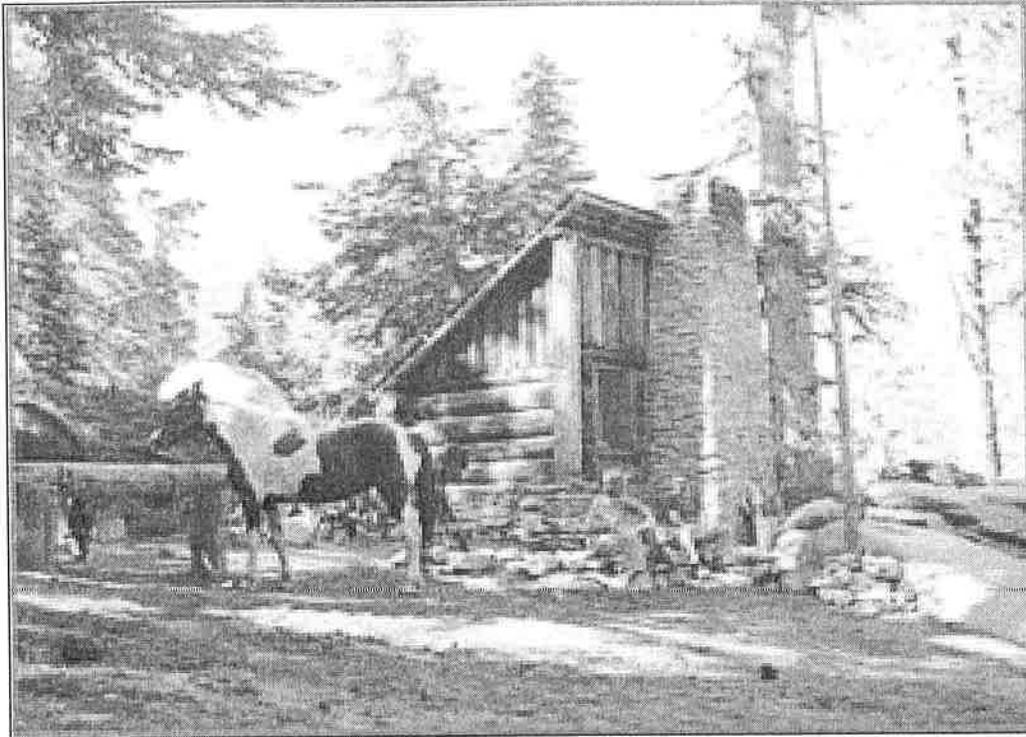
Photograph # HP11
Looking North at Round
Valley Shelter
Date: 1952 August
Source:
CA State Museum
Accession # 090-23420

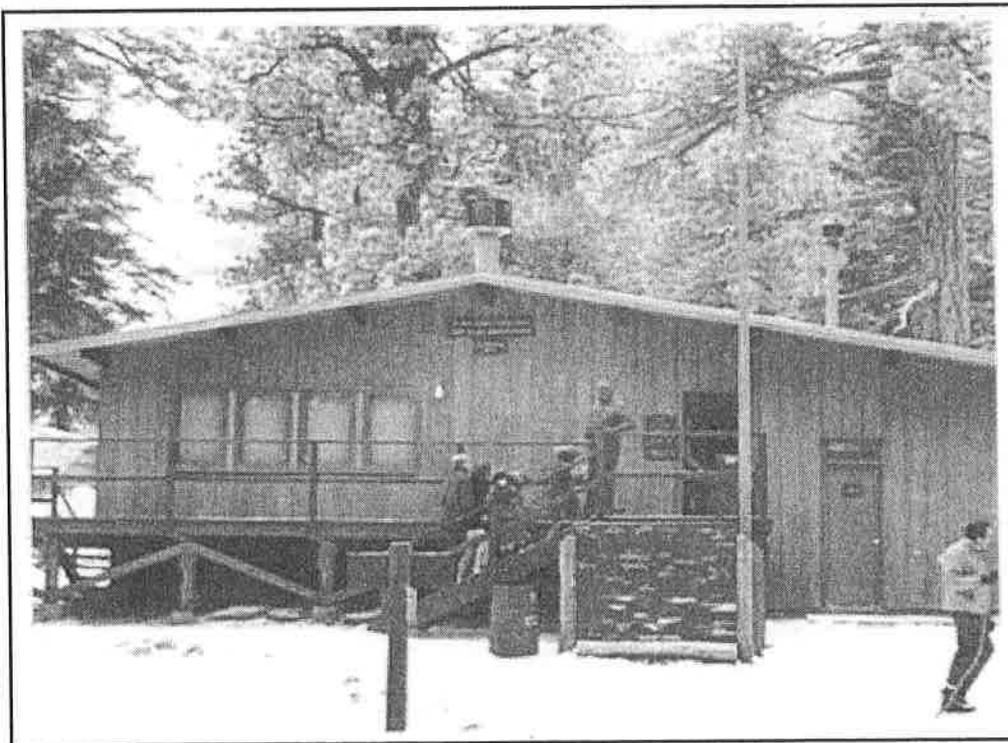
Photograph # HP14
Looking North at Long
Valley Ranger Station
Date: Winter 1964
Source:
Mount San Jacinto State
Park
Accession # N/A

Two contributing structures located at Mount San Jacinto State Park's Upper Mountain Section erected during this period are associated with the third variant of the evolution of the Stripped-Down Park Rustic style in California State Parks. They include the previously mentioned Ranger Station and Utility Structure at Long Valley. While there is some question as whether or not Uhte's 1962 designs were for newer, larger facilities at Round Valley, and that Williams, Clark & Fry later copied and adapted them for Long Valley, Uhte is still responsible for their original design. Williams, Clark & Frey's 1963 plans merely removed Uhte's original picturesque "gingerbread cottage" detailing from both buildings' initial design. The result is two unadorned minimalist structures that still follow Uhte's design philosophy that "architects and their designs should be quiet, and not disturb the landscape." Completed in 1964, both structures are simple, unassuming, functional constructs that blend in well with their rustic setting.⁷⁴
