National Register of Historic Places Registration Form

historic name Case Study House #18
other names/site number _____

Case Study House #18
Name of Property

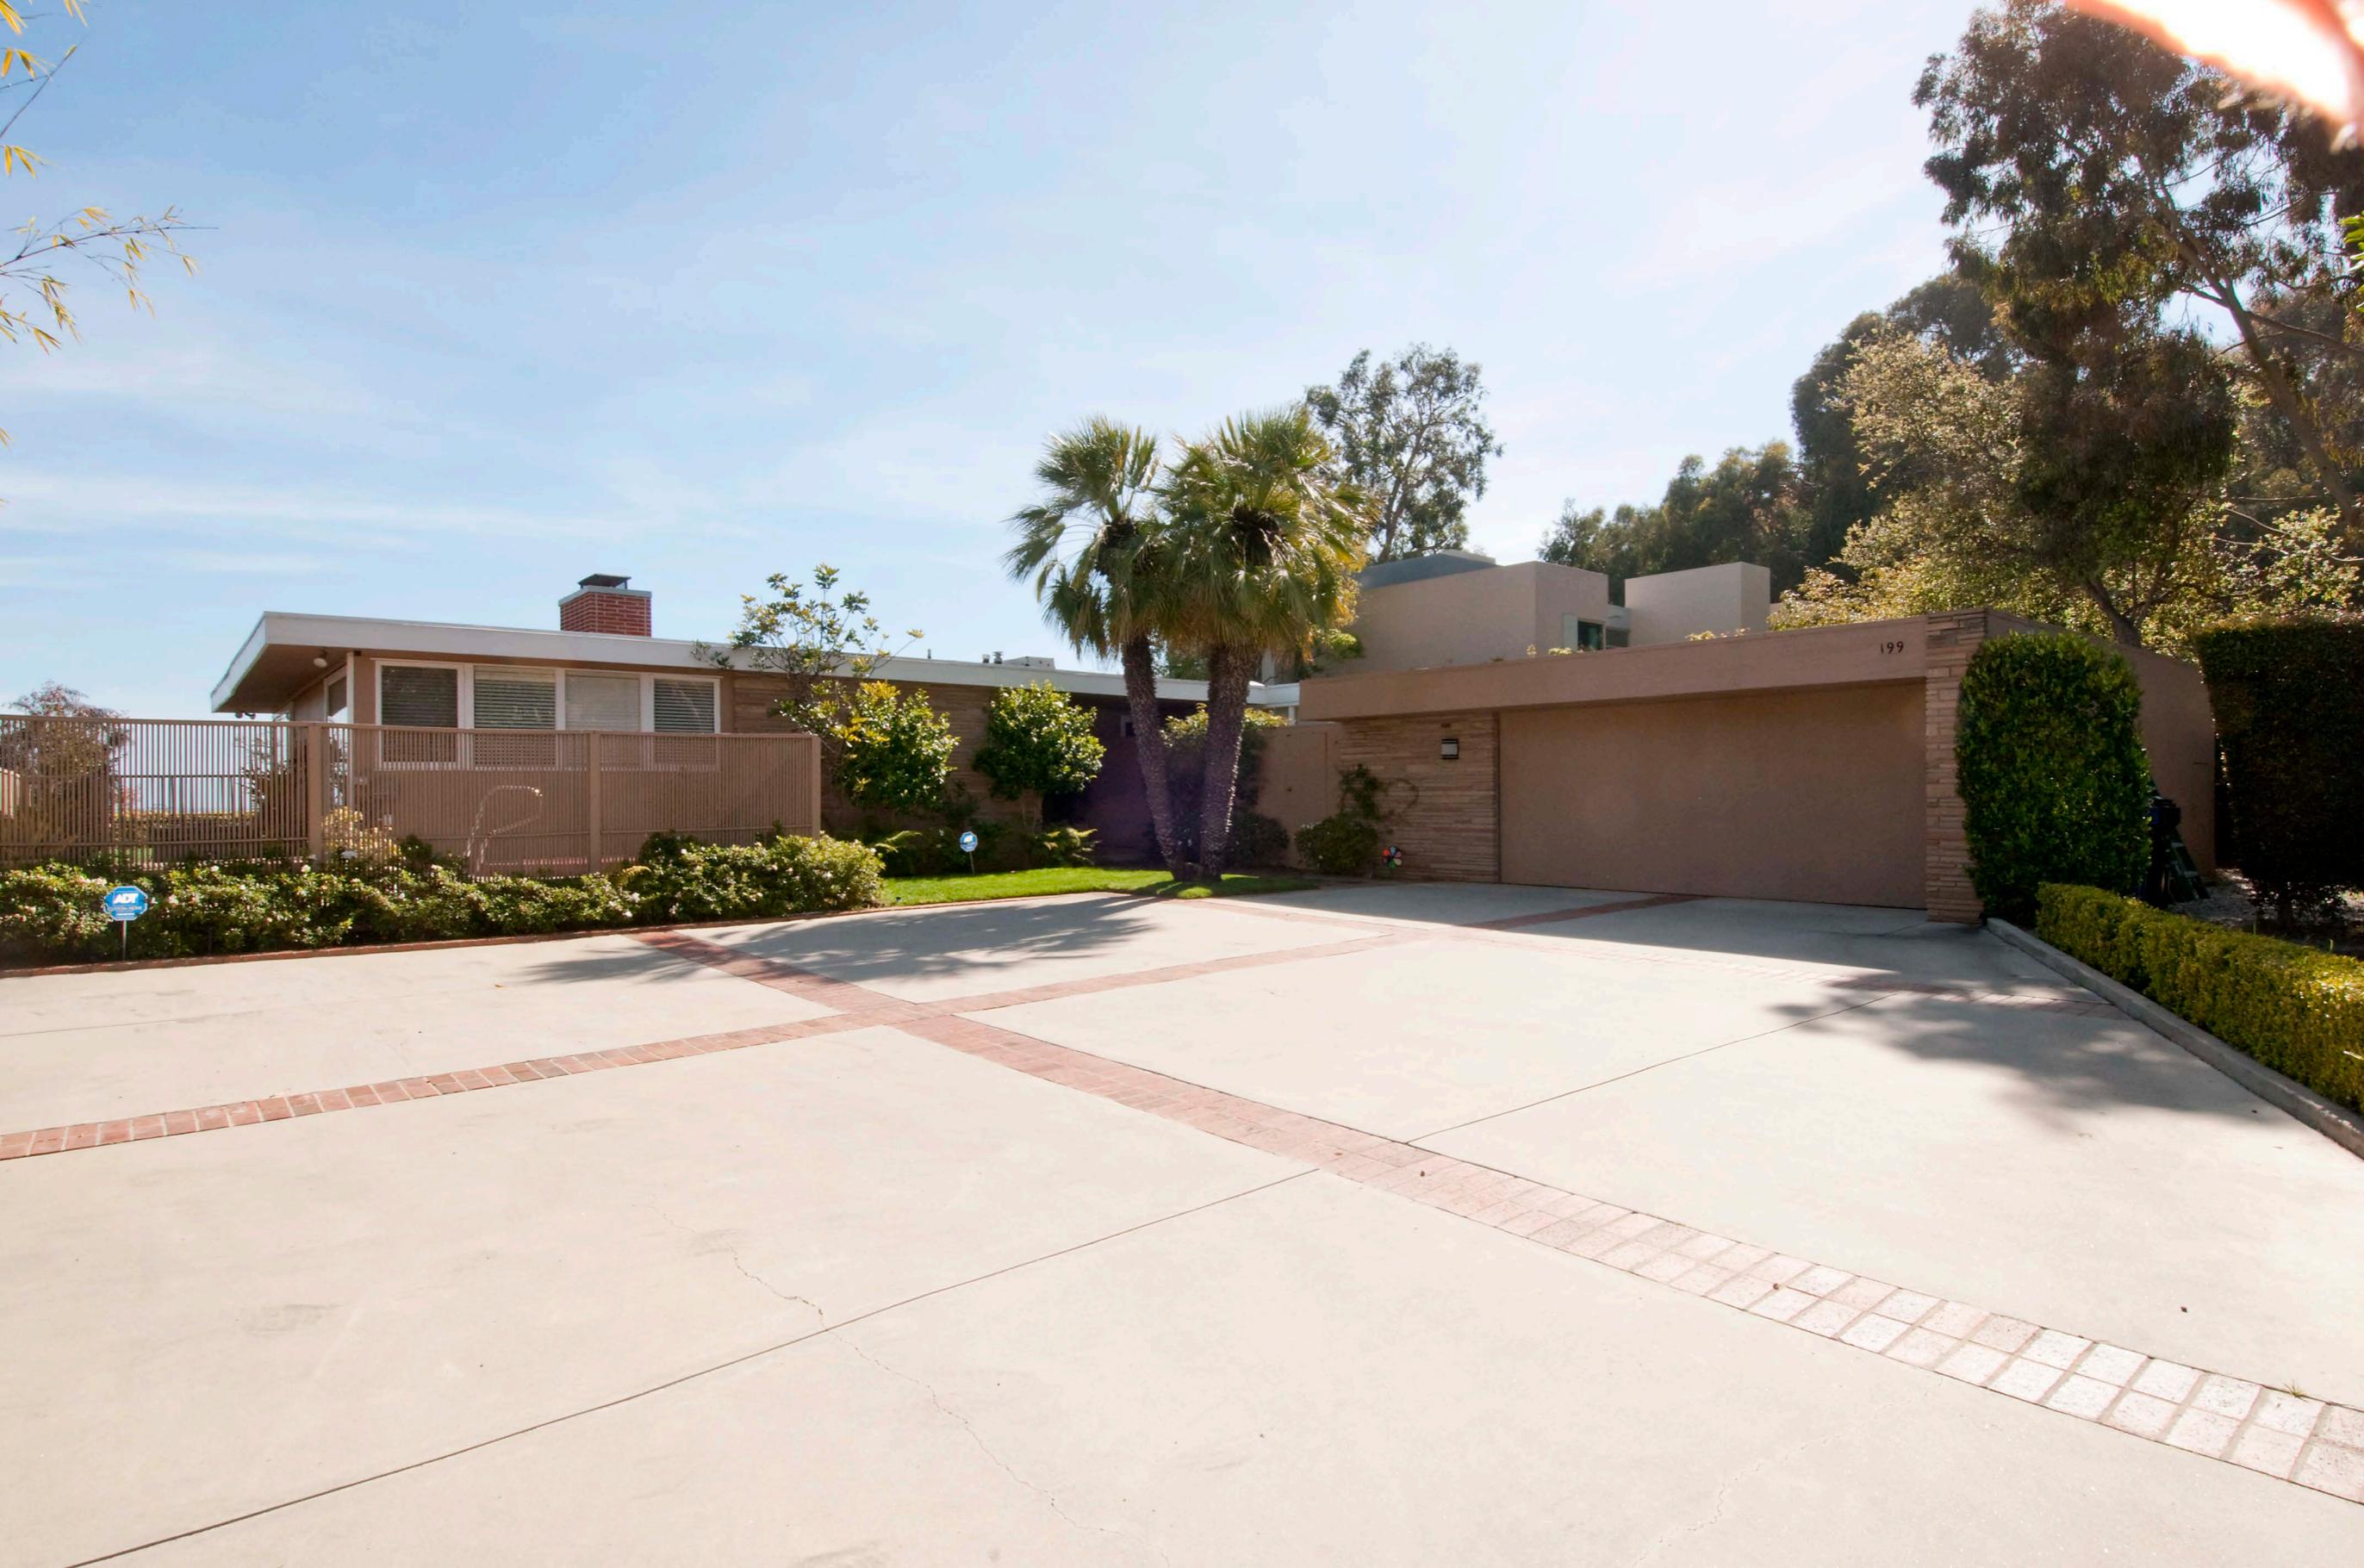
CA_Los Angeles County_Case Study House 18_0001.tif
North façade (left), East façade (right), camera facing Southwest

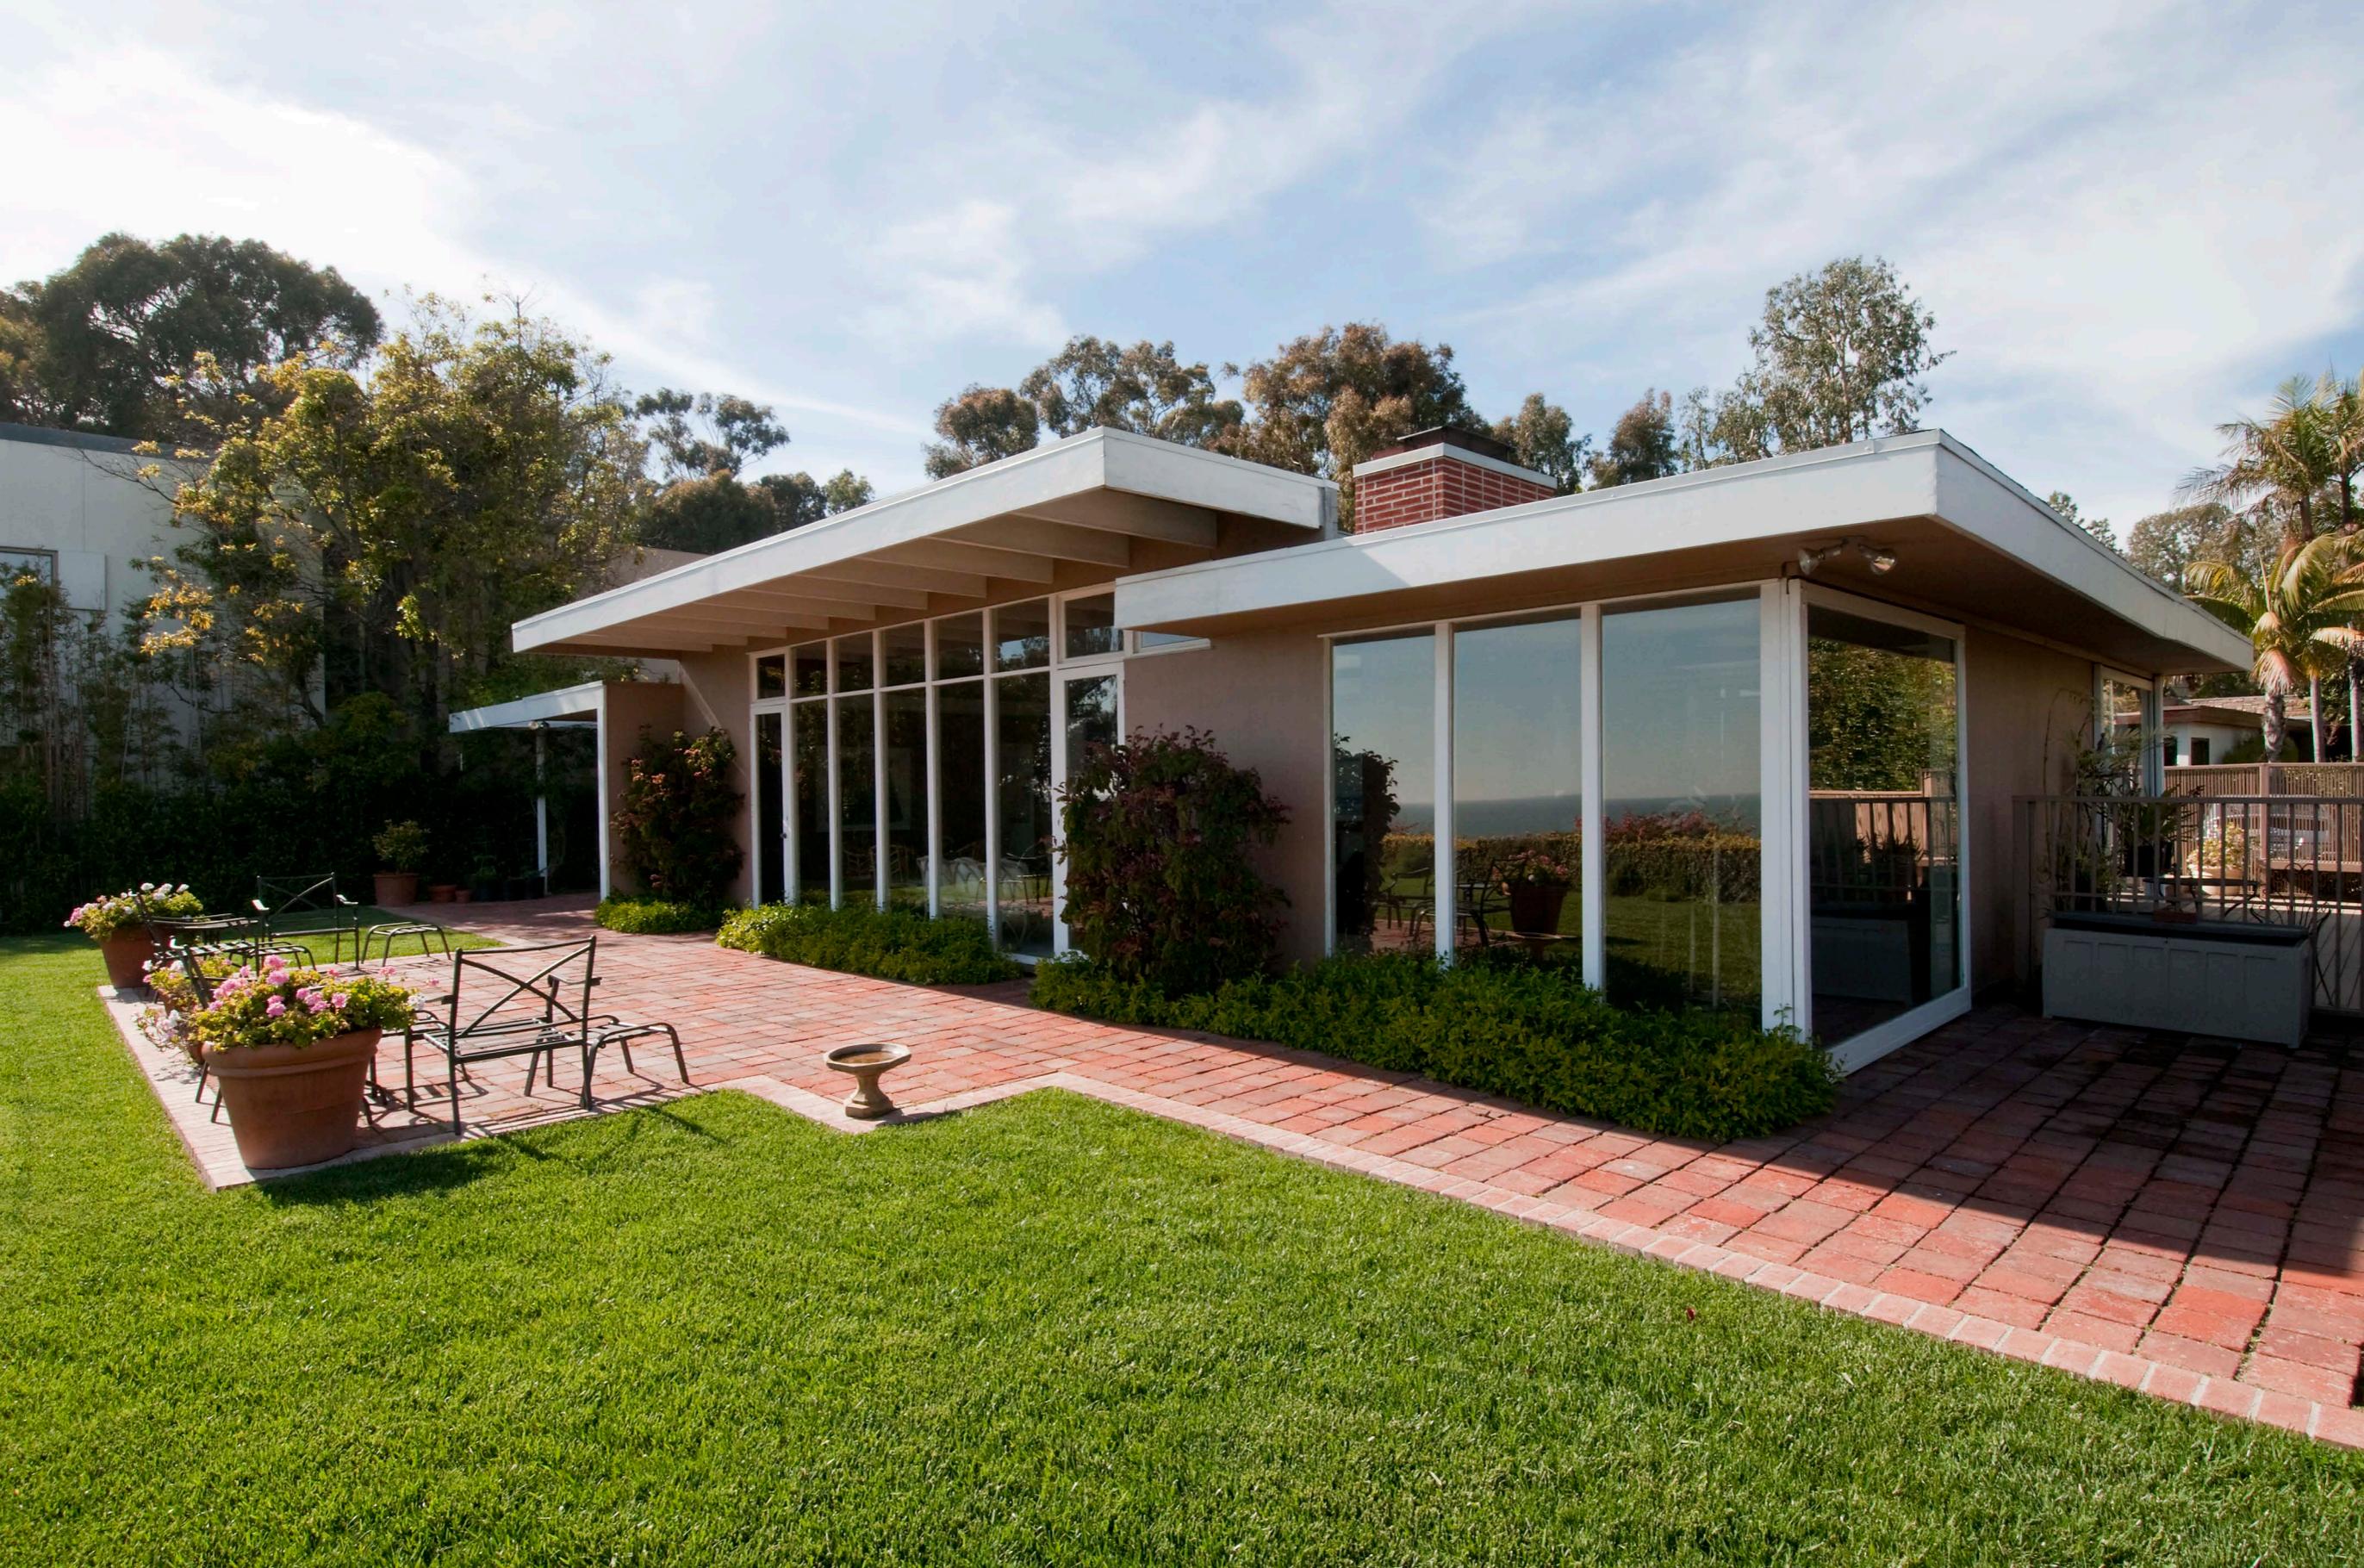
CA_Los Angeles County_Case Study House 18_0002.tif
South façade (left), East façade (right), camera facing Northwest

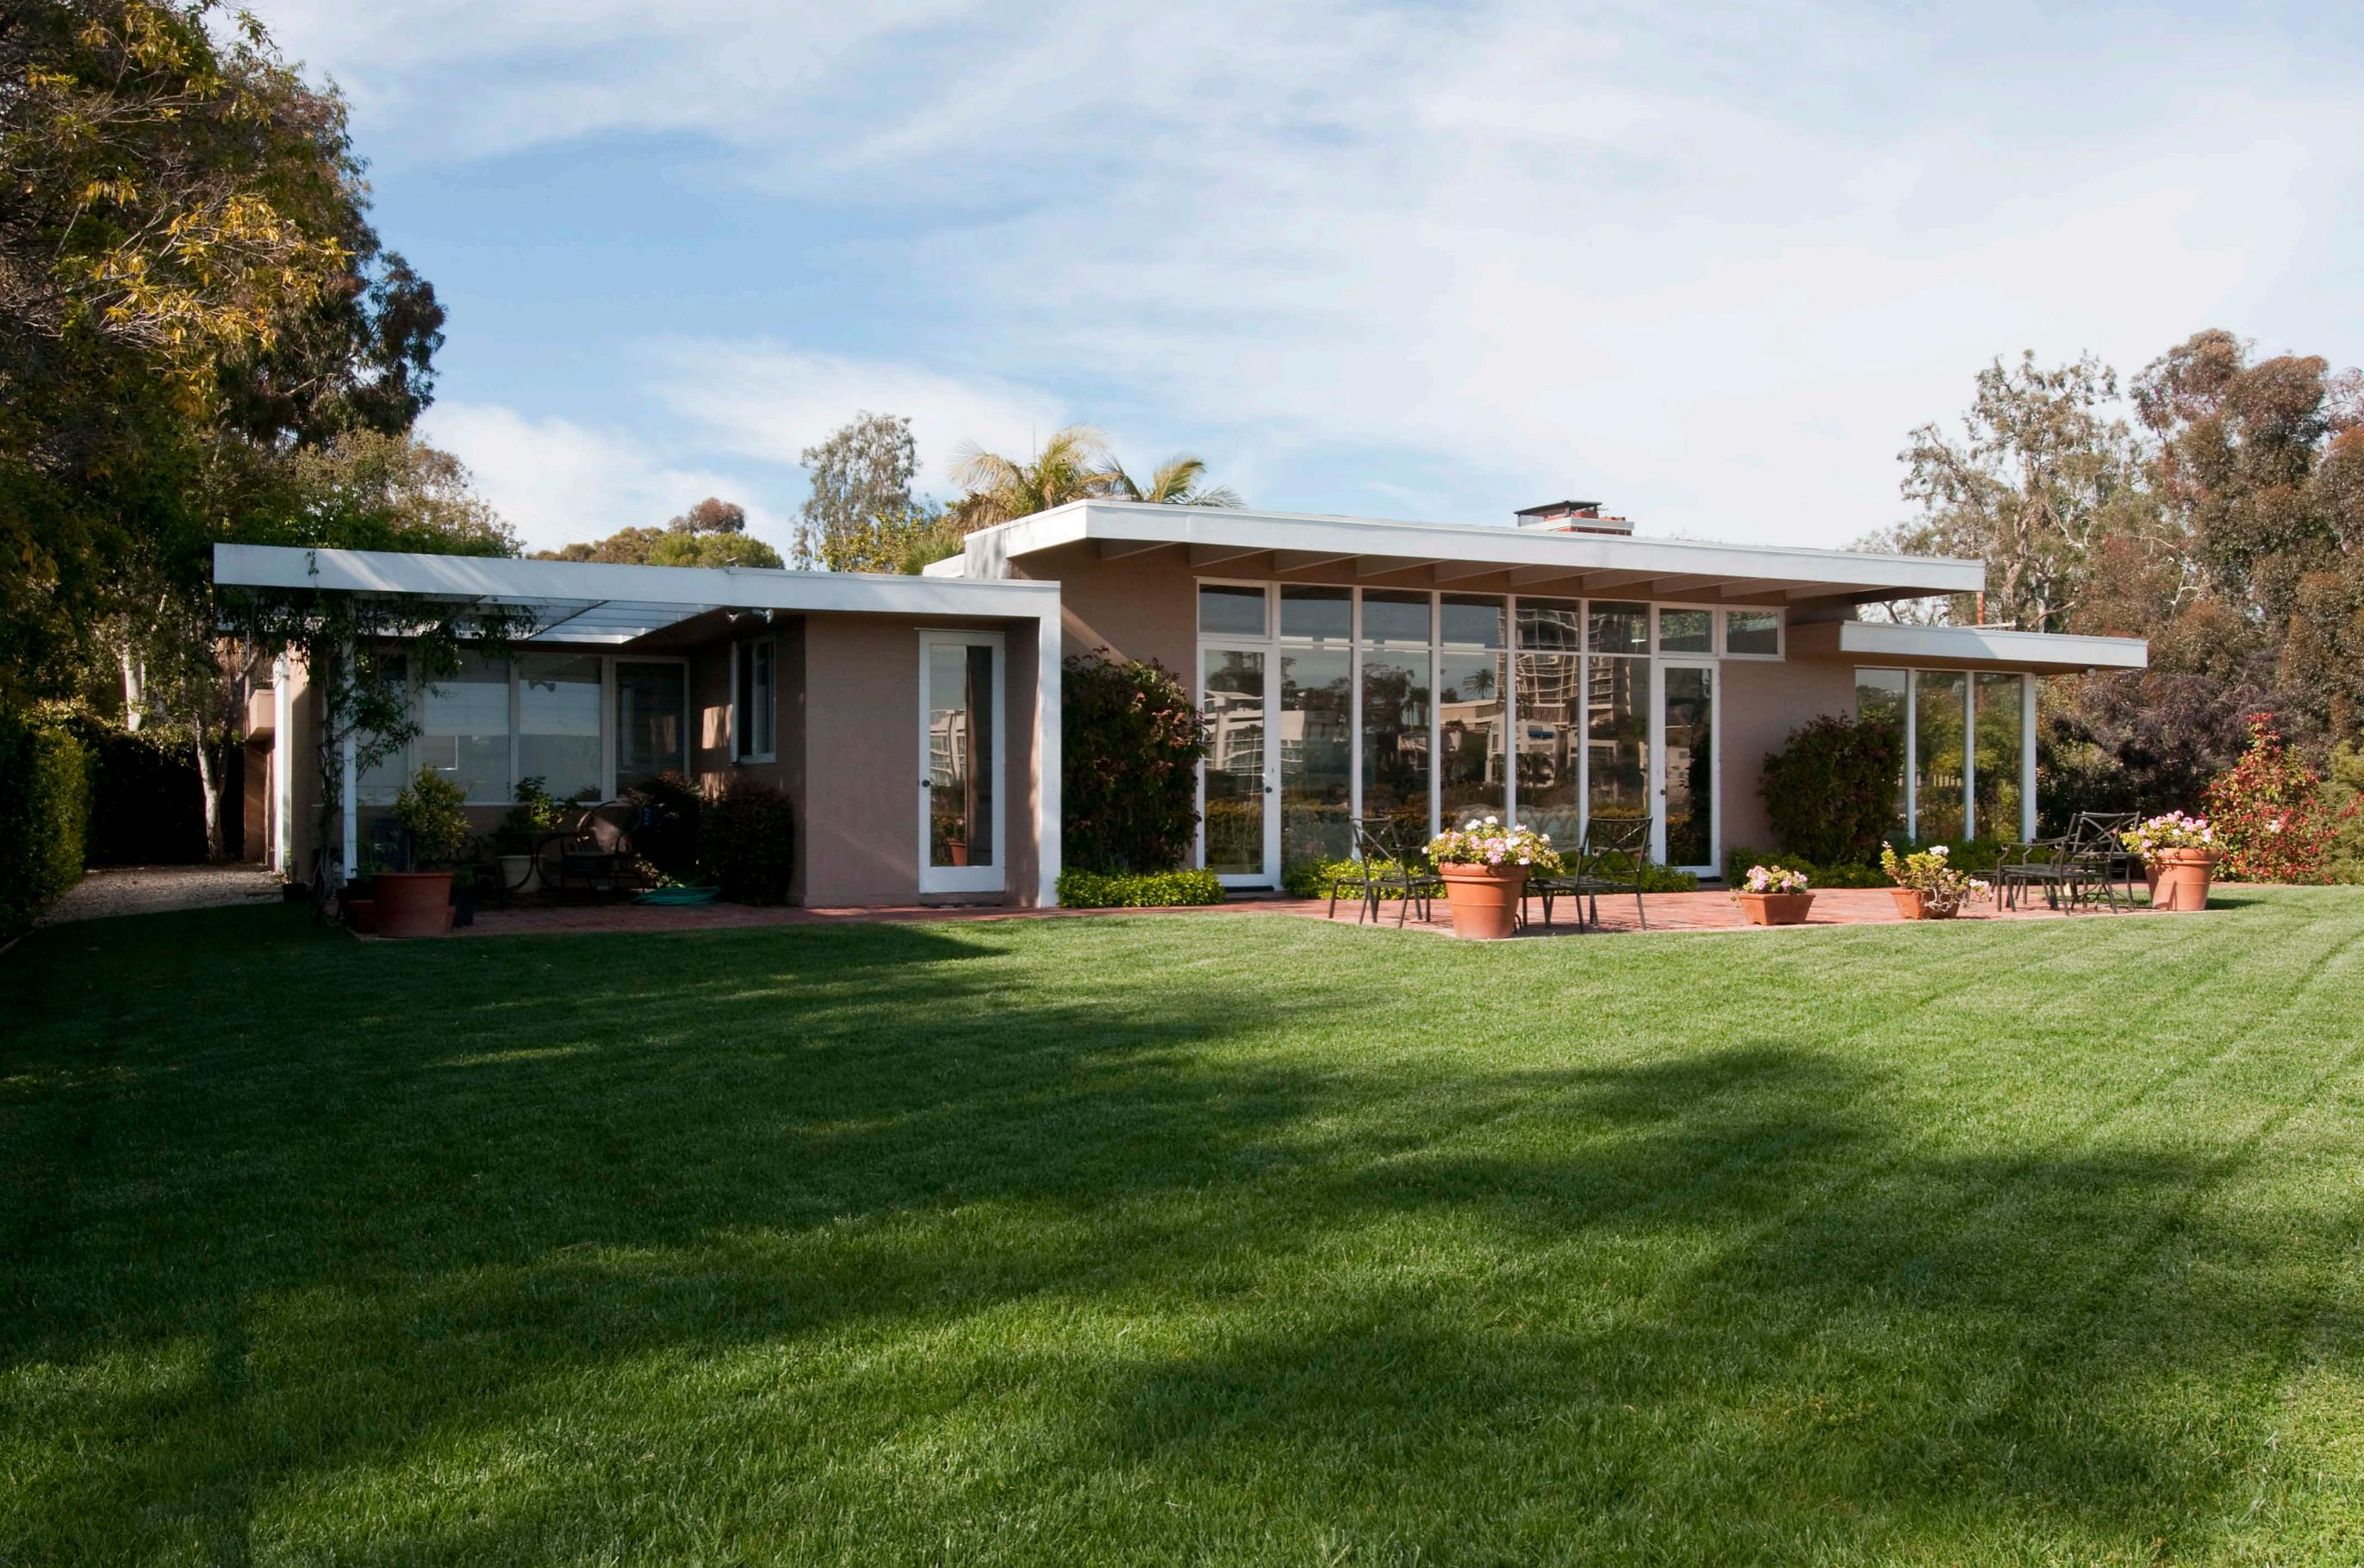
CA_Los Angeles County_Case Study House 18_0003.tif
South façade, camera facing Northeast

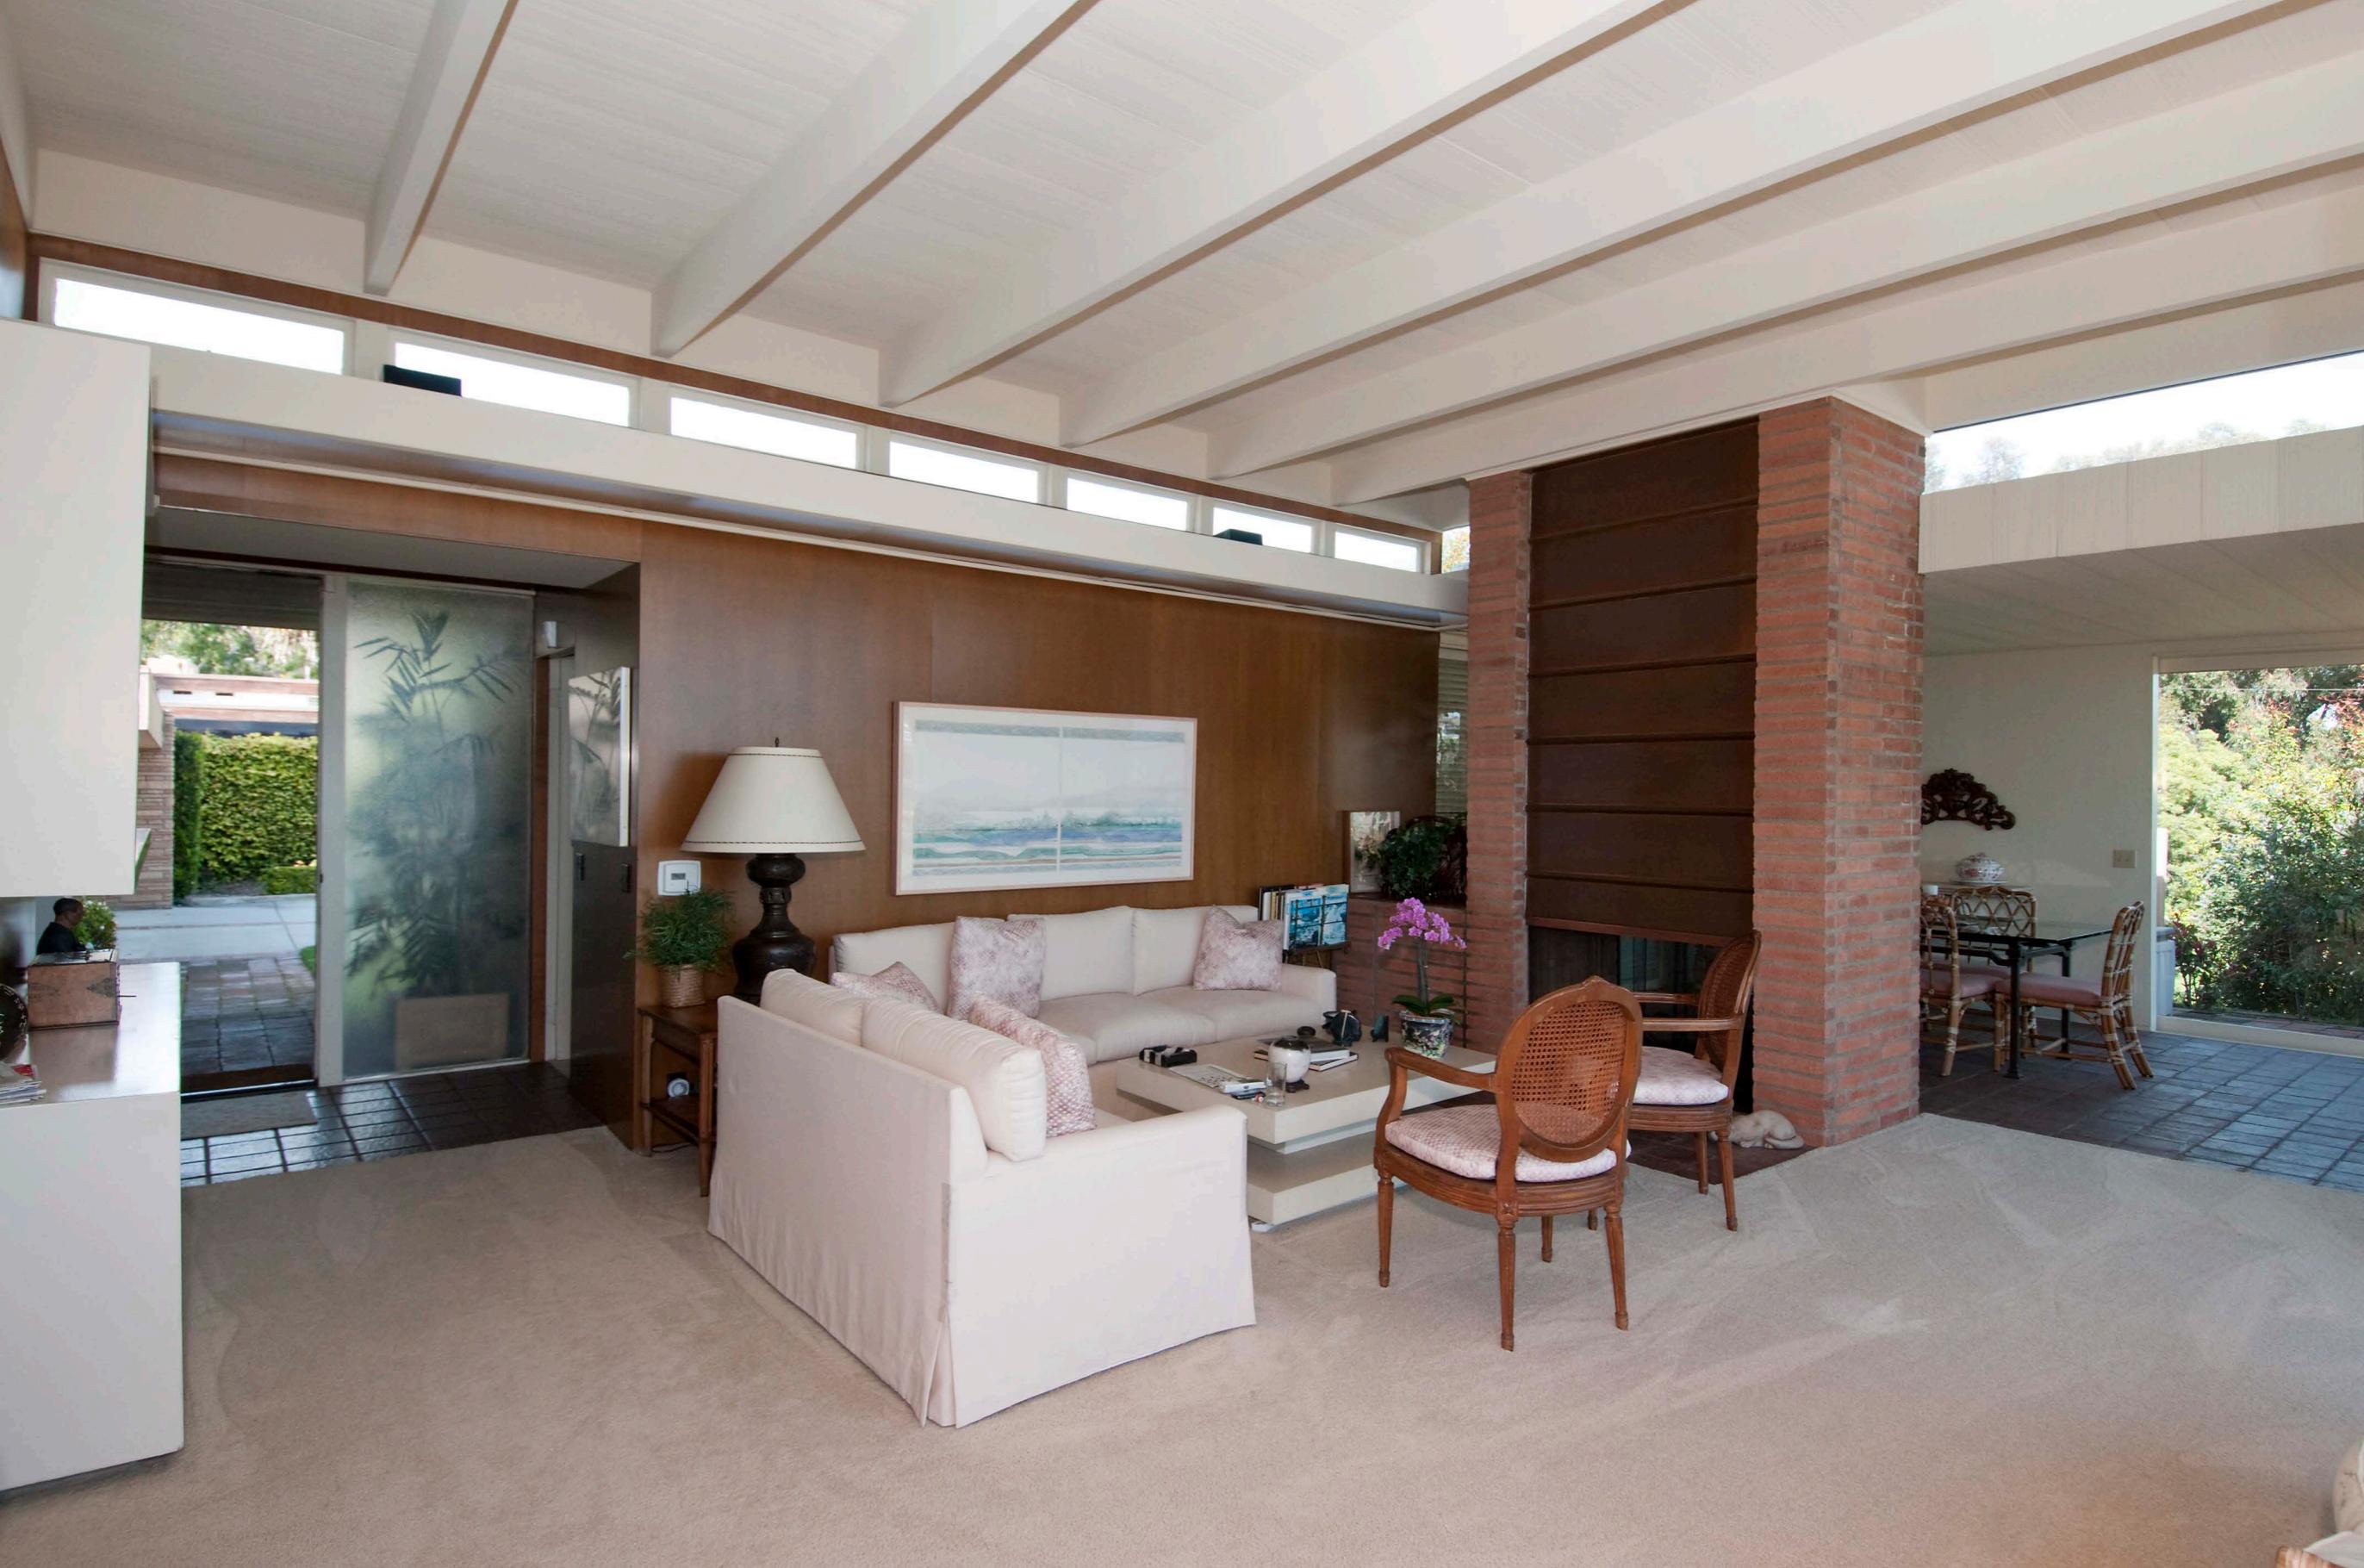
CA_Los Angeles County_Case Study House 18_0004.tif
Living Room, North façade, camera facing Northeast

The most unique interior feature of the dwelling is a large floor-to-ceiling brick fireplace faced with copper that dominates the living room and around which the roof is raised to 11 feet to accommodate clerestory windows. The fireplace is double sided with one side facing the living room and the other facing the garden room. A number of the glass walls are sliding panels opening to outdoor terraces.

Due to earthquake damage the fireplace was rebuilt and is now gas burning as opposed to the original wood burning. The fireplace is cosmetically preserved with its original materials and configuration. There appear to have been no other modifications to the primary residence, which is remarkably intact. The broad lawn facing south still affords sweeping unobstructed views. The house appears to be well maintained and in excellent condition. As a result, the house exhibits a high level of integrity of design, workmanship, and materials. The residence is in its original location and its setting has been retained. Integrity of association is high because of its continued use as a single-family residence. Because of these factors, integrity of feeling remains strong.
