National Register of Historic Places Registration Form

Historic name: Williams House

Street & number: 5 Williams Road

City or town: New Fairfield State: CT County: Fairfield

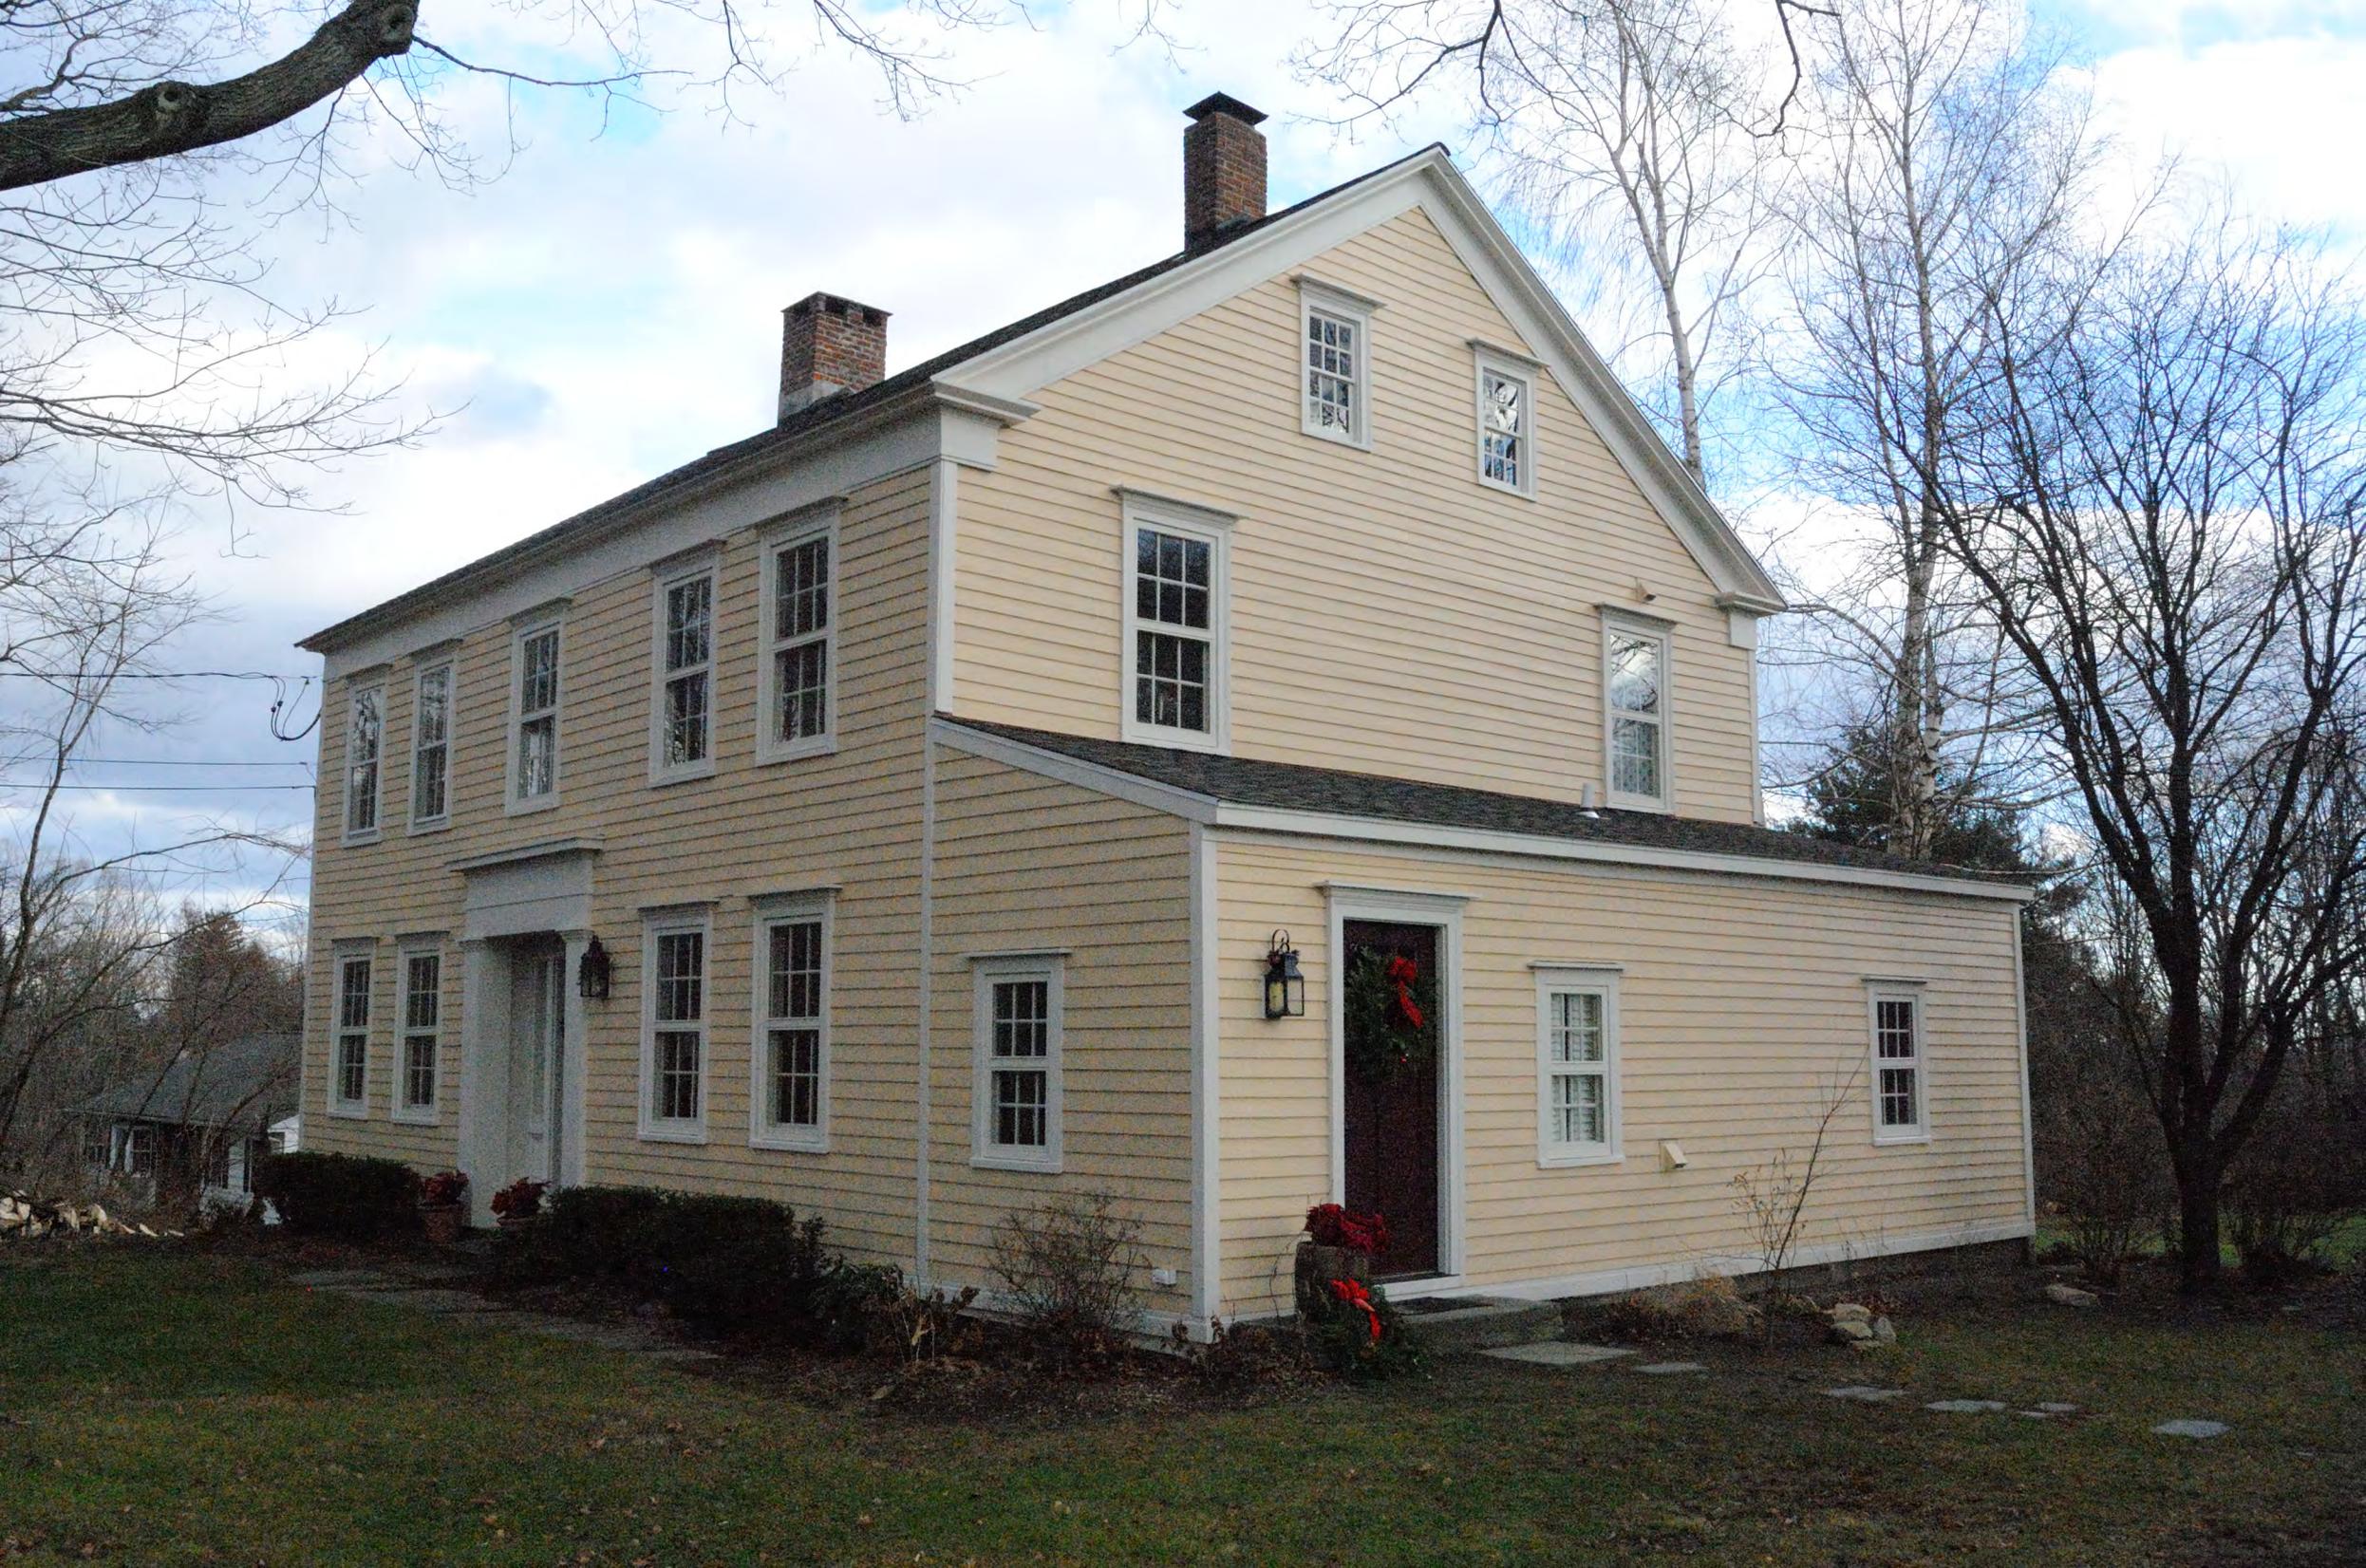
North elevation (left) and west elevation (right), camera facing southeast.

While the five-by-two-bay, eaves front orientation with massive paired chimney stacks identifies the Williams House as a good example of Federal architecture (Photograph 1), other prominent details suggest a shift toward the Greek Revival style of the early to mid-1800s. The most notable is the front entryway, with its recessed position and staunch, square pilasters distinguishing it as a later interpretation from the typical Federal entryway, which would have been either flush with or projecting from the building, with elements that were generally more slender and refined (Photograph 4).¹ It is unknown whether or not this entryway is original to the house, but more likely it was added to reflect the stylistic shift to the Greek Revival period, as was a common practice and is further evidenced by the appearance of the entryway trim work being modified to fit accordingly within the existing structure (Photograph 5). Another treatment which suggests Greek Revival influence is the thick, flat frieze band which runs directly above the second-story windows on the north and south-facing elevations, terminating with the cornice returns beneath each of the gable ends.

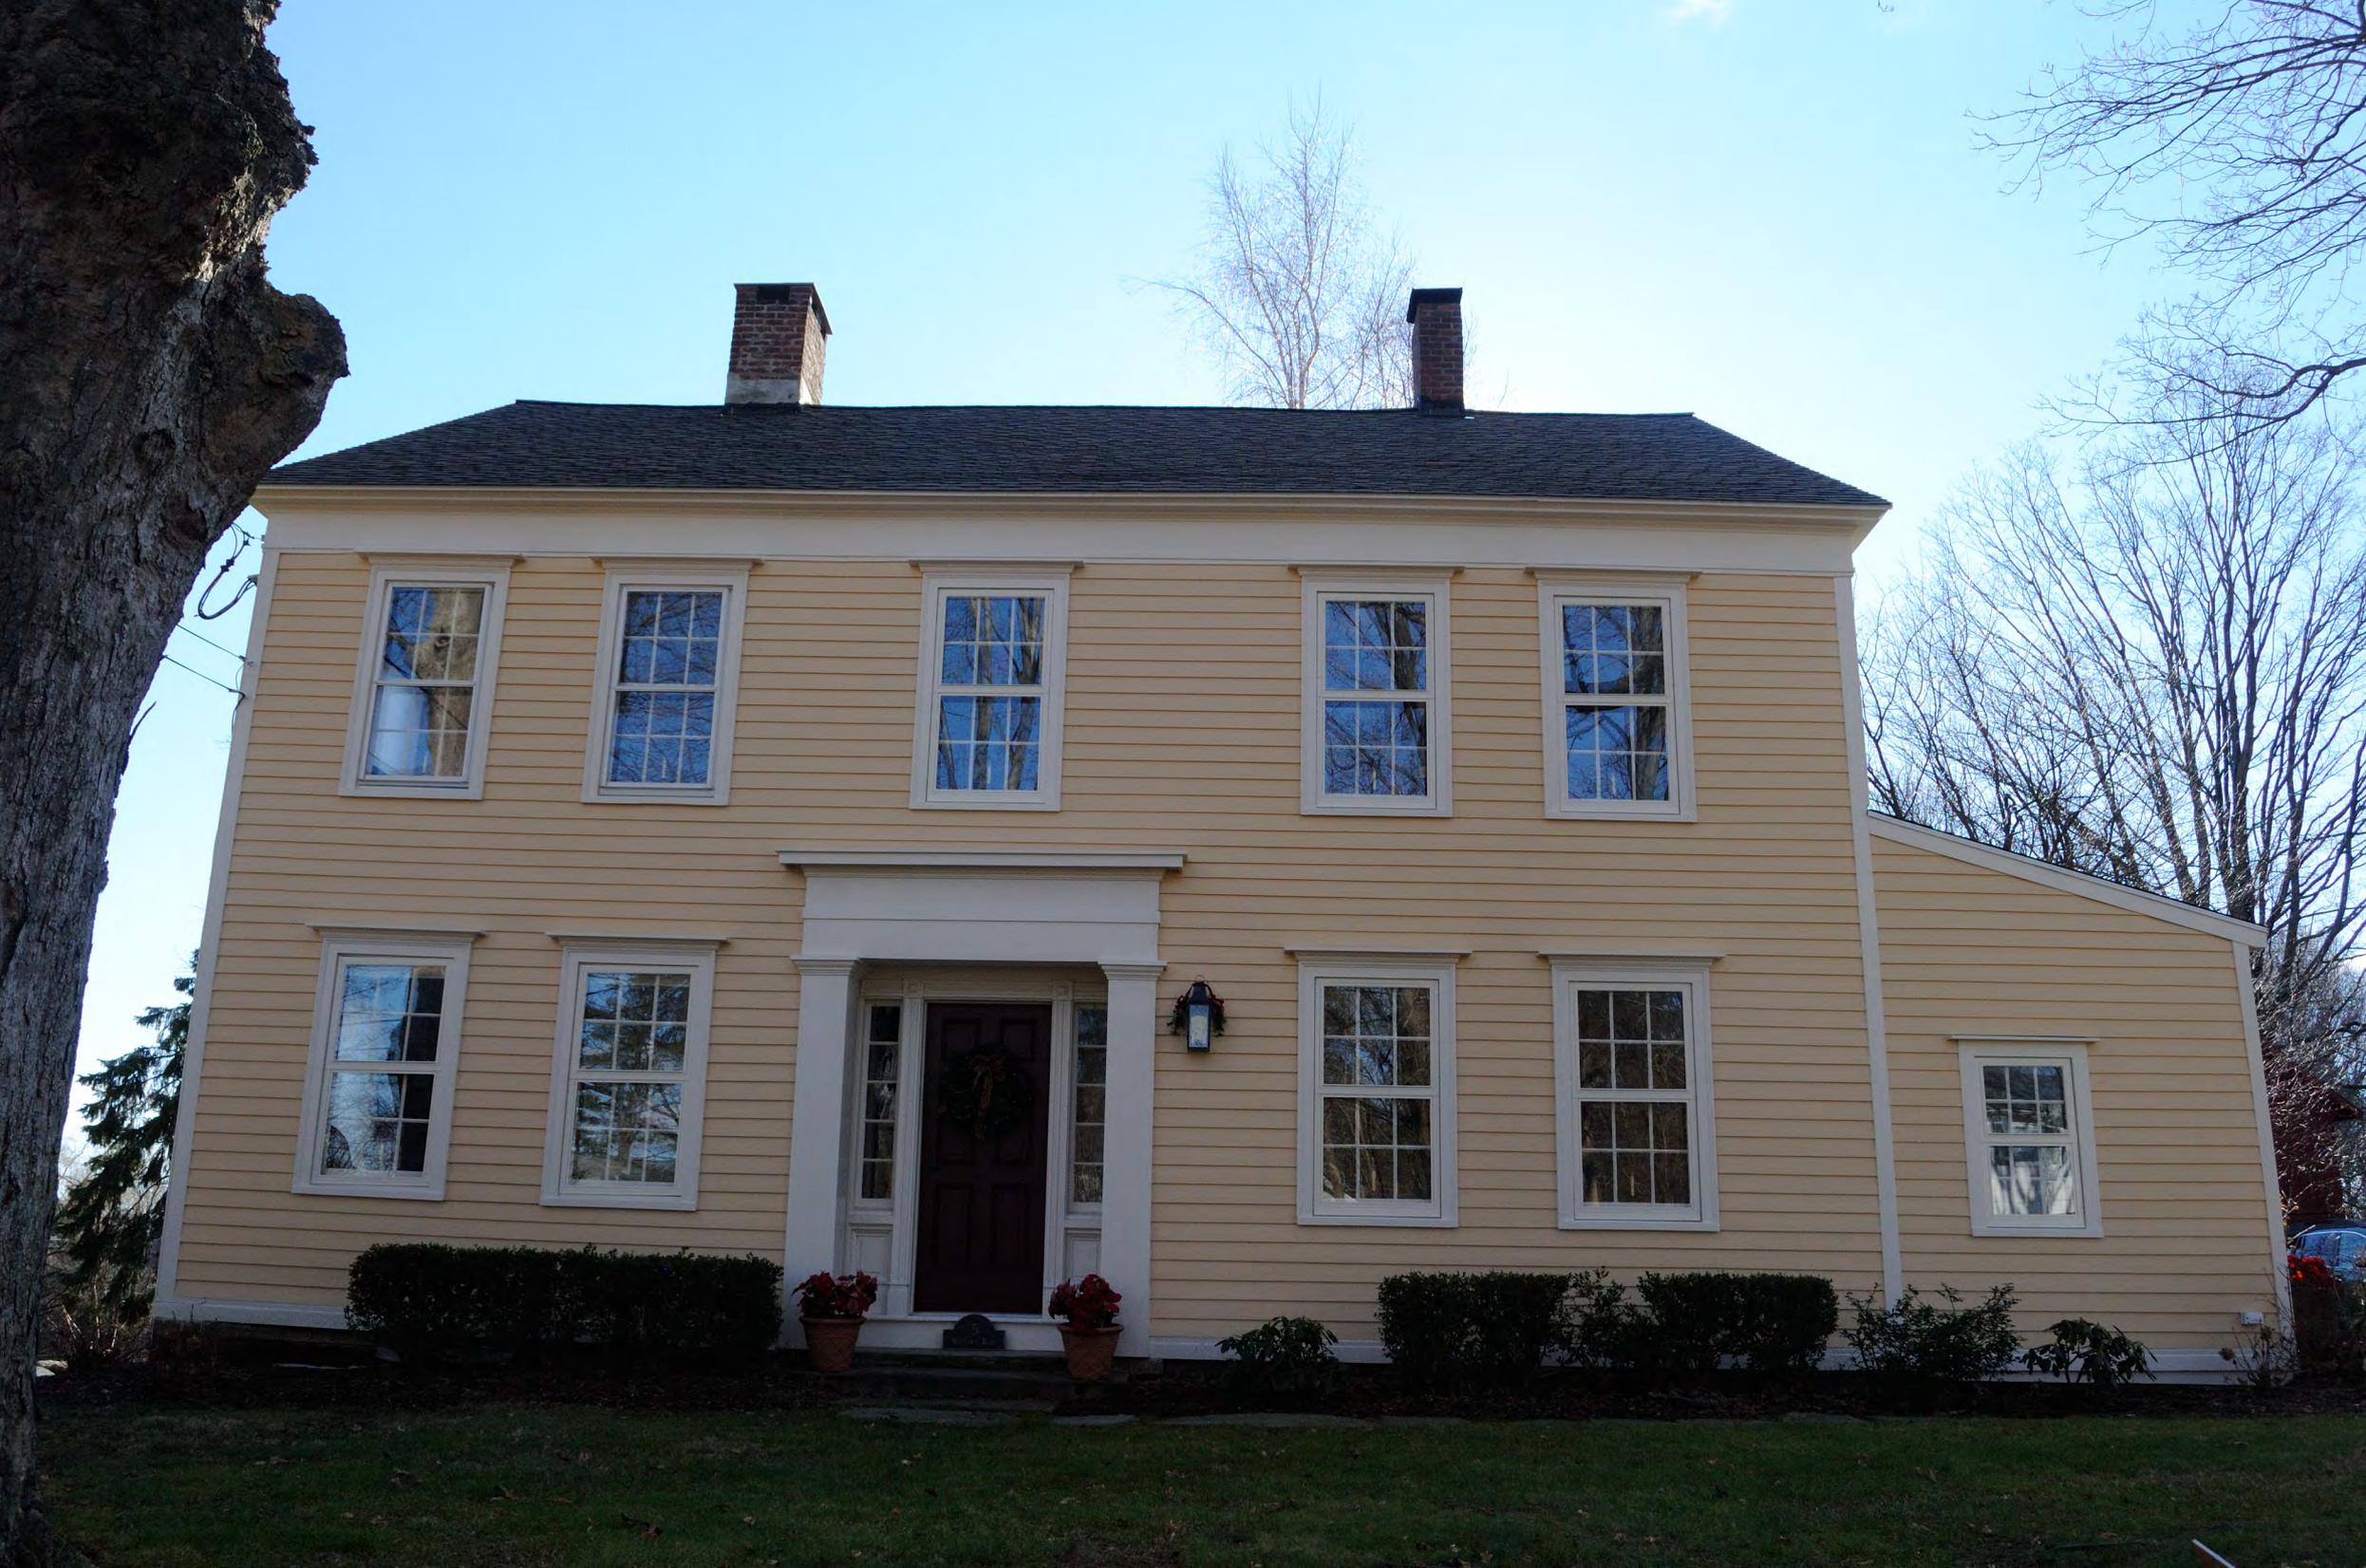
North elevation, camera facing south.

The north-facing façade is nearly symmetrical, with the formal entryway and central, second-story window slightly offset to the east (Photograph 2). The eight windows which flank the central bay are vertically and horizontally aligned. All nine double-hung, six-over-six windows are original to the house and are encased in simple beaded trim, and capped by a protruding trim piece supported by a crown moulding. The second story windows are separated from the roofline by a flat, thick frieze band with a bed moulding to the eaves. Two steps rise to the recessed, formal entryway, which contains an original wood door with six raised and moulded panels, flanked on either side by a vertical row of five rectangular sidelights (Photograph 4). The door and sidelight casings are tall and narrow in proportion with a deep run moulding at the center and square corner blocks with raised medallions at the top. A closer look at this trim work reveals a somewhat awkward intersection, with the outermost trim piece and medallions cut in half, suggesting that this Greek Revival entryway was fit accordingly and added to the already present Federal structure (Photograph 5). Two thick, square pilasters support the broad entablature composed of two large horizontally stacked trim boards, adorned with a thin, flat-stock trim piece separating the architrave from the frieze, and a simple crown moulding with a protruding cap. To the right of the entryway is a small, reproduction, lantern-style sconce.

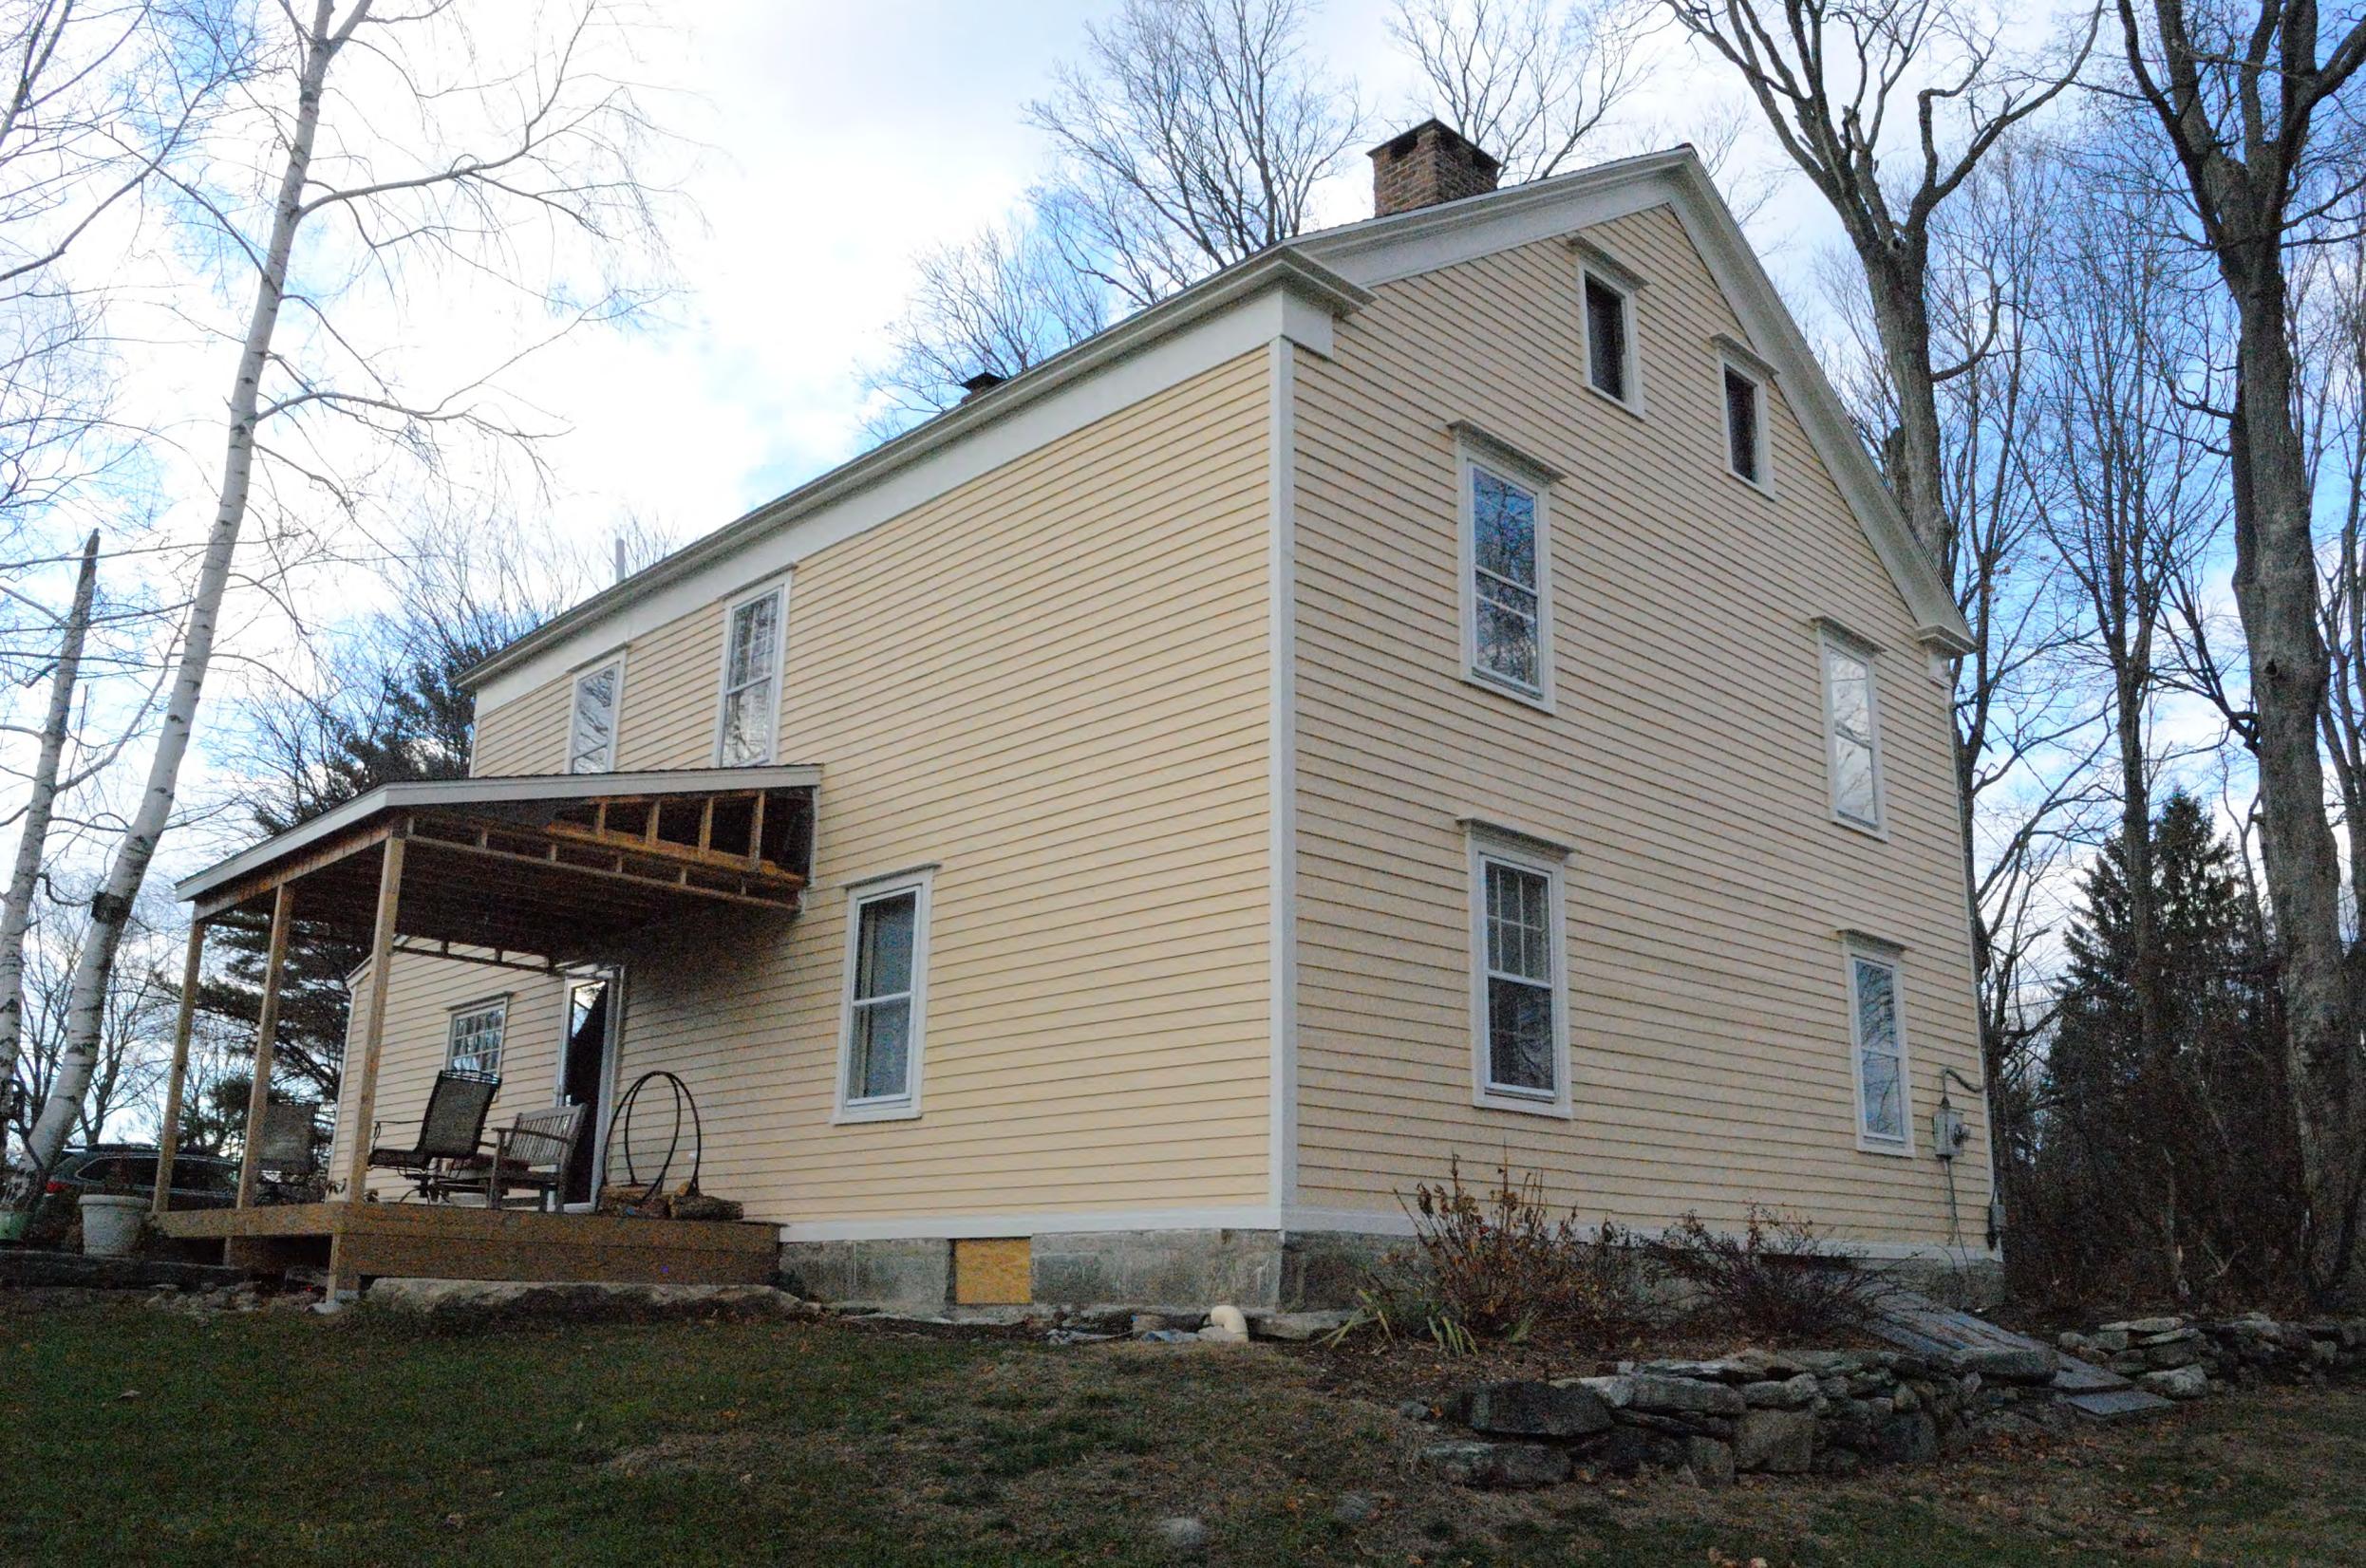
South elevation (left) and east elevation (right), camera facing northwest.

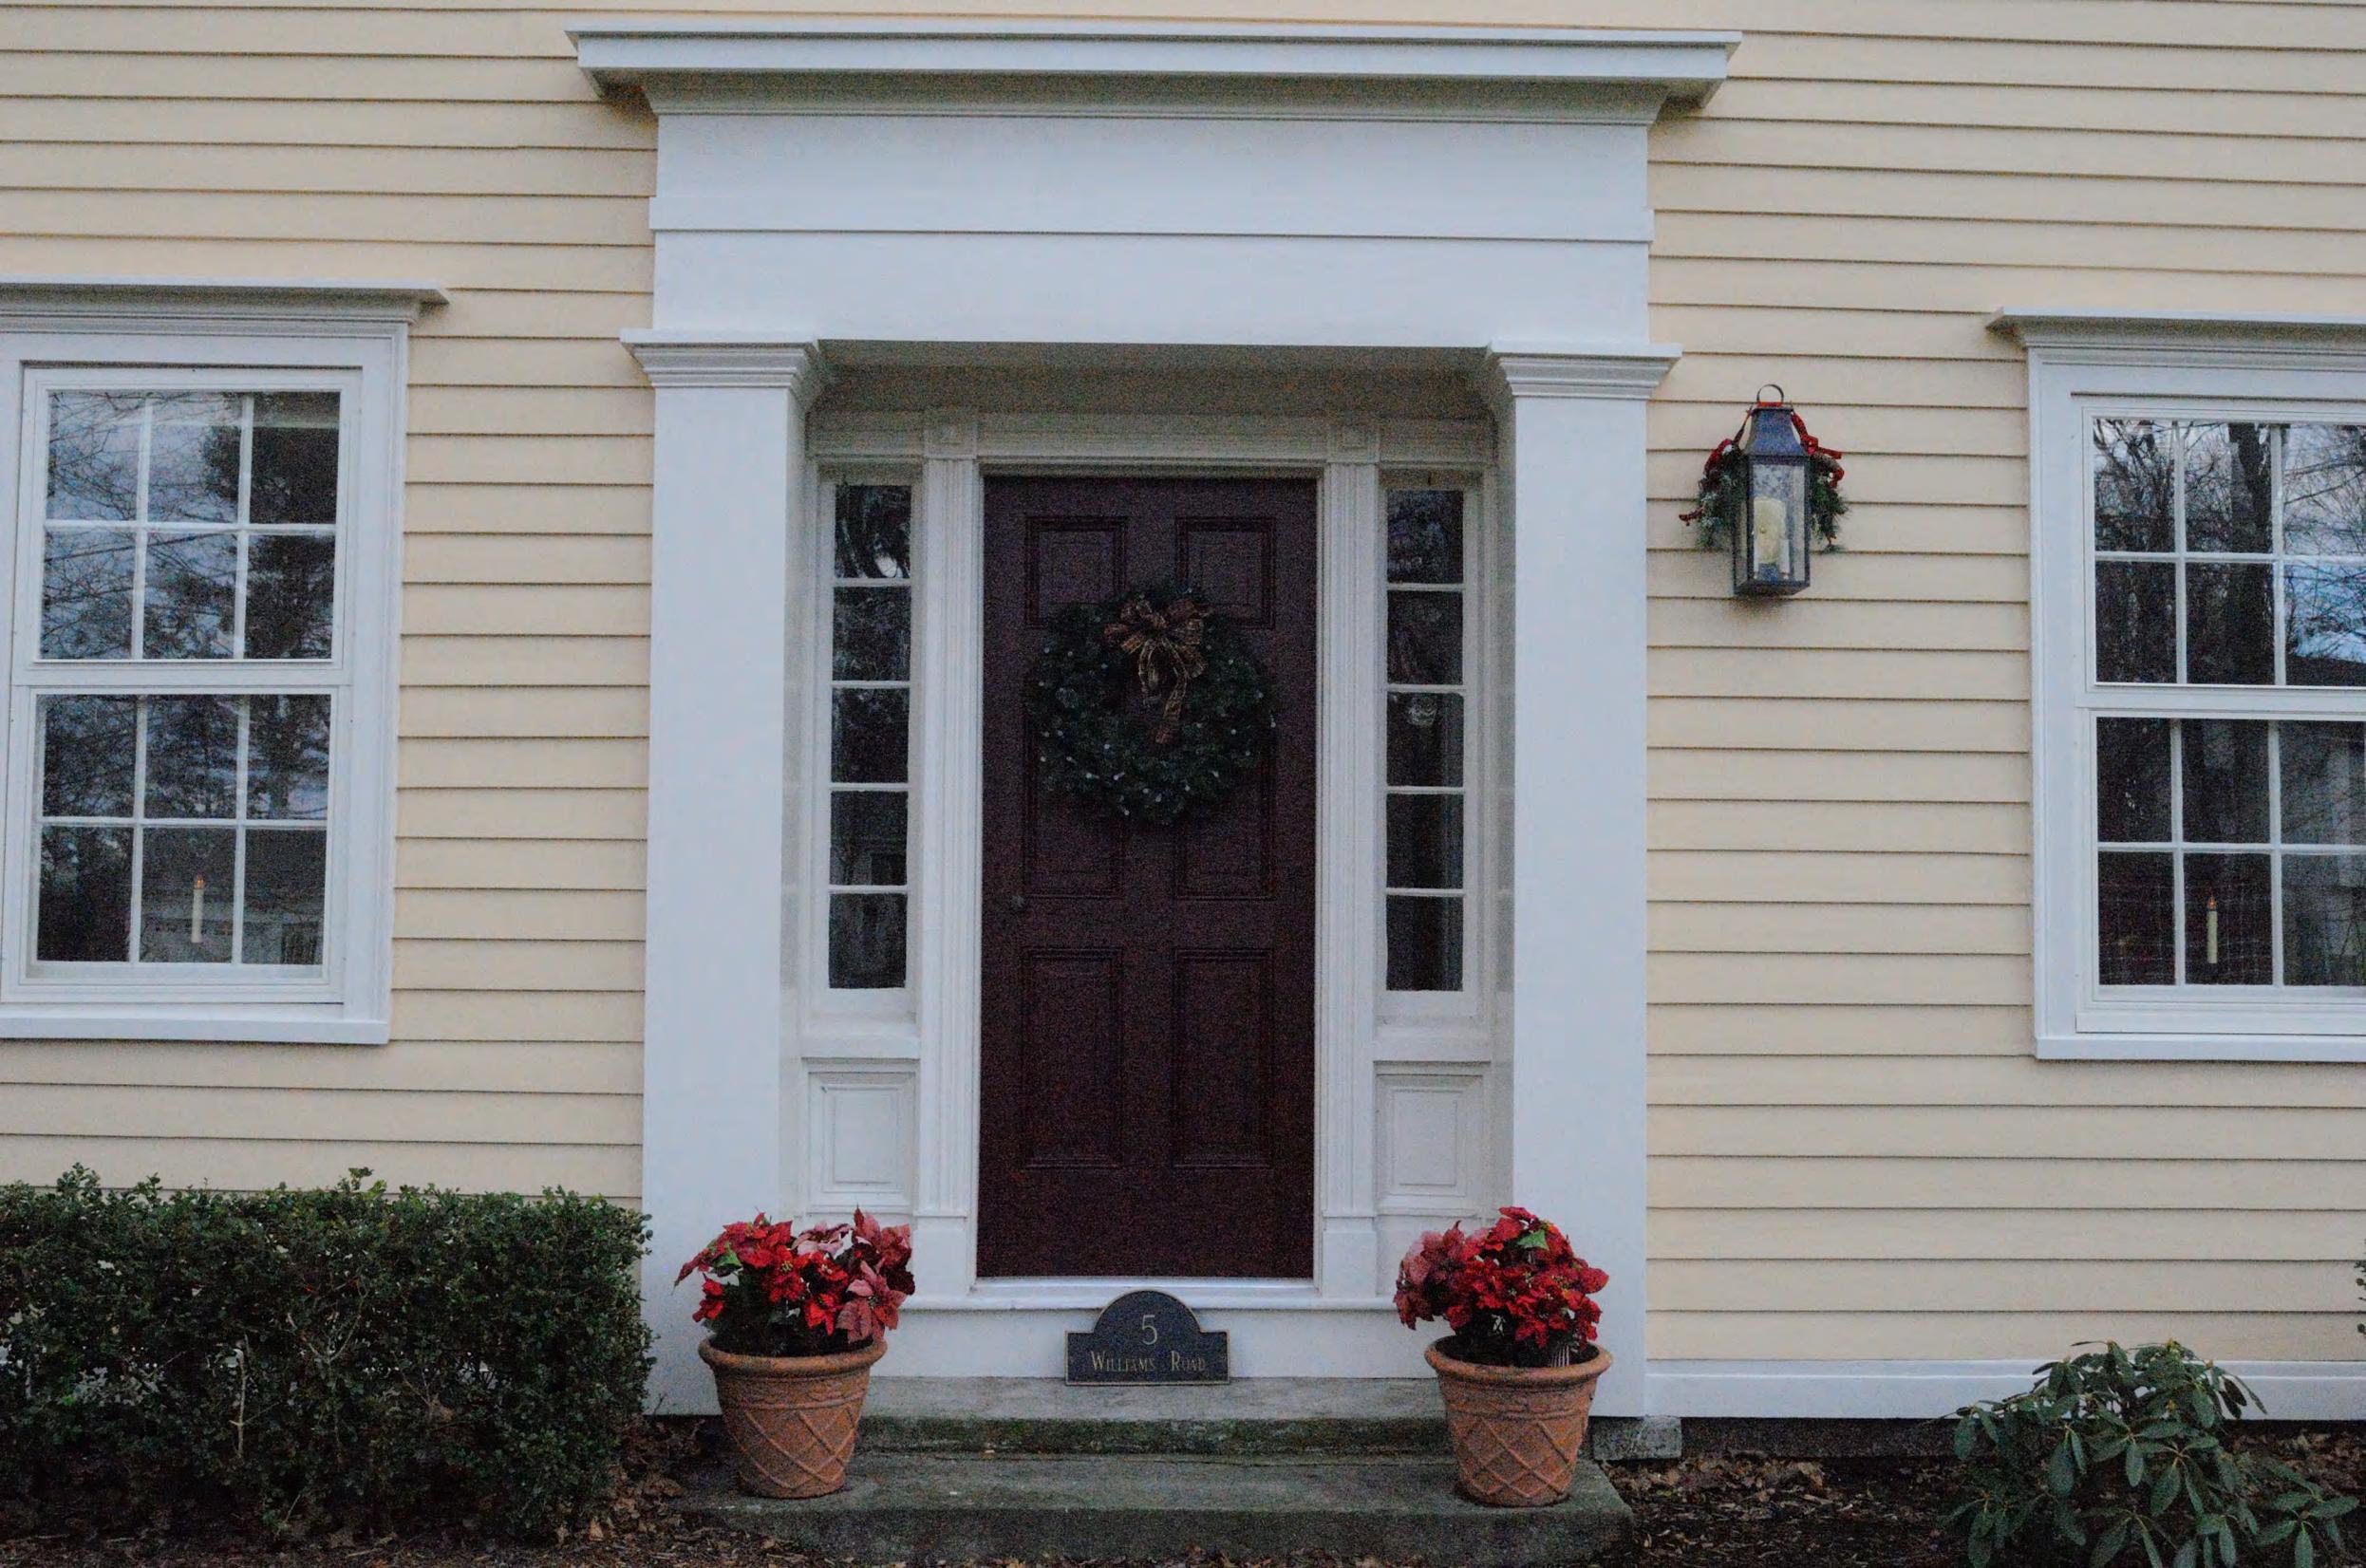
Front entryway, camera facing south.
