National Register of Historic Places Registration Form

historic name Staff Row and Old Post Area [Boundary Increase; Additional Documentation]

other names/site number Original Fort McPherson (Northeast Corner of Post)

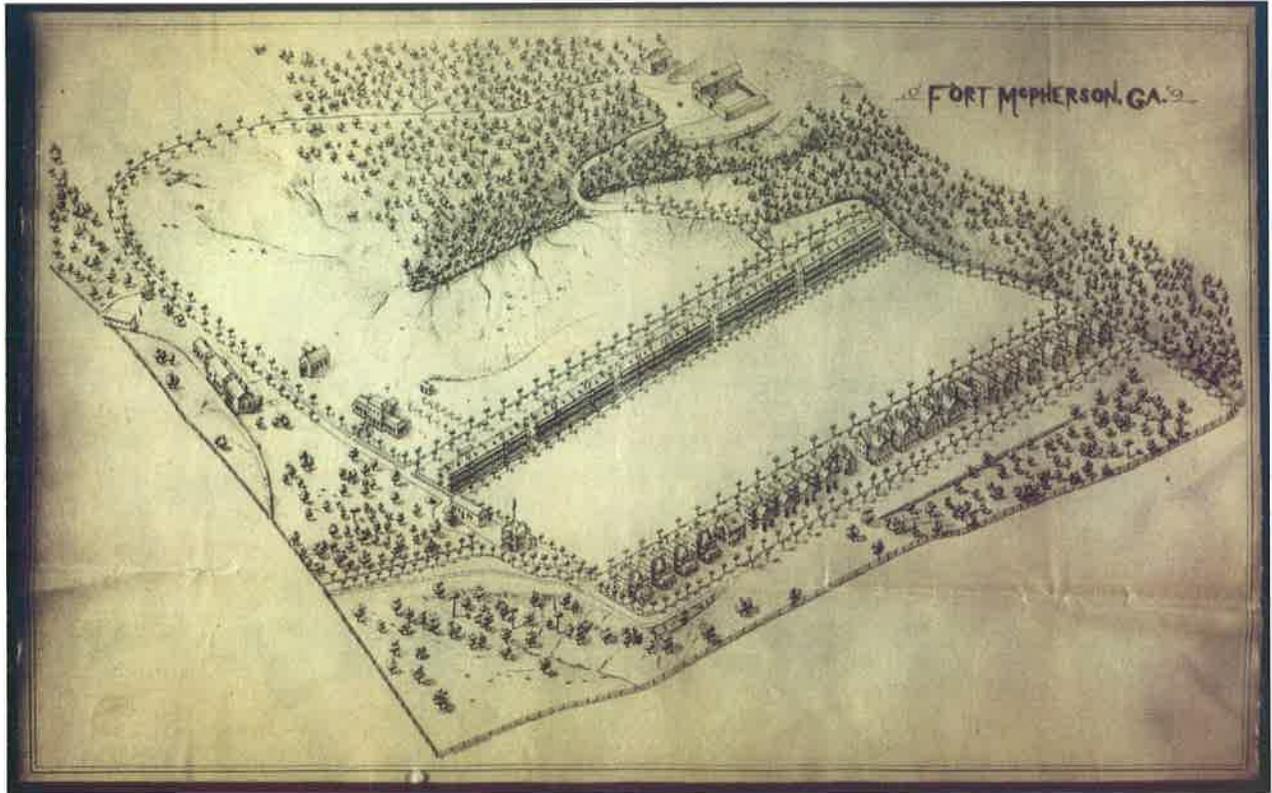
Figure 2. 1890 layout of Fort McPherson. Drawing from the US Department of the Army, Fort McPherson.

In a letter to the Quartermaster General on May 22, 1890, Captain Jacobs recalls his selection of appropriate building sites. Jacobs reports, "For this duty I associate with me a most capable civil engineer, a resident of Georgia, I found the topography of the land much broken, and cut by ravines, about two-thirds covered with timber and dense under brush, the latter I had cleared out that I might gain a clear and correct idea of its characteristics. But after careful and deliberate survey of the whole tract nothing was found more suitable for building sites than two ridges near the north east corner, about 1500 feet long nearly parallel and running almost due east and west."³² This large-scale grading at the post became one of the first construction projects initiated at Fort McPherson and was accomplished in stages from 1886 to 1888. Performed by local civilian workers, the grading of the land provided level building sites for the new post. According to Fort McPherson's Master Plan of 1890, the original layout of the post centered around the man-made plateau and the surrounding areas and included officer and troop housing separated by a large, central parade field.³³ Two rows of housing lined the northern and southern sides of the field along the 1,500 foot parallel ridges; officer dwellings faced south and troops barracks faced north. This arrangement followed the basic idea that the soldier should have a house with a convenient location and a relaxing natural setting. The intervening parade ground also allowed for adequate ventilation and natural light for the garrison. Captain Jacobs left the west end of the parade ground open, allowing the prevailing winds from the west and northwest to provide cool air during the hot Atlanta summers. The post headquarters and a guardhouse stood at the eastern edge of the field, while a bakery, magazine, oil house, coal shed, quartermaster's office, and commissary, stood southeast of the residential buildings and the parade field. Non-commissioned officers' quarters were located on the southern border of the post, while a stable and a workshop stood west of the parade field. A combination mess hall and kitchen, not yet completed in 1890, was located behind the row of troop barracks.³⁴ The location of the quadrangle 500 feet from the railroad depot on what is now Lee Street, providing peace and quiet to the residential area.³⁵ Figure 2 shows an artist's rendering of the post in 1890.
