National Register of Historic Places Registration Form

historic name Stehli Silk Mill

street & number 701 Martha Avenue

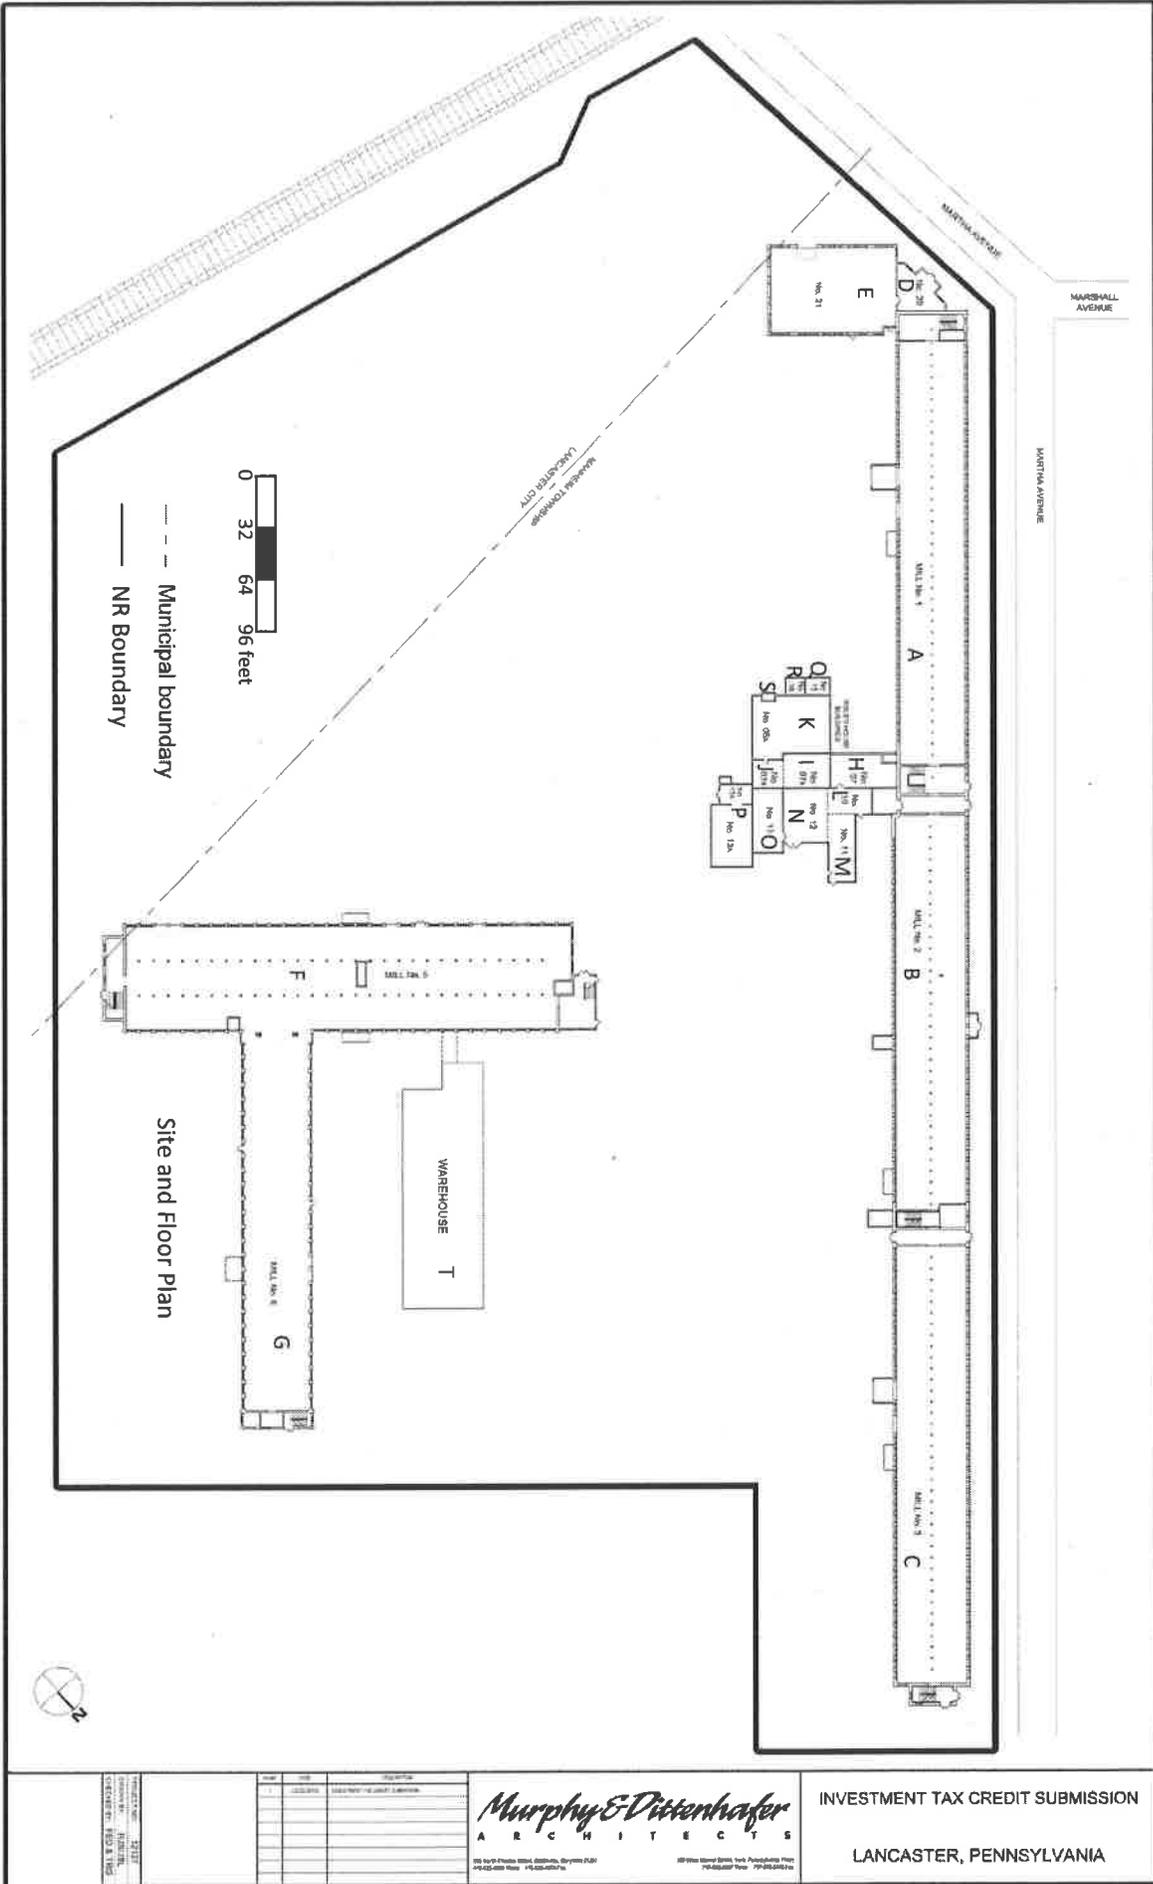
Site and Floor Plan

Building #7A	I	c. 1910	1	Brick masonry	Brick	Clerestory	Addition to Boiler House	C
		Building #7B	J	c. 1910	1	Brick masonry	Brick	Windows removed	Addition to Boiler House	C
		Building #10	L	c. 1910	1	Brick masonry	Brick	Windows removed	Addition to Boiler House	C
		Building #11	M	c. 1910	2	Brick masonry	Brick	12/12 dhwd sash	Addition to Boiler House	C
		Building #12	N	c. 1910	2	Brick masonry	Brick	12/12 dhwd sash	Addition to Boiler House	C
6		Building #13	O	1915-1925	1	Brick masonry	Brick	9/9 dhwd sash	Addition to Boiler House	C
4, 6	Building #13A	P	1915-1925	1	Brick masonry	Brick	Mixed type of mtl ind. sash	Addition to Boiler House	C	
5	Building #15	Q	1915-1925	1	Brick masonry	Brick	9/9 dhwd sash	Pump House	C	
5	Building #16	R	1915-1925	1	Brick masonry	Brick	9/9 dhwd sash	Oil House	C	
3, 6, 17, 18	Mill No. 21		E	c. 1925	1	Brick masonry	Brick	8/12 dhwd sash with 8-lite wood transom, and clerestory	Ladies Dining Room	C

3	Mill No. 20		D	c. 1925	1	Brick masonry	Brick	9/9 dhwd sash	Connector	C
4, 5	Smoke stack		S	1915-1925		Brick masonry	Brick	None	Mechanical system exhaust	C
