NATIONAL REGISTER OF HISTORIC PLACES  
REGISTRATION FORM

historic name McCanless, Napoleon Bonaparte, House

street & number 619 South Main Street not for publication N/A

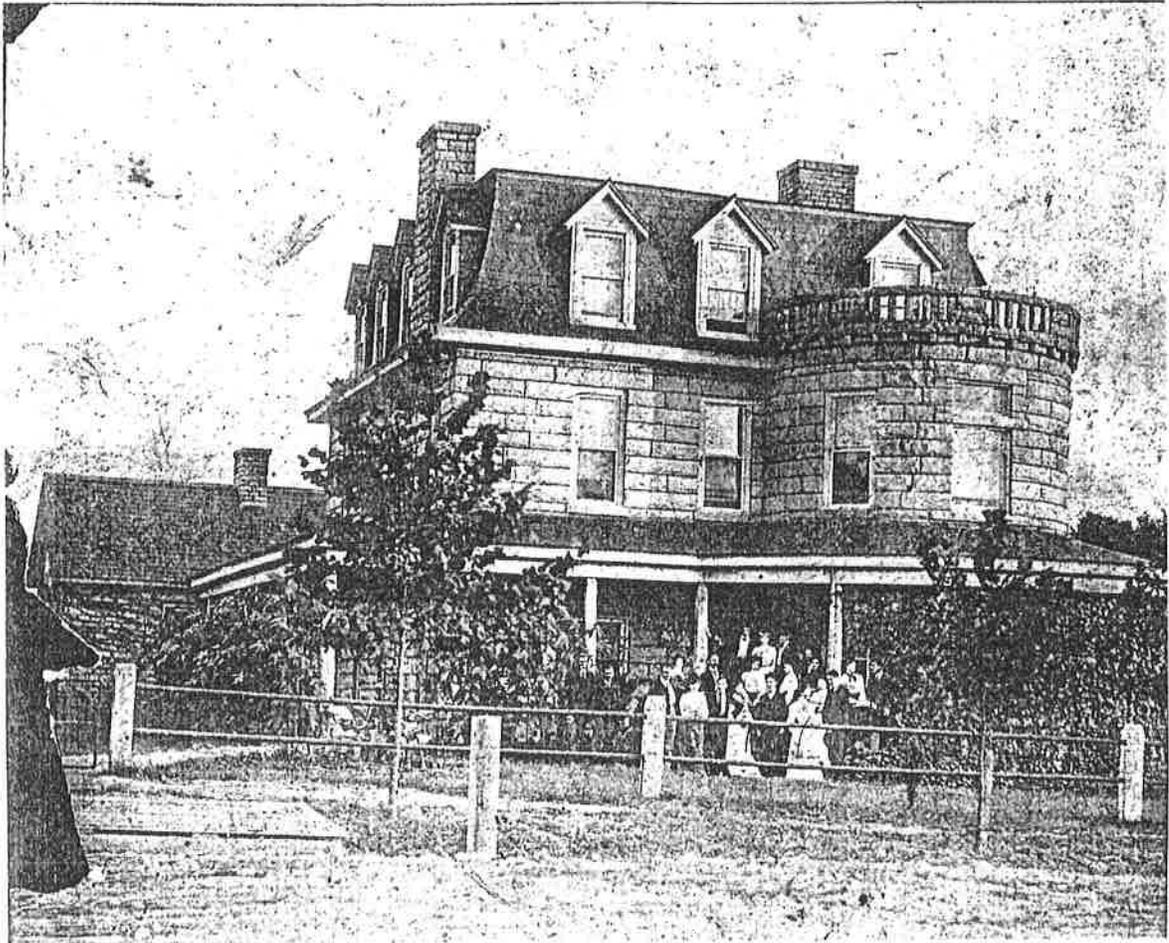
Section Number Documentary Photo Page 28

Ca. 1900 documentary of house with family. Photo courtesy of Mary Jane Fowler, great-granddaughter of N. B. and Georgia McCanless.

The physical integrity of the Napoleon Bonaparte McCanless House differs on the exterior from the interior. Judging from a ca. 1900 overall photograph of the house taken several years after its construction, the exterior remains remarkably intact. It retains its original three-story, three-bay-wide and four-bay-deep form with its round corner tower and wraparound porch. It retains its Second Empire styling with its third-story concave mansard roof with gabled dormers. The exterior retains most of its original materials, including its strong, rusticated-granite facing, its granite chimneys, its granite porch, and the decorative slate tiles that sheathe the roof and dormers. The house retains its unusual wraparound porch with tapered granite posts set on granite blocks and robust granite balustrade that is repeated around the flat roof of the tower. The structure of the porch roof remains intact, but the wood ceiling, boxed cornice, and fascia board are missing, and the replacement plywood decking is covered with asphalt shingles. The condition of the porch roof appears to be the result of unfinished repairs in recent years.

Several young trees in the front yard and the granite-post-and-metal-pipe fence shown in the ca. 1900 photograph do not survive. Despite the changes described above, the most essential features that define the exterior of the house survive in good condition, so that if Napoleon Bonaparte McCanless were riding down South Main Street today, he would have no problem recognizing the house that was his home from its construction in 1897 until his death in 1920.
