National Register of Historic Places Registration Form

Historic name: Barnes, David A., House

Street & number: 625 West Main Street

City or town: Murfreesboro State: North Carolina County: Hertford

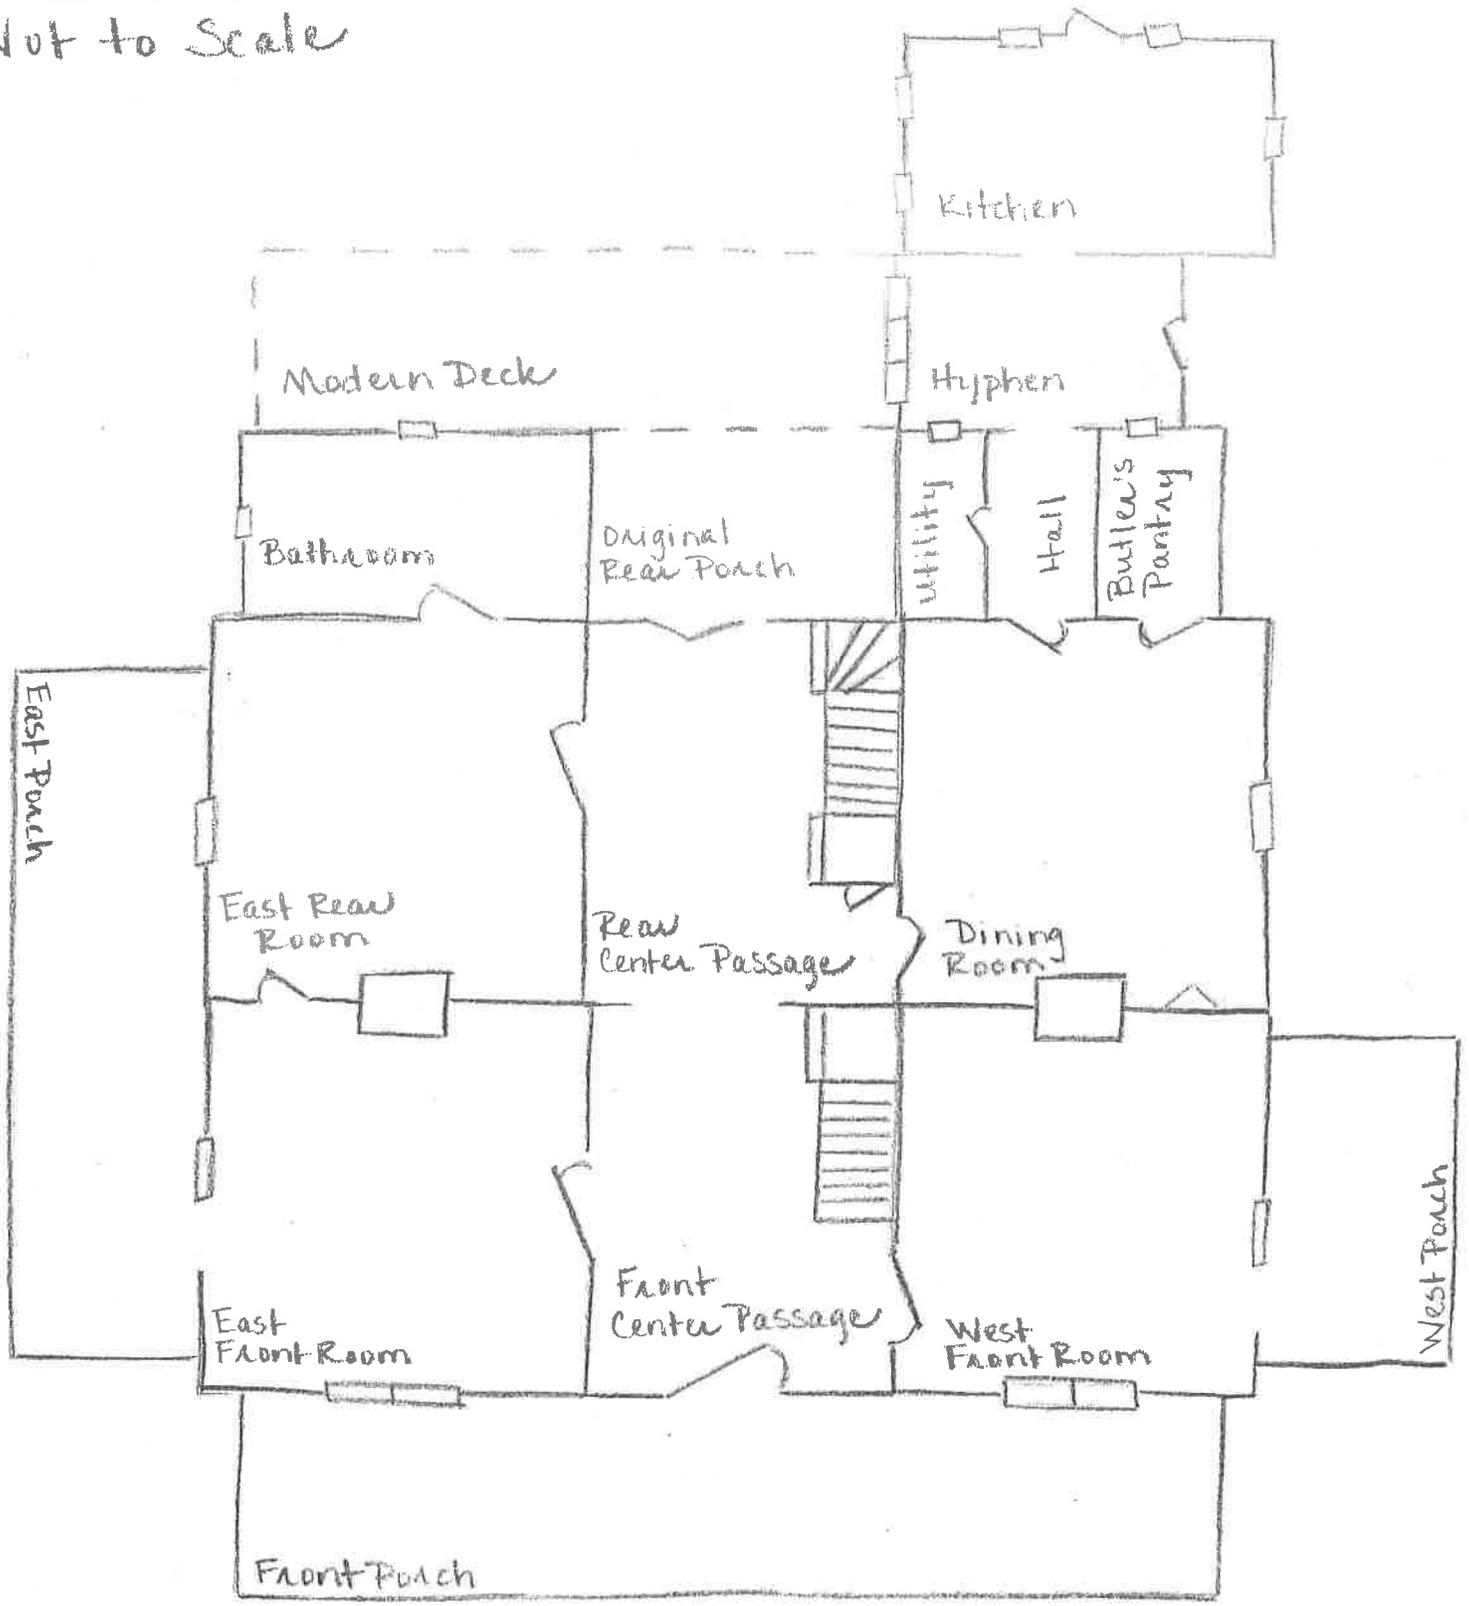
David A. Barnes House
Murfreesboro, Hertford County
First Floor Plan
Not to Scale

The Barnes House has a center-passage, double-pile plan. Originally, louvered doors separated the front two-thirds of the center passage, containing the primary stair, from the rear third and secondary stair. Four large, roughly square, heated rooms arranged around the center passage compose the first-floor plan. The front rooms are very similar. Both rooms contain a coal-burning fireplace tied to the central chimneys shared between the two east and two west rooms. Marble paneled mantels have molded, serpentine shelves. In the east room, the central element—a bracket that supports the shelf—is a later addition to the mantel. The east mantel is black with a white vein. This mantel was originally located on the second floor in the west front room. In the first-floor west room, much of the mantel's face has been covered with dark stained wood, presumably to mask damage sustained during the house's long period of unoccupancy during the late twentieth century. The mantel has a reddish-brown hue with a black vein and black inlaid panels. The west mantel retains a central stone medallion that supports the shelf. During the late twentieth century, three of the four stone mantels were removed from the house while it stood empty. At the request of former owner Erika Robb, two of the mantels were returned in the early

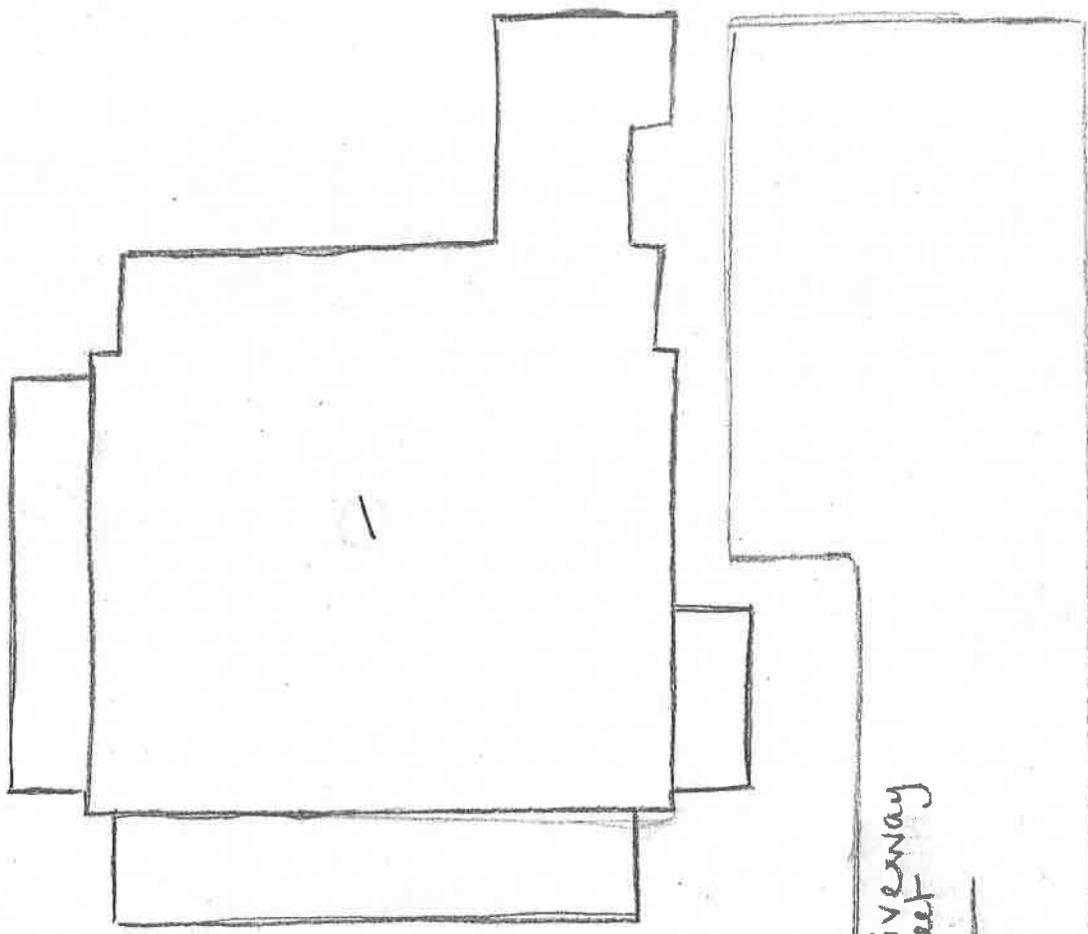
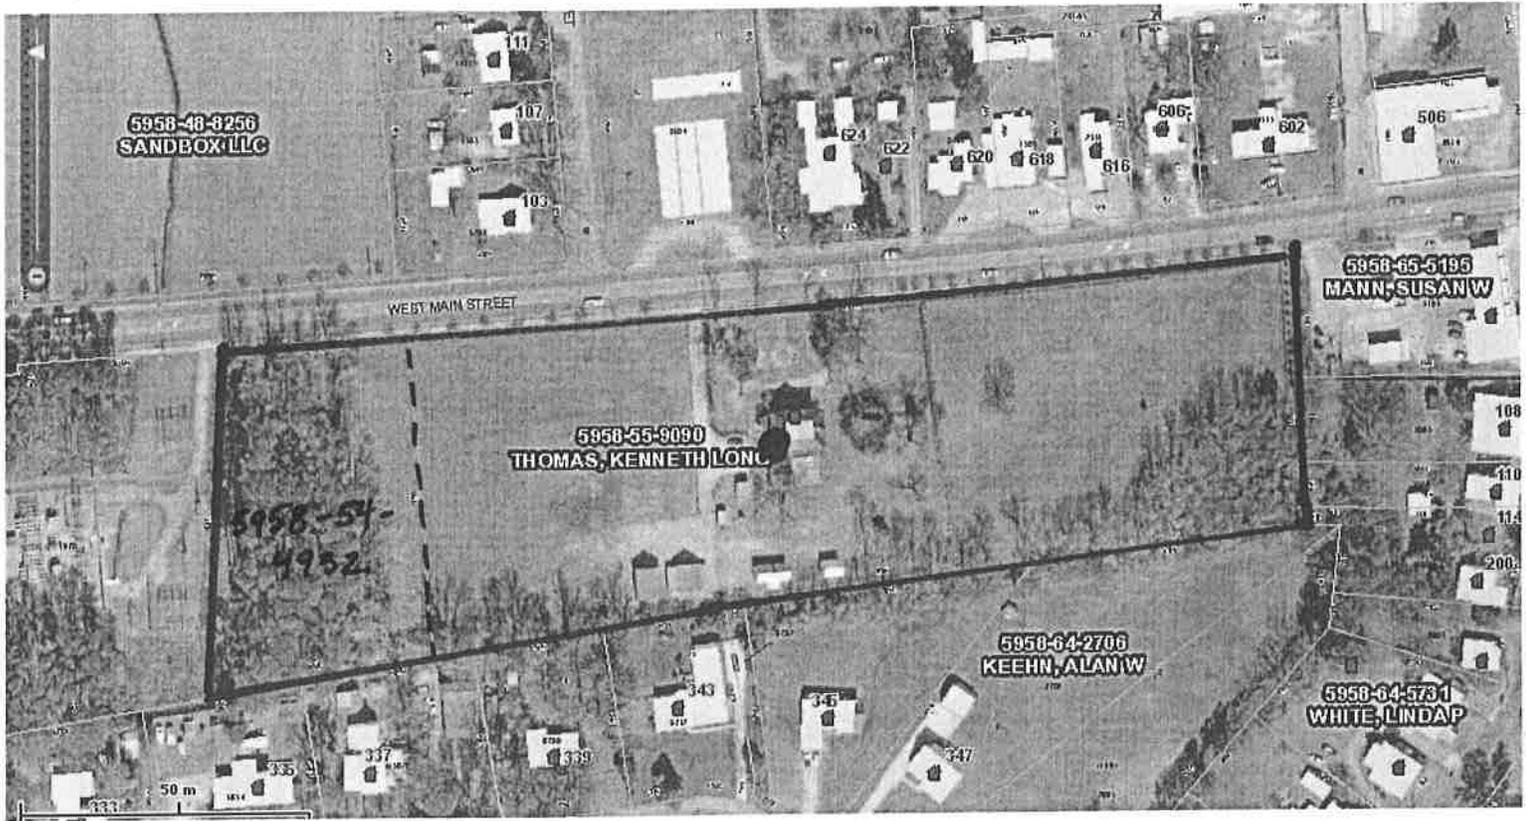
David A. Barnes House
 Mumfreesboro, Hertford County
 Site Plan
 Not to Scale

The David A. Barnes House, located at 625 West Main Street, is comprised of an 1875 house, four contributing 1875 outbuildings—a five-hole privy, a kitchen house, and two miscellaneous outbuildings—and non-contributing buildings and structures that include two turn-of-the-twentieth-century barns and a contemporary well pump, a woodshed and outdoor wood boiler (2010), and a chicken house (2012). These buildings stand on just over eight acres of land in the town of Murfreesboro, North Carolina, in northwestern Hertford County. The National Register boundary includes two parcels of land that comprise a portion of the acreage historically associated with the original house and yard (13.75 acres) on the west edge of Murfreesboro. The buildings sit on the south side of West Main Street and face north. The outbuildings are located south of the house. The entire property is bordered by a wire mesh fence. New wood pickets lined with young crepe myrtles separate the property from the street. A thin line of mature hardwoods screens the rear of the property from a subdivision to the south. A wooded lot to the west of the property separates residential Main Street from recent commercial development on the west edge of town. The yard contains a few mature hardwoods alongside recently cultivated flower beds and shrubbery. An ornamental brick walk leads to the front door. A long drive on the west side of the house leads from the street to side and rear entrances to the house. The west side of the property consists of an open yard that includes a grape arbor. The east side of the property consists of an open yard that includes a modern chicken house.
