National Register of Historic Places Registration Form

historic name Kiser, James, House
other names/site number BB-P-495

street & number 41 East Main Street
city or town Paris
state Kentucky code KY county Bourbon code 017 zip code 40361

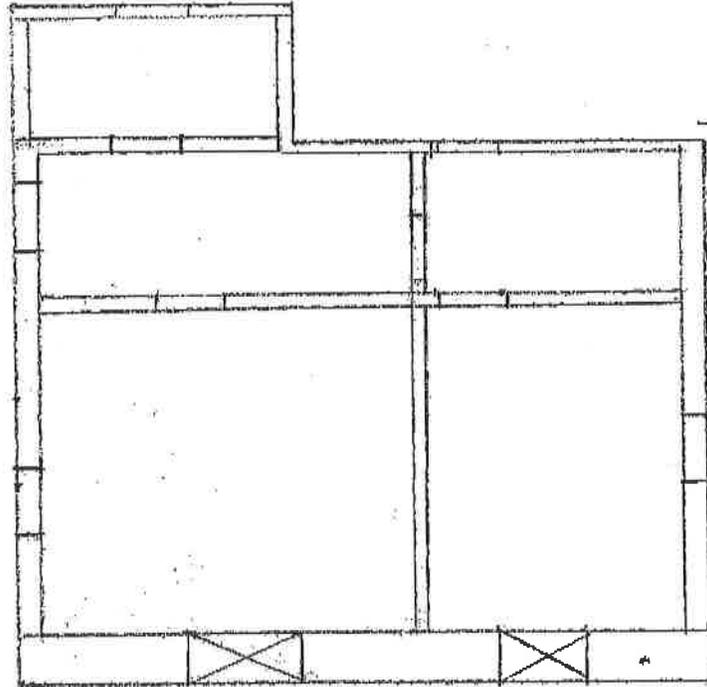
41E MAIN

SCALE: 1/8" = 1'

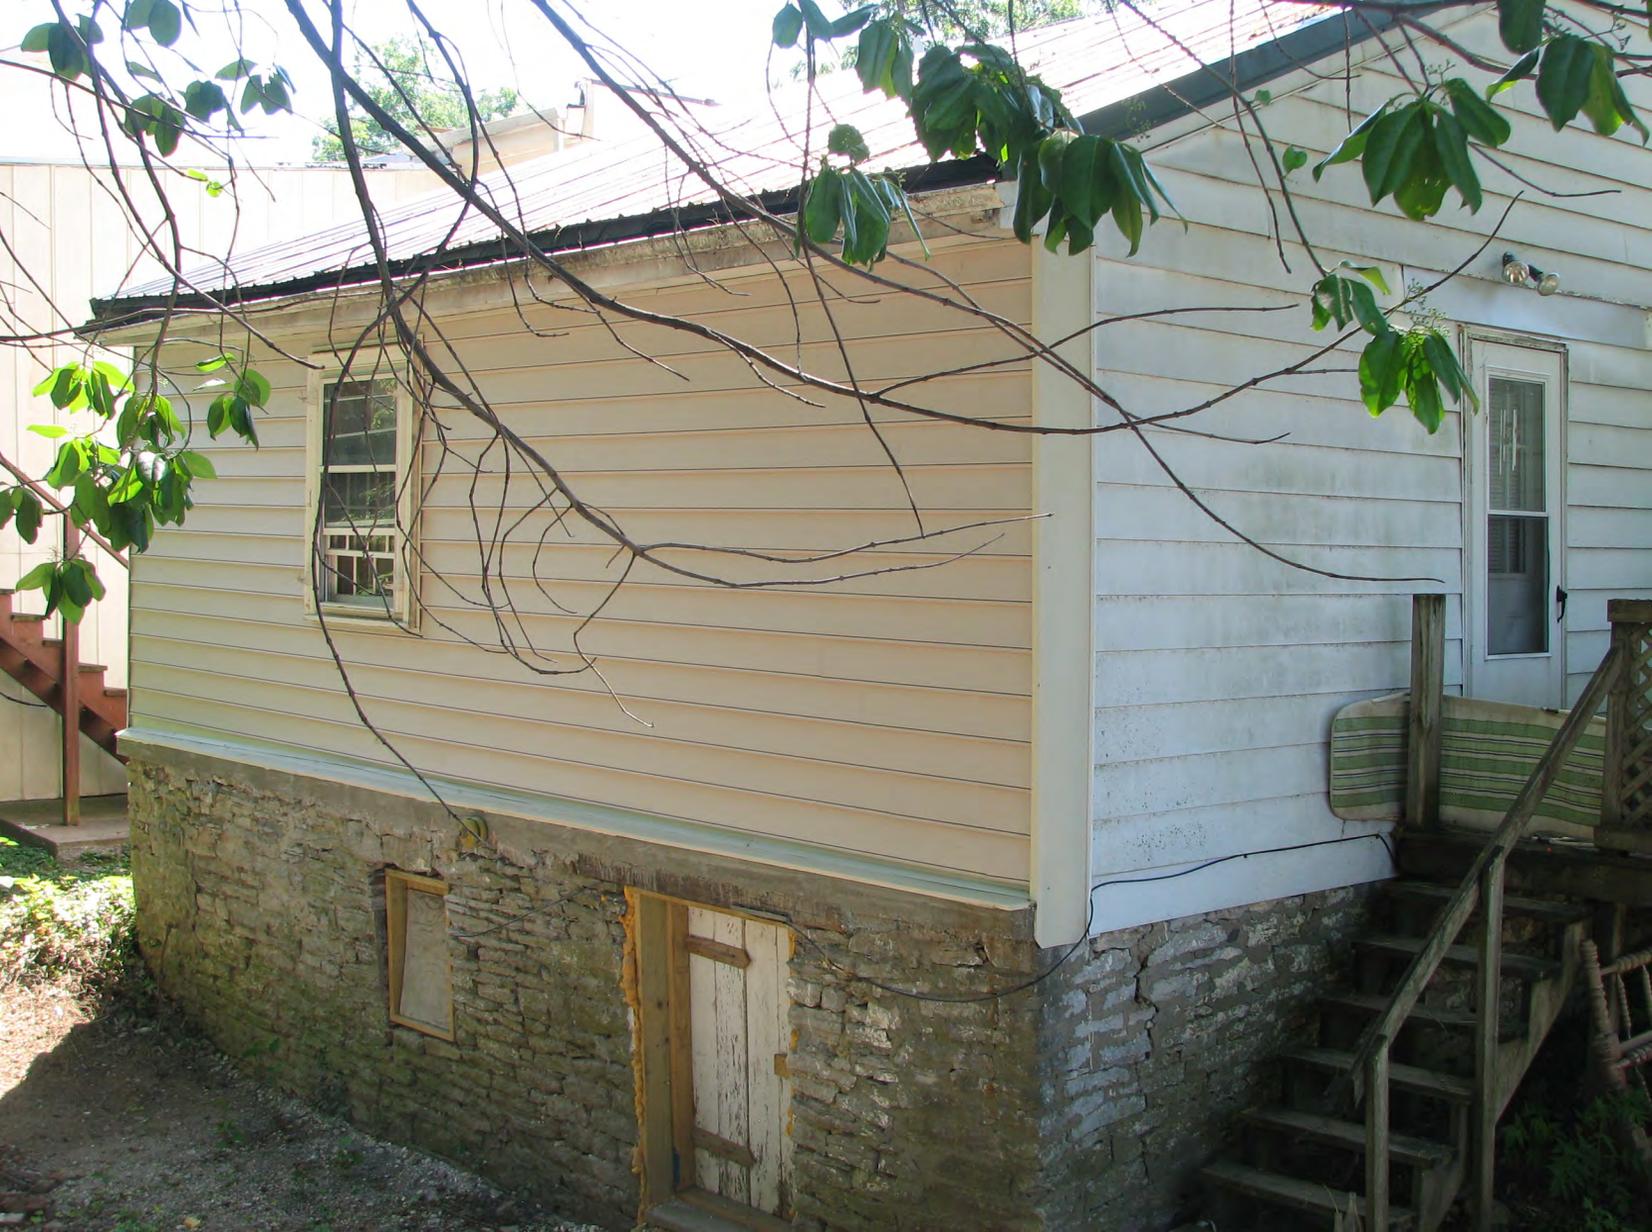
1. Hearth, basement, camera shooting east
2. Attic, camera shooting to the east
3. North and west façades, camera shooting to the east
4. South and west façades, camera shooting to the north
5. Hearth, basement, camera shooting east
6. North façade, camera shooting to the south
7. Main floor, primary fireplace, camera shooting to east

At approximately 800 sq. ft., the house is small by 21st-century standards, yet was probably typical of an early 19th-century yeoman cottage in Paris. The large open fireplace in the cellar of the house (see photo # 1) was first thought to be where Kiser's blacksmith work occurred. There had once been a very large fireplace in what is now the parlor, judging by the size of the base to this fireplace (photo #7) that would have served for cooking.
