National Register of Historic Places
Registration Form

historic name *Success Shipwreck (Scow Schooner)*

other names/site number 47DR493

Success Shipwreck (Scow Schooner)
Lake Michigan, Door County, Wisconsin

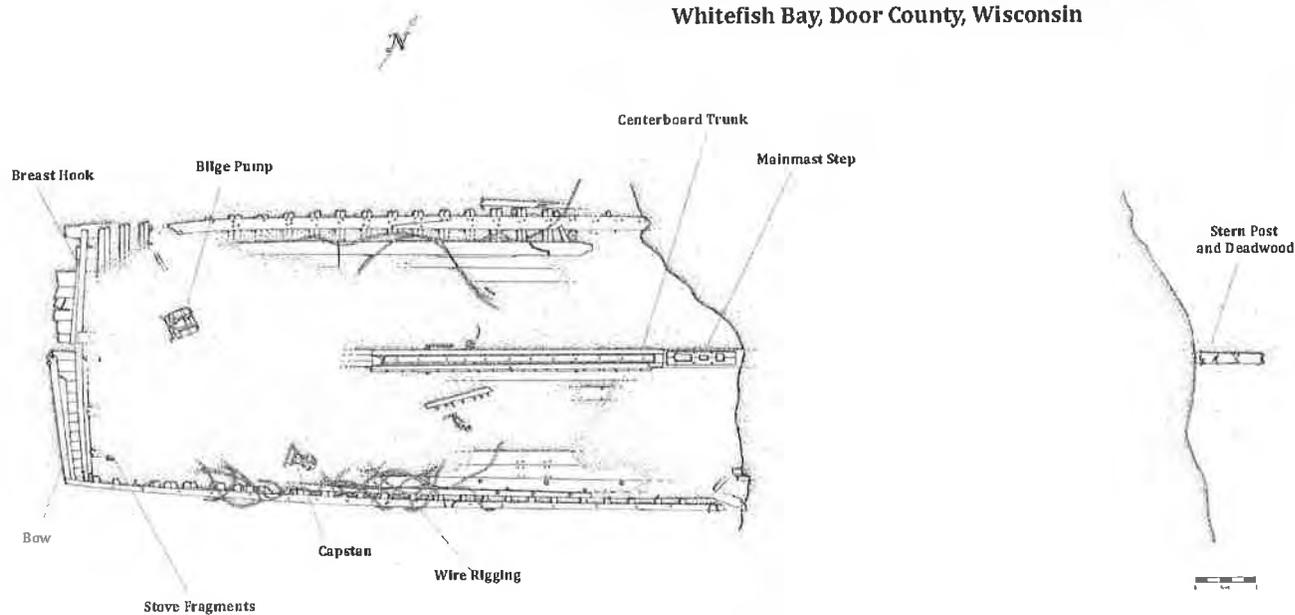
Scow Schooner Success

Whitefish Bay, Door County, Wisconsin

The *Success* measures 103.0 feet in overall length, and 26.0 feet in beam. A temporary baseline was established on the hull to which all hull measurements were referenced. The baseline started at the aft edge of the sternpost, passed over the top of the centerboard trunk, and extended forward where it ended at the stem post.
