Denali National Park Road Reconstruction

Mega-Project* Profile: The Denali Park Road Reconstruction

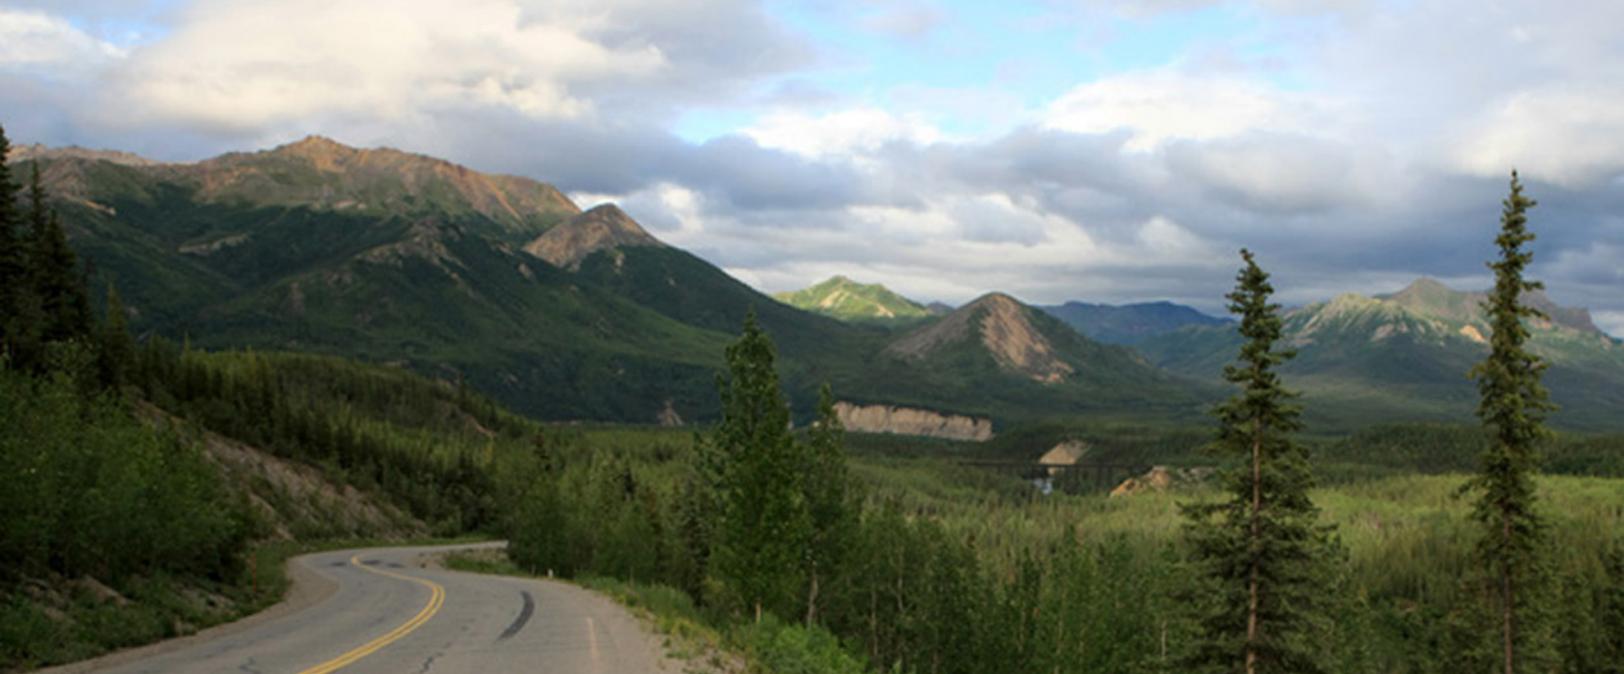
Above: The 92-mile-long Denali Park Road is the only road in the 6-million-acre park. The first 15 miles of the road are paved, and are in dire need of reconstruction. (Photo by Tim Vo, www.PatternsOfNature.com)

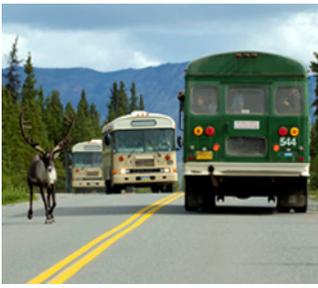
Because of the failed pavement at the milepost 2.5 pull-out, traffic stops in the middle of the road to view and photograph scenery, forcing following traffic to brake hard on a steeply curving section of the road.

The project will incorporate the re-paving of all pullouts, turn lanes, and intersections, including the total reconstruction of the scenic pullout at milepost 2.5. Subsurface failures in the roadway will be stabilized and the pullout will be widened to increase visitor parking to 20 vehicles. Construction will consist of a 500' long vehicle parking pullout with a viewing platform.

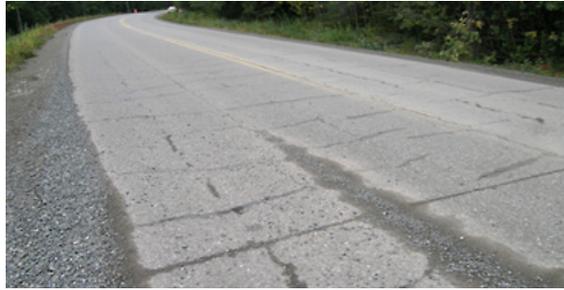
Middle: Much of the paved road surface on the Denali Park Road is failing. (NPS photo)

The paved portion of the Denali Park Road was last re-surfaced in 1989; many sections are now failing, due to year round use and Alaska's extreme freeze-thaw activity. Every spring maintenance crews struggle to keep the failing road glued together with crack seal.

Rutting and cracking causes vehicles to swerve sometimes into the opposite lane creating very unsafe driving conditions. Frost heaves have become extreme enough in some areas of the road to force larger vehicles such as motor homes and tour buses to lurch and rebound in such a manner as to cause injury to occupants; injuries have been documented.
