Interpreting The Secretary of the Interior's Standards for Rehabilitation

Subject: Rooftop Additions on Mid-Size Historic Buildings

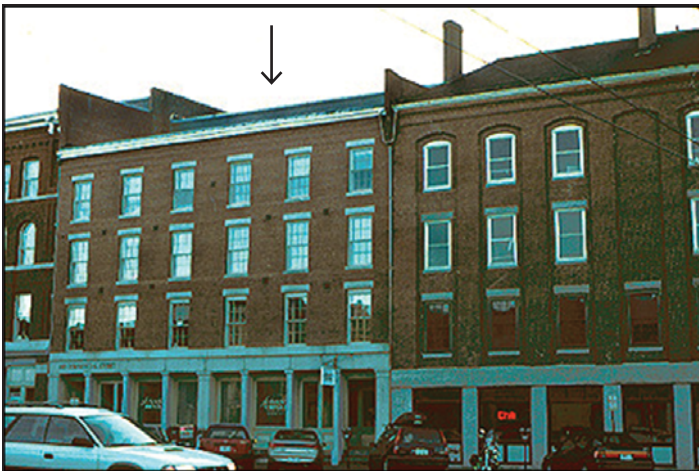
Mid-19th century commercial building with rooftop addition as it appeared after rehabilitation (center).

to reduce the impact of the addition and allow it to blend in with the adjacent rooflines. This rooftop addition does not detract from the historic character of the building and, therefore, meets the Standards.

Application 1 (*Compatible treatment*): The rehabilitation of this mid-19th century commercial building included a rooftop addition as part of the project. Though the building is only four stories in height, this rooftop addition is compatible with its historic character. It is set back substantially—almost halfway from the front façade and, thus, it is minimally visible from the public street and from within the district. High party walls on either side also help

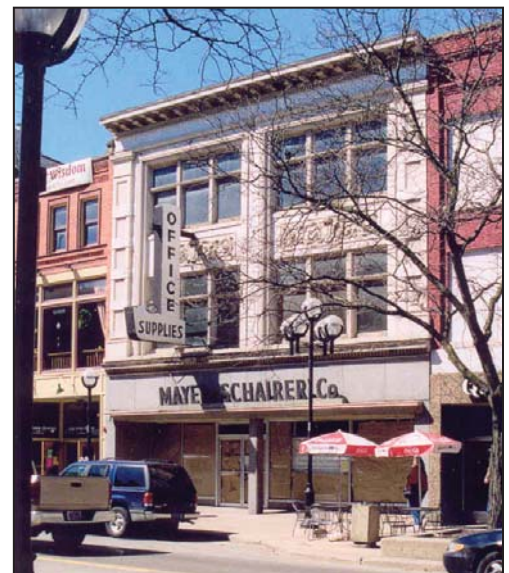
Three-story commercial building prior to rehabilitation.

Application 2 (*Incompatible treatment*): This three-story commercial building, originally constructed in 1847 but greatly altered in 1907, underwent rehabilitation for mixed commercial, office, and residential use. The rehabilitation included a substantial new rooftop addition.

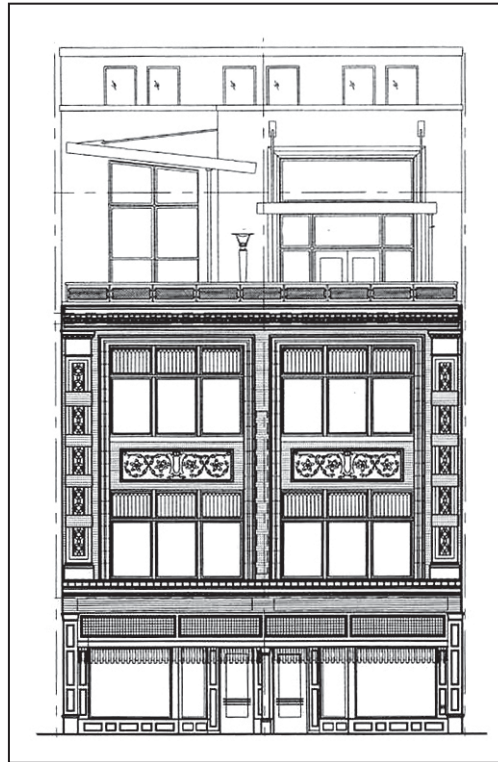
Drawing of front elevation with proposed rooftop addition.

Contrary to National Park Service guidance which states that rooftop additions should be limited to one story and are rarely acceptable for low-rise buildings, this addition rises a full story and a half above the roof. The prominent cornice, an important character-defining feature of the primary elevation of the historic building, is overwhelmed and greatly diminished by the new rooftop addition. Not only is the addition barely set back from the front of the building, its asymmetric, modernist design further detracts from the character of the building's classically-styled façade. The rooftop addition competes for attention with the historic building and it is also out of character with the surrounding district. This rooftop addition is not compatible with the historic character of the building and, therefore, does not meet the Standards.

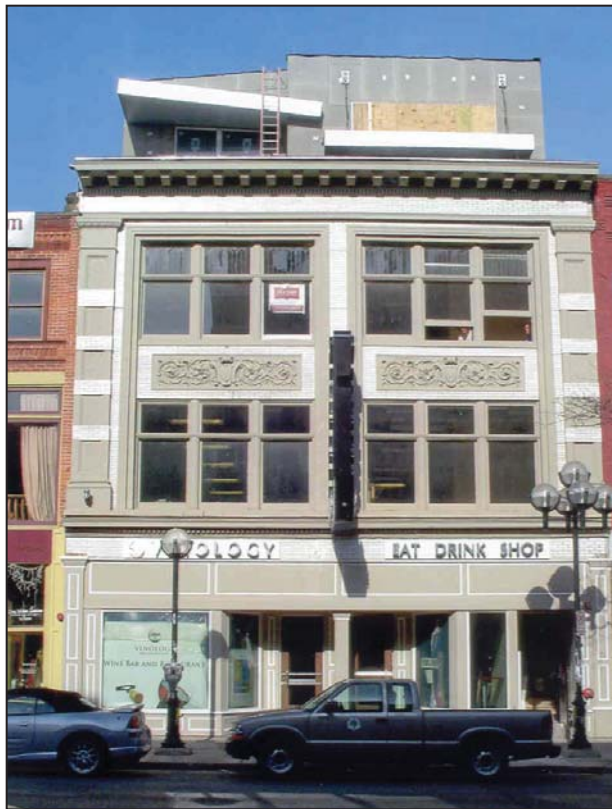
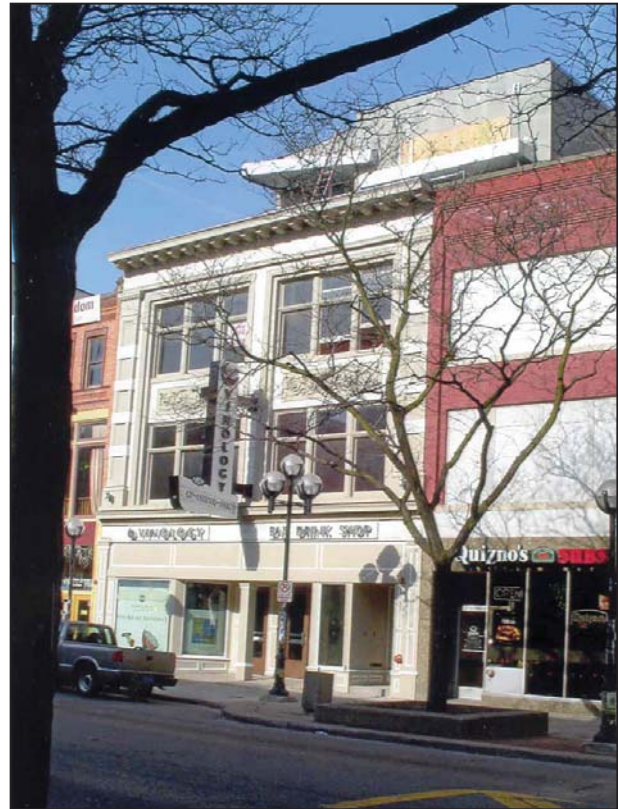
Three-story commercial building showing rooftop addition under construction.
