Interpreting The Secretary of the Interior's Standards for Rehabilitation

Subject: Incorporating Solar Panels in a Rehabilitation Project

August 2009, ITS Number 52

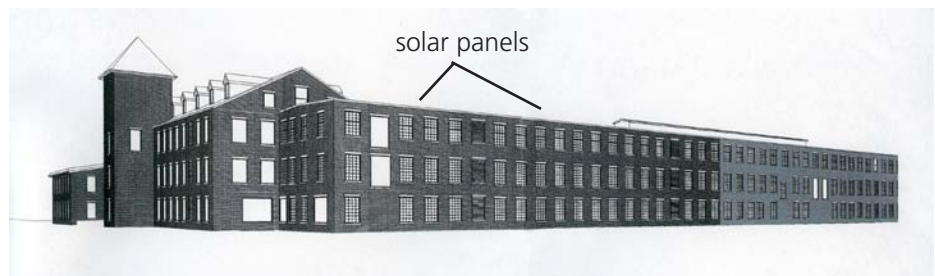
Because of the size of this historic mill, a large array of solar panels could be installed on the flat roof without being seen from the ground.

The rehabilitation of this mid-nineteenth century mill incorporated a large, roof-mounted photovoltaic installation. Although the historic building does not have a parapet wall at the roofline, the height of the building and the arrangement of the panels render the entire installation invisible from the ground. It is important to note that the panels are placed horizontally. Had the panels been installed with a vertical tilt, the angle required to maximize efficiency would have caused the panels to extend significantly higher above the roof. Simply changing the direction in which the panels are tilted can affect their visibility and reduce their impact on the character of the historic property.

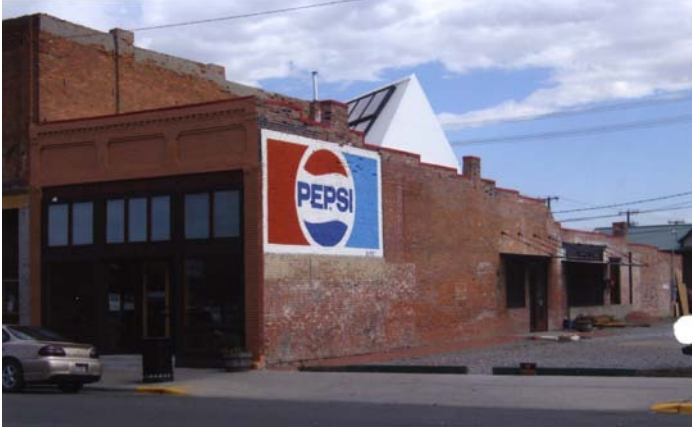
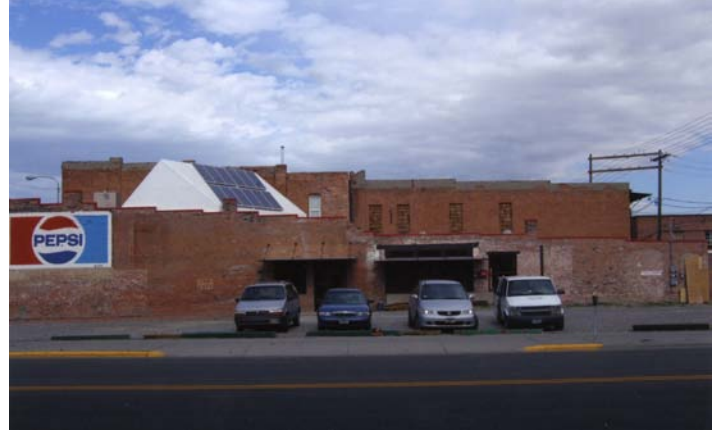
The addition of a large rooftop monitor featuring skylights on the front slope and solar panels on the rear slope is not compatible with the historic character of this small, one-story commercial building.

Application 2 (*Incompatible treatment*): During the rehabilitation of this late-nineteenth century commercial building, a conspicuous rooftop monitor with prominent solar panels and skylights was constructed on the one-story structure. The size and finish of this rooftop addition are incompatible with the historic character of the building. However, the building could have accommodated both skylights and solar panels if they had been installed differently. An alternative design that could have met the Standards would have included low-profile skylights and solar panels concealed behind the parapet wall.

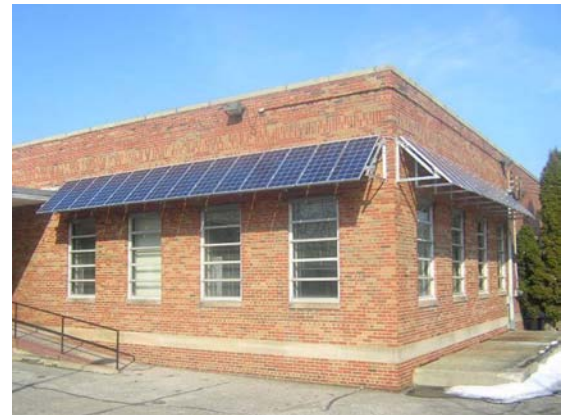
Above: Shown from the rear of the property, these solar panels serve a secondary function as awnings to shade south-facing windows. Because of their location at the back of the building immediately adjacent to a loading dock, the installation of these panels does not affect the historic character of the property.

Application 3 (*Compatible treatment*): The rehabilitation of this historic post office incorporated solar panels as dual-function features: generation of electricity and shading for south-facing windows. In this instance, the southern elevation of the building is also a secondary elevation with limited visibility from the public right of way. Additionally, because this area of the building is immediately next to the post office's loading dock, it has a more utilitarian character than the primary facades and, therefore, can better accommodate solar panels. Because the panels are in a suitable location at the rear of the property and are appropriately sized to serve as awnings, they do not affect the overall historic character of the property. Additionally, a screen of tall plantings shields the solar panels from view from the front of the building, further limiting their visibility.

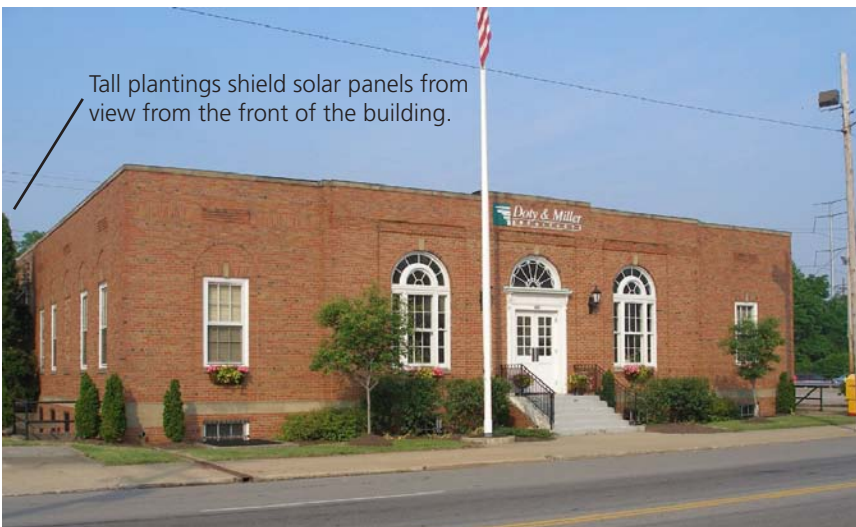
Left: The solar panels are not visible from the front of the building. Additionally, even if the vegetation were removed, the installation would only be minimally visible along an alley at the rear of a secondary side elevation.
