STANDARDS FOR RESTORATION & GUIDELINES FOR RESTORING HISTORIC BUILDINGS

Restoration

Standards for Restoration

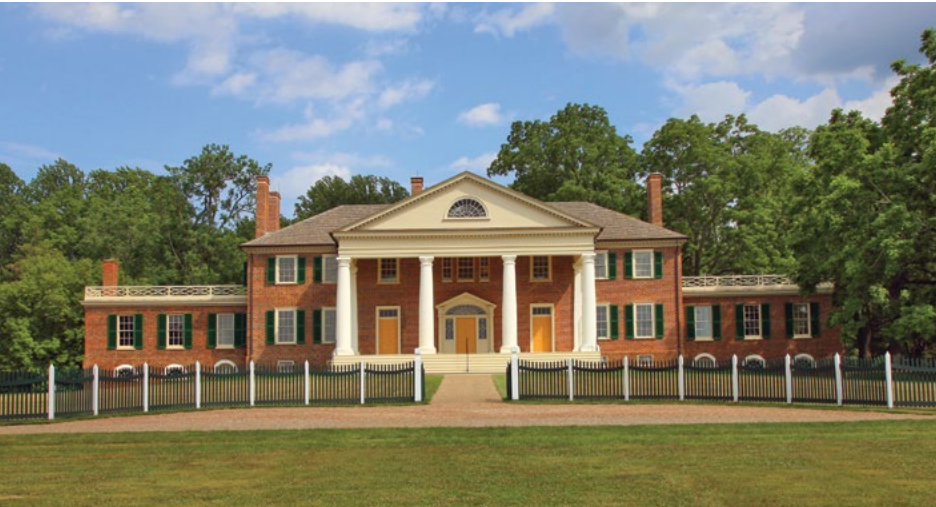
[1] (a) When it was acquired by the National Trust for Historic Preservation in the 1980s, Montpelier in Montpelier Station, VA, the home of James and Dolley Madison, had been much altered and enlarged since it was first constructed. Based on historical documentation and research, Montpelier was accurately restored to its 1820s appearance when the president and his wife lived there (b). Photos: Courtesy of The Montpelier Foundation.

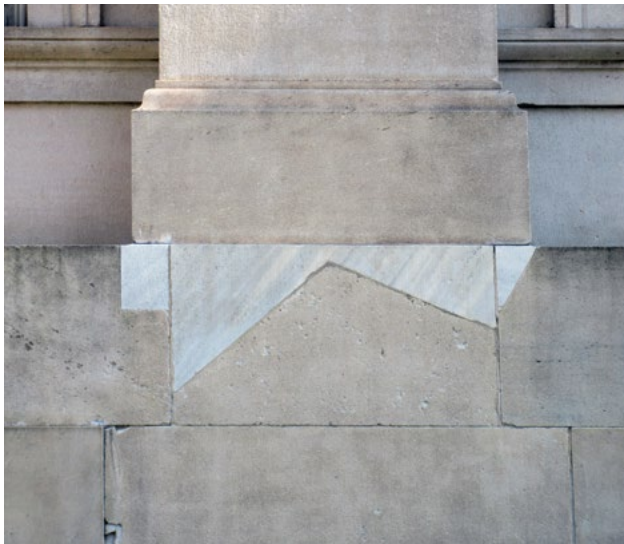
[3] **Not Recommended:** Although the Dutchman stone repair has been well executed, the replacement stone is not a good color match.

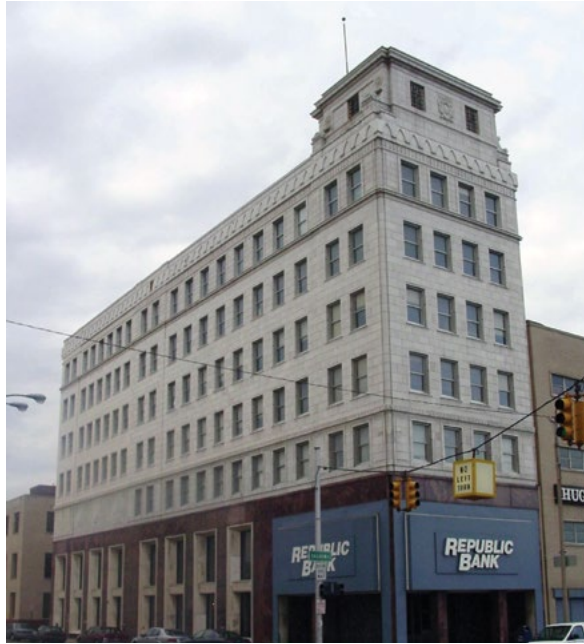
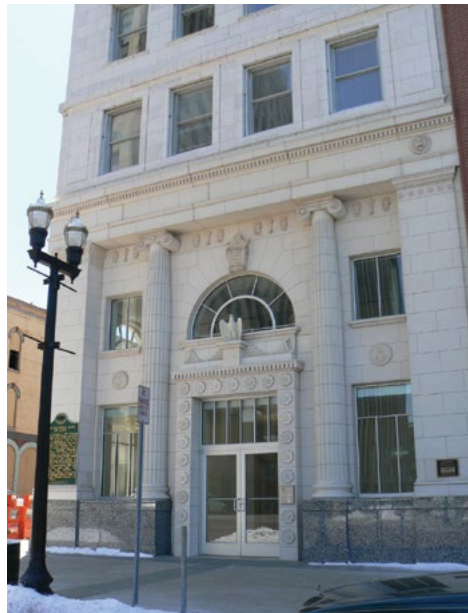
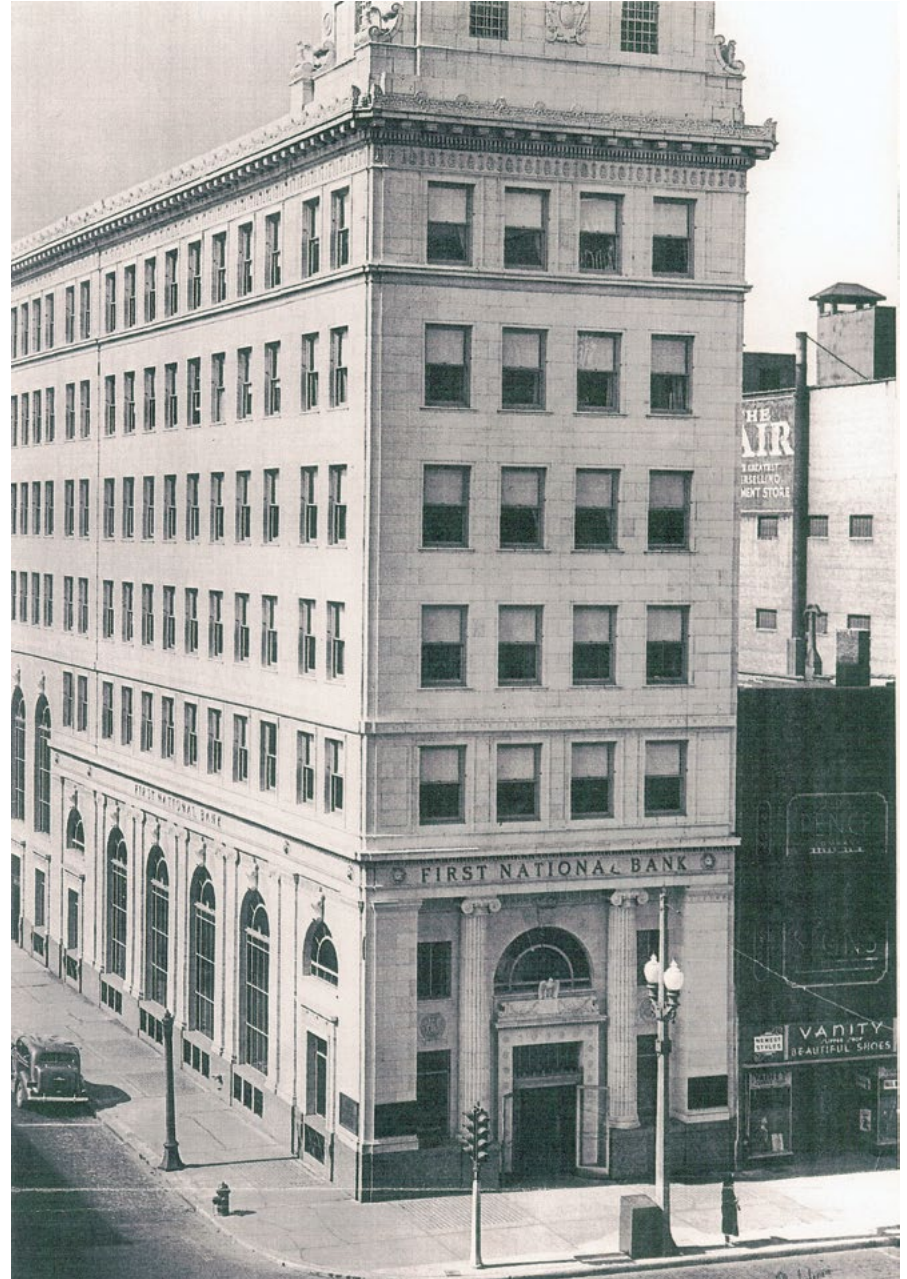
[4] (a) Over the years terra-cotta cladding had been replaced on the lower floors of this early-20th century bank building with a storefront and incompatible windows. (b) A 1936 photograph of the building provided the documentation to restore its historic appearance. (c) Glass fiber reinforced plastic (GFRP) was chosen as a substitute material, and samples were made in a variety of colors and textures to obtain the best match for the missing and damaged terra cotta. (d) This photo taken after restoration shows that the GFRP replacements successfully blend in with the original terra cotta. Photo (d): Blamonet at English Wikipedia.

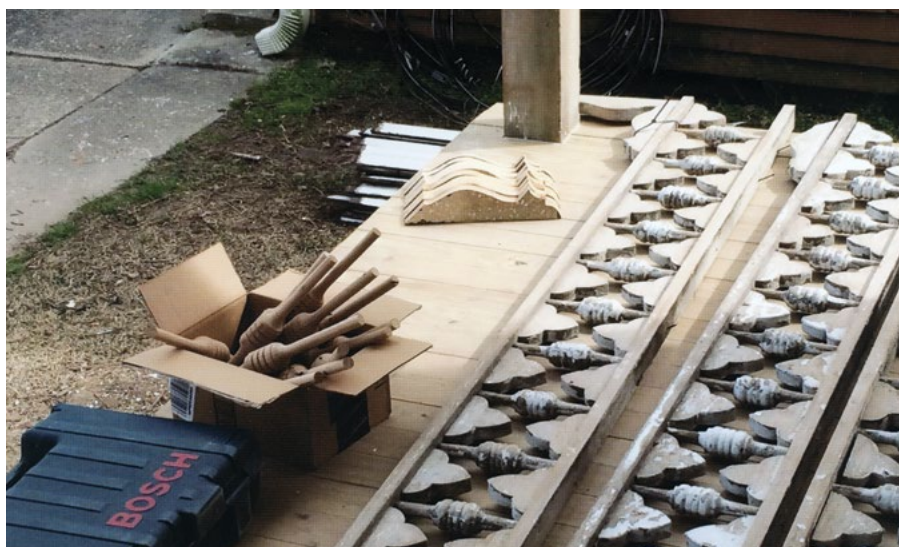
[5] New wood trim pieces were milled to match the few remaining historic features to replace those that were missing.

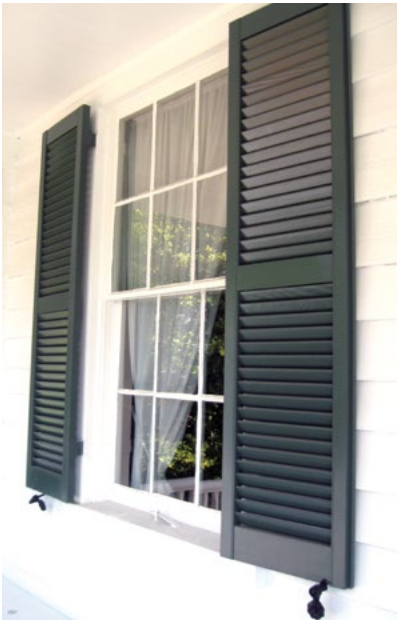
[9] Historic window and shutter hardware such as that shown here should be retained and repaired in a restoration project.

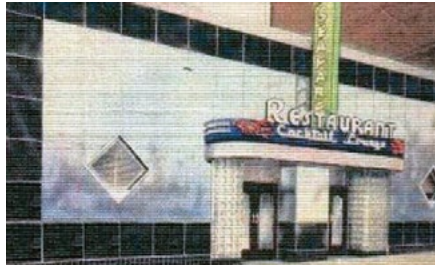
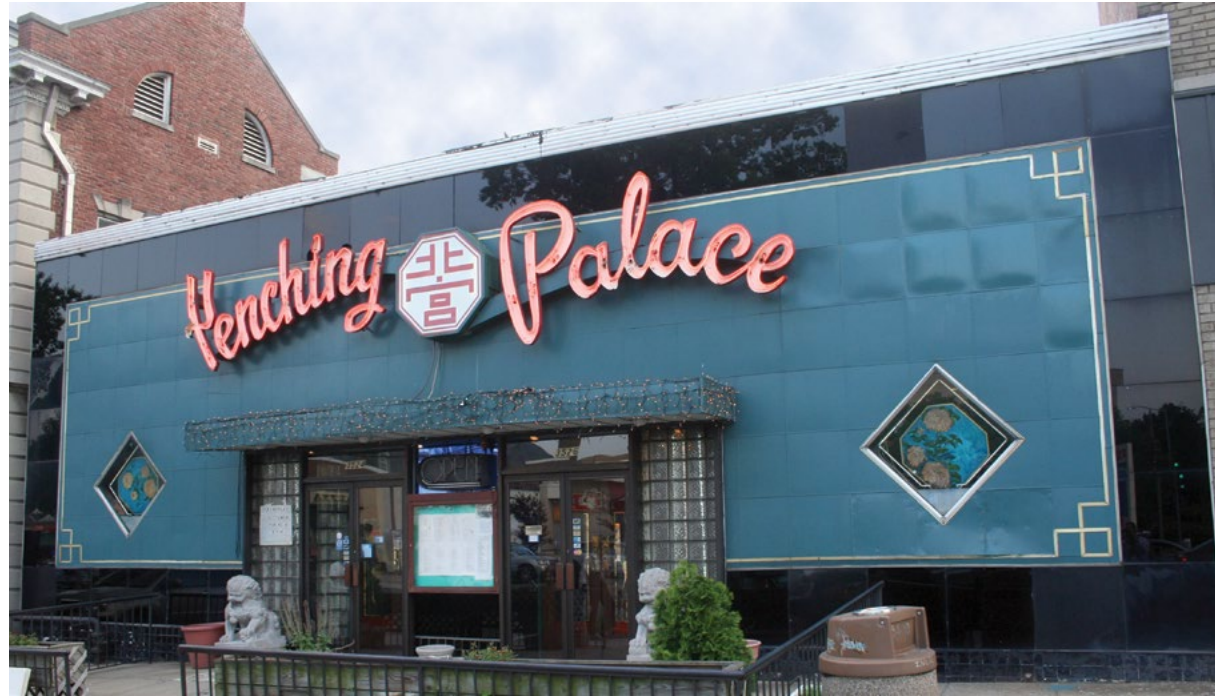
[11] (a) Some of the materials on the front of this historic building had been previously replaced, but the façade retained its essential distinctive features and design. (b) A vintage postcard of the building (far left) provided sufficient documentation to restore the façade to its historic 1945 appearance, using spandrel glass as a replacement for the original Carrara glass (c). Photo (b): Courtesy Kelsey & Associates.

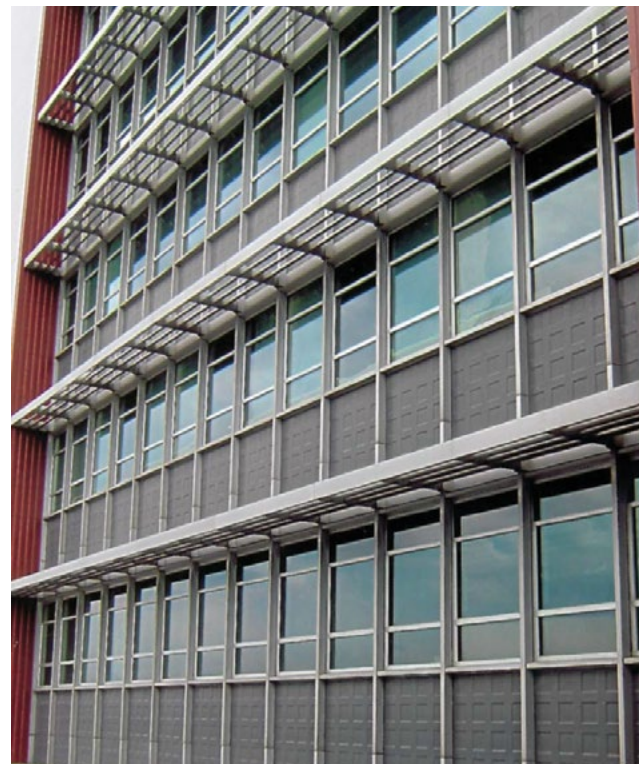
[12] This historic curtain wall features a distinctive variety of panel types which must be repaired or replicated in a restoration project if any are damaged or missing.

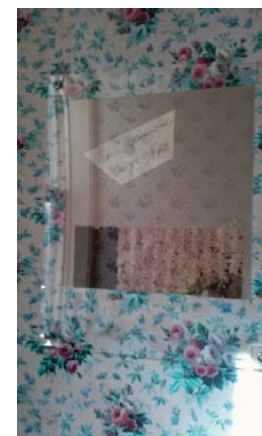
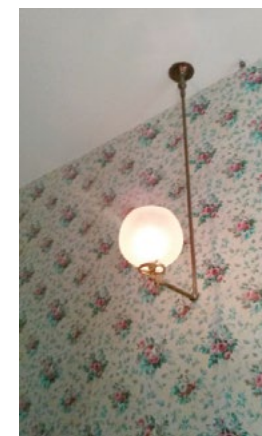
[13] (a) In the 1990s the Missing Soldier's Office—established by Clara Barton at the end of the Civil War—was discovered still extant on the third floor of a building in Washington, DC, that was slated for demolition. The office was restored to its historic appearance using physical and documentary evidence. The original numeral '9' is still on the door to the office, and wall paper was reproduced from scraps found on the walls (b-d).

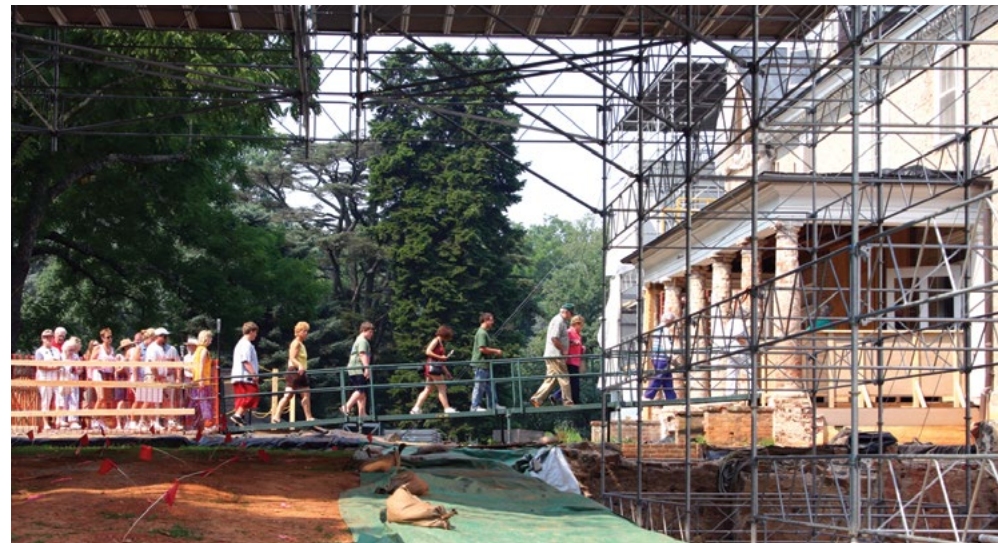
[16] Archeological investigation of the property was undertaken to ensure accuracy of the restoration of Montpelier. Photo: Courtesy of The Montpelier Foundation.

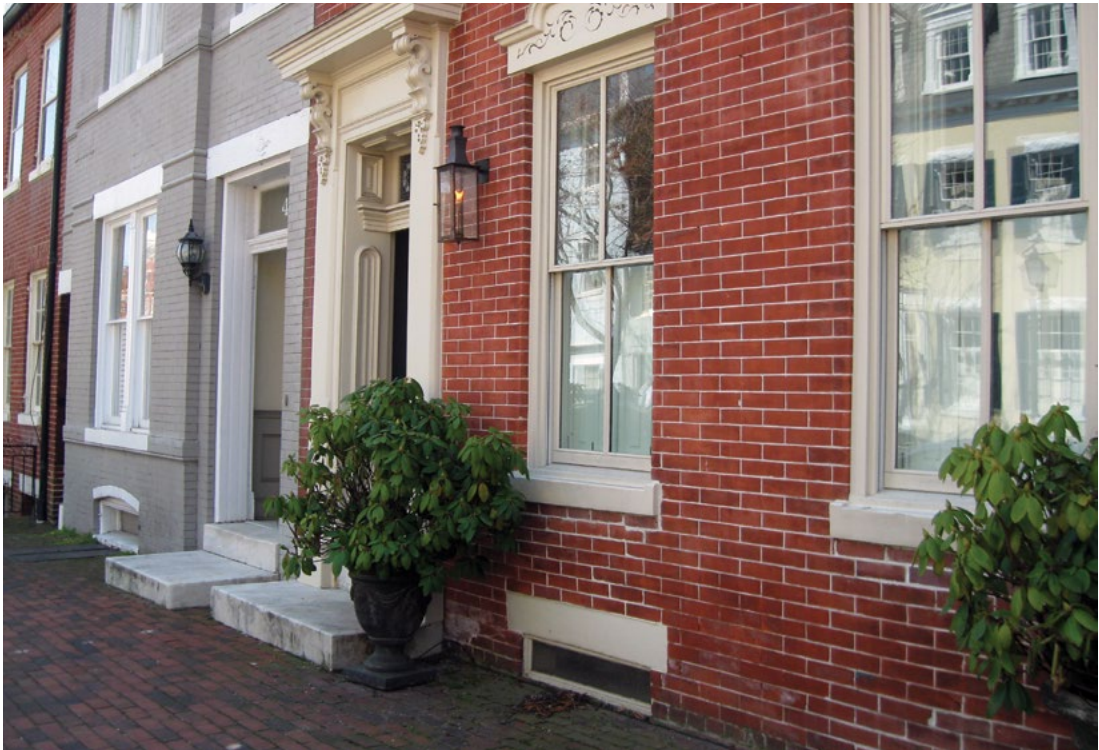
[17 a-b] The cobblestone street, brick sidewalks, and stone stoops of these houses are important restoration-period features of the late 18th-through the 19th-century restoration period of this historic district.

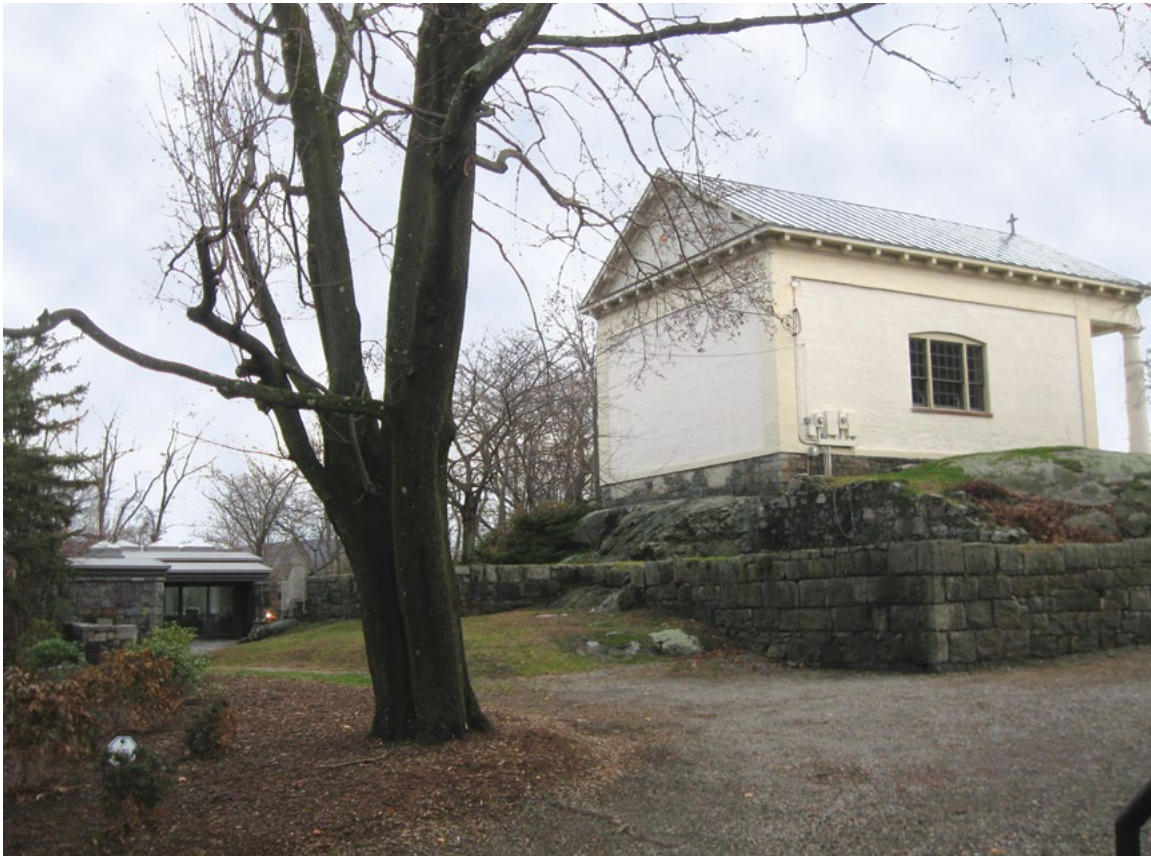
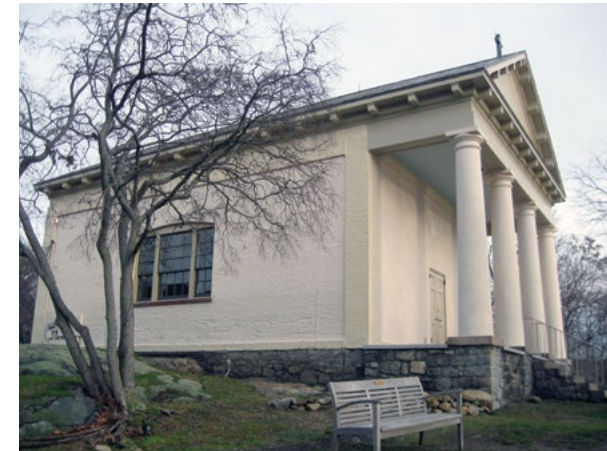
[18 a-b] The historic Chapel of Our Lady in Cold Spring, NY, is situated on a rocky promontory overlooking the Hudson River. Installing an accessible ramp would greatly compromise the character of the building and the site. However, an audio-visual program available in a separate building—located where it would not impact the character of the site, such as this small pavilion at the rear of the property—could provide visitors otherwise unable to access the Chapel an opportunity to experience the site.

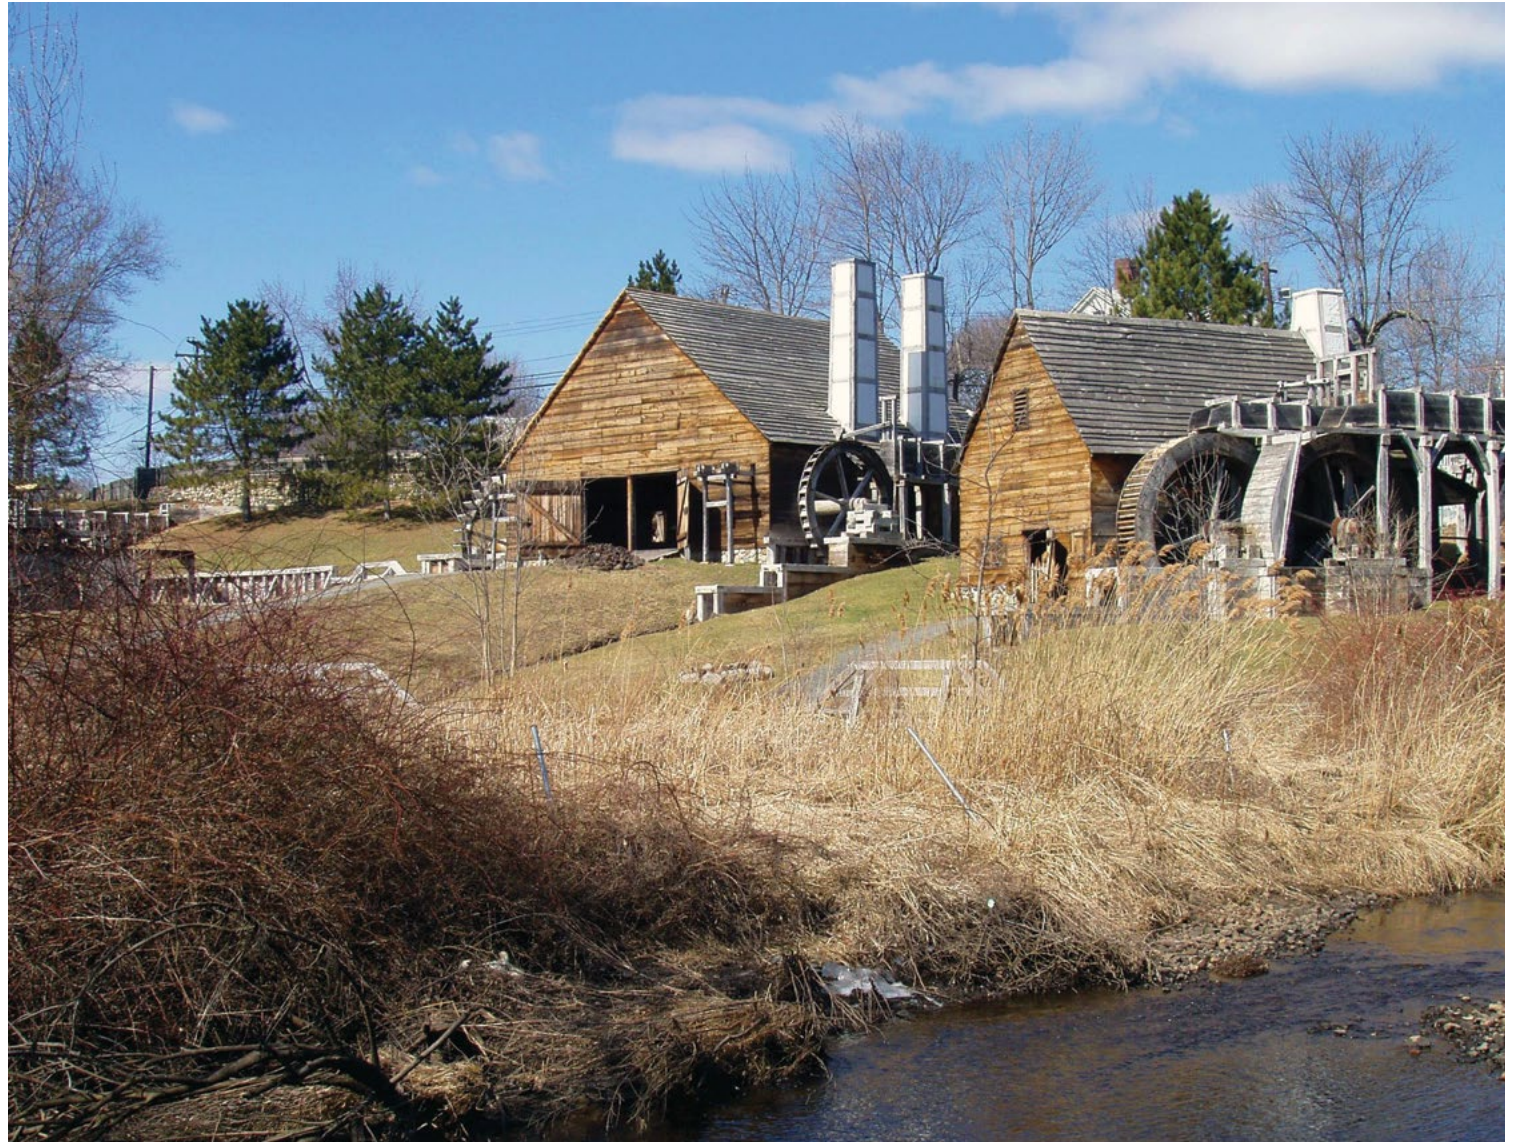
[2] The Saugus Iron Works, Saugus, MA, a National Historic Site, was active from 1646 to about 1670 and was the first integrated iron works in North America. The forge and mill (shown here) are part of the site which was reconstructed based on archeological research and historic documents and opened in 1954. *Photo: Daderot at the English language Wikipedia.*

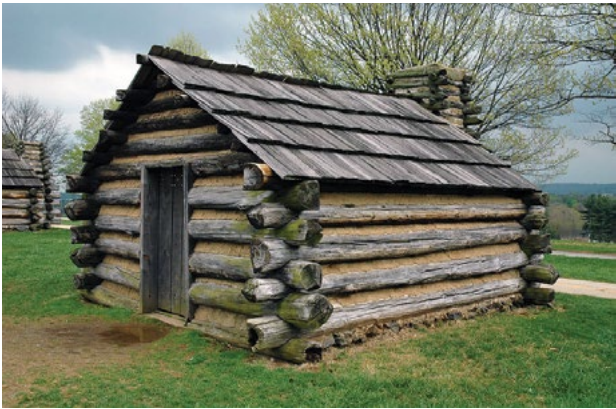
[7] The Muhlenberg Brigade Huts are reconstructions of nine log huts erected in 1777 at Valley Forge during the Revolutionary War. They have been reconstructed on the historic road with logs cut with modern power tools and finished with cement, unlike the original logs which were hand hewn and finished with traditional chinking. *Photo: Rdsmith4 at Wikimedia Commons.*

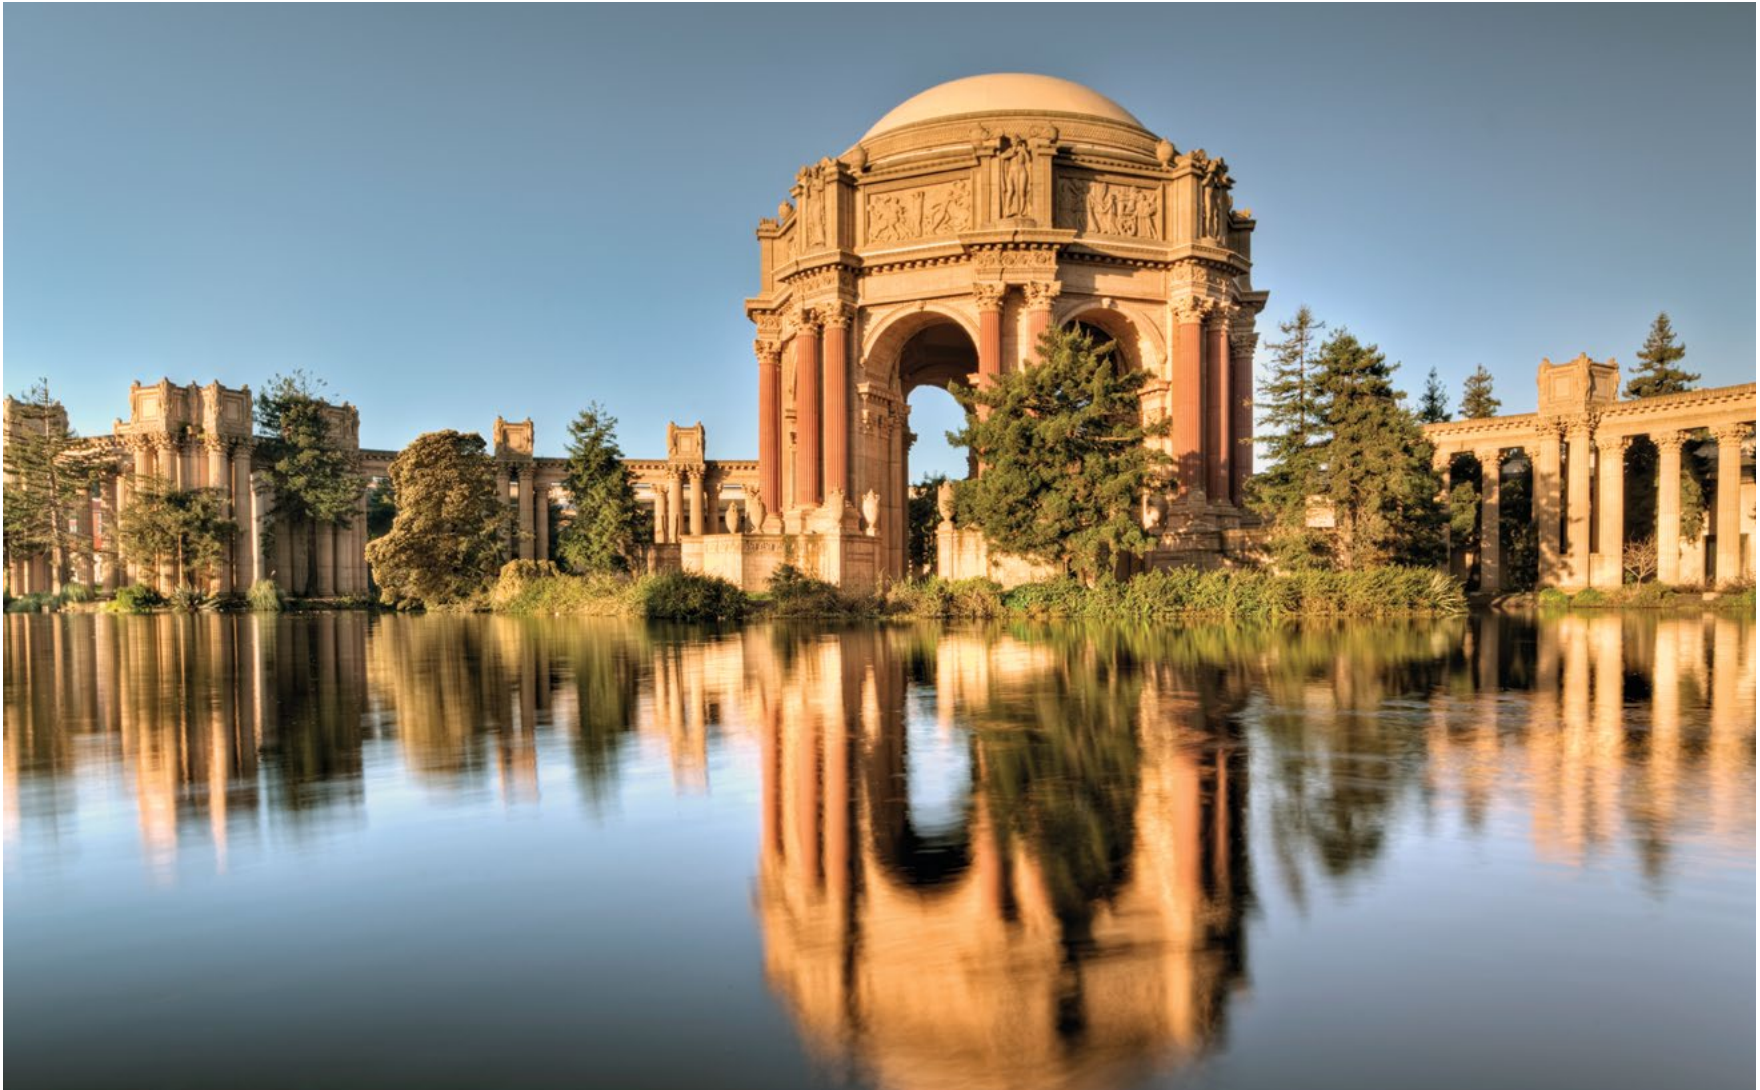
[8] The Palace of Fine Arts was designed by Bernard Maybeck and built for the 1915 Panama-Pacific Exposition in San Francisco. The pavilion was intended to be temporary and, although it had a steel structure, the exterior was finished only with stucco, an impermanent material composed of plaster and fiber. The building was not torn down after the exposition, and it eventually fell into ruin. In 1964, all but the steel structure was demolished, and the building was reconstructed with lightweight poured-in-place concrete. *Photo: KevinIcole at Wikimedia Commons.*
