THE  
STEAMBOAT  
BERTRAND

# THE STEAMBOAT BERTRAND

History, Excavation, and Architecture

by Jerome E. Petsche

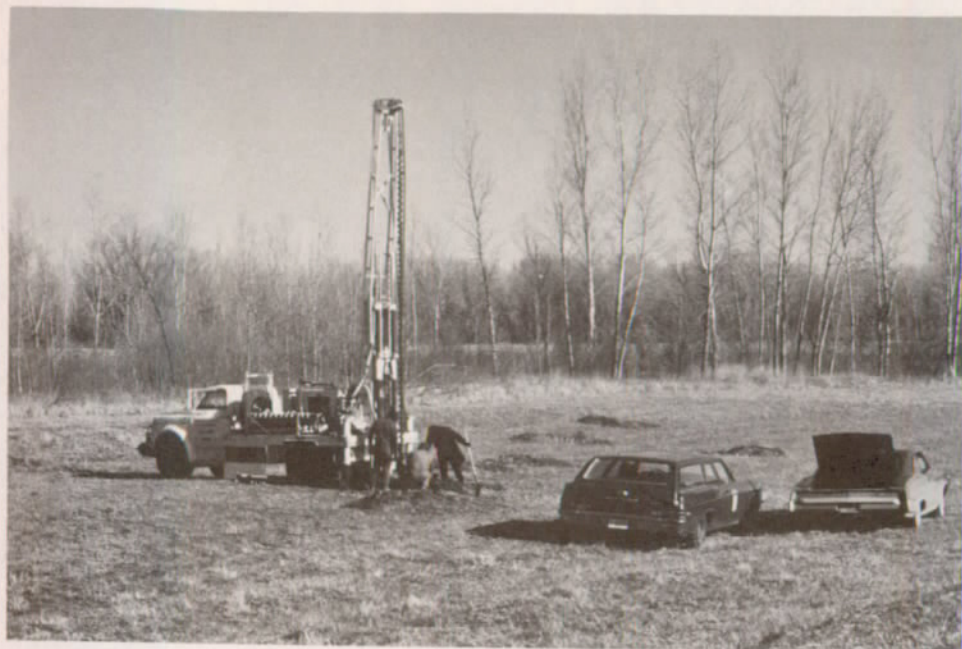
**Figure 19.** The Bertrand site, before excavation. The salvors' use of this truck mounted auger, drilled to depths of from 25 to 35 feet, resulted in the recovery of boat wood and fragments of cargo. Note line of auger holes to right and rear of truck, an alignment which roughly intersected the magnetometer's readouts of heavy ferrous concentration depicted in figure 18. View to north.

With the flux gate indicating the presence of ferrous masses under the surface, the salvors proceeded to test the area with an auger, drilling a line of holes approximately 15 feet apart to depths ranging from 25 to 35 feet to intersect the two areas in which the flux gate recorded the heaviest concentration of ferrous materials (fig. 19). As the holds of the *Bertrand* were later excavated, it was noted that this row of tests had very nearly been placed along the centerline of the boat. Samples of cultural material recovered included boat wood, fragments of green glass, brandied cherries, brick, crating, leather boot fragments, lead bars and shot, a substance that appeared to be

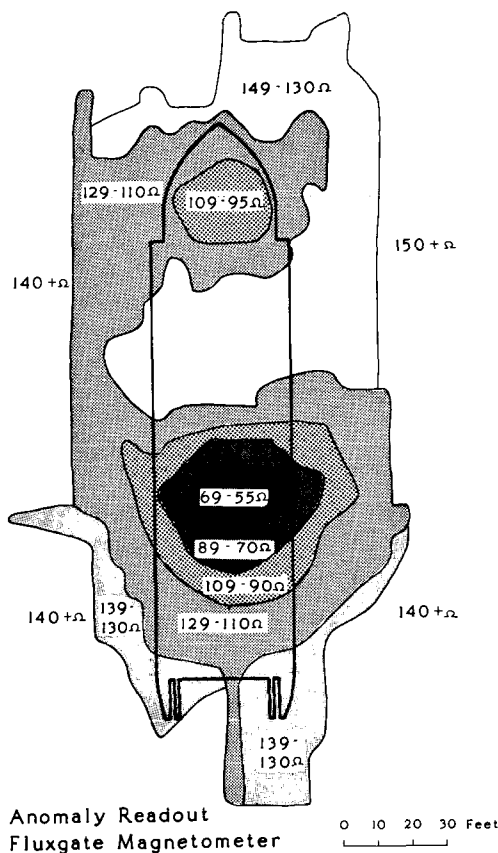
**Figure 18.** The surface anomaly readout of the flux gate magnetometer depicted relative to the periphery of the *Bertrand*, below surface. The area strength patterns are based on the flux gate readings taken at 5-foot intervals. The areas indicating the heaviest concentration of ferrous material (lowest readouts) correspond roughly to those areas in the holds where most of the iron and steel was found.

At this juncture, the salvors established a 5-foot square grid system, taking a flux gate reading at intersecting points, and covering an area of approximately 190 by 60 feet. The resulting grid readouts were later tied into the datum established prior to excavation and removal of ship's decking (fig. 18). Upon excavation of the holds, it was found that the two areas of greatest magnetic anomaly corresponded roughly with those areas in the holds containing large iron plows and howitzer ammunition in the stern and large amounts of steel bar stock and kegs of nails near the bow.

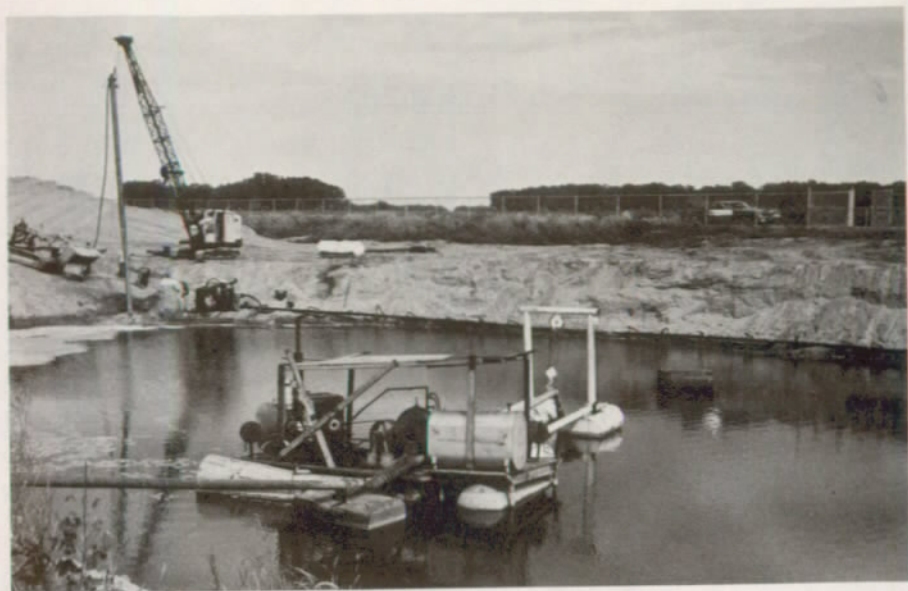
**Figure 22.** Initial sumping operation conducted on pontoons in the excavation immediately over sunken boat. Soils and silt in this first phase of the excavation were removed to the depth of the water table with the dragline and bulldozer at upper left.

The dredging operation, conducted on a platform supported by pontoons, involved the pumping of water from the lake (left leg of DeSoto Bend) several hundred feet west of the excavation into the excavation itself to loosen the silt, whereupon the water suspended silt was pumped from the excavation (fig. 22). The dredge flow was discharged through a 1/2-inch screened hopper in an unsuccessful attempt to recover cultural material (fig. 23). Early in April of 1968 the excavation was enlarged to an area approximately 100 by 50 feet, approximately 20 feet in depth. The salvors then engaged the services of two divers equipped with SCUBA in hopes that they might get far enough below the water table to make physical contact with the boat. Limited visibility and the remaining layer of silt hampered this exploration phase of the operation, and continual bank slumping, the high water table, periodic rains, and clogging of the dredging tubes and discharge system during the summer forced the salvors to use a series of wells in an attempt to lower the water table to the level of the boat.

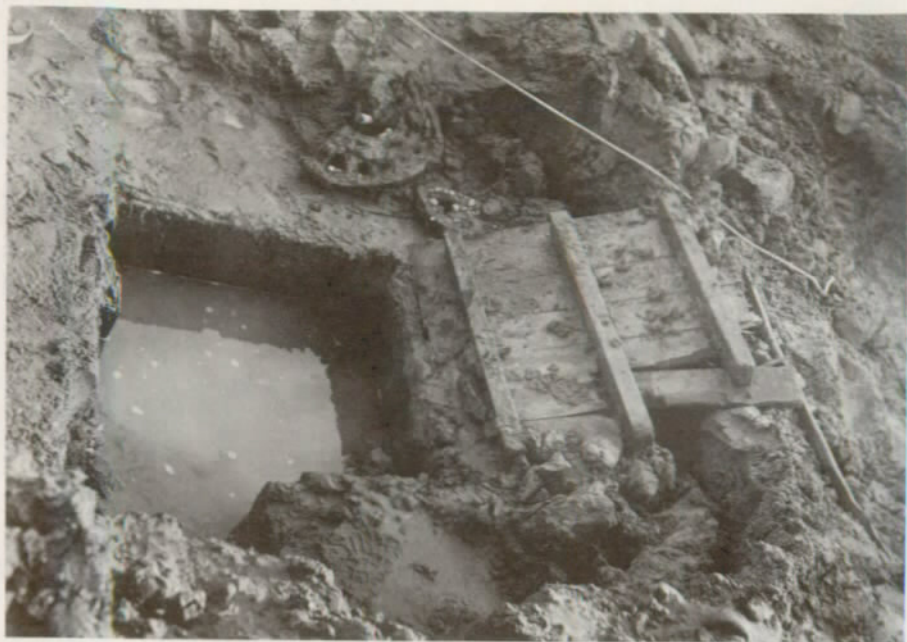
**Figure 24.** The bilge hatch (opened by salvors) was among the first features of the *Bertrand* encountered. Evidence of earlier salvaging activity could be seen on the hatch in the form of holes drilled on the cover to enable the early salvors access to the bilge in the stern. Note portion of engine eccentric above hatch.

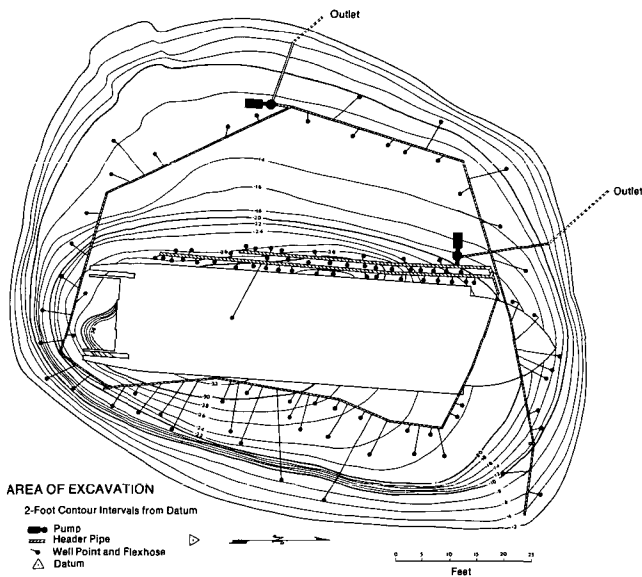
**Figure 28.** Periphery of *Bertrand* and limits of excavation in relation to datum. The isolines are drawn at 2-foot-deep intervals from datum. The figure also depicts the final positions of header pipes, well points, and pumps used to evacuate ground water.

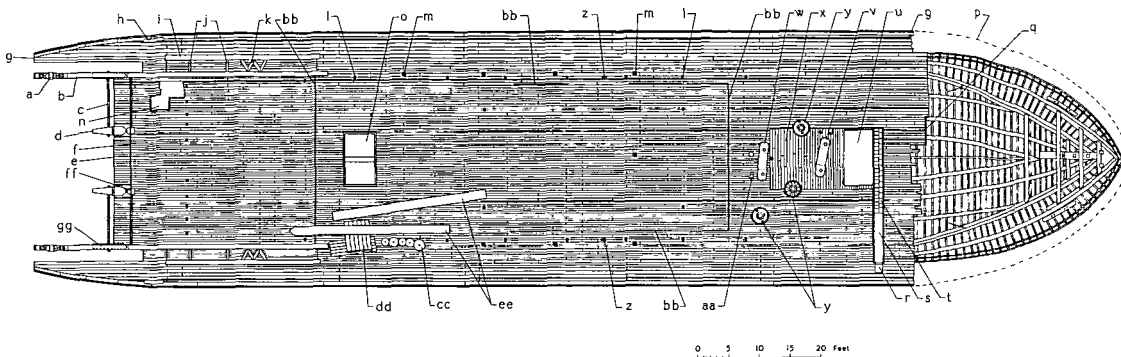
**Figure 29.** Surface of the *Bertrand* before removal of decking and the remains of the driving mechanism, superstructure, and hull: a. pillow block, b. inner cylinder timber, c. rudder articulating arm, d. master (balance) rudder, e. false transom, f. transom, g. guard, h. kevel, i. outer cylinder timber, j. cylinder cradles, k. cylinder timber braces, l. stanchion locations, m. hog chain brace locations, n. bilge hatch, o. stern hatches, p. guard periphery, q. forward port hatch edges, r. ash trap door, s. ash trough, t. fire brick on ash trough, u. ash pan, v. mud drum, w. steam drum, x. boiler flooring, y. paddle wheel flanges, z. hog chain grommets, aa. hand pump, bb. quarter-round moulding, cc. sharpening wheels (cargo), dd. scantling and hatch cover, ee. spare buckets (?), ff. stern posts, gg. wing rudders.

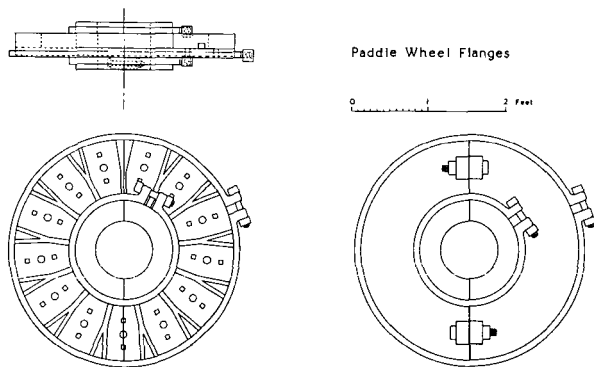
**Figure 30.** Spare paddle wheel flanges found on deck near the boiler area. The parts show evidence that the *Bertrand* stern wheel consisted of 13 arms and buckets. End view at top, left; view to outside of flange, left; to inside of flange, right.

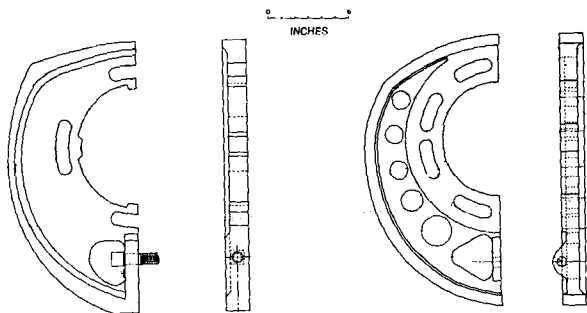
**Figure 31.** Full stroke (left) and exhaust cams found near the stern during excavation. The eccentrics were constructed in halves, just as depicted, for easy adjustment and replacement.

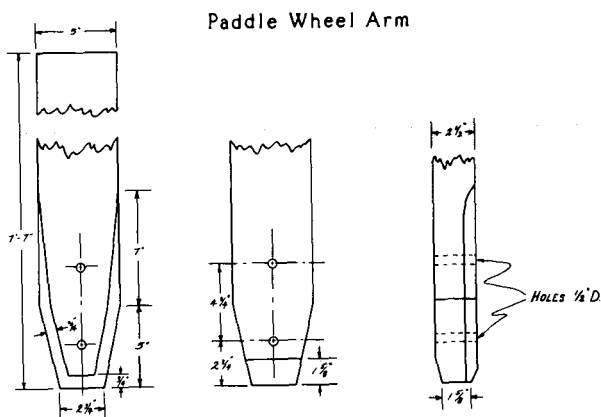
**Figure 32.** Paddle wheel arm found on deck near stern. With spare flanges (fig. 30) the part allows a reasonably accurate reconstruction of the paddle wheel.

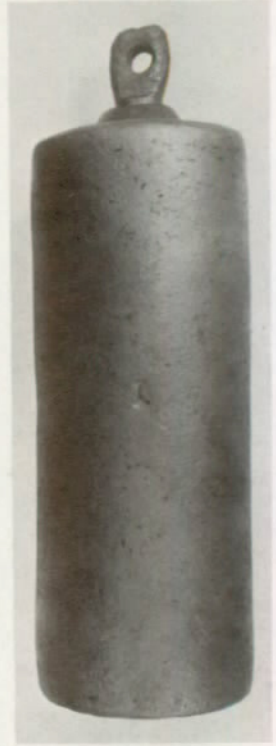
**Figure 68.** One of the nine containers of mercury found in the forward holds of the *Bertrand*. The wrought iron vessels contained the standard 76 pounds of mercury each.

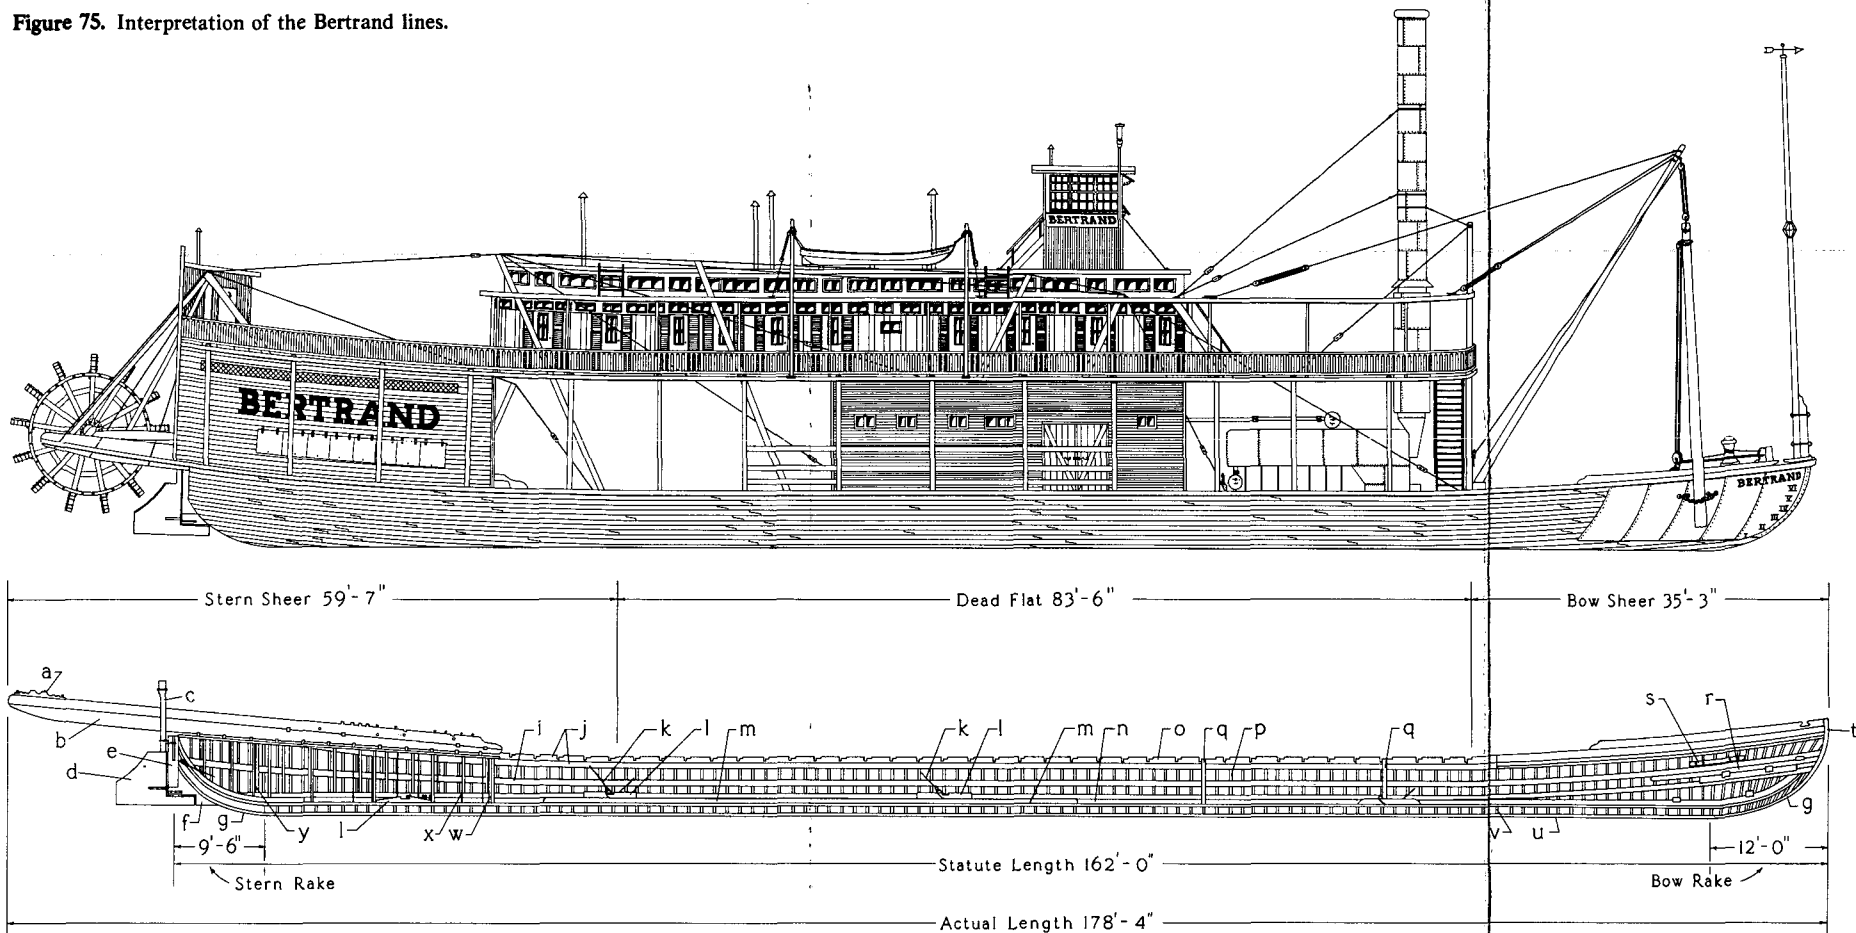
Figure 77. Longitudinal section; view depicting sheer of vessel and major structural members from main (central) keelson outboard, port side. a. pillow block (lower section), b. cylinder timber, c. upper rudder assembly, d. balance (master) rudder, e. stern post, f. skeg, g. turn of bilge (stern), h. deck beams, i. side strakes, j. top wale strakes (clamp), k. hog chains, l. footlings, m. side keelson, n. main (central) keelson, o. rabbets for deck beams and outriggers, p. side rib, q. boiler stanchions, r. yoke assembly, s. spar chain strap (interior), t. stempiece, u. bottom planking, v. bottom ribs, w. cylinder stanchions, x. cylinder supporting rods, y. bulkhead (transverse).

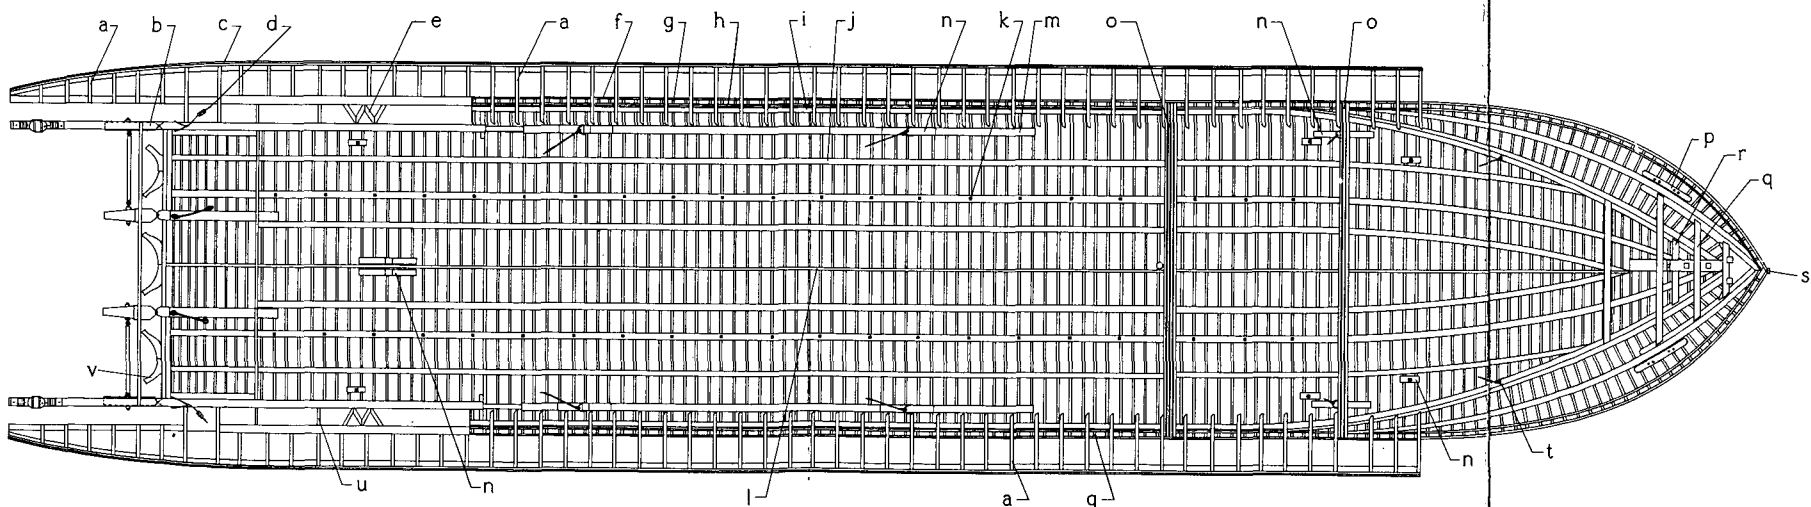
Figure 78. Plan of hull bottom; all decking and remnants of superstructure removed. a. outriggers, b. wing (slave) rudder, c. guard, d. hog chain, e. cylinder timber brace, f. side planking, g. side ribs, h. top wale strake (clamp), i. bilge keelson, j. floor strakes, k. deck stanchion positions, l. main keelson, m. side keelson, n. footling, o. boiler beams, p. spar chain strap (interior), q. upper yoke assembly, r. lower yoke assembly, s. stempiece, t. hog chains, u. cylinder cradles, v. rudder stops.

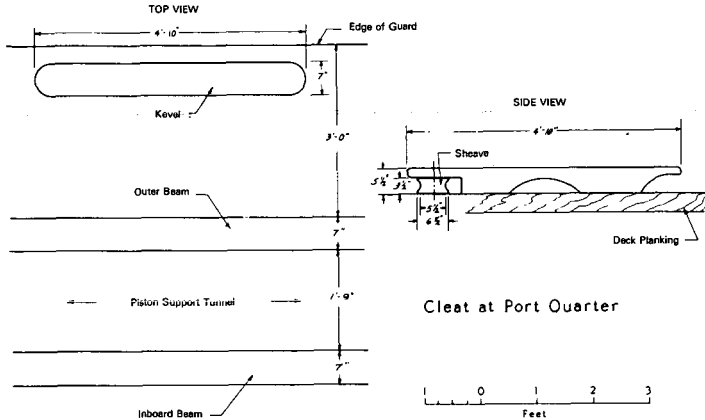
**Figure 80.** Rendering of kevel, situated on guard at sternmost port quarter.

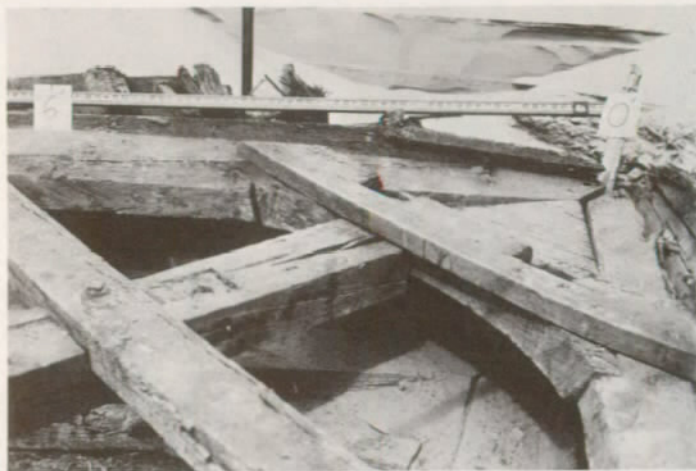
**Figure 81.** Yoke assembly in the extreme portion of bow. The two notches cut into the crosspiece of this upper yoke assembly are set to receive the timberhead which extended through the deck. Note also the frayed tops of the side ribs which had been chopped and snapped off in early salvage attempts.

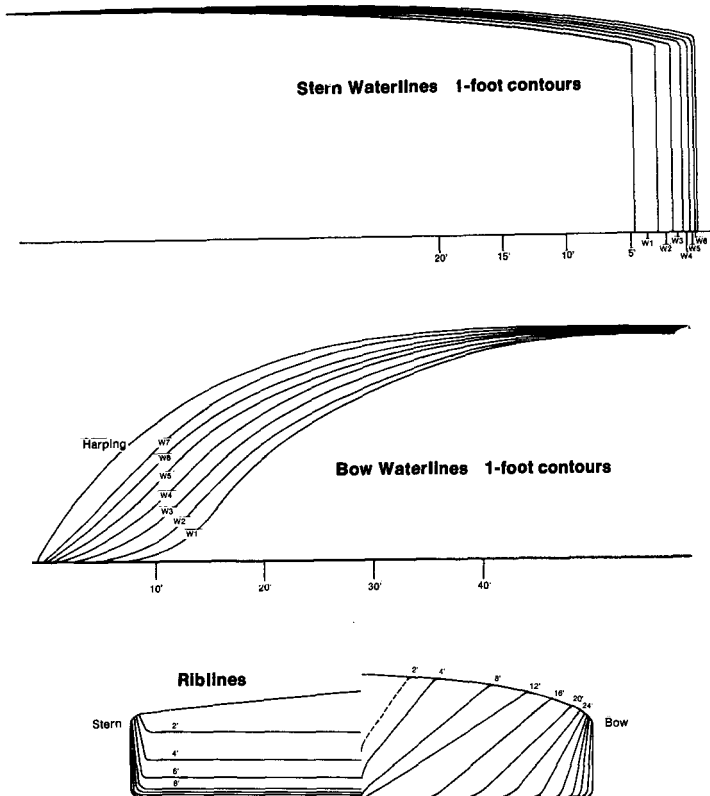
**Figure 82.** The *Bertrand*'s waterlines and riblines.

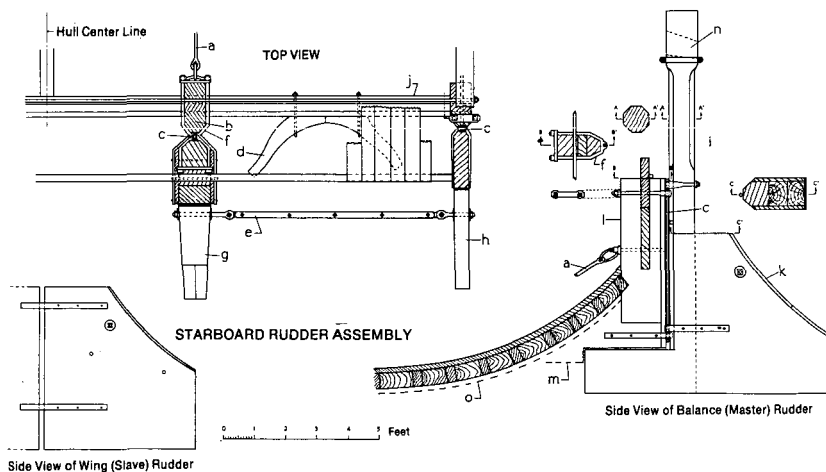
**Figure 83.** Starboard rudder assembly, top and side views. The balance (master) rudder on each side extends slightly under both the stern rake of the hull and the former position of the paddle wheel; a. hog chain and its heel, b. stern post, c. pintle, d. rudder stops, e. rudder articulating arm, f. hinges, g. lower (balance) rudder assembly, h. wing (slave) rudder, i. upper (balance) rudder assembly, j. false transom, k. wheel arc, l. stern post, m. skeg, n. tiller bar socket, o. stern rake.

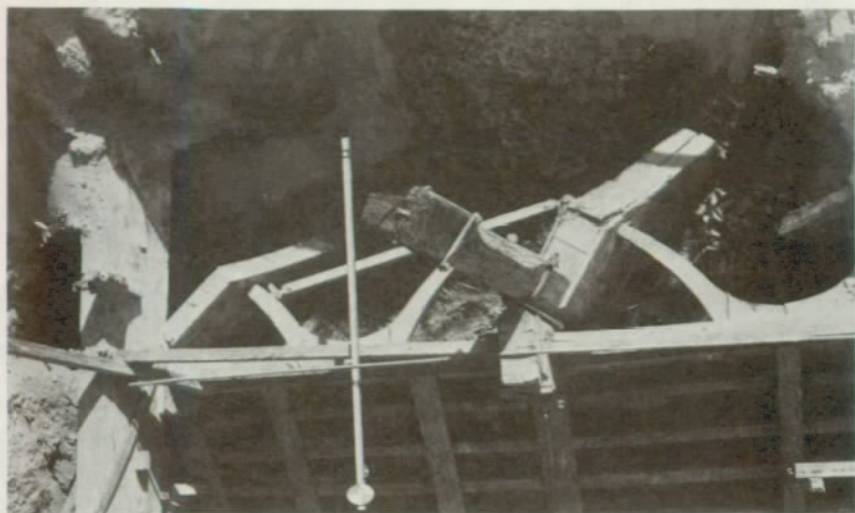
**Figure 84.** Top view of rudder assembly, starboard side. Note the articulating arm connecting the master and slave rudders which are jammed against the 90-degree stops.

logs and other wood debris. The boat was aligned at a bearing of 4 degrees (magnetic) and, on the basis of the 1867 Corps' sketch map, appears to have been headed directly upstream when it swamped and struck bottom. While the actual depth of the channel at the time of sinking is not known, the mapper on the steamer *Miner* in 1867 indicated a sounding of 7½ feet immediately upstream from the heavy concentration of snags in Section 23 (fig. 16). While we cannot be certain whether Captain Yore had taken evasive action to avoid the snags, it was noted during excavation that the rudders were in a hard port position, jammed against the 90-degree stops.

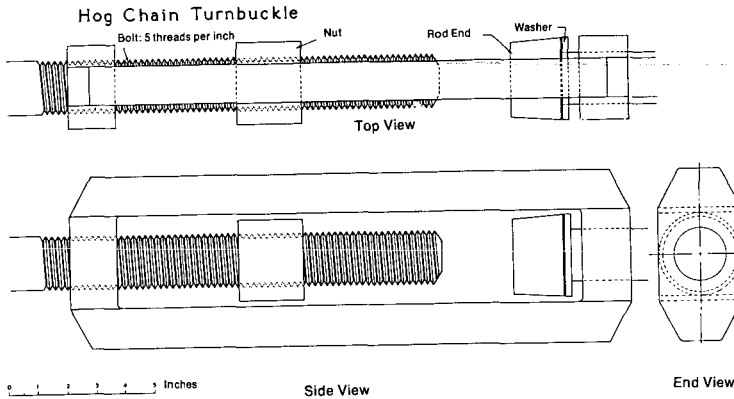
**Figure 85.** Detail of typical turnbuckle used to tighten hog chains.

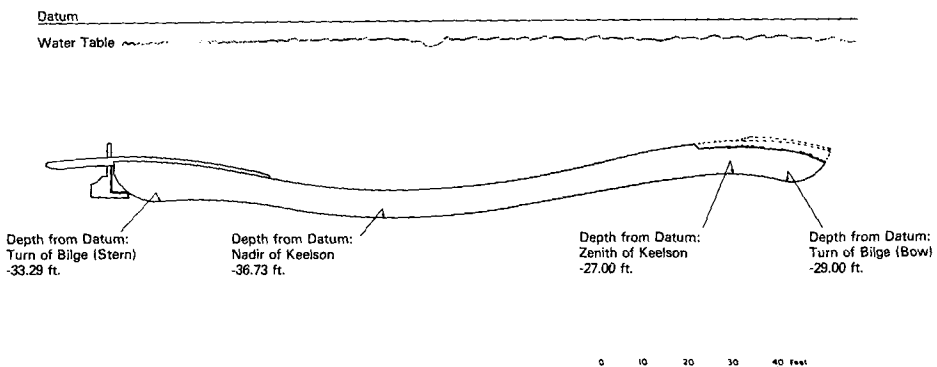
**Figure 89.** Conformity of *Bertrand* and its relationship to level of datum and the water table.

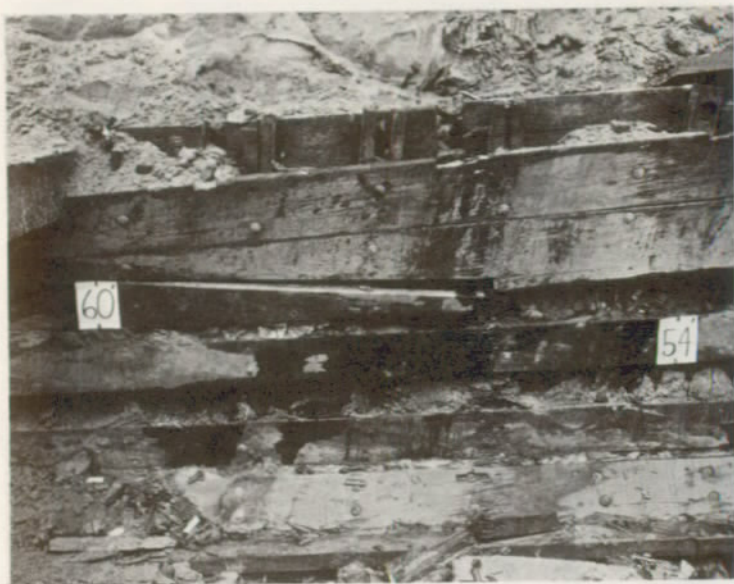
**Figure 90.** Side view (to port) of interior of hull, 59 feet to rear of stem-piece. Note futtock or "cocked hat" at bottom of photograph set at 45 degree angle. The notches cut in the side ribs (top) are set to receive deck beams and outriggers. The scarf joint of the interior supporting strake to the right of the paper tag numbered 60 has collapsed.

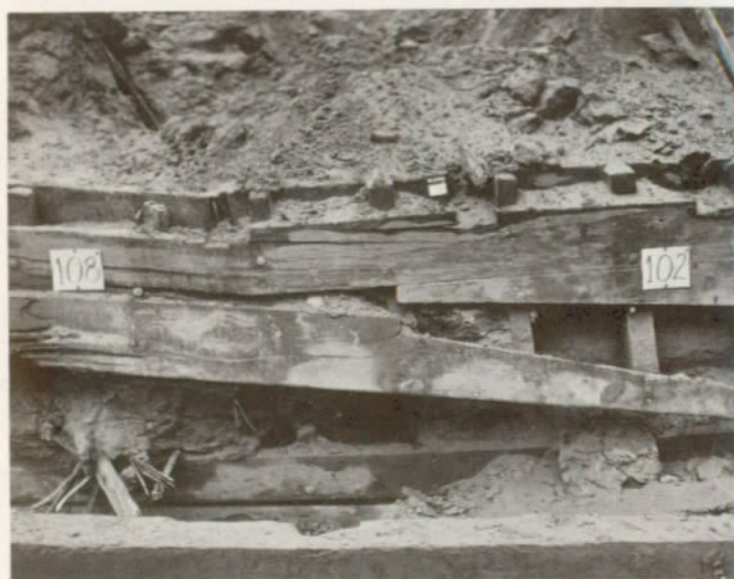
**Figure 91.** Side view (to port) of interior of hull, 105 feet to rear of stem-piece. Note collapse of scarf joint of interior supporting strake, a major structural component.

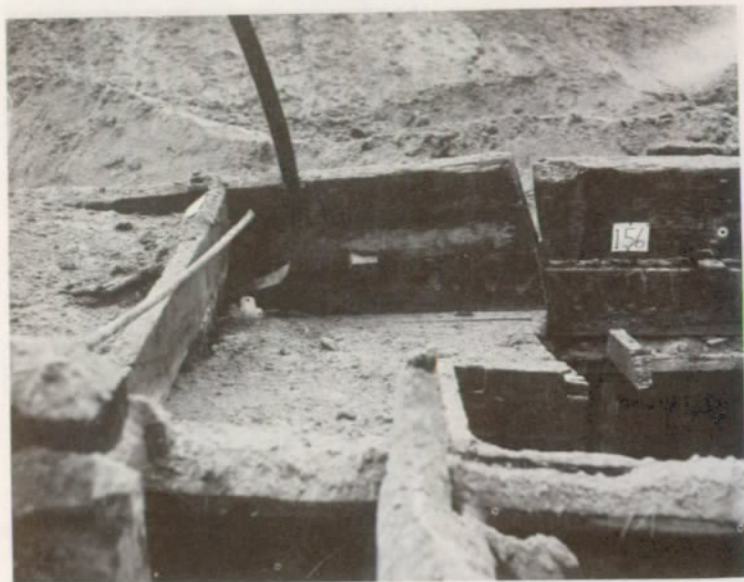
**Figure 92.** Activity of the early day salvors can be seen in this photograph of the inner cylinder timber, port side. Note the cut made by the saw which nearly truncated the huge timber and sliced into the bilge hatch at right-center. The remarkable aspect of this feat is the probability that it was accomplished under water, with crude diving equipment.

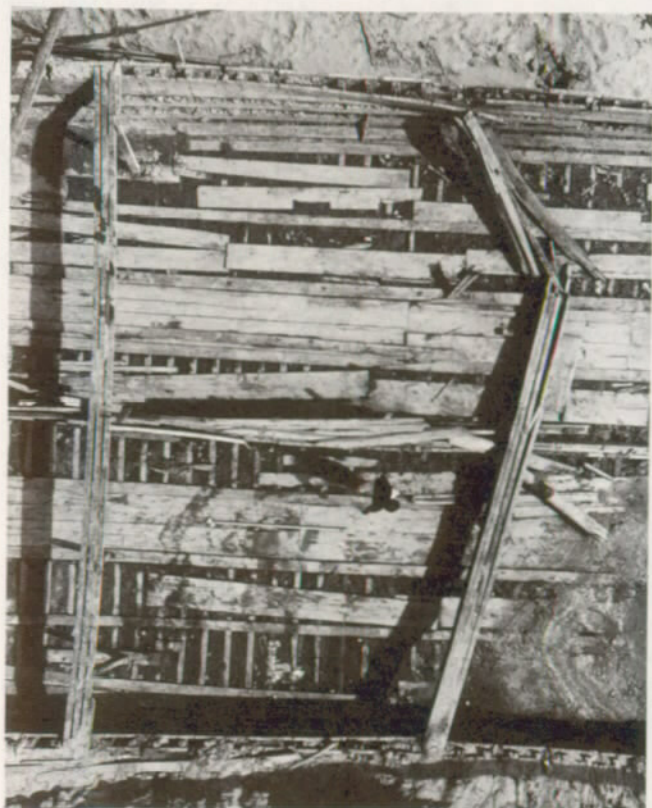
**Figure 93.** Top view of hull bottom, cargo removed, at a point directly over the boiler area. The forward boiler beams have collapsed.

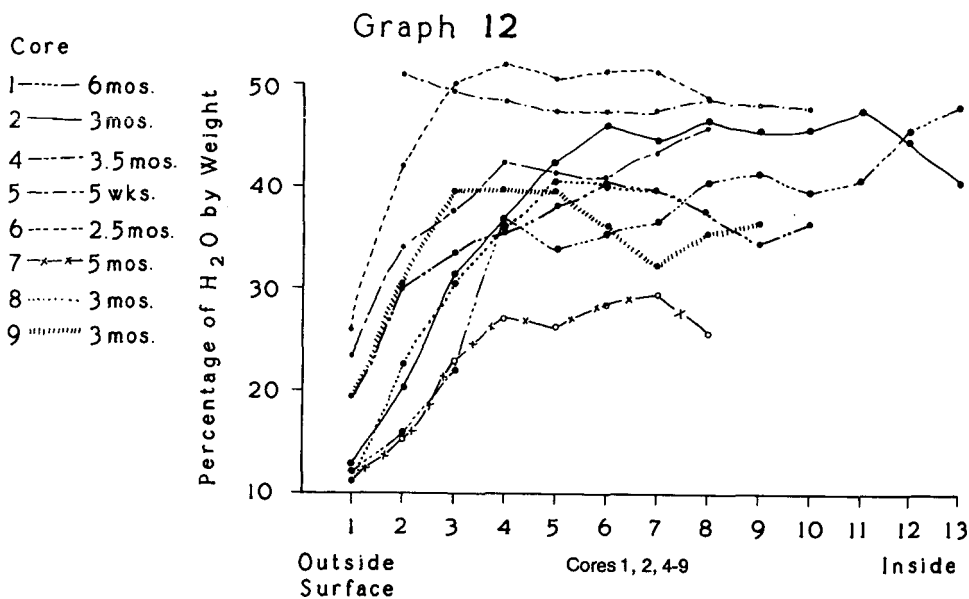
Figure 98. Percentage of water in the B core series, Cores 1, 2, 4-9.

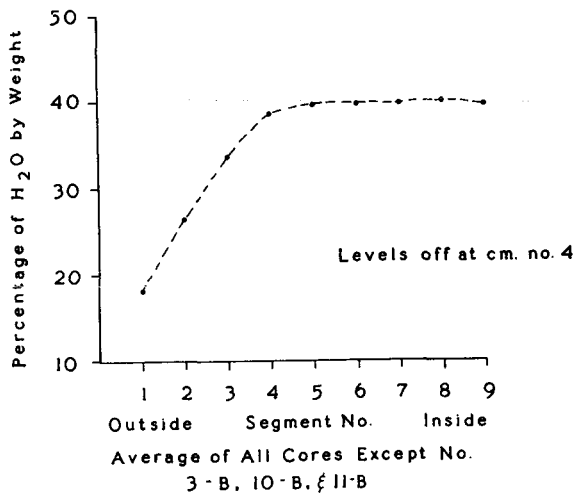
**Figure 99.** Percentage of water, B core series; average of all cores with the exception of numbers 3, 10, and 11.
