Carl Sandburg Home National Historic Site
Connemara Main House
Historic Structure Report

September 2005

Historical Architecture, Cultural Resources Division

National Park Service

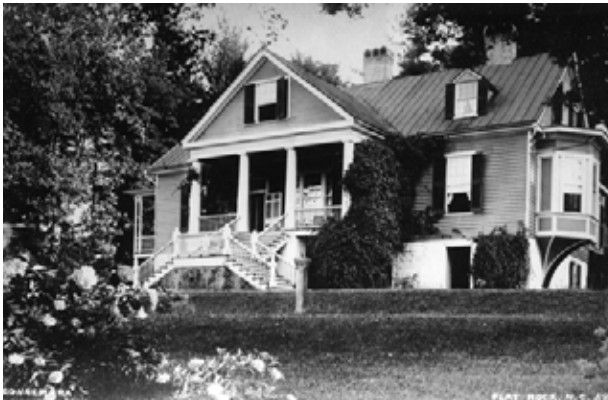
FIGURE 73. View of Connemara, perhaps around 1915, showing bay window added at west end of Main House in the 1890s. (Photograph by Baker Barber, CARL3001/01/06P)

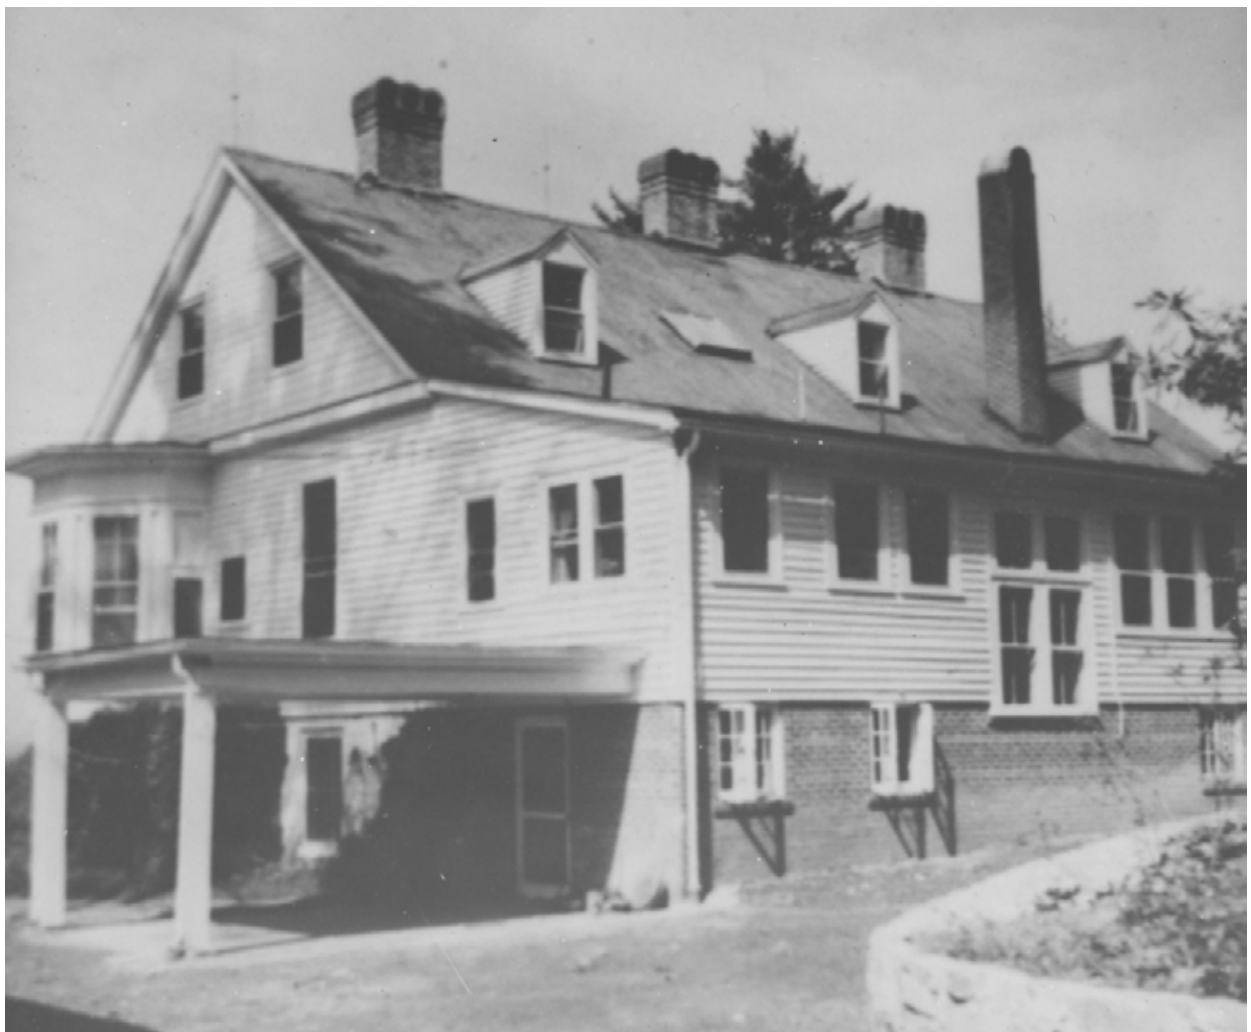
FIGURE 85. View of rear and west end of house in 1946 or early 1947. Aga stove chimney had not yet been built and the foundation remains unpainted. (CARL3000/15/26P)

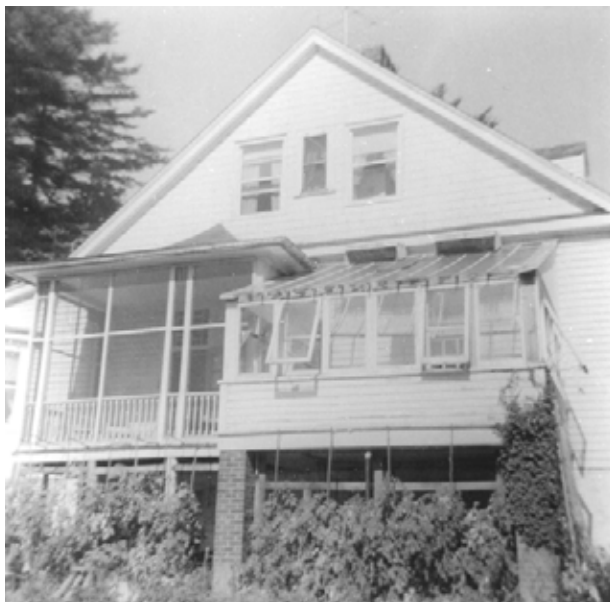
FIGURE 87. View of East Porch and Conservatory, showing window added in east gable for new bathroom on second floor. (CARL3000/15/28P)

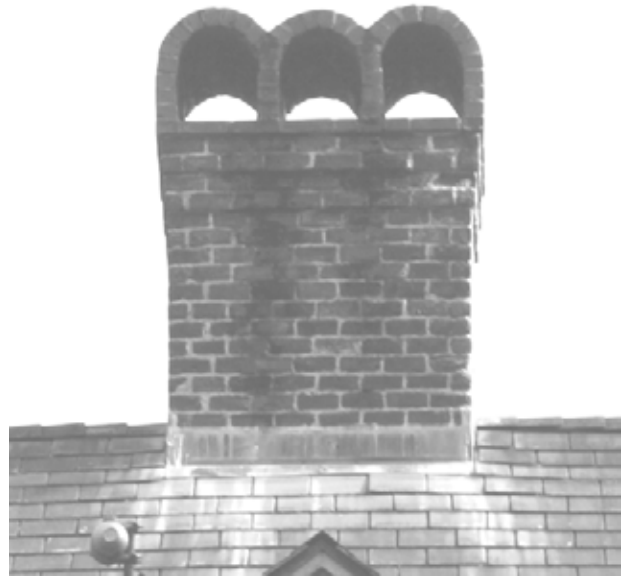
FIGURE 107. View of center chimney, as reconstructed in 1983. (T. Jones, NPS-SERO-CR, 2004)

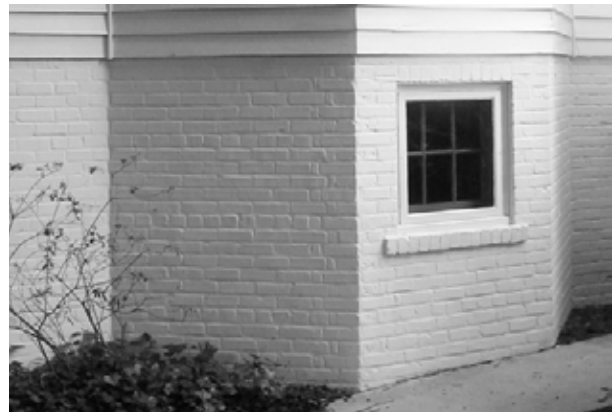
FIGURE 108. View of foundation at east end of 1920s rear addition. (T. Jones, NPS-SERO-CR, 2004)

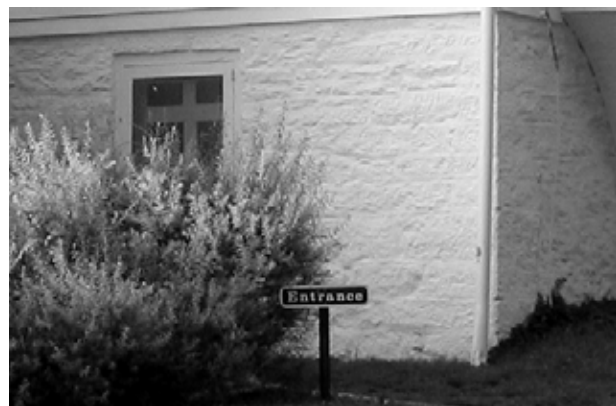
FIGURE 109. View of foundation at northwest corner of original house. (T. Jones, NPS-SERO-CR, 2004)

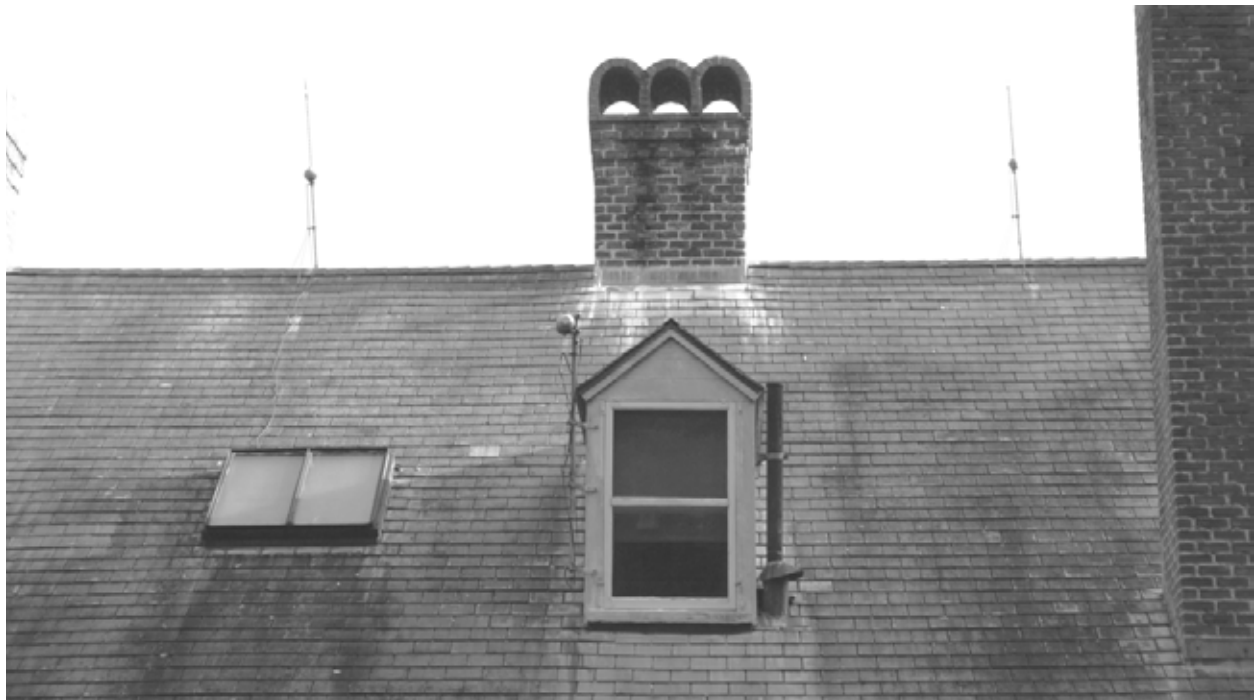
FIGURE 117. View of rear (south) shed of main roof, showing skylight, lightning rods, and typical dormer. (T. Jones, NPS-SERO-CR, 2004)

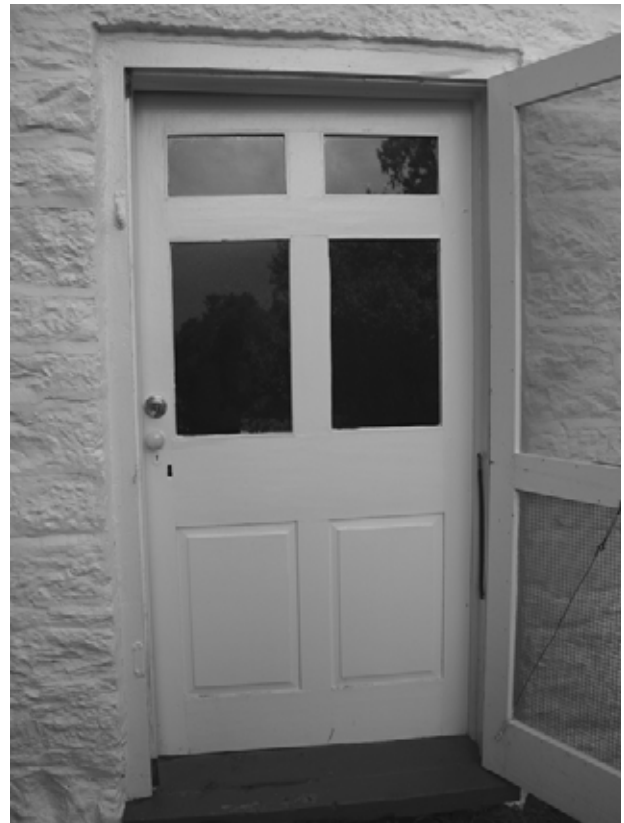
FIGURE 124. View of Door D-1, one of the house's original doors (c. 1838), altered by the Sandburgs in 1945. (T. Jones, NPS-SERO-CR, 2004)

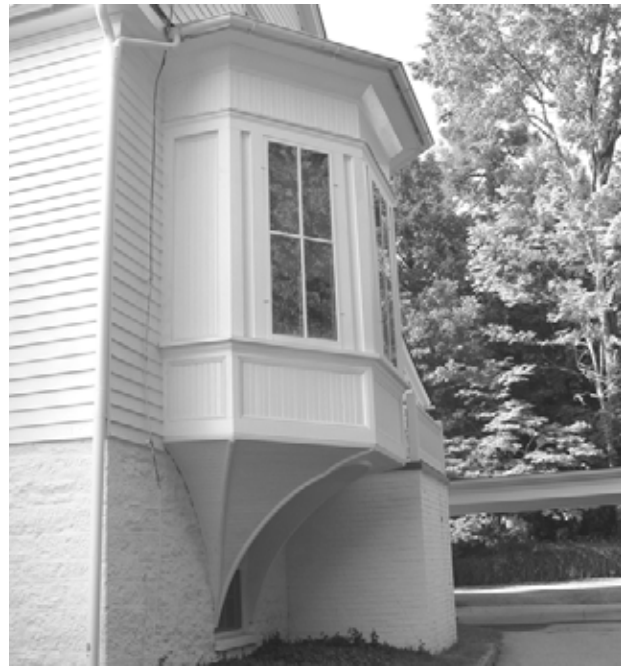
FIGURE 128. View of west bay window.(T. Jones, NPS-SERO-CR, 2004)

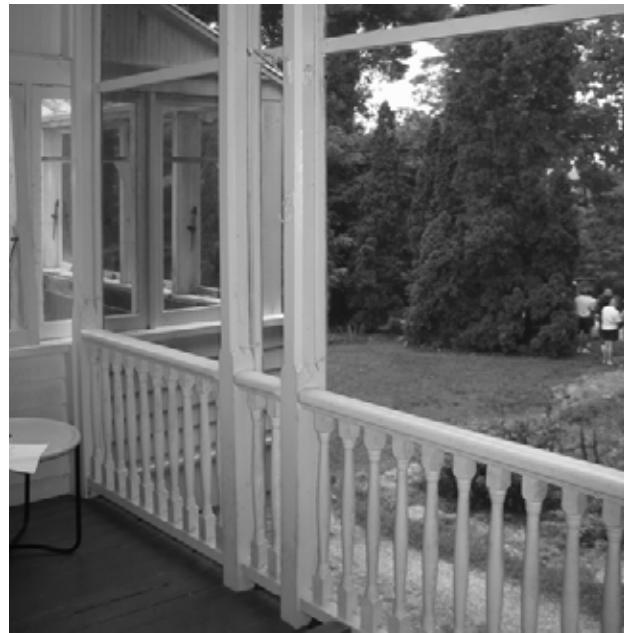
FIGURE 134. View of original posts and balustrades (c. 1890) on East Porch..(T. Jones, NPS-SERO-CR, 2004)

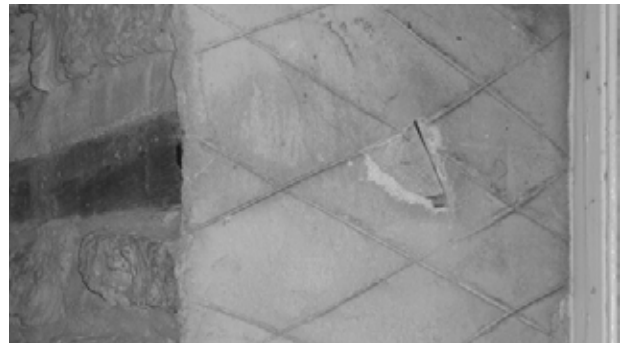
FIGURE 145. View of west jamb of Door D-1. Left of center is part of the wooden nailer inset into the masonry. (T. Jones, NPS-SERO-CR, 2004)

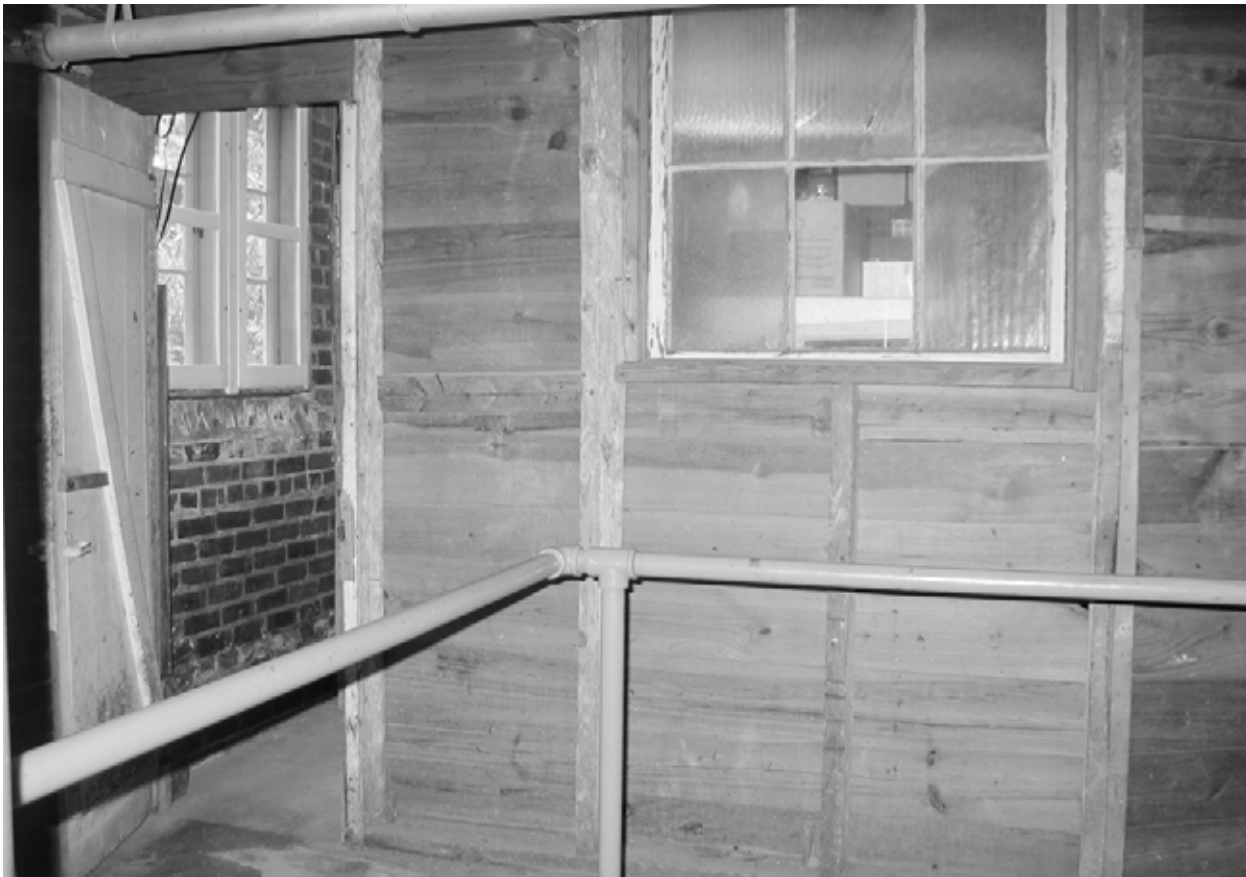
FIGURE 157. View southwest into Room 012. Window sash was probably salvaged by the Sandburgs when they demolished Smyth’s master bathroom where the west Porch is now located (T. Jones, NPS-SERO-CR, 2004)

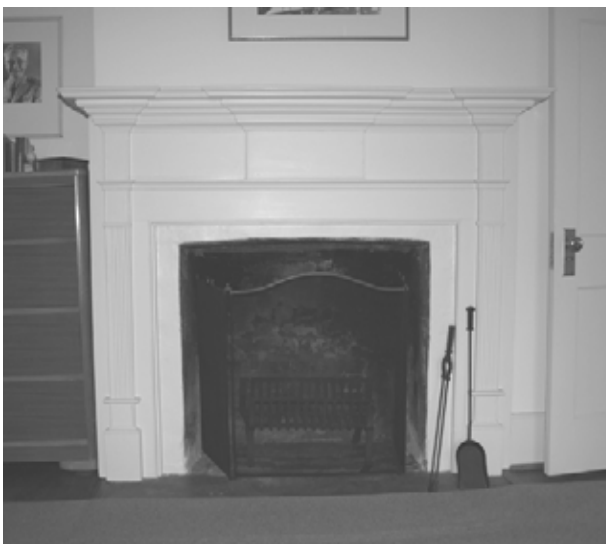
FIGURE 169. View of mantel in Mrs. Sandburg's Bedroom (121). A similar mantel was removed from the house, probably from Room 113 or 118, and is now stored in the wood shed. (T. Jones, NPS-SERO-CR, 2004)

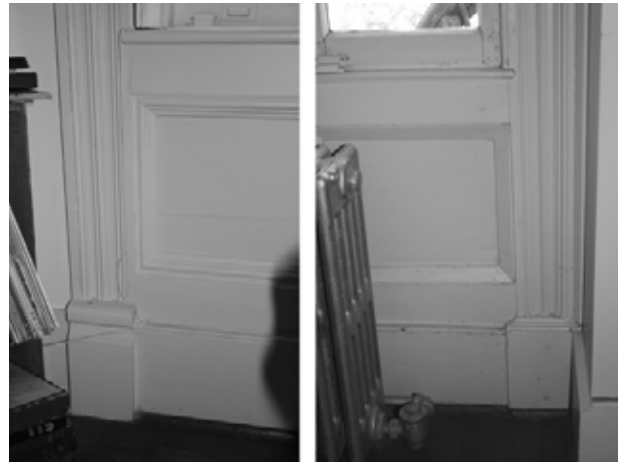
FIGURE 170. View of original window panels, right, and panels added c. 1890, left.(T. Jones, NPS-SERO-CR, 2004)

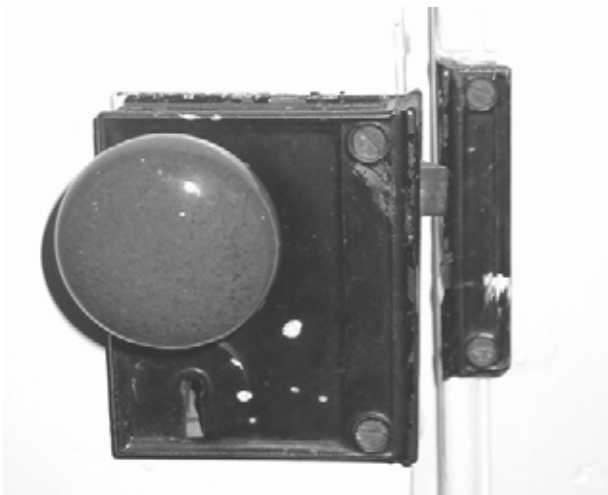
FIGURE 199. View of typical late-nineteenth century rim lock in Sandburg's Study (201). (T. Jones, NPS-SERO-CR, 2004)

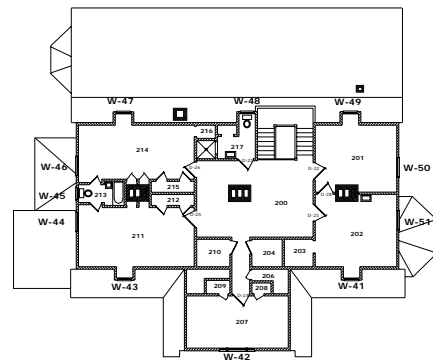
Repair to working order windows W-41, W-42, W-43, W-45, W-47, W-48, W-49

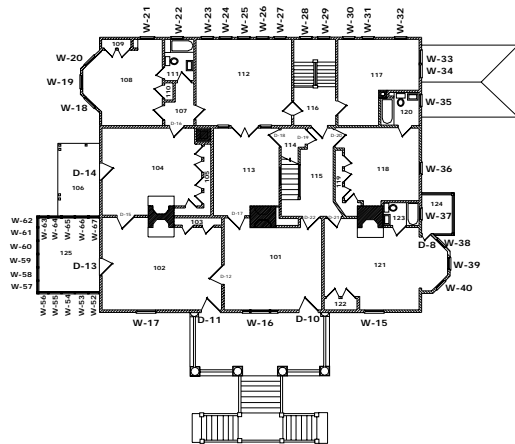
Repair to working order all doors as well as windows W-15, W-18, W-20, W-21, W-22, W-24, W-26, W-28, W-29, W-30 through W-34, W-35, W-36, W-37, W-53, W-55, W-58, W-62, W-65 through W-67

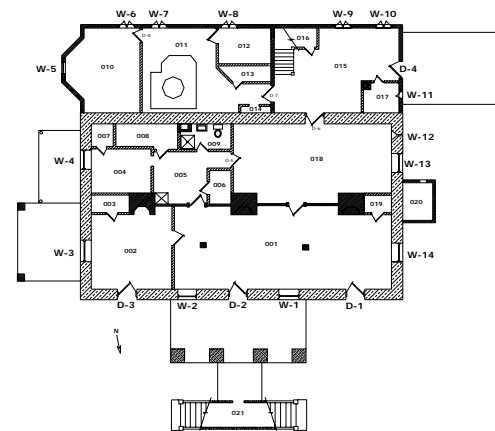
Repair to working order all doors as well as windows W-3, W-4, W-6, W-7, W-8, W-9, W-10, W-14
