Herbert Hoover National Historic Site Cultural Landscape Report

National Park Service

Midwest Region Omaha, Nebraska

September 1995

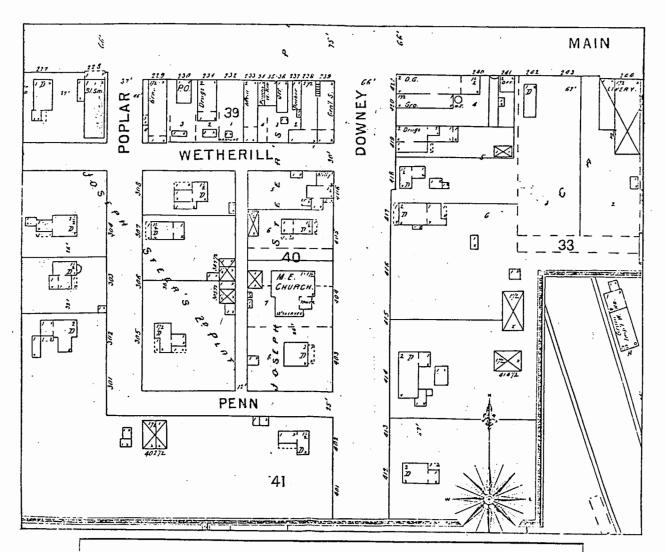
SANBORN MAP 1895 HOOVER HOMESITE, WEST BRANCH, IOWA

Map B. Sanborn Map, Hoover Homesite, West Branch, Iowa, 1895.

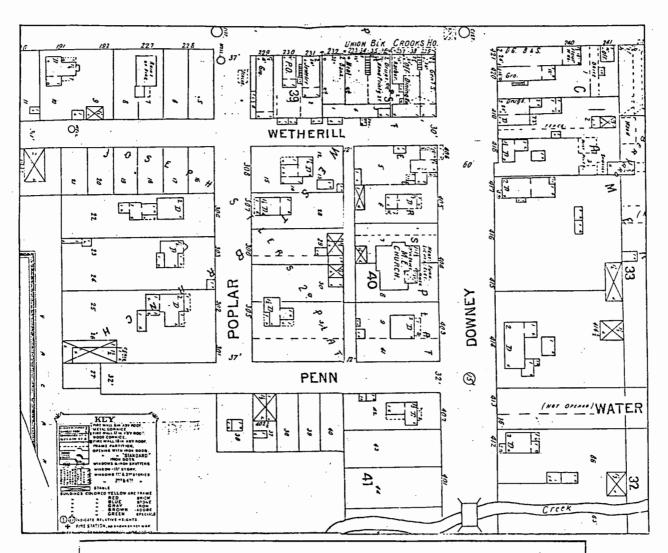
SANBORN MAP 1900 HOOVER HOMESITE, WEST BRANCH, IOWA

Map C. Sanborn Map, Hoover Homesite, West Branch, Iowa, 1900.

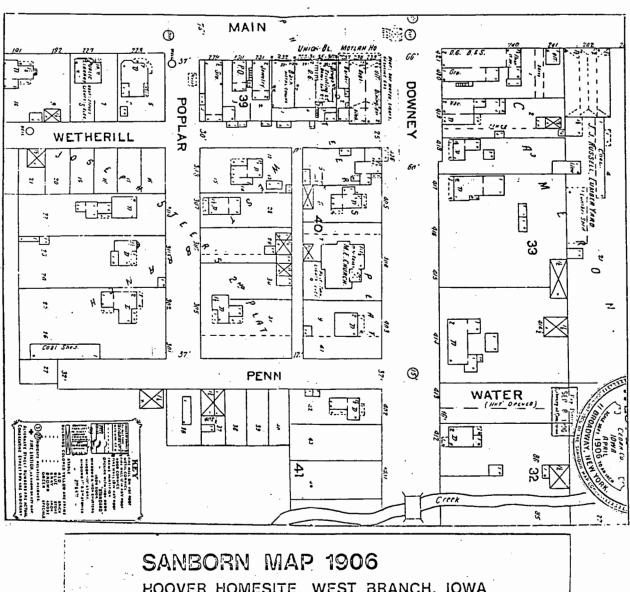
HOOVER HOMESITE, WEST BRANCH, IOWA

Map D. Sanborn Map, Hoover Homesite, West Branch, Iowa, 1906.

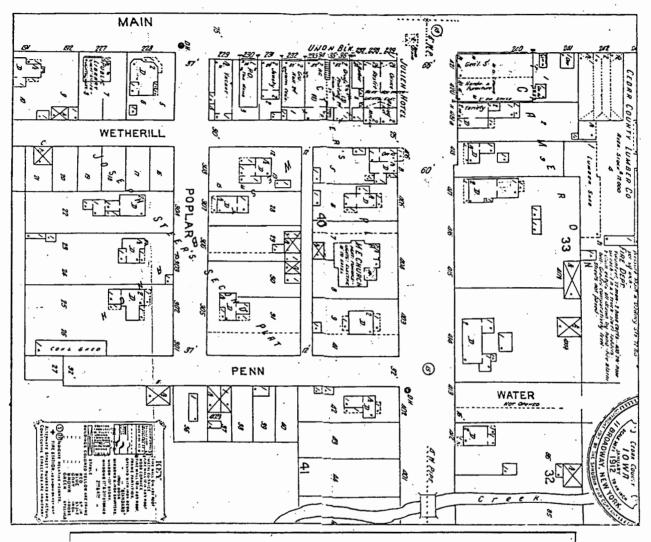
SANBORN MAP 1912 HOOVER HOMESITE, WEST BRANCH, IOWA

Map E. Sanborn Map, Hoover Homesite, West Branch, Iowa, 1912.

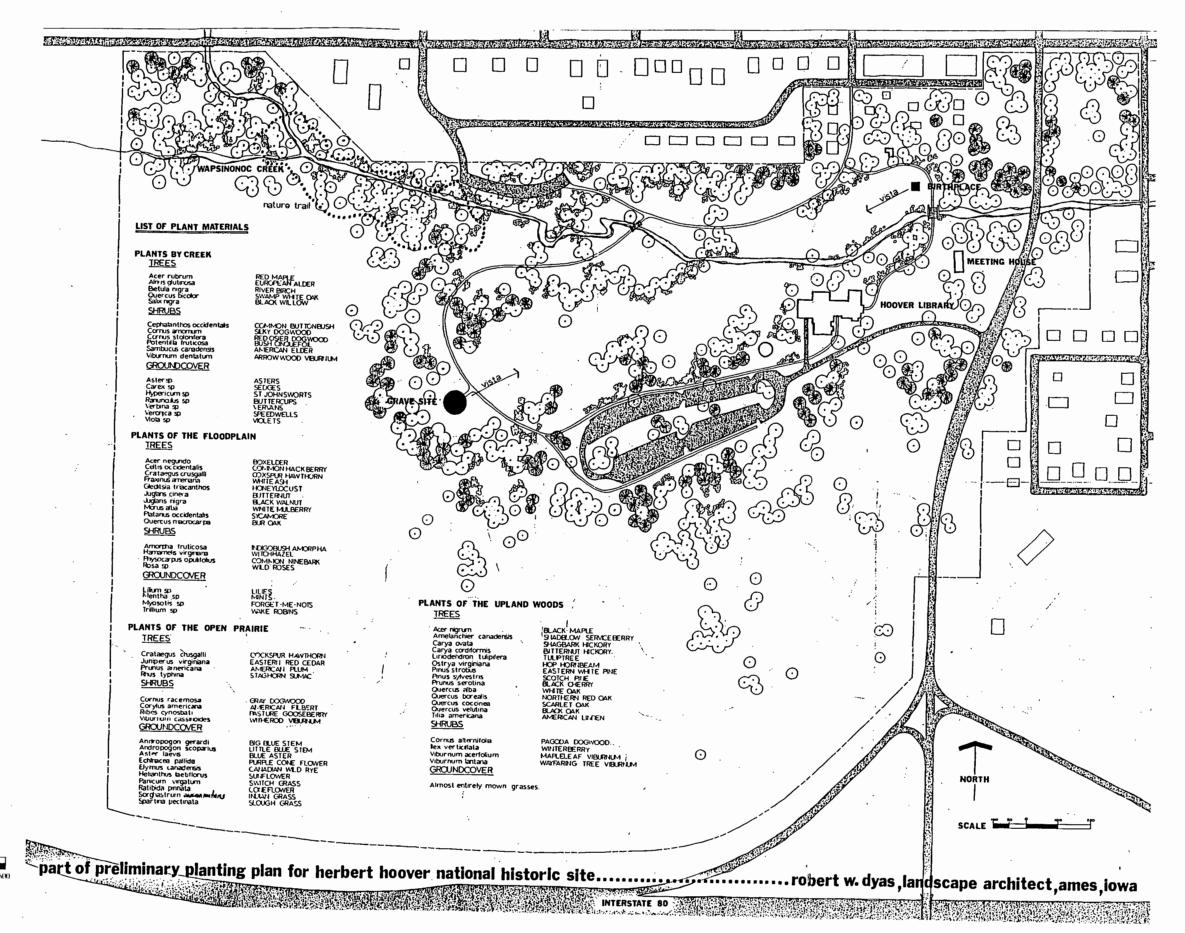
Map M. "Part of Preliminary Planting Plan for Herbert Hoover National Historic Site." Robert W. Dyas, 1968.

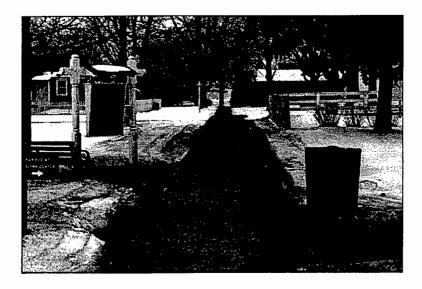
Figure 54. Brick sidewalk in the historic core area.

A number of streets that existed historically have been substantially altered or are no longer extant. Downey Street formerly served as the entrance road into West Branch from the south, but was rerouted and replaced by Parkside Drive in 1970. The road trace within the site that runs between the birthplace cottage, Quaker meetinghouse, and a number of the nineteenth-century residences follows the former alignment of Downey Street right-of-way (Figure 56). Water Street was an east-west street that is now the general location of various visitor walks south of the visitor center. Part of Water Street has been incorporated into the visitor parking lot at the visitor center. Penn Street was an east-west street that originally ran immediately north of the birthplace cottage. In 1956 it was rerouted eighty feet north of the present site of the blacksmith shop and was aligned approximately with the present site of the schoolhouse. The 1956 alignment of Penn Street is now a lawn. Poplar Street was a north-south street that occupied a site west of the current schoolhouse location and provided access to the western cluster of nineteenth-century residences. Cedar Street was an east-west street north of the P.T. Smith House that is also currently a lawn. Wetherell Street was a short east-west street in the neighborhood north of the birthplace cottage. It was extended to the west and east and that currently serves the contemporary residences north and west of the site and the visitor center.

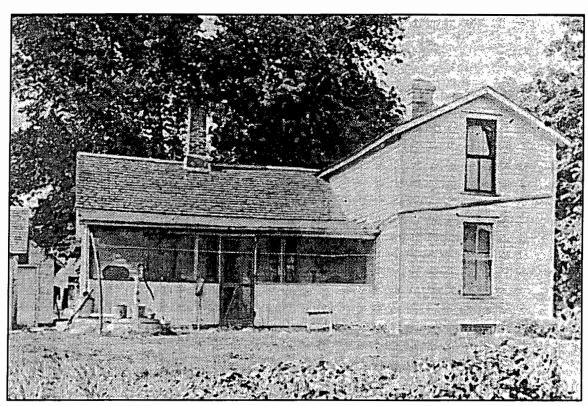
Figure 85. Birthplace cottage after being turned 90 degrees with Scellars' two-story addition, 1928.

During the late 1880s, R.P. and Jennie Scellars, the new owners of the birthplace cottage, replaced the maple tree west of the cottage with a stock barn and, in 1890, had the cottage turned 90 degrees and attached to a two-story house they had moved to the site (Figure 2).

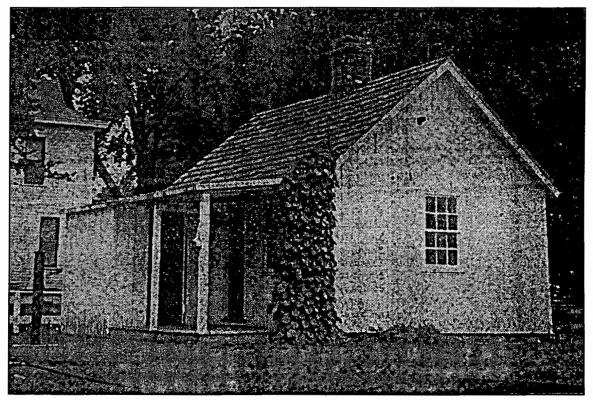
Figure 86. Birthplace cottage after restoration turned 90 degrees to its original orientation, 1939.

In 1938 Lou Henry Hoover had the Scellars' two-story house removed and returned the birthplace to its original orientation. Bruce McKay, the architect hired by the Hoovers to complete the project, oversaw the installation of a new foundation and a new roof on the birthplace cottage and the construction of a caretaker's cottage nearby (Figures 5,6). They had the caretaker's cottage stained dark brown to be unobtrusive in comparison with the white-painted birthplace cottage. Lou Henry Hoover played an integral part in each step of the process. In addition to supervising the restoration or construction of buildings on the site, she approved the re-grading and landscaping of the yard based on her research, the installation of the stone walkway leading from the cottage to the street, the design of the new wood fence around the cottage yard, and the planting of trees and ivy to screen the caretaker's cottage from view. Herbert Hoover seems to have been less interested in the project than his wife, at least initially. The June 17, 1937, edition of The West Branch Times quoted him, "This isn't my idea, but it would please Mrs. Hoover, who is the one who wants to have the old home restored."

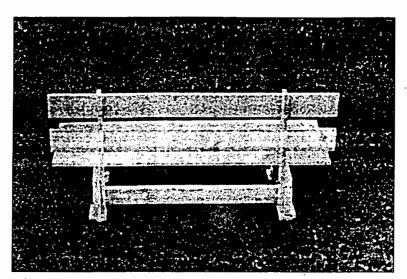
Figure 96. This simple wooden bench, shown in a detail from a c. 1964 photograph of the Herbert Hoover gravesite before construction (above right), may serve as a prototype for contemporary site furnishings that do not convey a historic appearance.

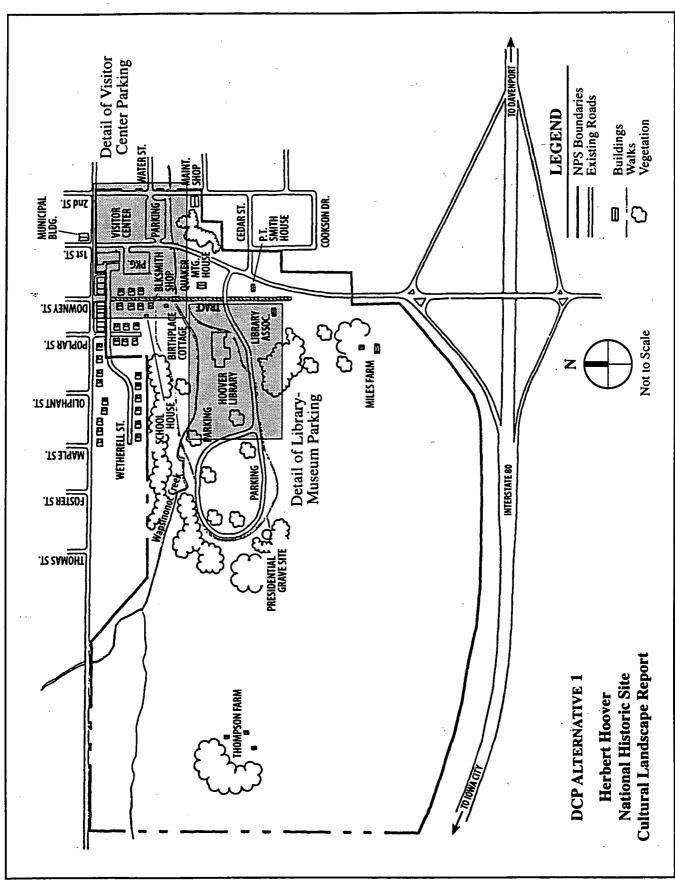
Exhibit 5. Expanded Parking at Library-Museum, DCP Alternative 1

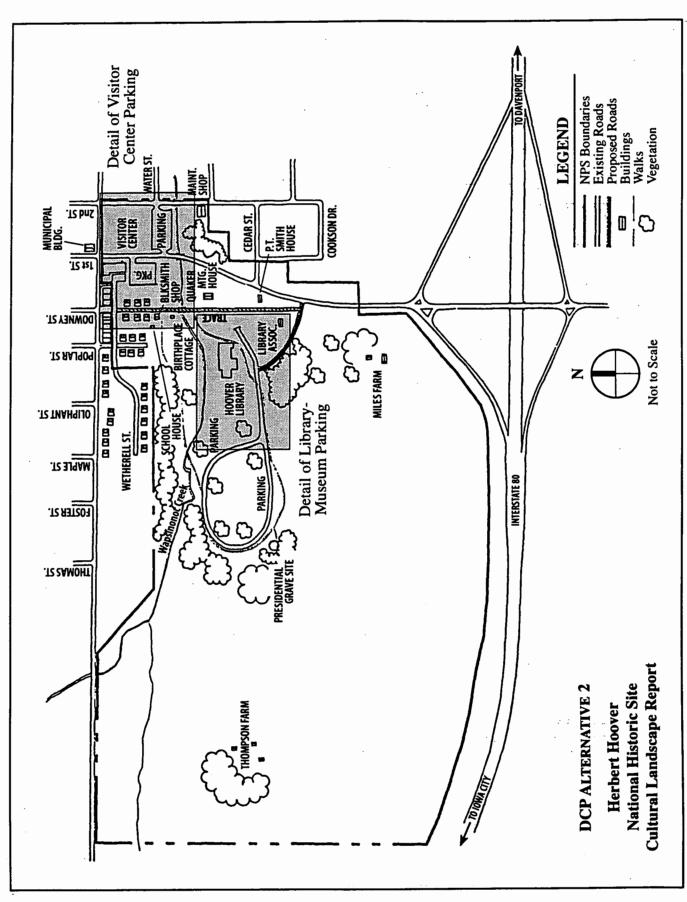
Exhibit 8. Expanded Parking at Library-Museum, DCP Alternative 2

- + A new entrance south of the Library Association Building would eliminate vehicular traffic crossing the Downey Street trace.
- + The entry would permit unification of the P.T. Smith house and the second Hoover house site landscapes with the landscape of the historic core as they were during the Hoover boyhood.
- The entry will require a reduction of the amount of vegetation and open space in the new entry location.
- Creating a new entrance south of the library association building will increase the vehicular presence in the vicinity of the library association building.
