Standards for Rehabilitation & Guidelines for Rehabilitating Cultural Landscapes

Standards for Rehabilitation

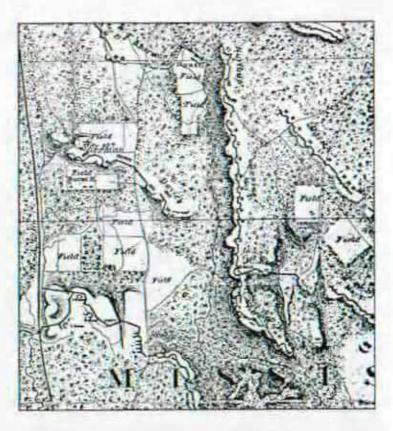
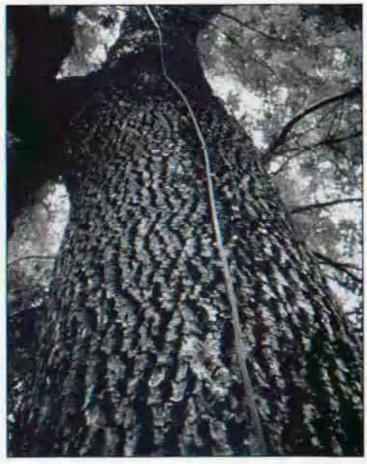
When evaluating the surviving spatial organization and lead patterns of beltefold lands foliay, it is recessary to understand historic documents, such as this map section flop right], prior to making management decisions. This documents the 1862 entrenchments lines and the routes foliosed by U.S. Forces under the Command of Union MG Halleck, in their advance on the Confederate stronghold of Corinth, Mississippi. (NPS archive). This century-old piak (opposite) from a Hiddeon river estate has been grounded for its protection with a significant good. (author, 1991).

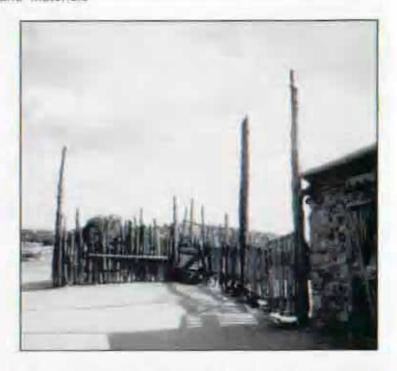
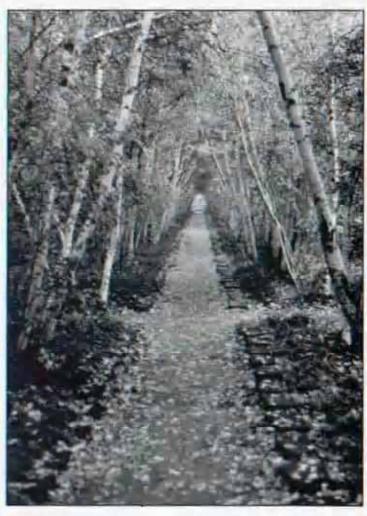
Traditional maintenance practices for the comal fences at the Hupbell Trading Post NFS frop oghly in Ganado, Arizona have preserved the integrity of the wooden tenoing and the dirt yards they define. This historic birch alive (opposite) at Sinn Hywer Hall. Airon, Olino, was suffering from borist infessation and leaf miner. Dying trees were topped and basis spouli growth encouraged. Trees were thinned, and when new growth matured, order truess were removed. Original rootstock and genetic material were preserved. This work took filtern years to maître. (without 1996, 1994)

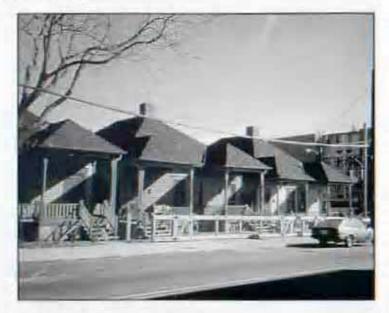
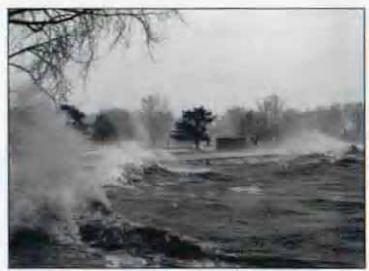
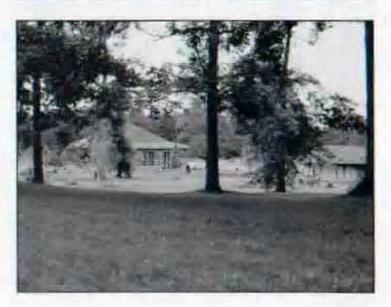
Where historic fences were lost, new replacement fences (top right) have been constructed based on historic photographs of nearby neighborhoods for the Mercin Luther King, Jr., National Historic Site, Atlanta Georgia (courtesy NPS) Historically, plant materials for the design of Perry's Victory and International Peace Memorial in Put-in-Bay, Ohio, Jointerf were ill-chosen for the severe conditions. The design for repassement hedges at this waterfront location should use a harder species than prignally planted (courtesy NPS). This former curousel in Genessee Valley Park, Rochester, New York, [opposite] has been re-used as a picnic shelter. The installation of a new restrictin facility has also been required by the heavy public use of the park. This design of the latter facility is ossarly new, but is inapired by earlier park shelfor dissign. (LANDSCAPES)

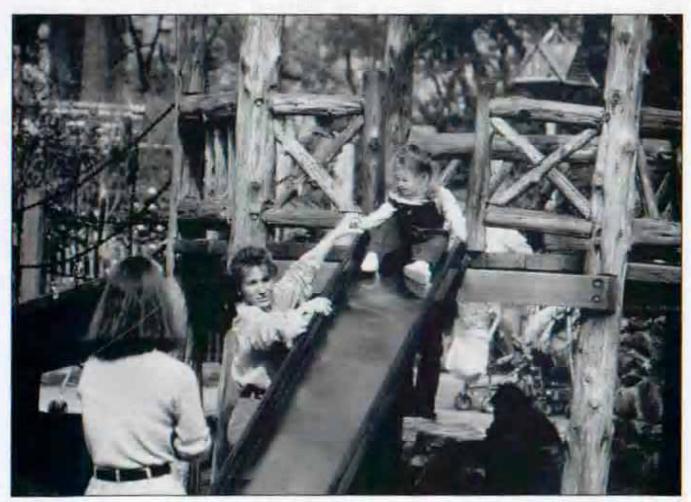
This Central Park payground had become deteriorated over time. Rather than replace the structures with standard apparatus from a catalog, the new play structures—mode of zuditional materials—are compatible with the park's historic character. (Central Plark Conservancy)

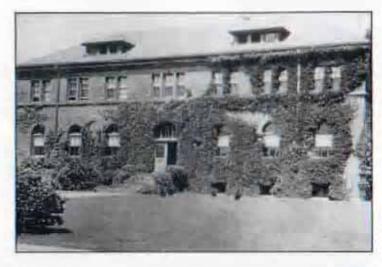
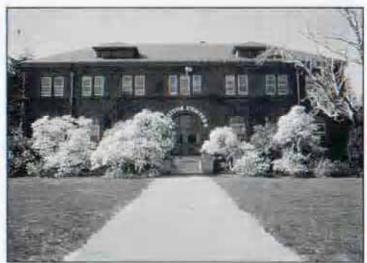
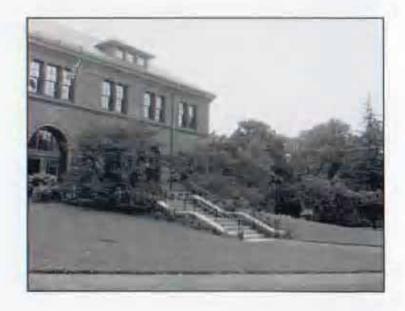
The Amoid Arbonotum's Hunneywell Visitor's Center in Jamaica Plain. Messachusetts was constructed in 1892. [top right] Its immediate setting has changed considerably over time. [center]. Since the existing landscape immediately surrounding the structure has little remaining integrity. The new accessibility solution has the latitude to integrate a broad program including site orientation, circulation, interpretation, and maintenance. The new planting design, references the original planting design principles, with a strong emphasis on form, color and furture. The new curvitinear walks also provide a connection to the larger arbonatum landscape for everyone. [opposite]
