Meridian Hill Park

Cultural Landscape Report

Volume 2: Treatment

National Park Service - National Capital Region
Contract # 1443X300094034
architrave, p.c. architects, Washington, D.C.

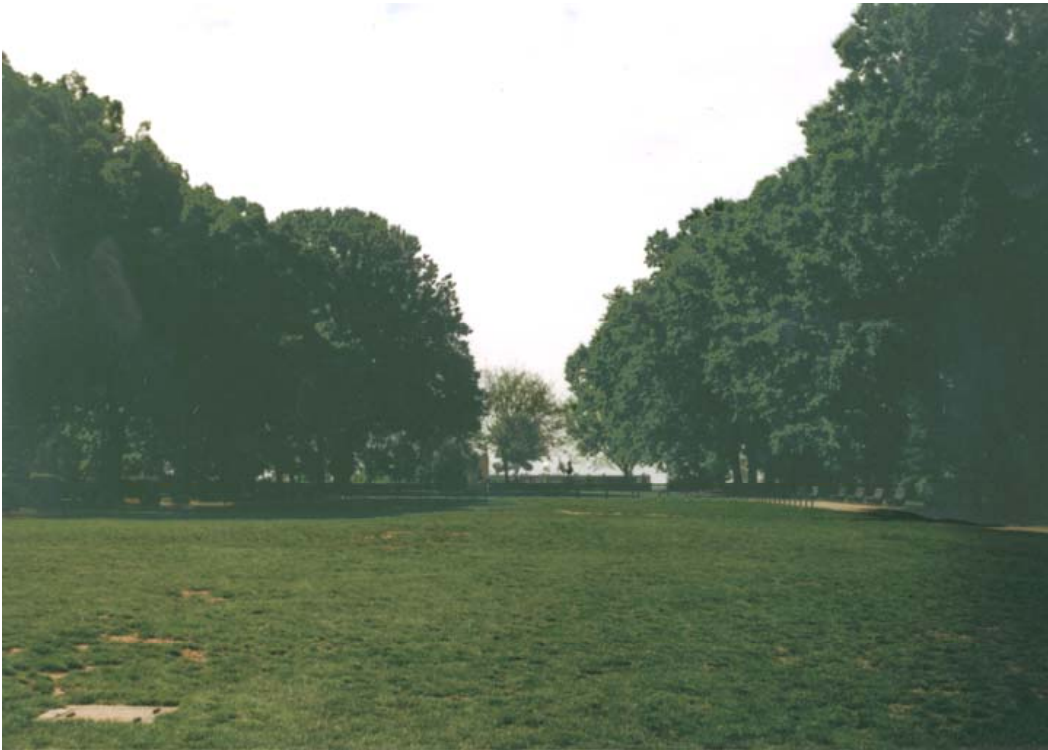
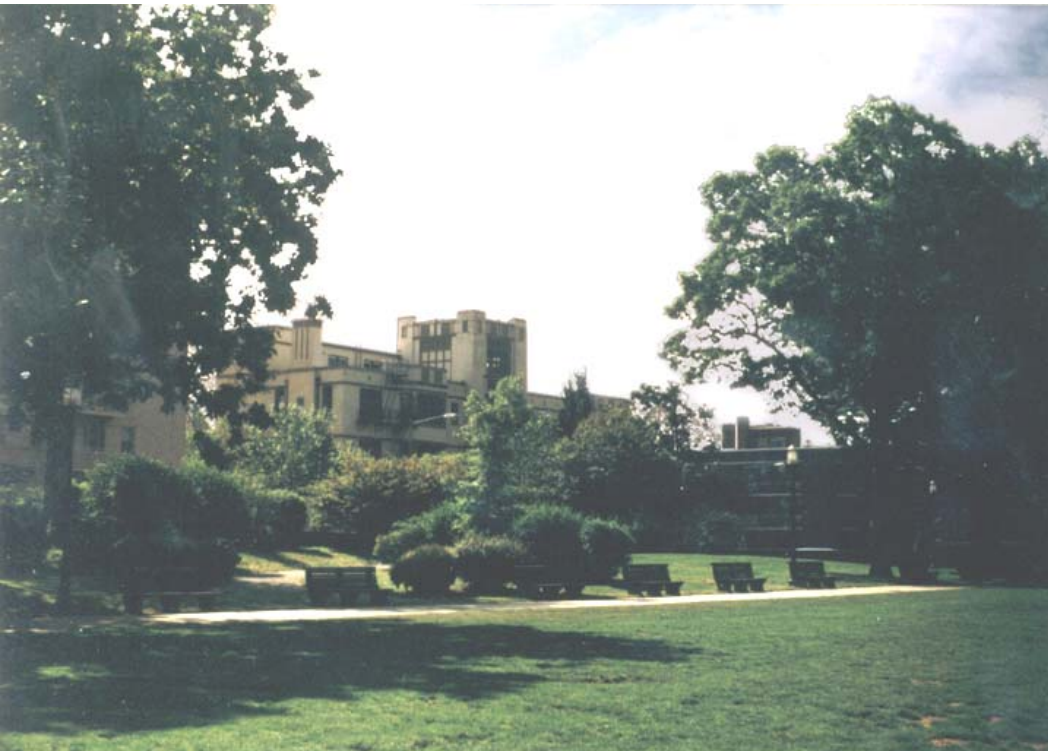
Above: This view south along the main axis of the park through the mall toward the great terrace overlook shows how effectively the mature oaks behind the mall walkways contain and define the mall space.

Below: However, as seen in this image, the loss of two of these mature trees leaves a substantial gap in that edge definition.

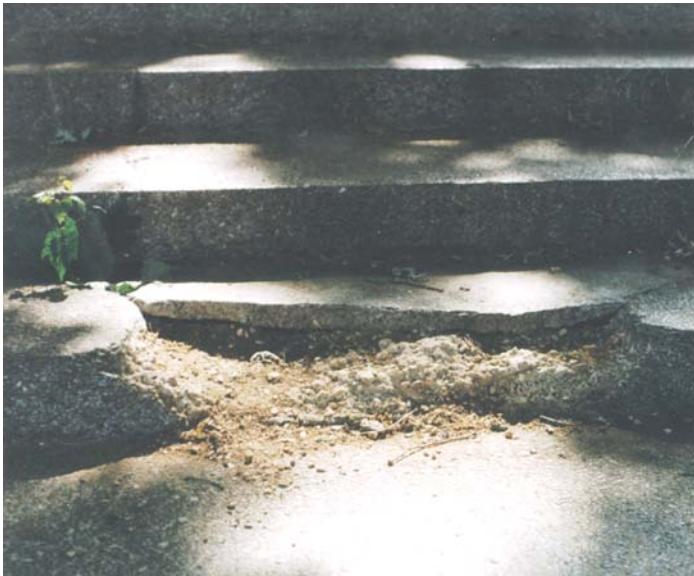
Below left: Corroboration that the method called for in the specifications for pouring pavement in two layers is provided in this picture of the deteriorated steps at the upper 16th Street entrance.

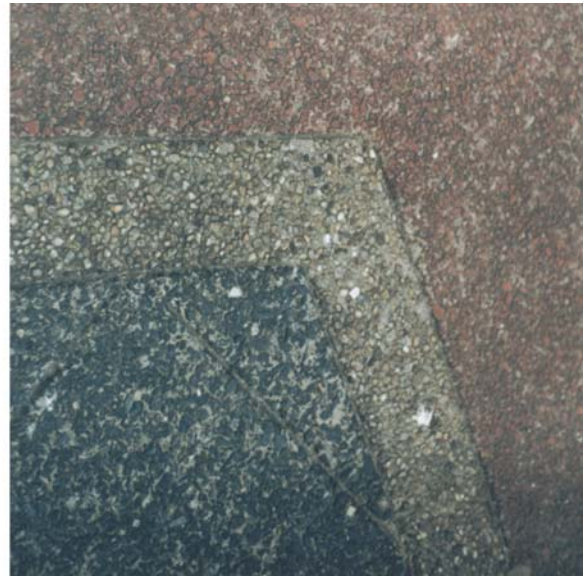
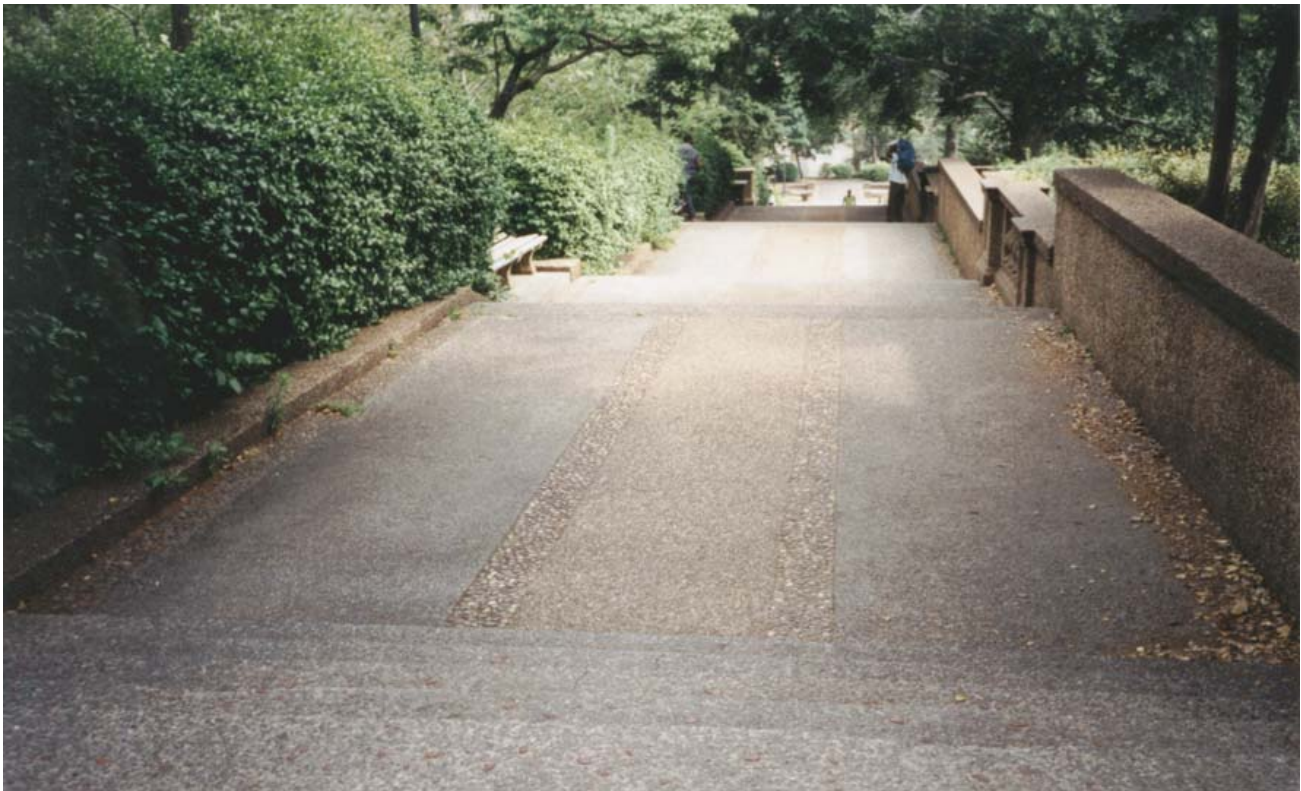
Above and above right: While the colors are not seen in these pictures, the tonal and textural differentiation created by polychromy in the concrete aggregate is nonetheless visible. It is critical that the colors and types of aggregates used in the historic concrete in the park be matched exactly in any new or repair concrete work.

The remarkable quality of the concrete in this park, including not only the highly ornamental work, the urns, water features, and patterned paving, but also the typical paving with its gradations and wall, requires a higher level of craft and expertise for repair and replacement in kind than is generally available. Therefore, this work should be done by specialists in work of this kind.

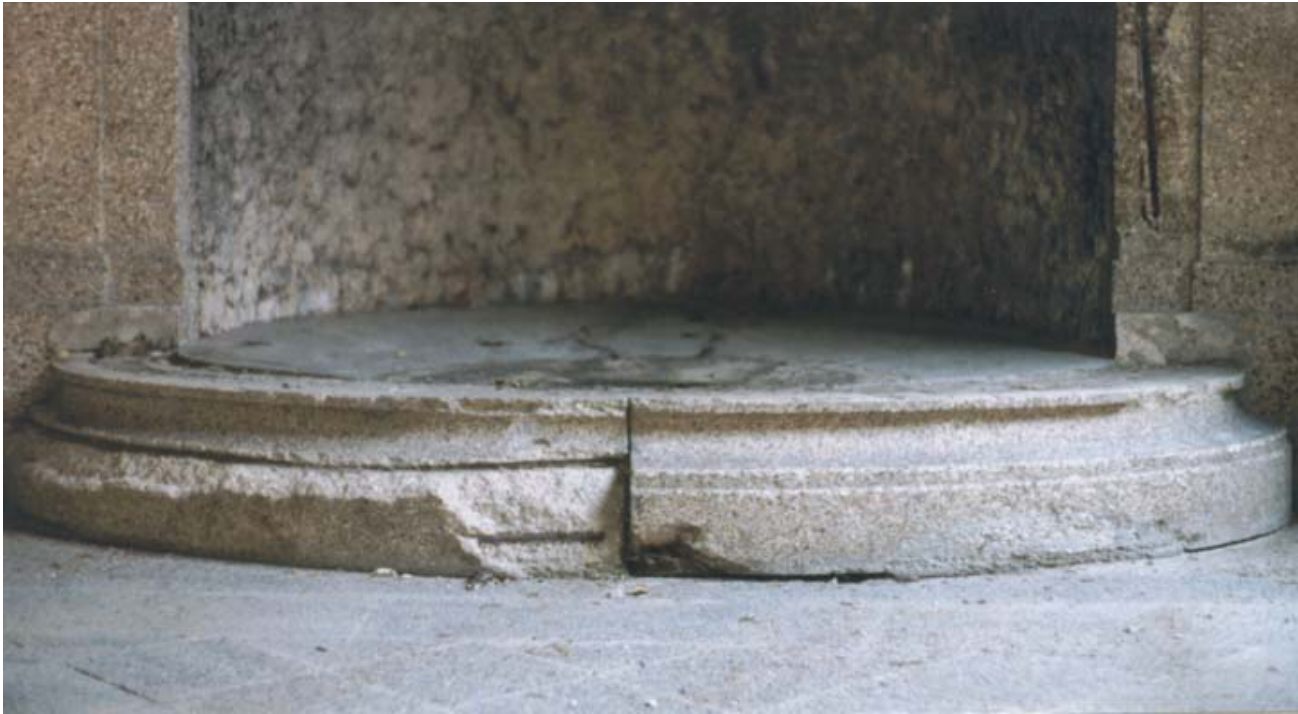
Fountain basin with missing lip and severe deterioration at main 16th Street entrance.

All extant water features would be returned to operation. In some cases, this would entail significant repair of broken elements or replacement of missing pieces of fountains, such as the lip of the fountain on the great terrace or the fountain in the Sixteenth Street entrance.

- all cracks and spalls in walls, piers, and paving
- the lip of the western bowl fountain on the great terrace
- damaged stairs
- heaved and deteriorated paving
- all locations of exposed reinforcing steel

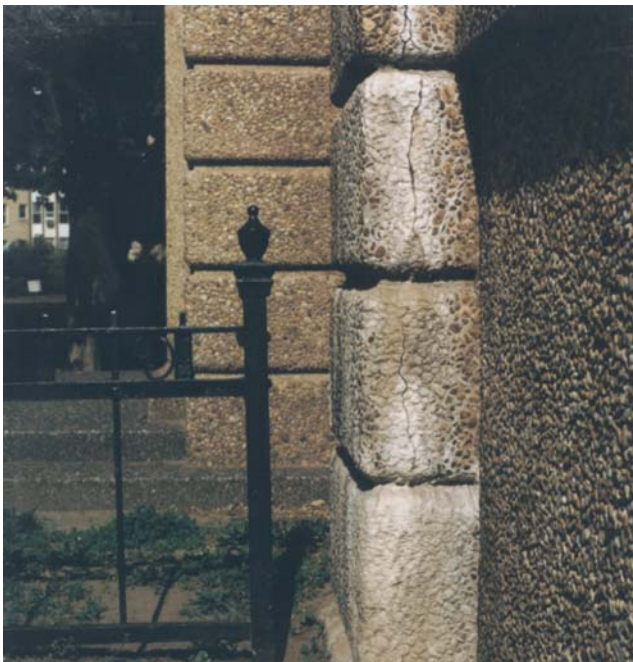
(above left) An example of cracks and efflorescence, on the northern wall of the park, looking west from the children's play area. This fence finial is the only one still in place on the fence at this play area.

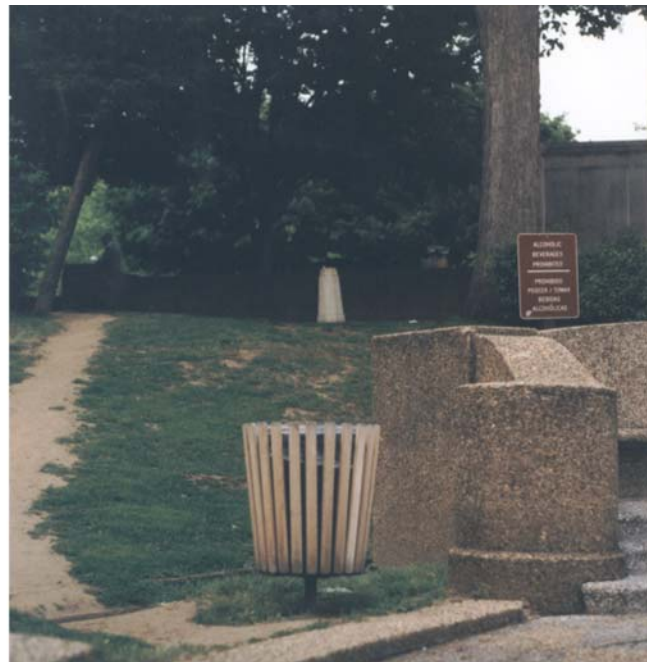
(above right) This picture illustrates the agglomeration that has occurred in the park since its official opening in 1936. Intrusive and non-original elements include the signage, the replacement drinking fountain, the tulip- type trash receptacle, and the informal path. This view is taken from the entrance at 15th and W Streets looking toward the lower plaza.

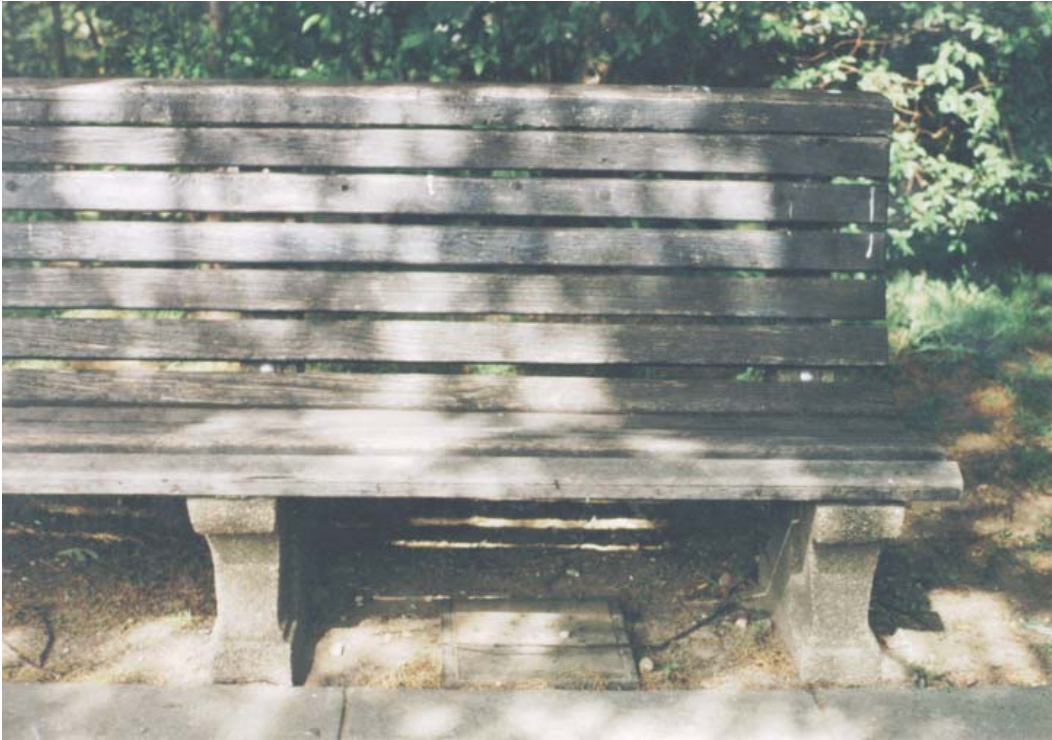
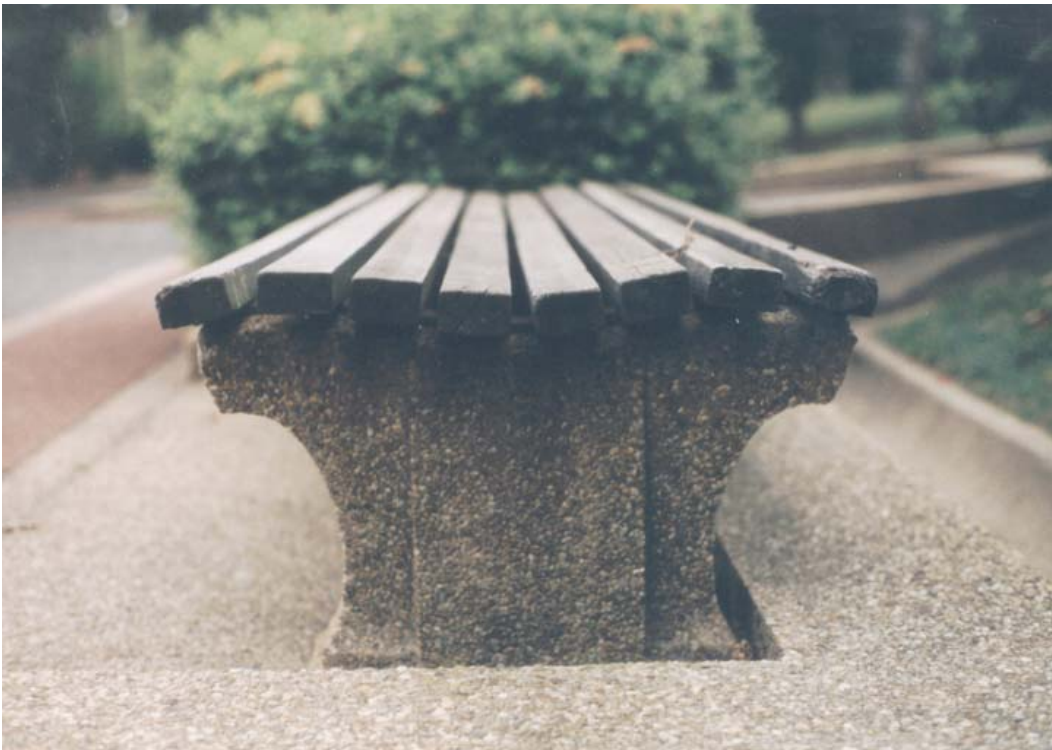
The original bench slat attachment detail on these contoured benches is both elegant and difficult to maintain. It is critical to develop a practical method of attachment that is consistent with the historic character of the benches.

Benches: Many benches are missing slats: these and inappropriate replacements would be replaced to match the original materials, sizes, shapes, and finishes. A new attachment system developed to facilitate maintenance could be implemented in this treatment alternative. If it is, the contoured profile of bench slats would be restored on those benches where it has been flattened.

Benches: Any site the age of this one shows accumulated repair strategies. The original benches had an ingenious system for attaching wood slats to the complexly curved bases. Unfortunately, over time, parts of that original system have been replaced with substitute bolts, nuts, and washers. Also, the original system required removal of the entire wood slat structure to replace a single slat. Either the original system should be fully restored on all the benches and park maintenance personnel trained in its operation and provided with parts, or a new system designed that is consistent with today's maintenance demands.

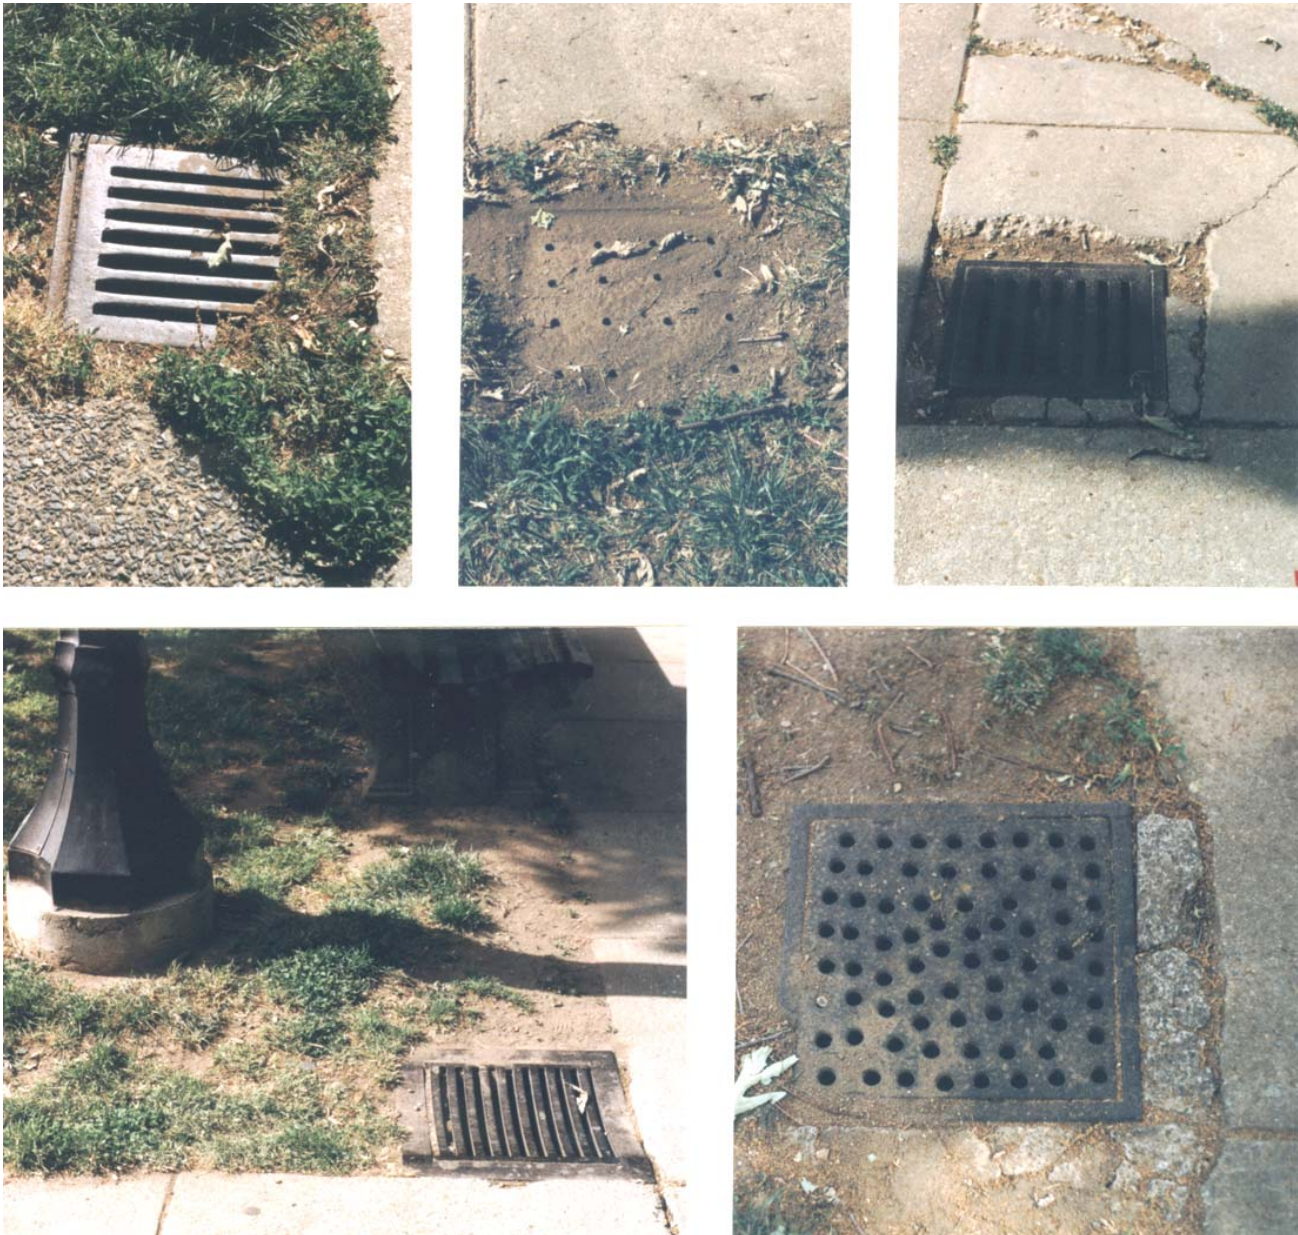
These pictures illustrate the diversity of non-original catch basin inlet covers found in the park. The one located in paving (obscured by the light fixture shadow) is an original location for a catch basin, but has had paving added around it. The steel plate inlet covers with holes are apparently expedients to replace the original brass covers, which have been stolen.

Maintenance and repair of the mechanical, electrical, plumbing, and drainage systems would continue, while the comprehensive repair/replacement plan is prepared for the fountains, lighting, and drainage systems. In addition, all the drainage systems should be cleaned, inlet covers secured with tamper-proof fastenings, and missing inlet covers replaced.
