Technical Evaluation of Potential Public Access
Alignments for the Giacomini Wetland Restoration Project
Part II: Technical Feasibility Study

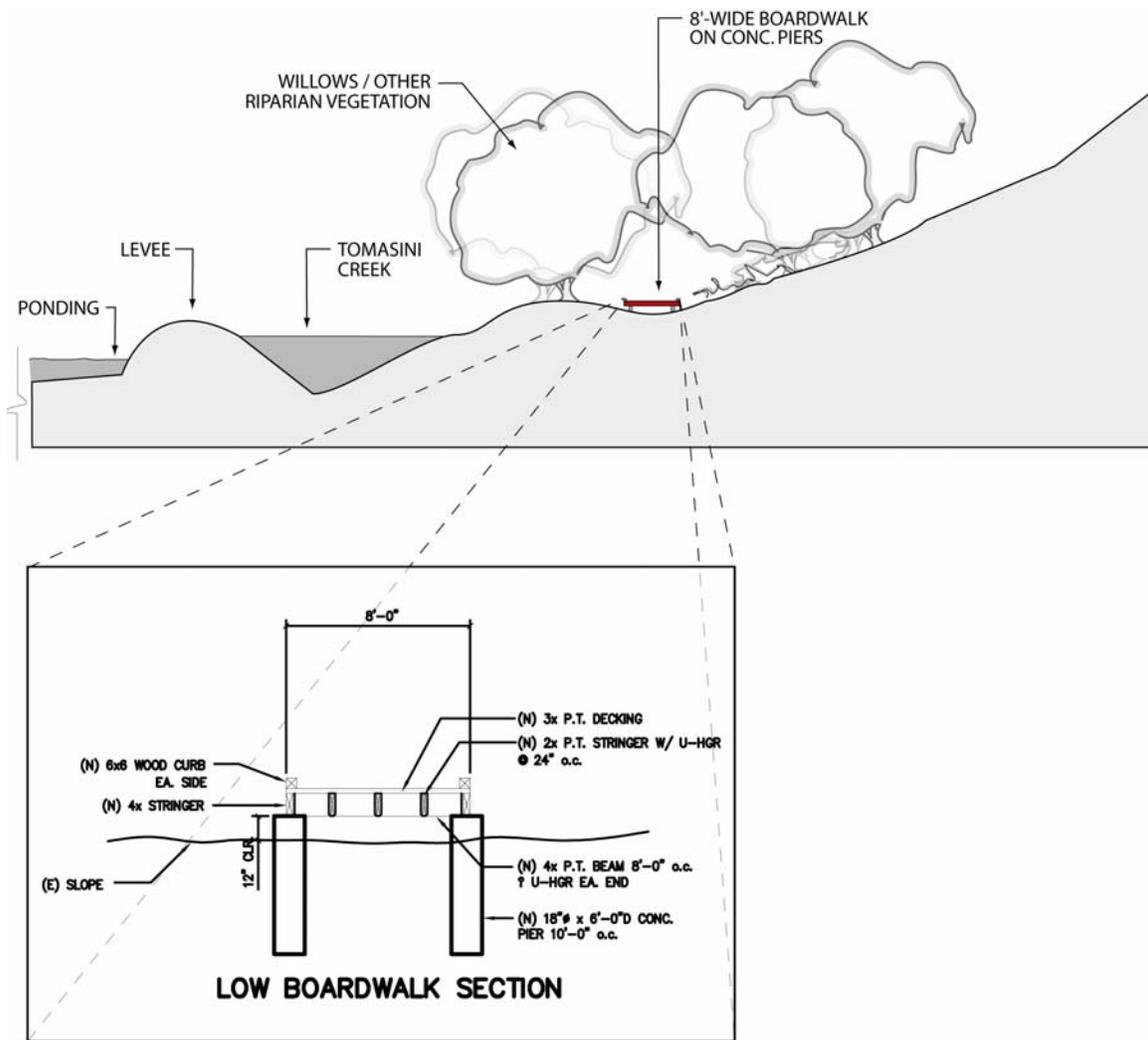
Figure 8: Alignment 2c Slope/Boardwalk Cross-Section
