## Accessibility Self-Evaluation and Transition Plan

# SAN FRANCISCO MARITIME

NATIONAL HISTORICAL PARK | CA

JANUARY 2016

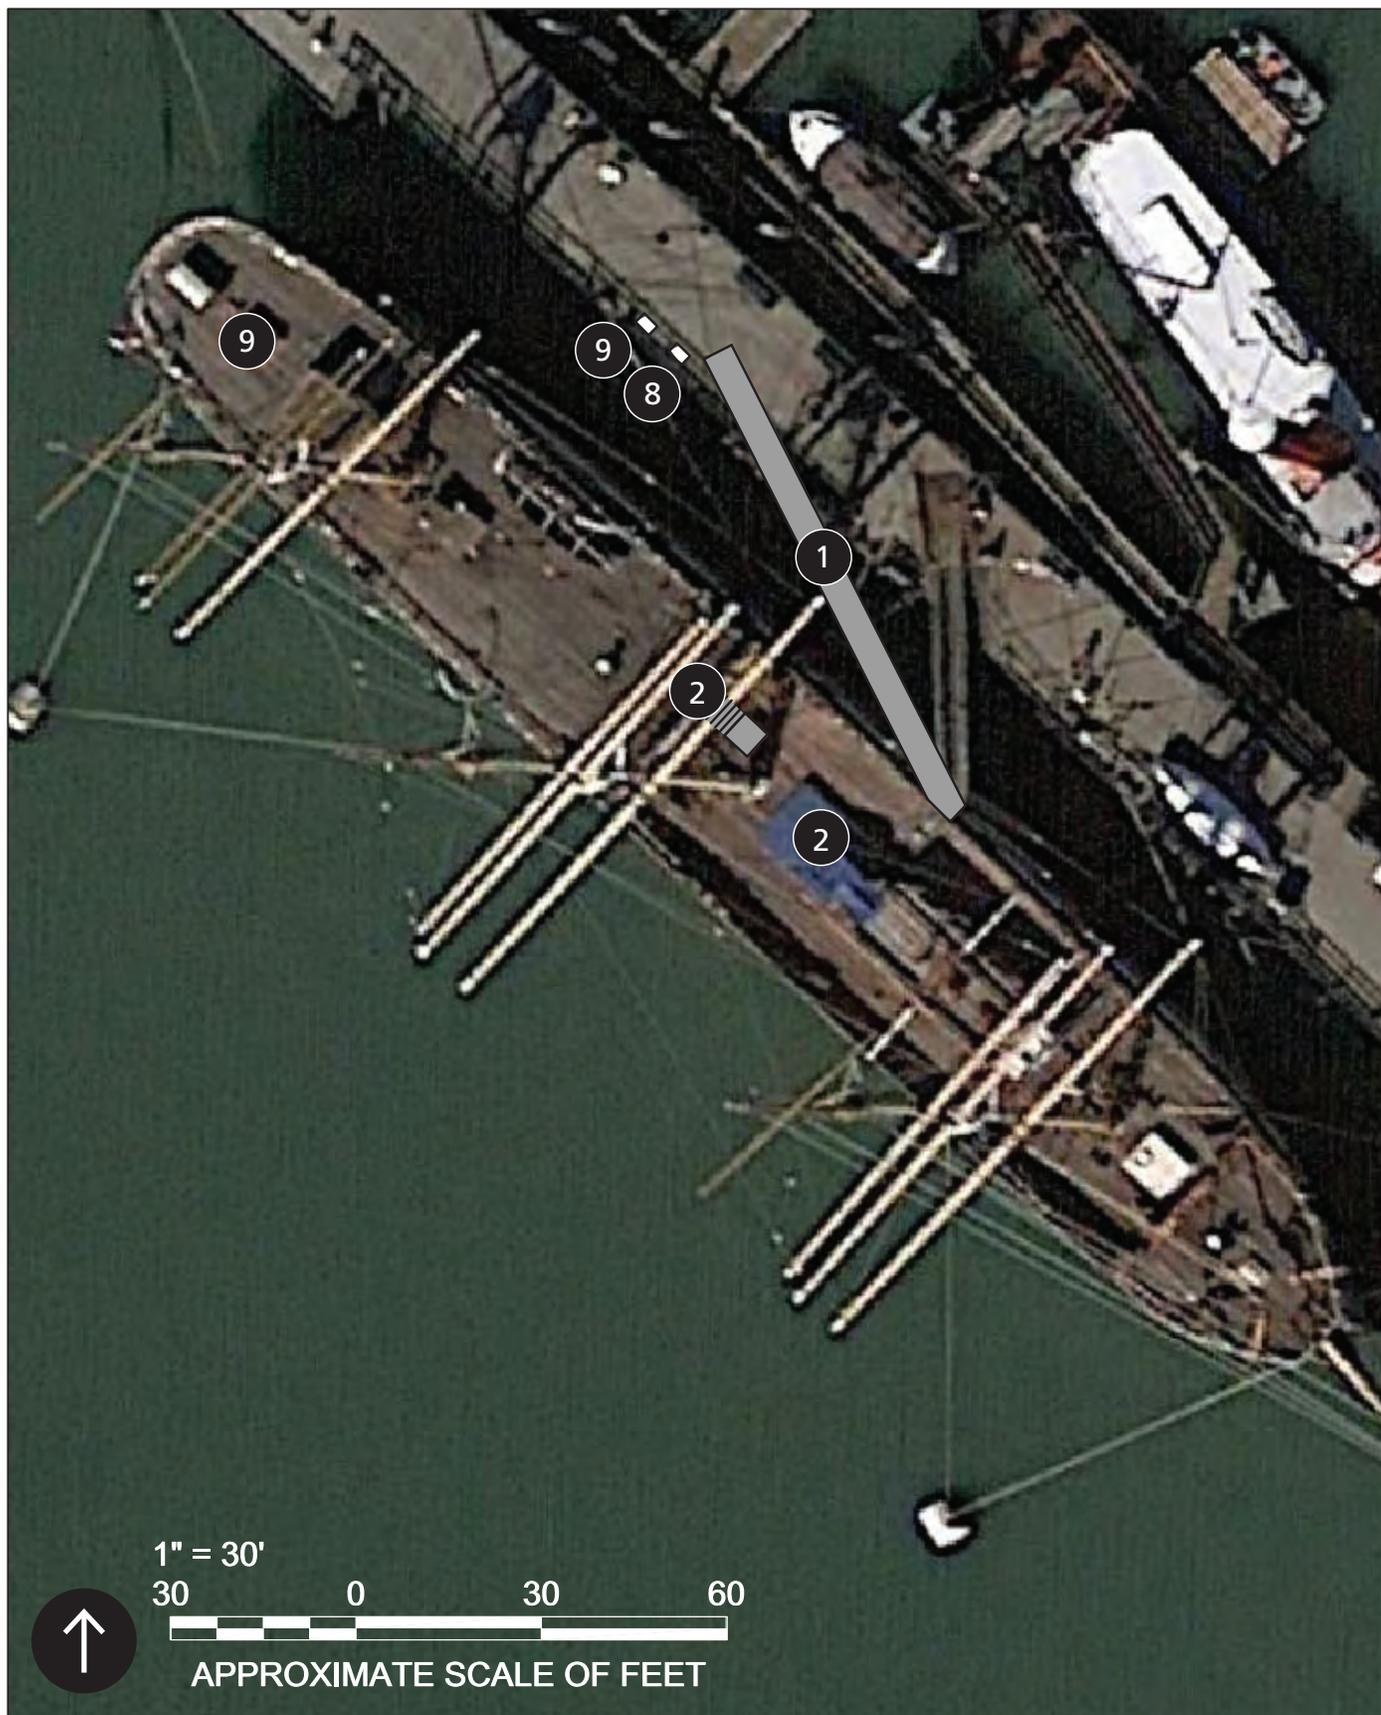
## Site Plan 1

- 1 Gangway Accessible Route and Walking Surfaces.** 1) Rehabilitate or replace gangway to be as close to 8.33% running slope and 2% cross slope during typical tidal levels. Refer to exceptions in ABAAS 1003. Provide 4" edge protection on ramp. 2) Provide a tidal chart that describes typical cross and running slopes found throughout the day / month / year. Provide tidal charts in large-print, accessible electronic document and braille handouts at visitor center, fee ticket booth, and on website. Address fluctuating gangway conditions for increased information. 3) Provide verbal and informational signage about typical slopes at fee ticket booth before purchase of tickets. 4) Place signage at the entrance to the “Balclutha,” describing length, running, and cross slopes. 5) Create a standard operating procedure for advising visitors of tour closures in times of extreme tidal conditions (i.e., closure signs at pier, website postings, etc.) and post the standard operating procedure for ship access to the park’s website.

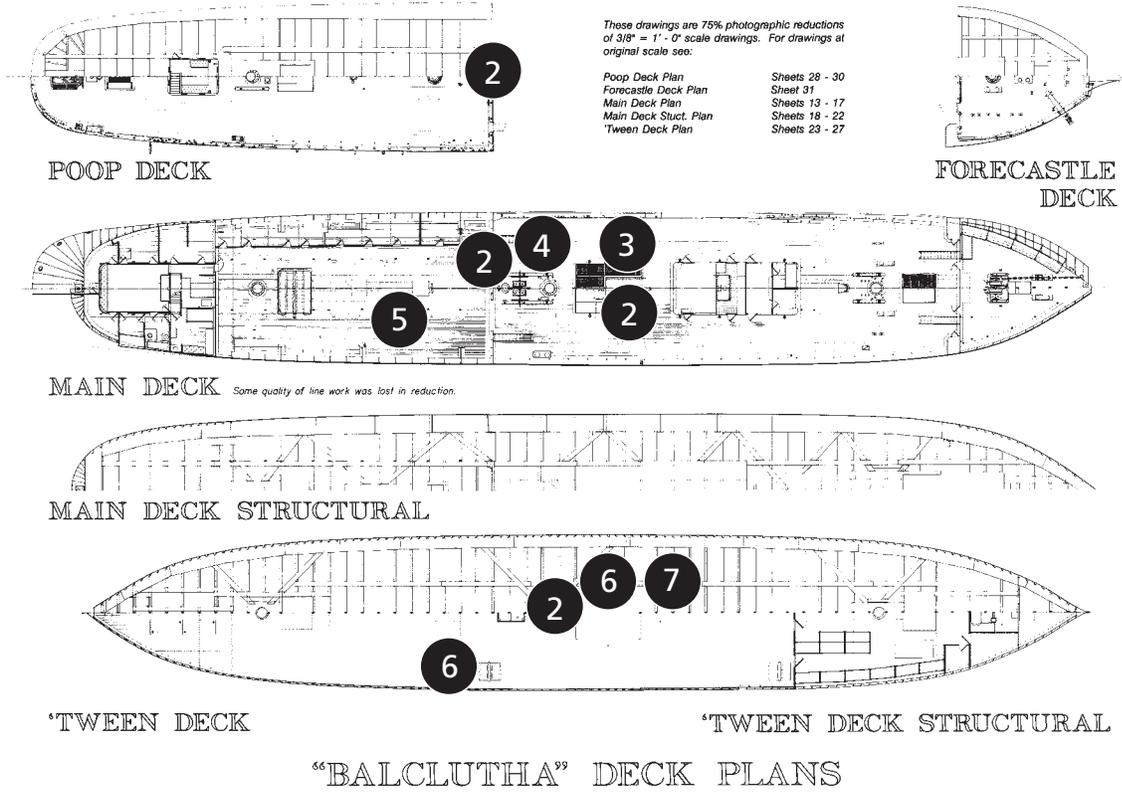
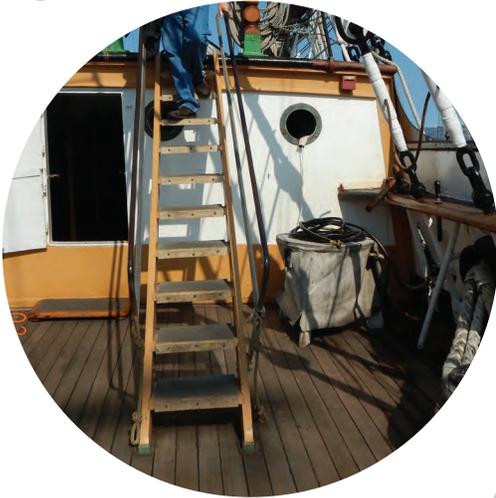
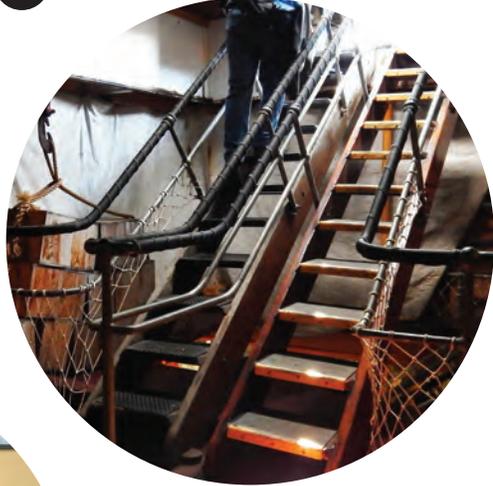
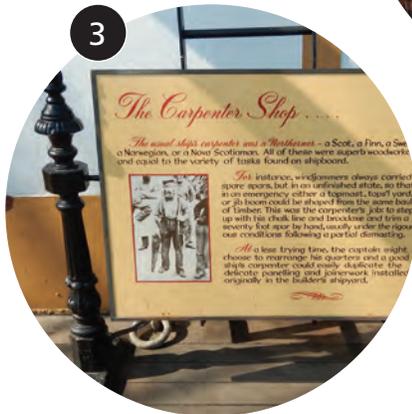
## Site Features 2

2 Main deck to poop deck

2 Main deck to tween deck

around ship that explains conditions and settings within and around the ship. 6) Forecastle and small rooms throughout the ship can be made accessible through a live video feed with simultaneous audio tour and tactile map to be a part of guided tours that are not accessible.

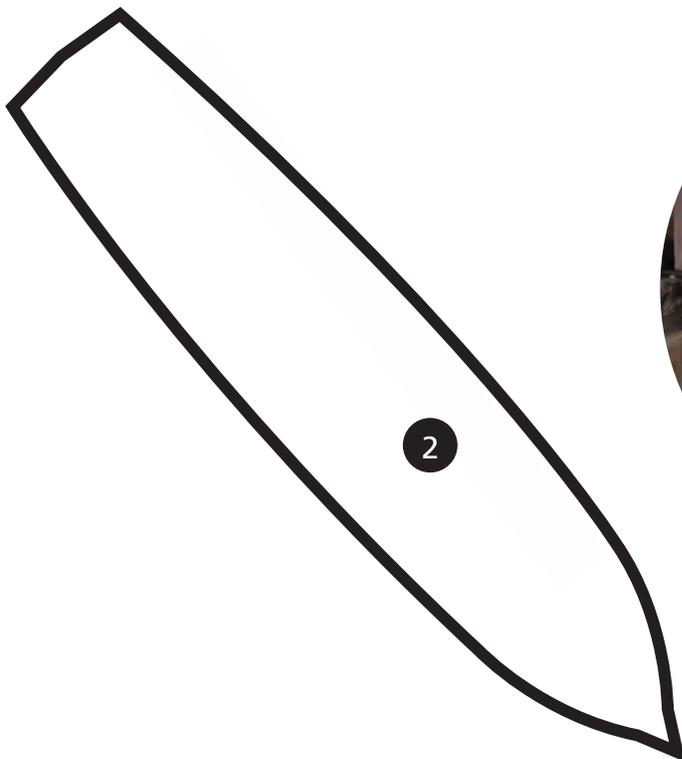
## Site Plan

Below Deck

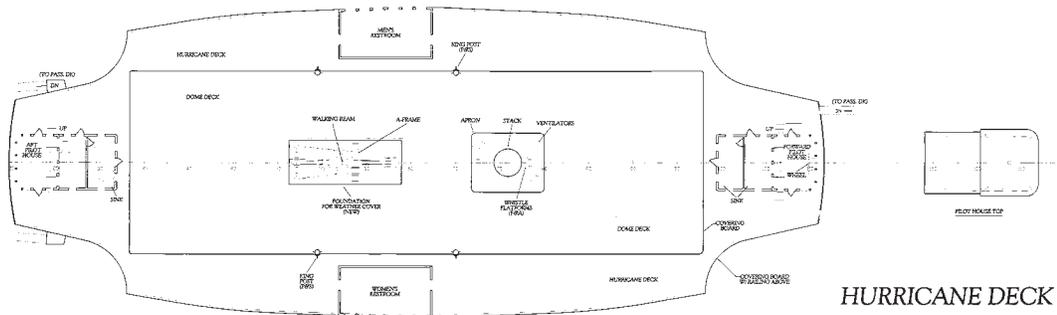
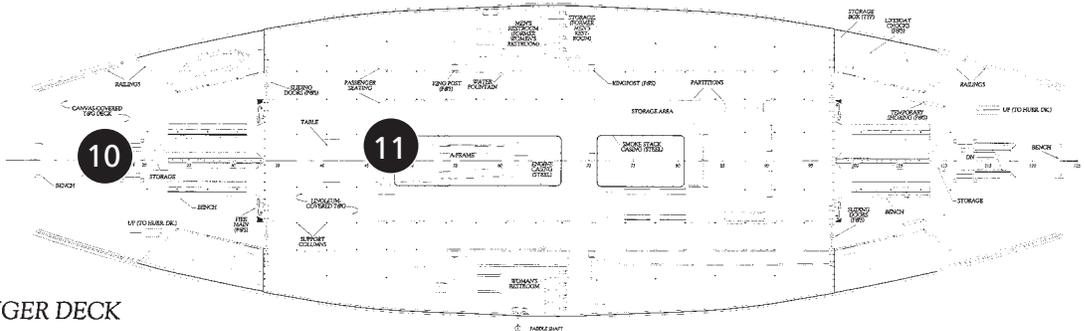
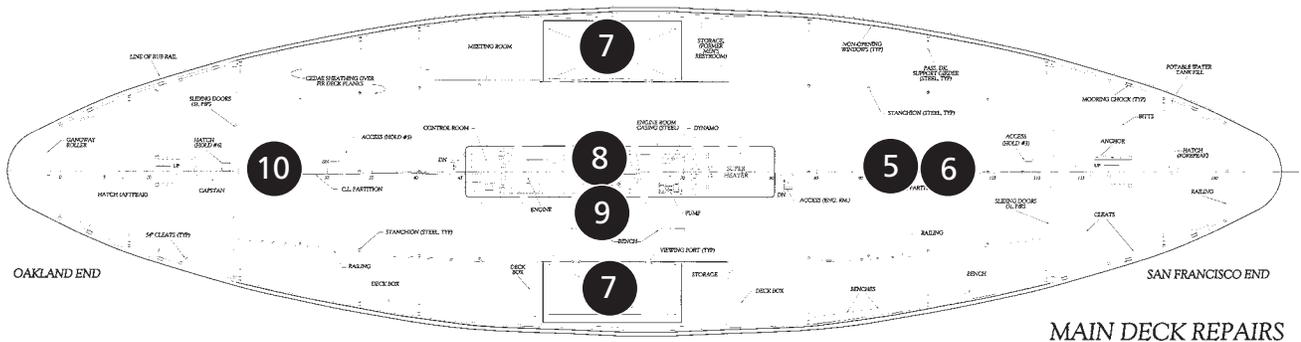
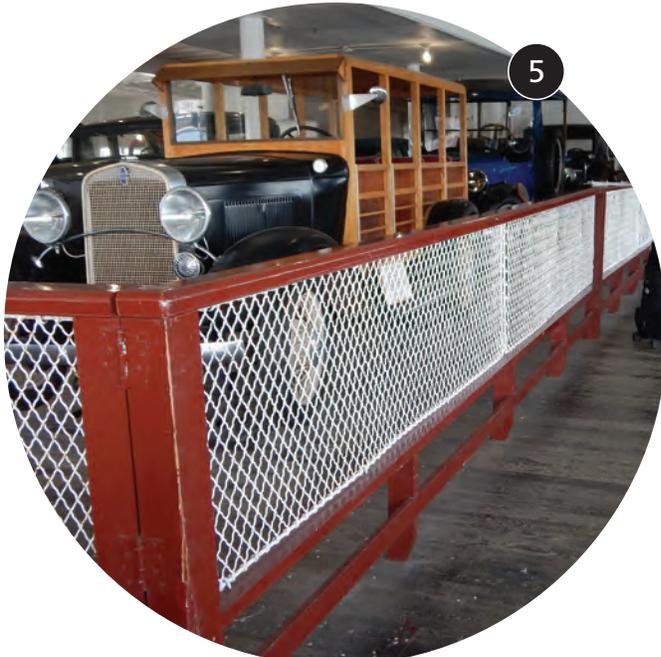
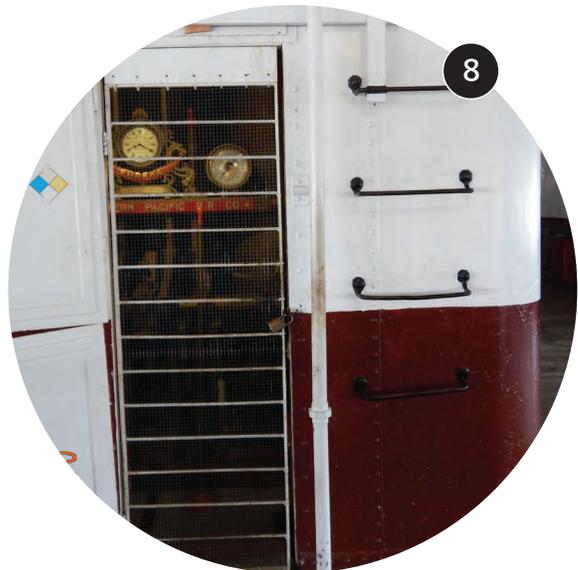
## Site Features 2

HURRICANE DECK

PASSENGER DECK

MAIN DECK REPAIRS

- 4 **Cell Phone Tour (Hyde Street Pier).** 1) Provide audio description on cell phone tour and large-print transcript that describes the "Eureka."

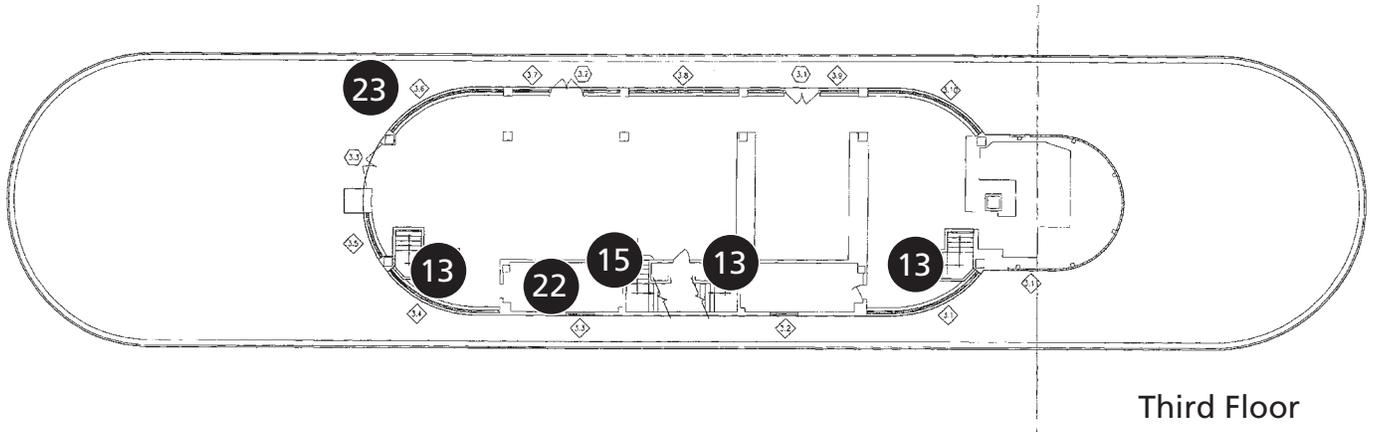
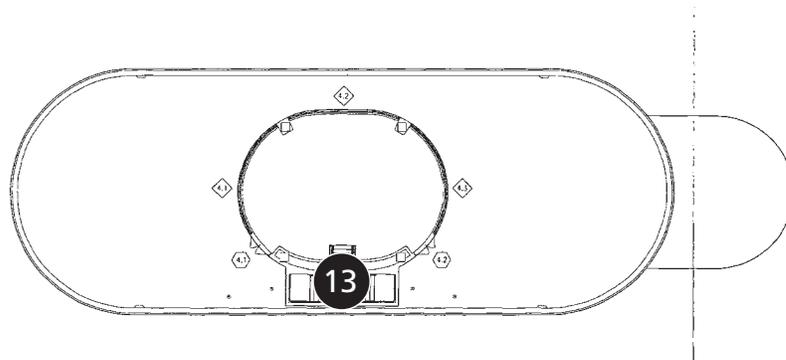
Floor Plan 3

Third Floor

Fourth Floor
