Delaware and Hudson Railroad, Snow Flanger #36037.

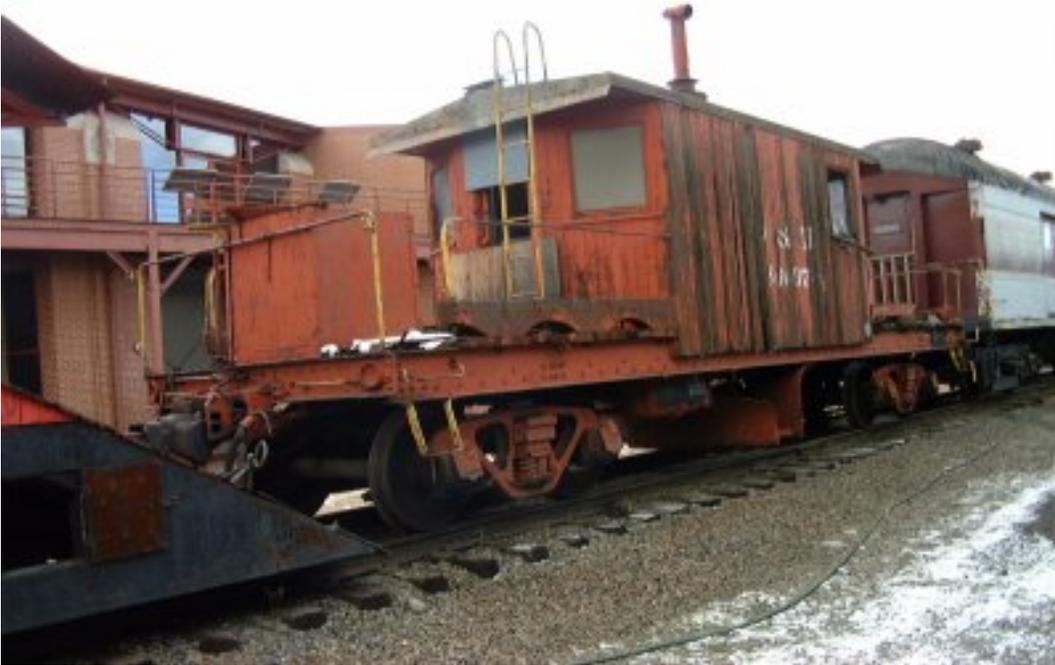
Flanger, #36037. Shop-built, probably before 1910. Used for snow removal. Wood with a steel flange notched to fit over the rails. Pushed by a locomotive with a crew inside to raise and lower the flange, as needed, to avoid grade crossings and other obstructions. Received by Steamtown Foundation, 1985-1987.
