Case Study 4: Cultural Resources Inventory and Vulnerability Assessment, *Bering Land Bridge National Preserve, Alaska* *Cape Krusenstern National Monument, Alaska*

Contributing Authors: Dael Devenport (Alaska Regional Office) and Frank Hays (Western Arctic National Parklands)

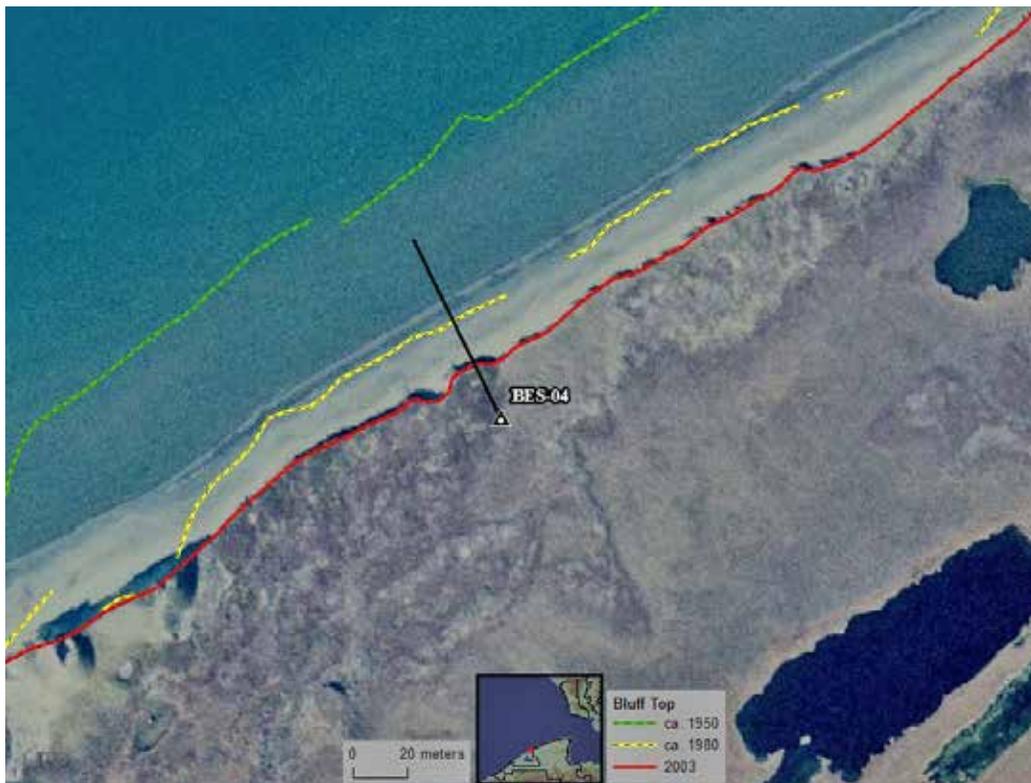
Bluffs along the coast eroded 78 m (256 ft) in only 54 years. Image credit: NPS I&M Program.

Both parks preserve some of the earliest most significant archeological sites in North America including ancestral villages of the Inupiat people. Some of these prehistoric sites are being lost due to destabilization of the coasts and the resulting erosion that can be up to 3.7 m (12 ft) per year. As the permafrost that encases the soil of the region melts, the stratigraphy, artifacts, and buried house remains that make up a typical site are exposed and then become victim to mechanical erosion from the waves and thermal degradation from the warmer temperatures that prevail on the bluff faces.

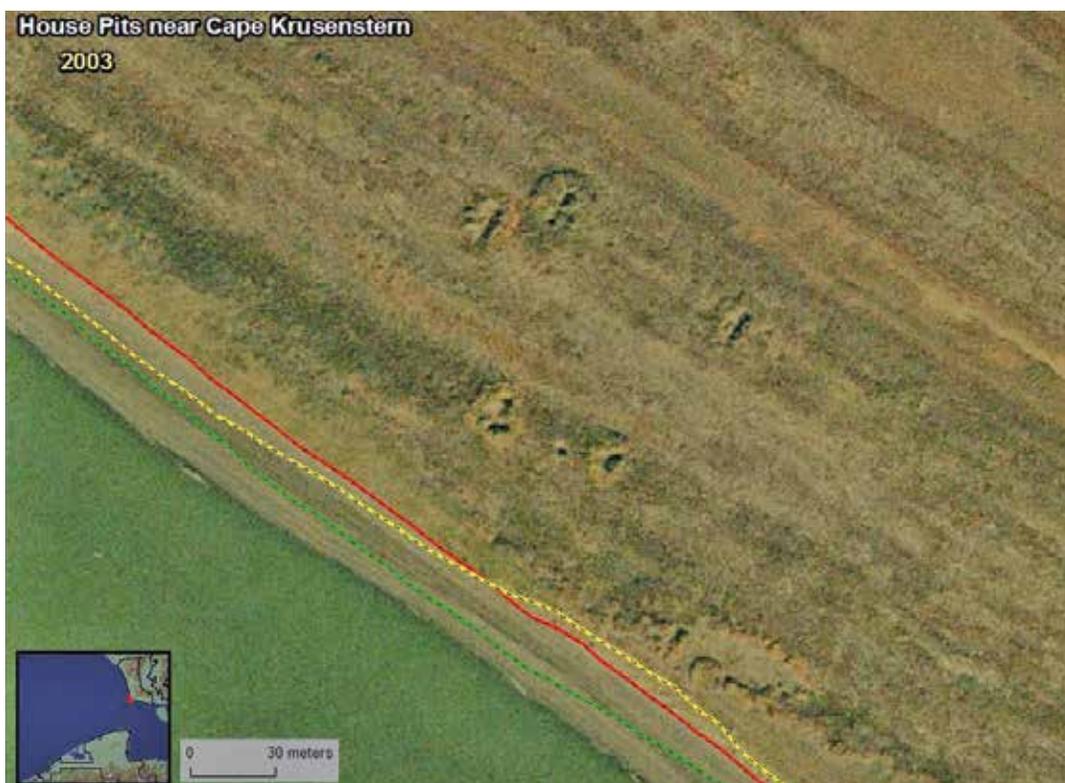
House pits are visible near Cape Krusenstern in this 2003 orthophotograph. Image credit: NPS I&M Program.
