Case Study 5: Strategic Planning and Responsible Investments for Threatened Historic Structures, *Dry Tortugas National Park, Florida*

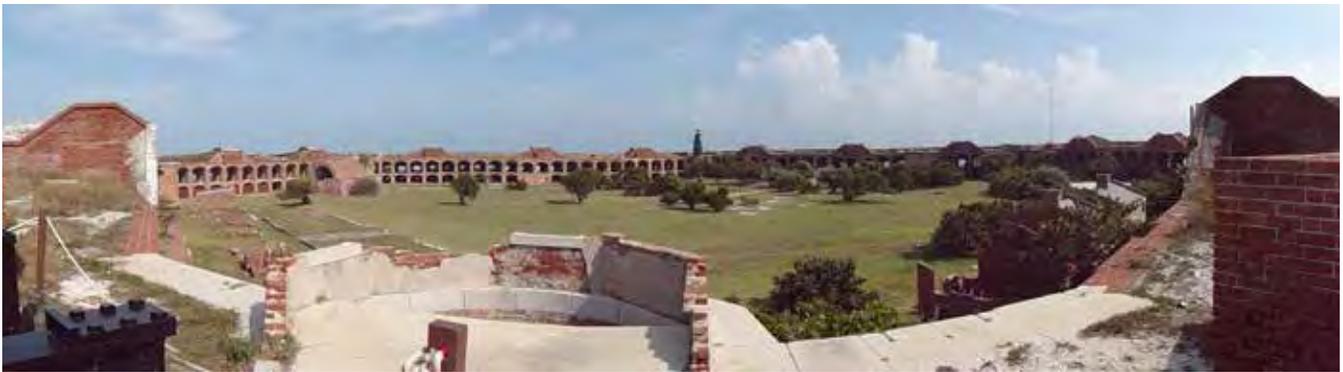
Historic Fort Jefferson is a six-sided structure built on a landform that is impacted by coastal processes.
Image credit: Marcy Rockman, NPS.

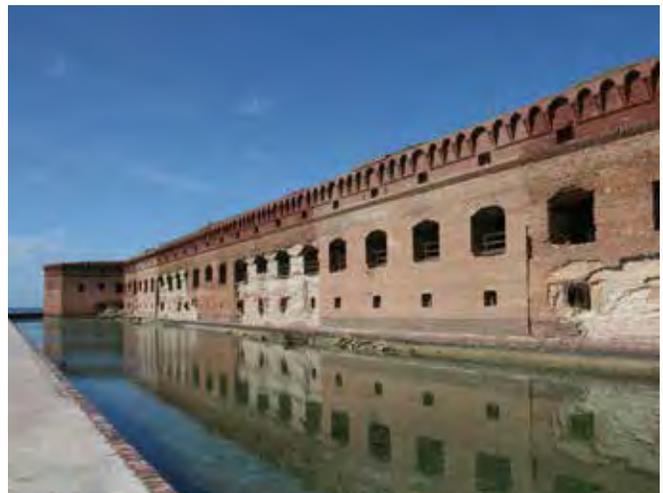
Fort Jefferson needs repairs to its front and moat wall.
Image credit: Kelly Clark, NPS.

Throughout the architecture of the fort, there are iron components embedded within the masonry that served various functions, including water collection, supports for catwalks, and, most importantly, protection against enemy fire. In this salt water environment, the wrought-iron has rusted and expanded, pushing the brick apart and causing serious structural damage to Fort Jefferson's exterior scarp walls; large sections of the fort walls have collapsed into the moat.

The moat wall surrounding the fort also needs repairs in many places. Because it is an integral part of the site design and protects the fort from wave forces, it also protects the investment in stabilization of the fronts.
