Testing the Energy Performance of Wood Windows in  
Cold Climates- A Report to the Vermont Division for  
Historic Preservation, Agency of Commerce and  
Community Development | 1996-08

# **Testing the Energy Performance of Wood Windows in Cold Climates**

A Report to  
The State of Vermont Division for Historic Preservation  
Agency of Commerce and Community Development

August 30, 1996

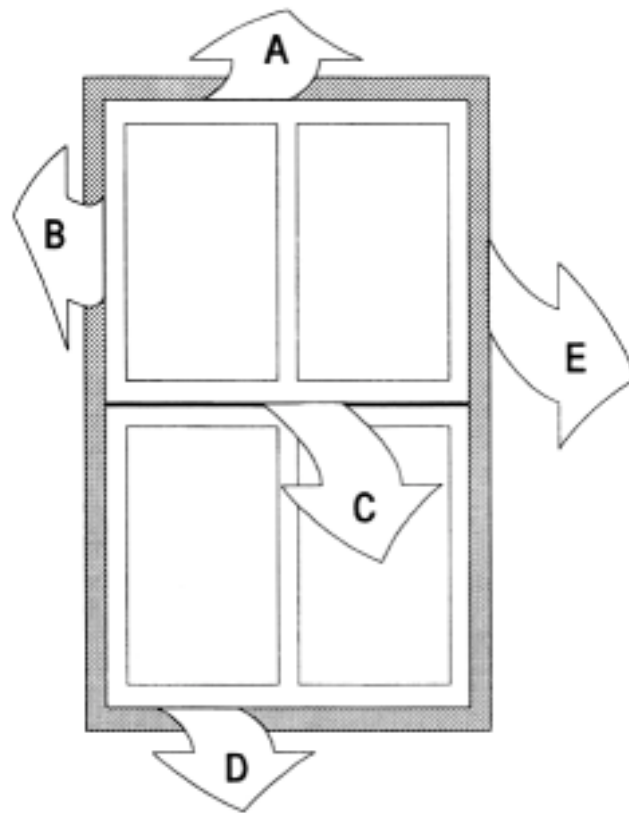
**Figure 1:** Principle air leakage sites for a typical double-hung window

- A - air infiltration through the head junction
- B - air infiltration through the sash/jamb junction
- C - air infiltration through the meeting rail
- D - air infiltration through the sill junction
- E - air infiltration through and around the jamb from the rough opening

losses were investigated by field and laboratory pressurization testing. Figure 1 is a schematic diagram of a standard double-hung window, showing typical air leakage sites for that style window. Non-infiltrative losses include conduction, convection, and radiation through the materials of the window and were simulated using a computer model.

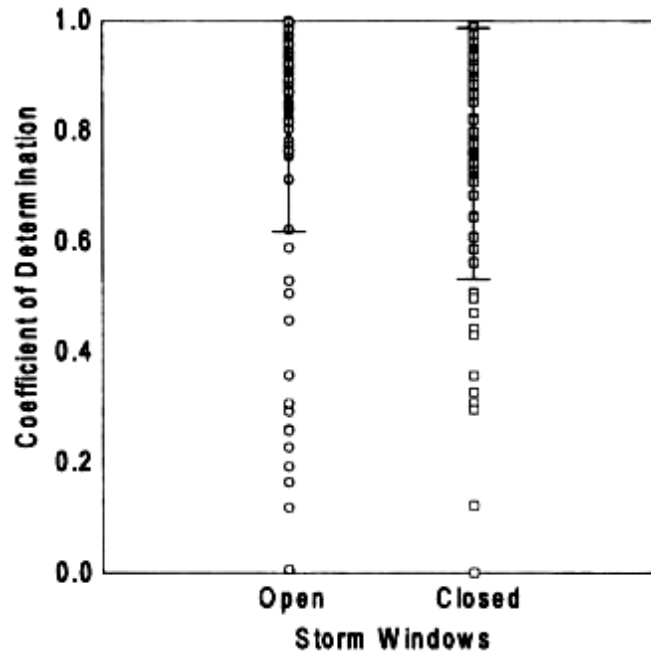
**Figure 2:** Variability in  $R^2$  values of standard flow model fitted to the field data

A larger variation in  $R^2$  values was observed for those windows allowing little induced air

leakage. For those windows, the effect of even moderate winds on test accuracy increased as both air flow rates and pressure differentials decreased. Table 3 shows wind speeds equivalent to pressure differentials used in the test, with pressures being expressed in both conventional (Inch-Pound) and metric (SI) formats.

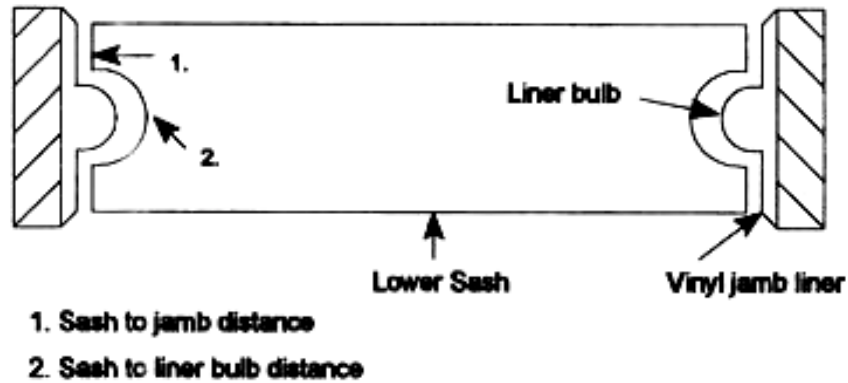
**Figure 3:** Schematic of lower sash and vinyl jamb liner junction

Separate variance t-tests showed site 12 windows to have significantly larger jamb liner/sash gaps than either site 13 or 7 at a 97% confidence level while having statistically the same  $ELA_{s \times 19}$  as site 13. Routing of the sash to accommodate vinyl jamb liners was

done by the same work crew at sites 12 and 13. A different work crew performed the work at site 7. No significant difference in jamb liner/sash gaps was found between sites 7 and 13 at a 98% confidence level while there was a significant difference in  $ELA_s \times 19$  between the sites. Based on the limited data, it is inconclusive as to whether differing work crews had a significant effect on installation quality. In an earlier study, few significant differences in leakage rates were observed when differing contractors installed the same type windows in new residential housing in Minnesota (Weidt, 1992). It remained unresolved as to why site 7 window upgrades had better sash leakage characteristics than sites 12 and 13.

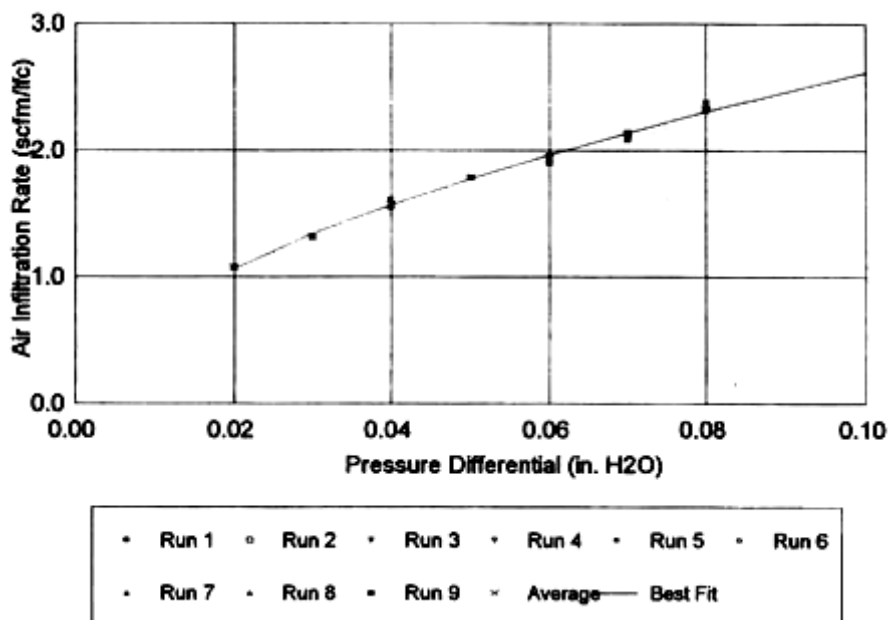
**Figure 4:** Reproducibility of lab pressurization test results and test device over time

These same sets of data also demonstrate the reproducibility of the test over a period of nine days, resulting in a high degree of confidence in the test procedure and the fan

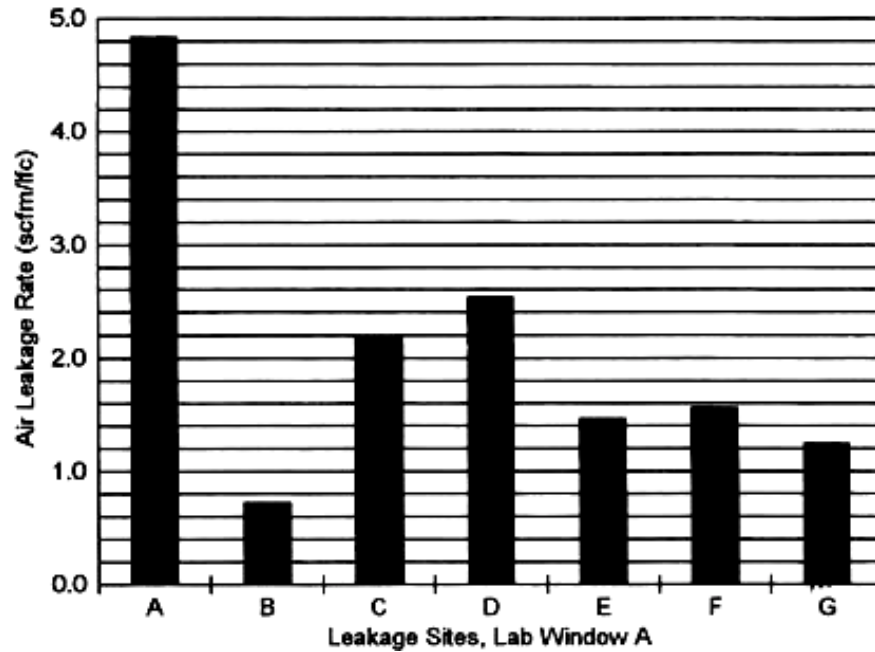
**Figure 5:** Lab window A leakage rates by site at 0.30 in. H<sub>2</sub>O for original condition window

- A - Leakage rate through the total window (extrapolated value)
- B - Leakage rate through the meeting rail
- C - Leakage rate through the upper sash with the meeting rail sealed
- D - Leakage rate through the lower sash with the meeting rail sealed (extrapolated value)
- E - Leakage rate through the sill junction
- F - Leakage rate through the inside edges of the exterior trim
- G - Leakage rate through the outside edges of the exterior trim

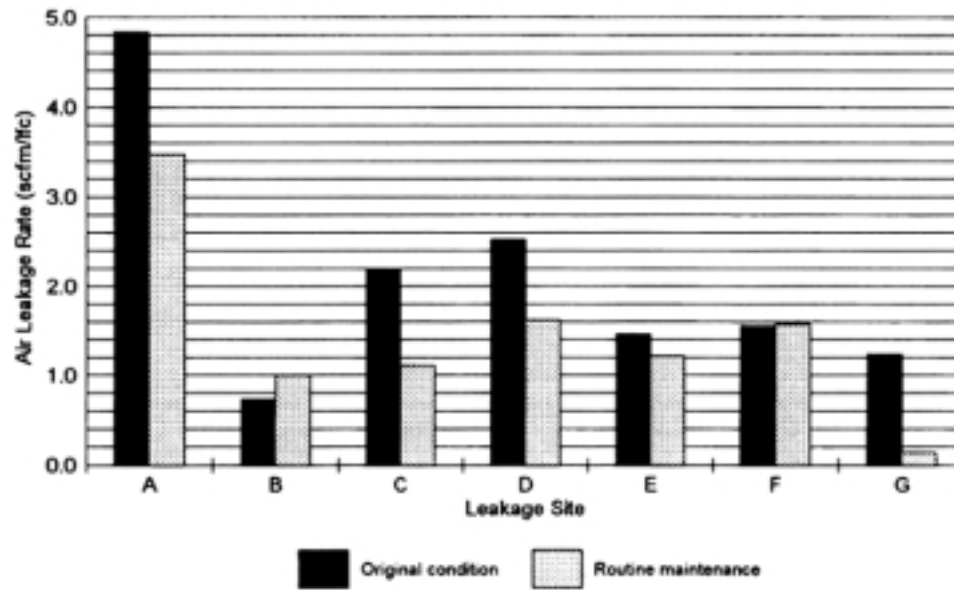
**Figure 6:** Lab window A sash leakage rates, original condition versus routine maintenance

Leakage rates did not appear additive once again, as noted in the previous section. Effective leakage areas (ELA's) were calculated for leakage sites in both the original condition window and after routine maintenance. Leakage site ELA's are shown in Figure 7. Effective leakage areas appear more additive than leakage rates, overestimating the whole window value by an average of 30%, as opposed to a 65% overestimation when using leakage rates. An anomaly serving to increase overestimation based on ELA's was noted at the meeting rail (site B). Air leakage increased by 25% after routine maintenance, but was expected to remain relatively constant, as leakage rates did at sites E and F. That

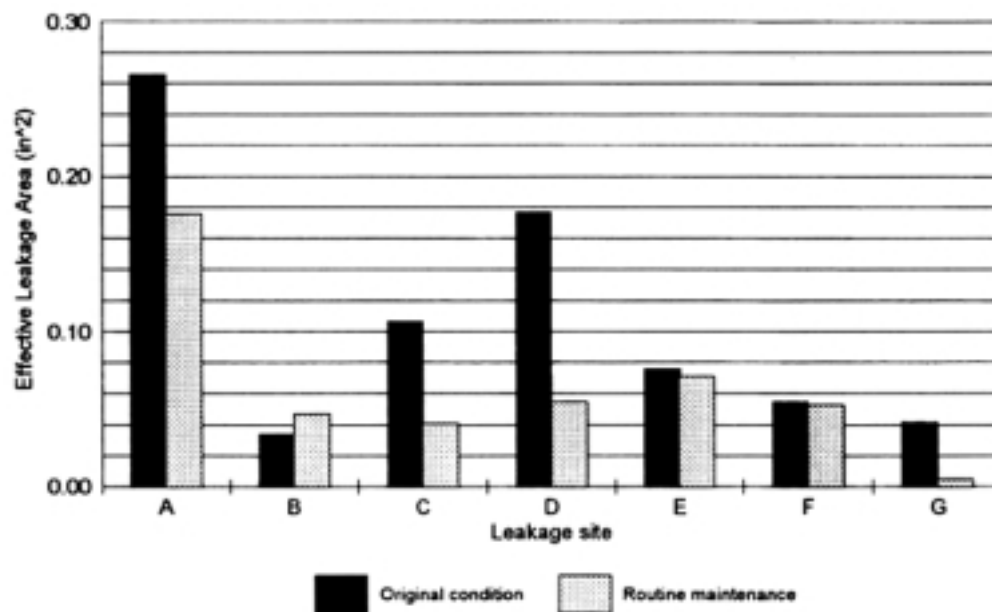
**Figure 7:** Leakage site ELA's for lab window A, original condition versus routine maintenance

increase was not investigated further as the purpose was to check the approximate additive nature of ELA's.

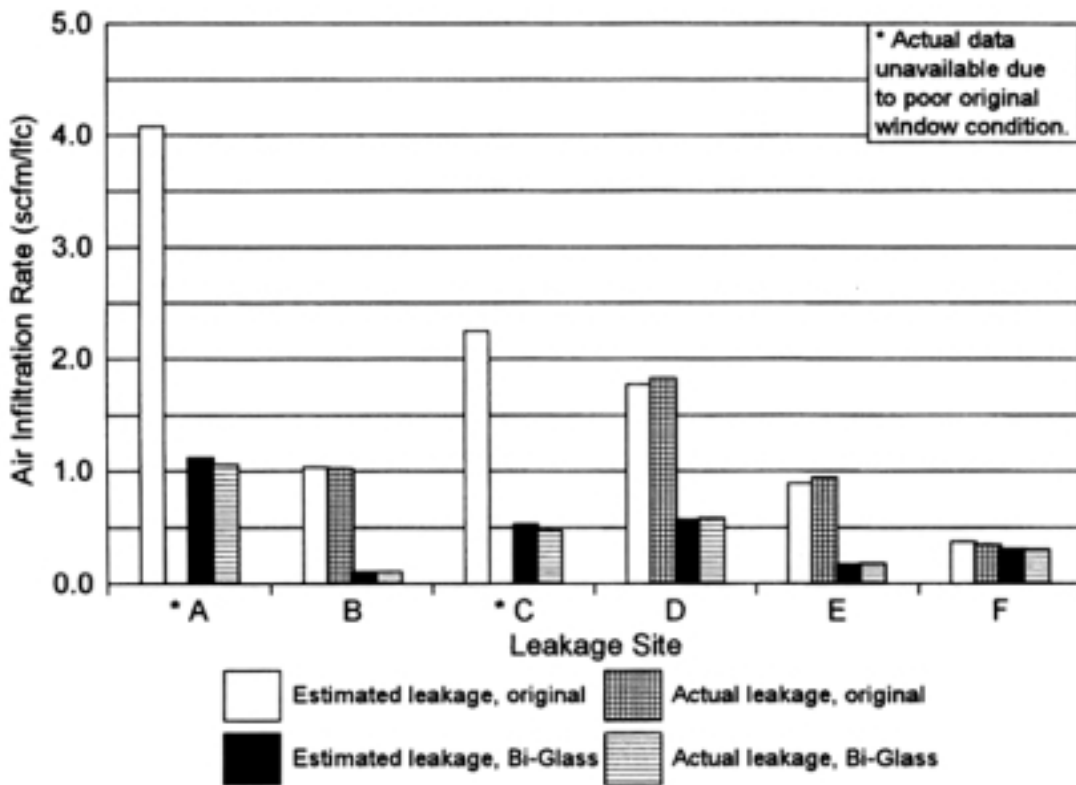
**Figure 8:** Lab window B, relative air leakage reductions at 0.30 in. H<sub>2</sub>O due to Bi-Glass Systems upgrade

Extrapolated leakage rates for lab window B were over 4.0 scfm/lfc, based on regression coefficients for sash leakage at 0.30 inches of water pressure. The Bi-Glass System

- A - Leakage rate through the total window
- B - Leakage rate through the meeting rail
- C - Leakage rate through the upper sash with the meeting rail sealed
- D - Leakage rate through the lower sash with the meeting rail sealed
- E - Leakage rate through the sill junction
- F - Leakage rate through the outside edges of the exterior trim

upgrade decreased the sash leakage rate to 1.1 scfm/lfc, a 360% reduction. While the improvement was significant, the air leakage rate was well above the industry standard for new windows (0.37 scfm/lfc at 0.30 inches of water pressure).
