Historic American Timber Joinery, A Graphic Guide

I. Tying Joints (Tie below Plate)

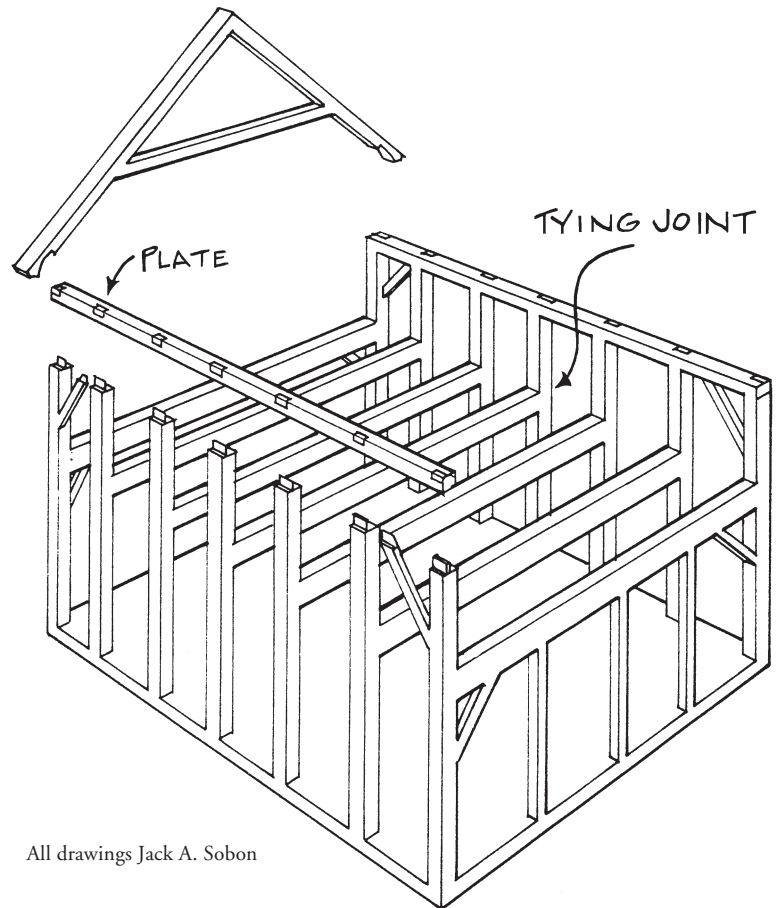
Fig. 1. In the typical New York State timber-framed Dutch house, the plate is 3 to 4 ft. above the second floor. The closely spaced H-bents, typically 3 to 5 ft. on center, illustrate the tie-below-plate condition.

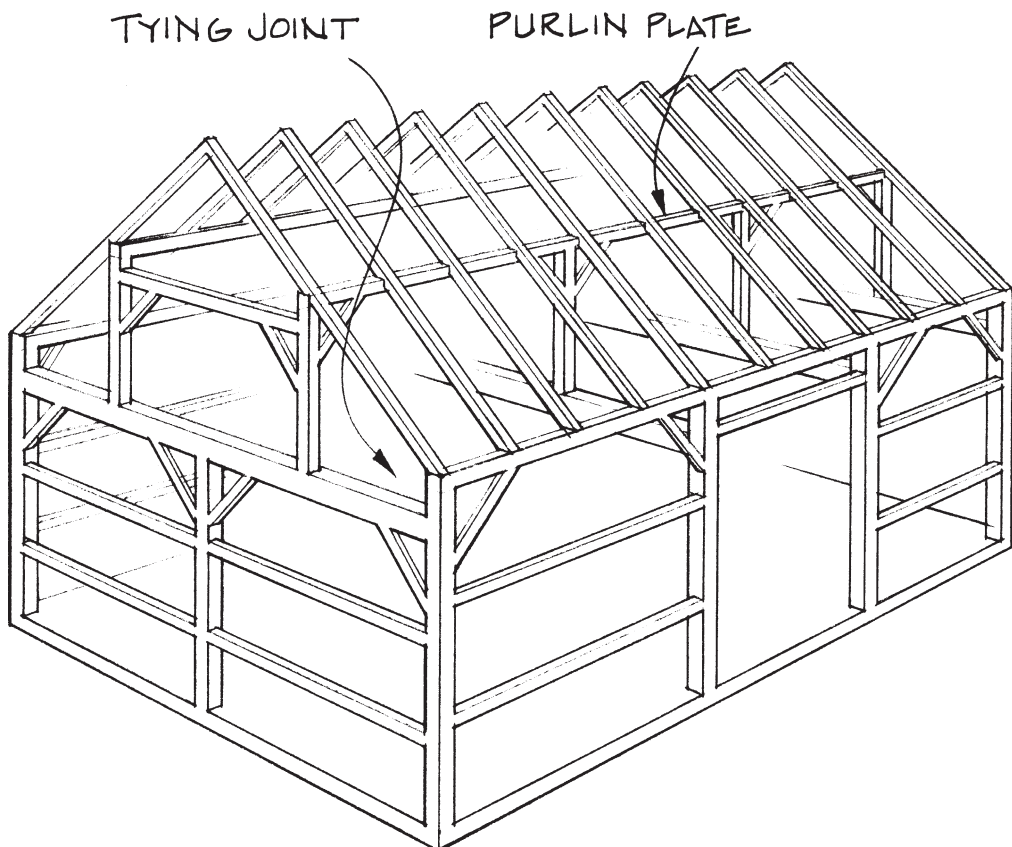
Fig. 2. The three-bay, side entrance barn, common throughout western New England and New York after about 1800, made use of the tie-below-plate tying joint. The rafters were additionally supported by continuous purlin plates at their midspan.

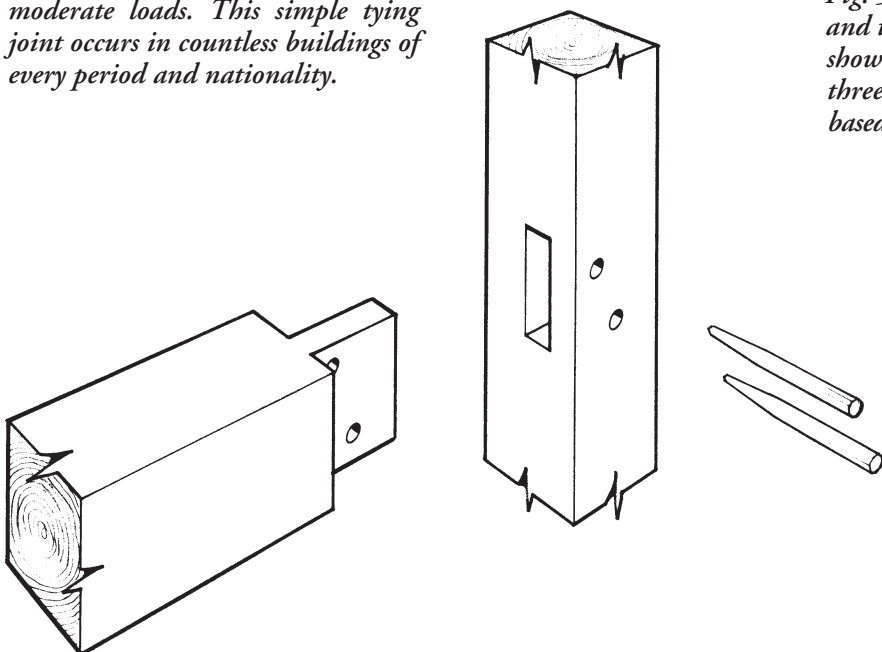
Fig. 3. The through mortise and tenon. In its most basic form, it handles moderate loads. This simple tying joint occurs in countless buildings of every period and nationality.

The Through Mortise and Tenon (Figs. 3-5). Probably the most prevalent tying joint in America, the through mortise and tenon was the standard joint in the carpenter's repertory where a joint was subject to tension loads. The mortise is cut completely through the post to maximize the tenon length. Because the connection relies entirely on the pins to resist withdrawal, pin size and location are critical. Failure of this joint can occur in five ways:

1. The pin can shear off (pin too small or decayed), and the joint withdraws.
2. The wood in the tenon between the pin hole and the end of the tenon, called the *relish*, can split out (tenon too short or pin hole too close to end of tenon), and the joint withdraws.
3. The mortise face can split out (pins too close to face), and the joint withdraws.
4. The post can split in a line from the pin hole up to the post's top tenon (joint too near the post top), and the top portion of the post breaks away.
5. The post can break off at the tying joint (too much cut out of the post).

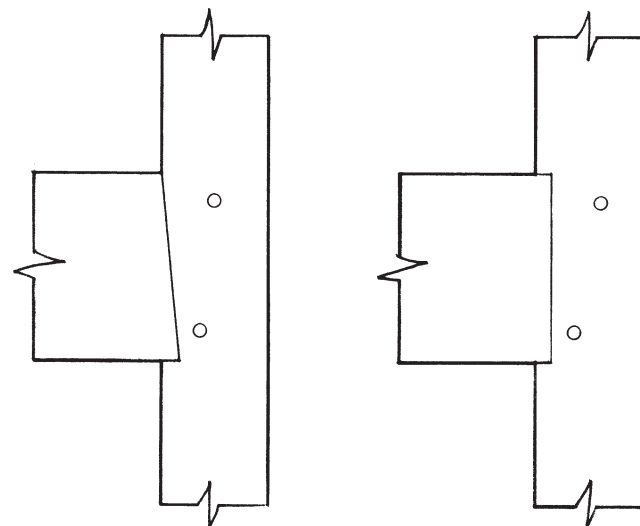
Fig. 4. The two basic types of housed through mortise and tenon joints. The diminished housing (on the left) was primarily used in scribe rule frames. The parallel housing (on the right) is found in both scribe rule and square rule frames.

In most buildings, this joint is housed because the tie beam often carries floor loads. Instead of the tenon alone, the full width of the beam bears on the post; a substantial increase in bearing as well as shear strength is accomplished. A diminished housing is typical in scribe rule frames, a parallel housing in square rule frames. (Square rule frames are marked and cut according to a

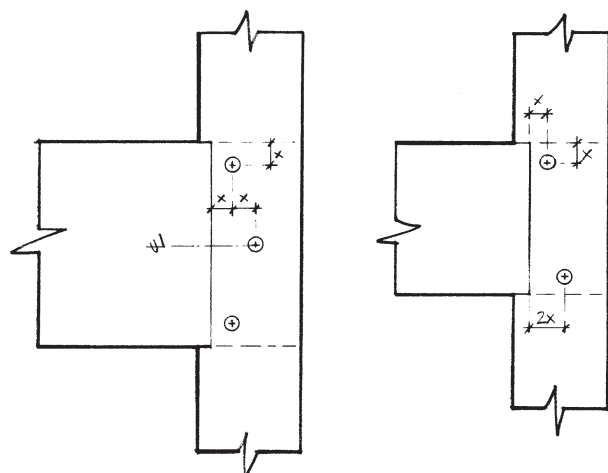
Fig. 5. Pin number and placement varied with the size of the member and the preferences of the builder. Members 6 in. deep or smaller (not shown) usually have one pin; 7 to 10 in., two pins; and above 10 in., three pins. The distance shown as "x" is often either 1½ in. or 2 in., based on the tongue or blade of the framing square used by the builder.

tenon beyond the pin hole, but a few blind (not through) tenons have been found. The use of two or more pins is common, often not in line to avoid mortise face split out. Some typical pin placements are illustrated in Fig. 5.

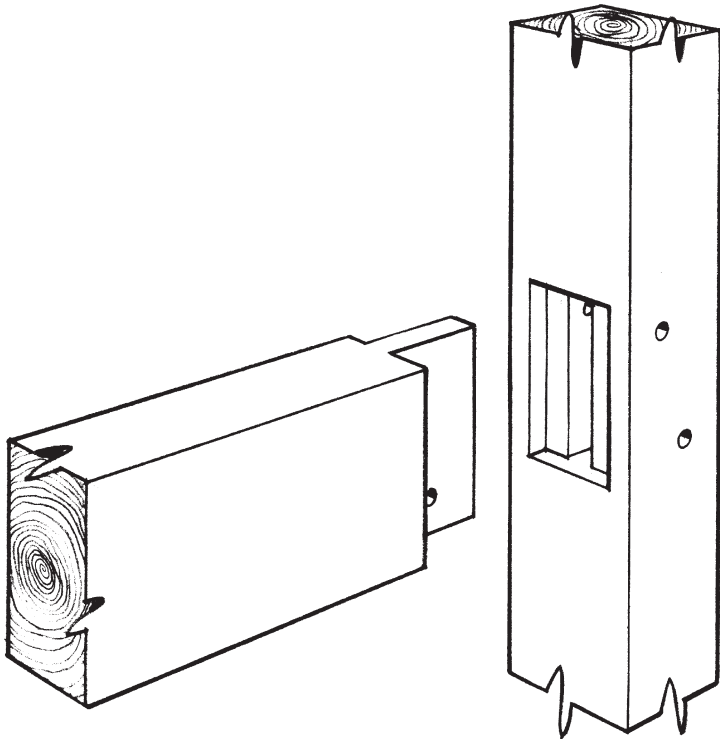
Fig. 6. In a blind-housed through mortise and tenon, the tie beam may be flush with one side or centered as shown. The uninterrupted long grain flanking the joint on the post resists breaking at the joint and mortise face splitout.

Blind-Housed Through Mortise and Tenon (Figs. 6 and 7). When the post face is wider than the tie beam, the tie beam is often housed into the post. It may be set flush with the layout face of the post (for example, the outside face of an outside post) or centered. A wide post can minimize breakage at the joint. Occasionally a tie beam is reduced in width at its end to allow for a blind housing. This extra wood retained on the post adds considerable strength compared with a post whose face has been cut right across to form an open housing.

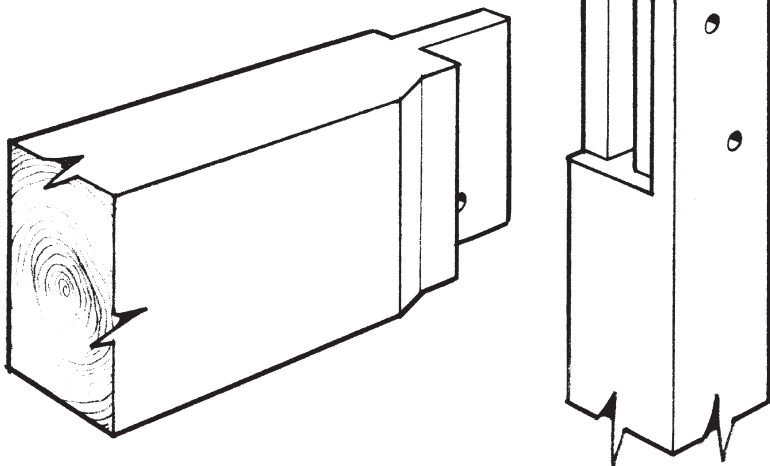
Fig. 7. Occasionally, the tie beam end is reduced in width at the housing. In some cases, it is done to square up an irregular or twisted beam end, in others to remove as little wood as possible from the post. Considerable wood can be removed from the side of the tie beam without creating a shear problem.

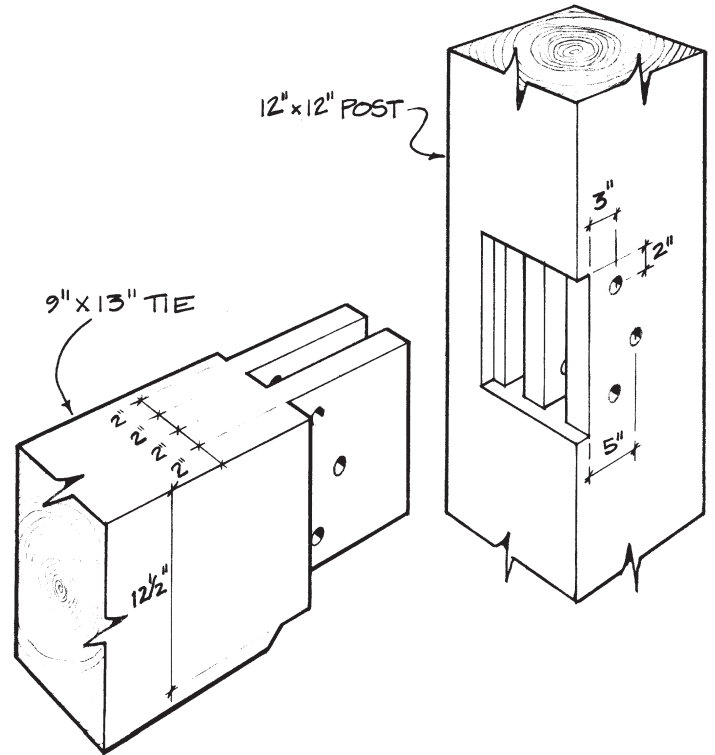
Fig. 8. Paired or twinned through mortise and tenon as found in a ca. 1840 barn in Middleburg, New York. The joint is housed flush with one side. As is typical of square rule structures, the tie beams are reduced to a consistent depth (here 12½ in.) at the joint. This rugged connection has well resisted the forces in the 50-ft.-wide barn.

Paired Through Mortise and Tenon (Fig. 8). In frames with larger members, paired or twin tenons were occasionally used. Such a configuration will likely outperform a simple mortise and tenon, with reduced tendency for pin shear and mortise-face splitout. However, the advantage must be judged against the substantial additional work in the cutting of the joint. Paired tenons are sometimes found in mill structures, barns and large wooden machines like cider presses.

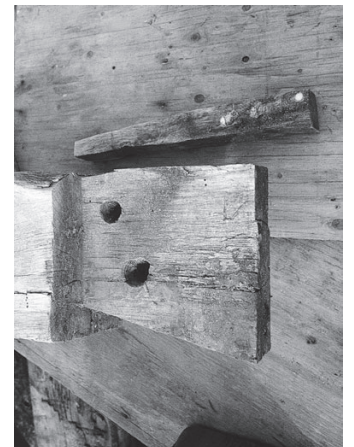
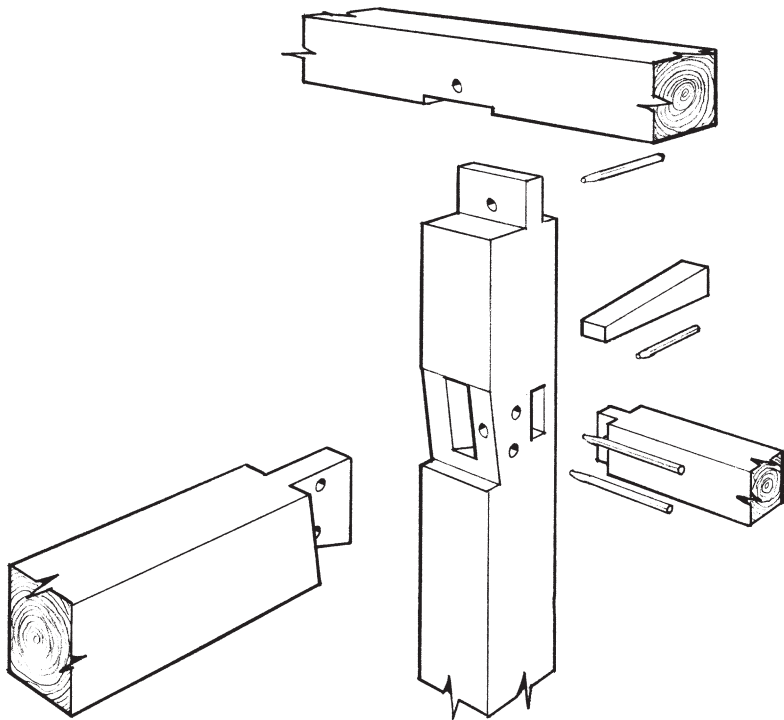
Fig. 9. Above, exploded view of the wedged dovetail through mortise and tenon in a late-1700s three-bay, 30x40-ft. English barn in Adams, Massachusetts, framed almost entirely of beech.

The Wedged Dovetail Through Mortise and Tenon (Figs. 9 and 10). This joint is arguably the strongest to use in this particular application. It does not rely upon pins to resist tension. Instead, the bottom of the tenon is angled to form a half-dovetail as shown in the photo (from a late-18th-century barn, Great Barrington, Mass.). The mortise is extended above and also angled to permit a wedge to be inserted from the outside of the post. Though pins are used to bring the joint tight, the wedge-and-dovetail configuration does the work. If worked in green timber, shrinkage will allow some withdrawal. However, in many old frames with this joint, the connection is still snug. This is probably due to the speed at which timber ends dry. Much of the tenon's shrinkage has already occurred prior to assembly even though the interior of the timber a few feet away may still be saturated with water. Ordinarily it is difficult or impossible to drive the wedge further after the exterior skin is applied. Though this joint involves more work than the basic one, it is certainly worth the effort. It has been found in buildings of all nationalities and types and from every period.

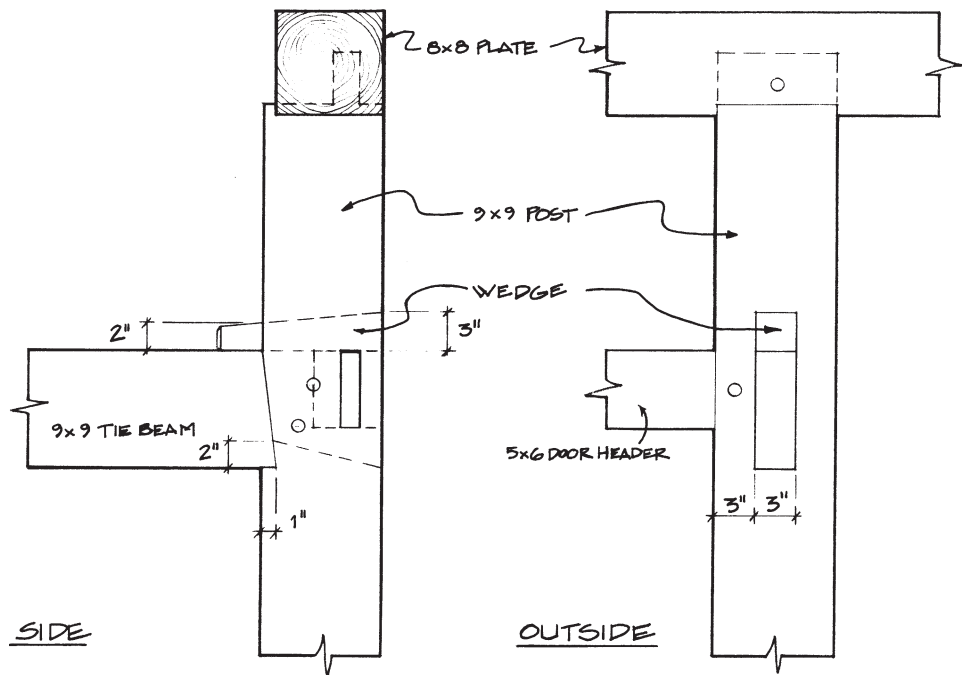
Fig. 10. At right, side and end views of the same joint with dimensions. A door header joins the post at the same height as the tie beam.

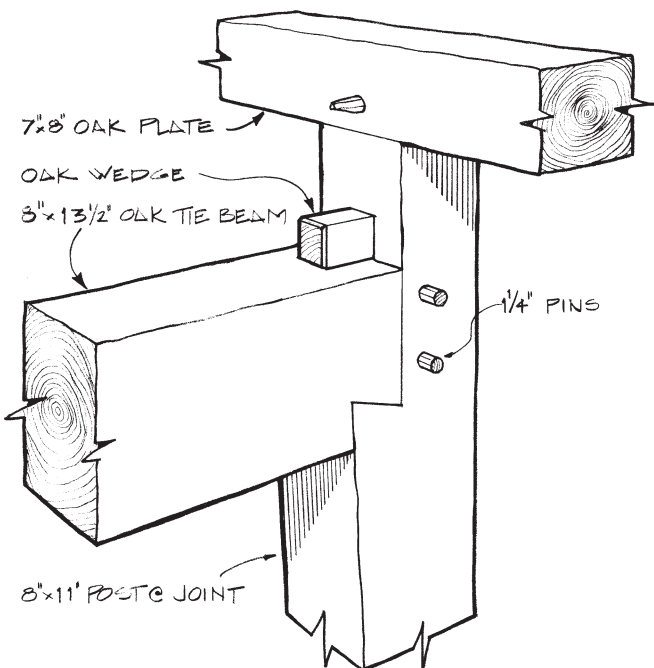
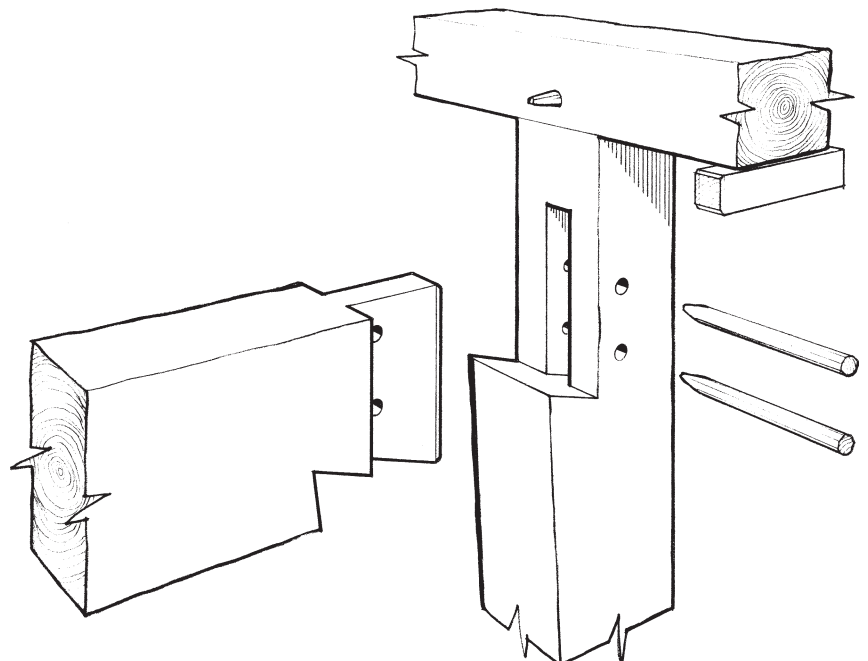
Figs. 11 and 12. Below and below right, assembled and exploded views of a wedged dovetail through mortise and tenon with dovetailed housing, as found in a 28x34-ft., three-bay side entrance barn in East Chatham, New York, probably dating from the second half of the 18th century. This unique joint has exceptional tensile strength.

The Through Mortise and Tenon with Dovetailed Shoulder (Figs. 11 and 12). A local (Columbia County, New York) variation of the wedged dovetail joint has the dovetail on the tenon continue into the housing which, because of the flare of the post, is about 3 in. deep. Only two buildings have been found with this joint. Judging by their location and similarities, they are likely the work of the same builder. The drawback to this joint would be the potential for the tie beam to fail in shear where it is notched to fit the housing. Apparently the load on the joint in this 28-ft.-wide barn is matched by the heavy oak tie beam, for nothing has failed in over 200 years.

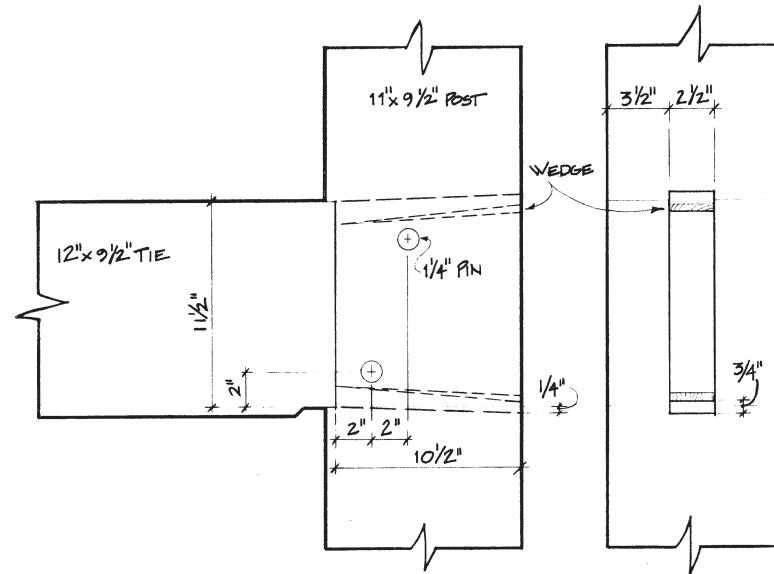
Fig. 13. This kerf-wedged dovetail through mortise and tenon joint is found in the upper floors (after 1810) of the Machine Shop at Hancock Shaker Village, Hancock, Massachusetts. It was used for both the tying joints and the queenpost trusses. This joint is much more common in furniture than in framing. Because of shrinkage in the height of the tenon, the wedges are loose, indicating that the pins are carrying the load.

The Kerf-Wedged Dovetail Through Mortise and Tenon (Fig. 13). A variation allows a basic tenon to become a full dovetail. Kerfs are sawn near the edges of the tenon and wedges are driven in to expand the tenon to fit a dovetail-shaped mortise. The kerfs are not parallel to the tenon edges, but angled away from the edge to avoid creating a splitting plane in the tie beam tenon when the edges of the tenon are bent away to follow the splay of the mortise ends. The advantage of this type over the wedged half-dovetail is that the tenon is not reduced in cross-section to create the dovetail. The disadvantage is that the angle of the dovetail must be shallow, and thus it will be affected relatively more by shrinkage of the tenon. In the illustrated example, the tenon flares only 1/4 in. on the top and bottom. After seasoning and shrinking of the members, the two pins may be carrying the entire load. It would seem that seasoned timber is necessary to use with such a subtle dovetail flare. I have found only one timber example, though the joint is common in furniture.

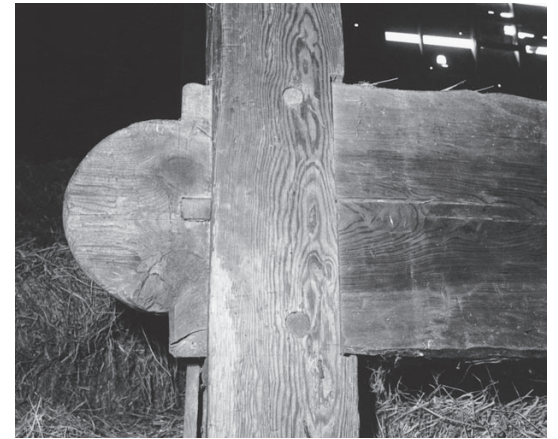
This unusual tenon profile appears on three Dutch barns in Coeymans, New York, and is likely the signature of a particular builder.

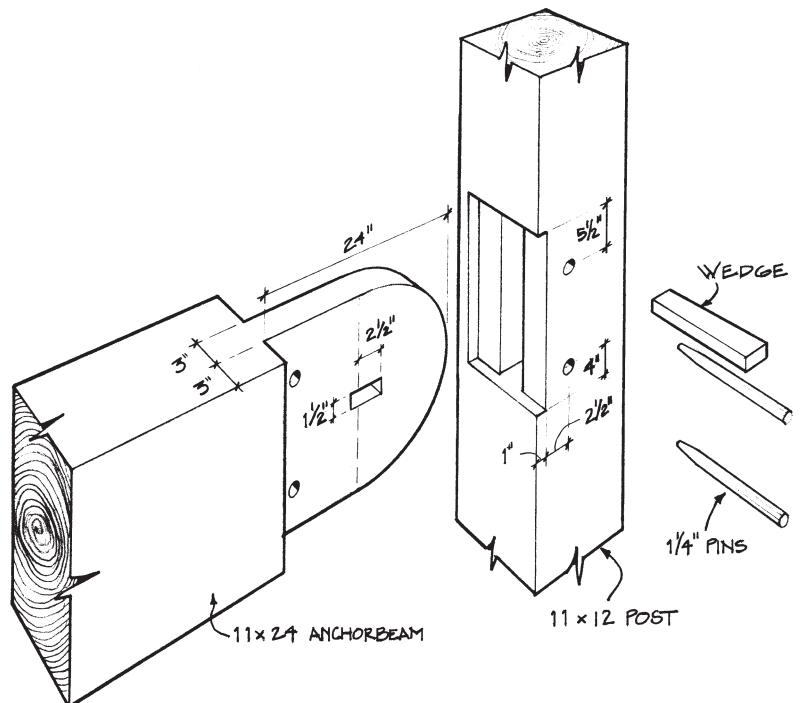
Fig. 14. Below, a through mortise and extended tenon as found in an 18th-century 47x45-ft. Dutch barn in Root, New York. Two pins and a single wedge secure this housed version. Note that the pins are not equidistant from the top and bottom of the tenon. Perhaps this was done to reduce the tendency of the 24-in.-deep white pine anchor beam to lift off the shoulder as it shrank.

Through Mortise and Extended Tenon (Figs. 14-16). When the building is aisled as in Dutch barns, the primary tying joints typically occur at the posts that flank the central aisle. These posts are joined by an *anchorbeam*, creating an H-shaped bent. The side aisles are treated as lean-tos and gain their strength from the H-bent. Since the tying joint is now interior, the tenon can be extended for additional strength without being exposed to the weather. (In Europe, such tenons are often exposed on the exterior of buildings.) Adding a foot or so of tenon prevents relish failure. By adding wedges through this tenon, all five potential modes of failure mentioned earlier are effectively eliminated save one: where the post breaks at the tying joint. The wedges can be driven additionally after the building is finished and the wood seasoned. The only disadvantage is that an additional 2 ft. or more of length are required on the anchorbeams, typically the largest timbers in a building. (Sections 12 by 24 in. are not uncommon.) The profile of the tenon varied with the builder.

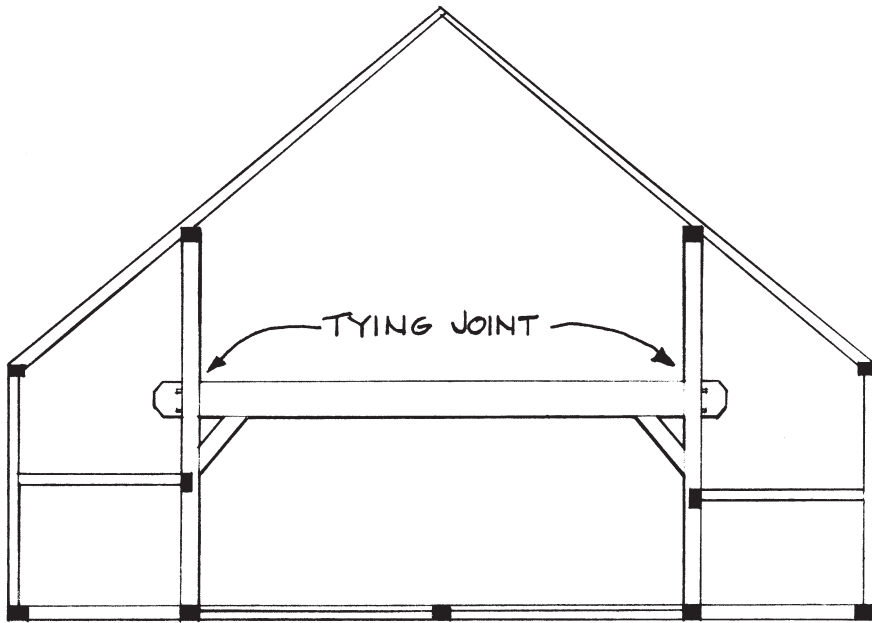
Fig. 15. The New World Dutch barn is an aisled building. The structural core is the H-shaped bent, each composed of aisle posts and an anchorbeam with heavy braces. Because the tying joint is interior, the tenon can be extended without being exposed to the weather.

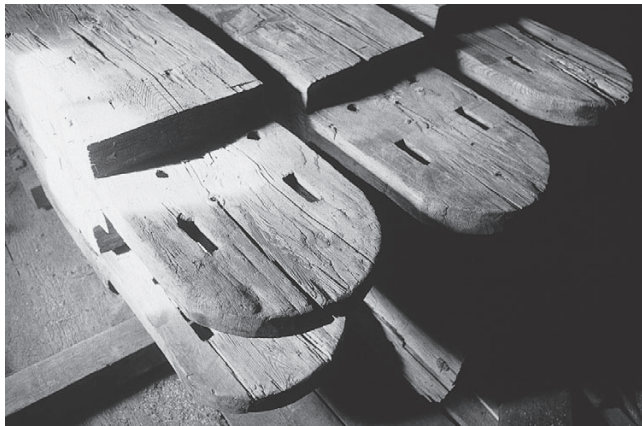
Anchorbeam tenon ends from a pre-1820 Dutch barn taken down in Altamont, New York.

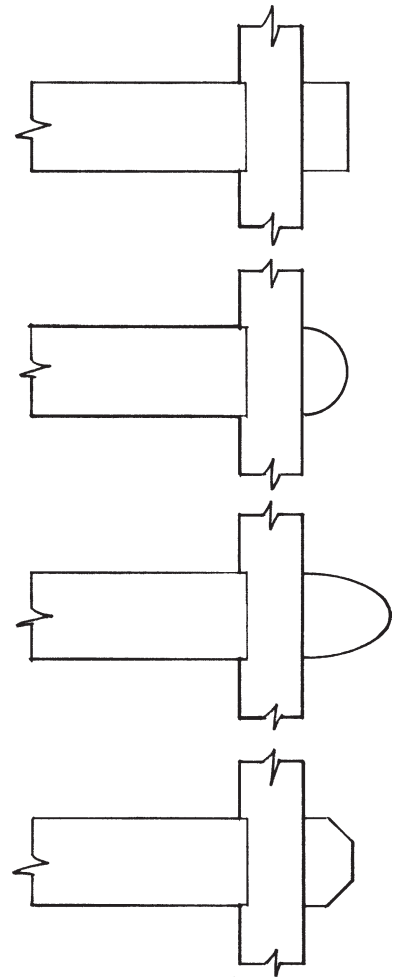
Fig. 16. Common variations on the shape of the protruding tenon. All versions have been found with two wedges, one wedge or no wedges.

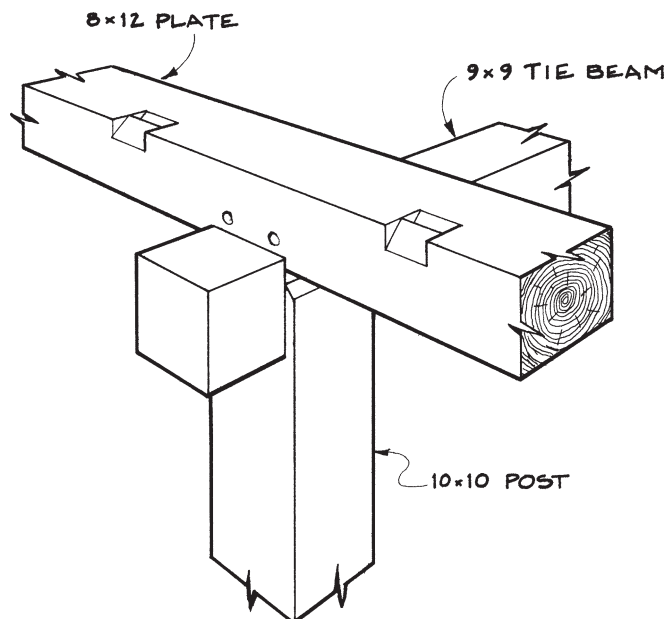
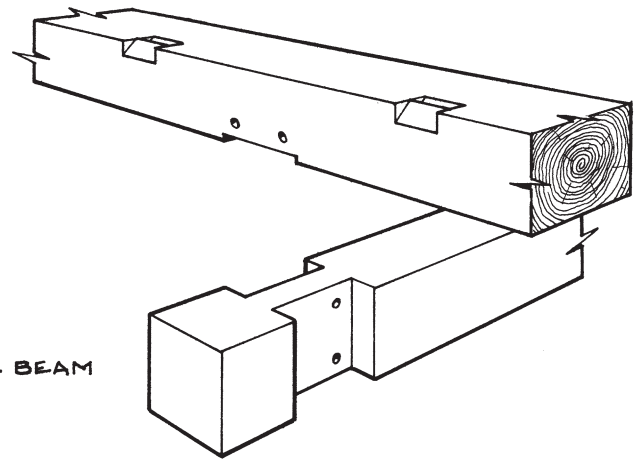
Fig. 17. Assembled and exploded views of a necked tying joint in a ca. 1840, 30x40-ft. English barn in Warren, Vermont. The 9x9 tie beam has a 3-in.-thick neck secured as a normal through tenon with two 1-in. pins. The head protrudes 8 in. past the post. Two, 2-in.-thick tenons secure the post to the plate. This building was cut using the square rule system, and consequently the joint is housed into the plate. Roof thrust is additionally resisted by the plate bearing directly against the head of the tie beam.

Necked Tying Joint (Fig. 17). Referred to in The Netherlands as a *Kopbalkgebint*, this joint also extends beyond the post for great strength. It may be used in non-aisled structures and still be protected from the weather as it can be tucked under an overhanging roof. The tie beam end resembles a head and neck. The tenon or neck fits in a slot cut in the top of the post to make a form of bridle joint. The post has paired tenons into the plate. This ingenious joint could hardly be improved upon. Its only disadvantage is that its location is fixed at just below the plate. It also requires posts wider than normal to accommodate the extra joinery. Only three American examples have been documented, two in Dutch barns in Blenheim and Schoharie, New York, the third in a three-bay "English" barn in Warren, Vermont (See TF 30).
