HISTORIC AMERICAN TIMBER JOINERY

A Graphic Guide

IV. Wall and Brace Joints

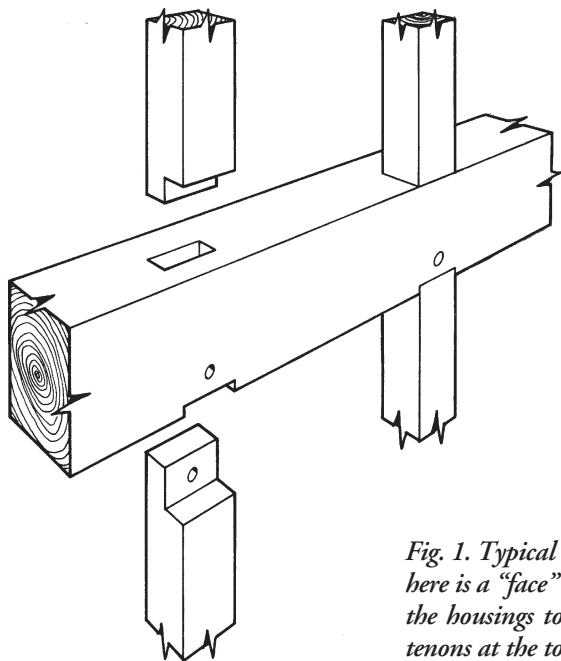
Fig. 1. Typical barefaced tenon wall studs in a square rule building. The top surface of the girt here is a "face" (a reference surface) and thus has no housings. The lower surface is reduced at the housings to the size of the ideal-timber-within. It is common for studs to have pinned tenons at the top end and stub tenons at the bottom.

The barefaced mortise and tenon joint typically secures studs to sill, girt, tie beam and plate. Since a barefaced tenon has only a single shoulder, it is very quick to cut. In a scribe rule building, these studs are not usually housed into the mortised piece. In a square rule building, they are typically housed at one or both ends (Fig. 1).

If pinned, tenons are typically twice as long as they are thick (for example, a 1½-in. tenon would be 3 in. long). Unpinned joints are common, as are stub tenons. Stub tenons are the same length as their thickness. Square rule buildings typically have stub tenons at the bottom of studs and pinned tenons at the top, to keep the studs from falling out during the rearing of assemblies but to allow easy insertion of the many studs into the sill mortises as a bent or wall approaches vertical.

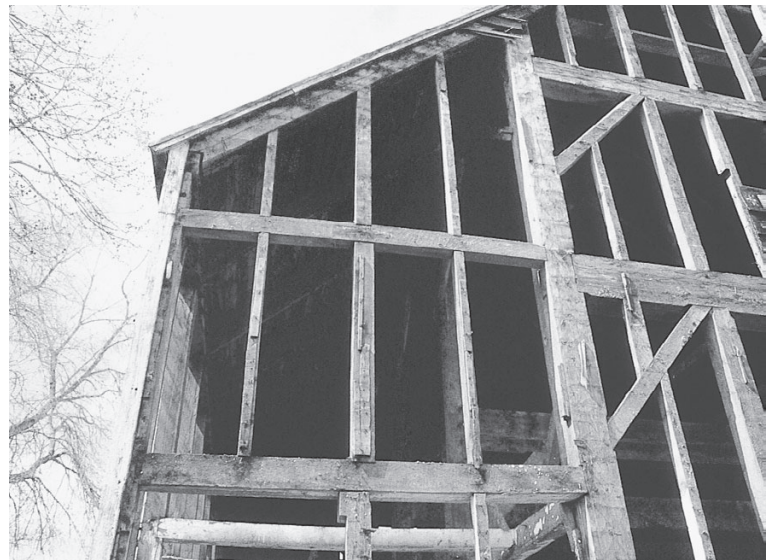
Sheathing direction determines the orientation of wall framing. This early 1800s barn (now dismantled) from Middleburg, N.Y., has studs to support wide clapboards. Note how the braces take precedence over the studs.

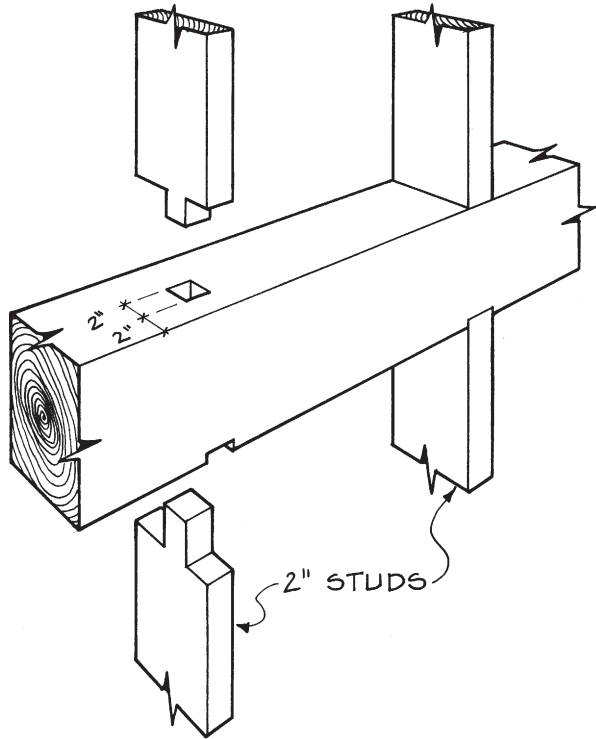
Fig. 2. In churches where the framing was concealed by plaster, studding was commonly as wide as the main timbers, to present a flush appearance on the interior. Here, 2x8 studs are framed by the square rule. Two-in. studs are rarely pinned and occasionally nailed. Tenons on 2-in. stock are quickly sawn out. The mortises require just a single bore.

The most common stud sizes were 3x4 and 4x4. The 3x4 could be framed flat to the wall with a 1½-in. shoulder and a 1½-in. tenon, or turned on edge for a 2-in. shoulder and a 2-in. tenon. Four by fours were typically framed with a 2-in. shoulder and a 2-in. tenon. In some larger public buildings where the framing was concealed, the studs were as wide as the principal posts so that the interior walls had no protrusions (facing page, Fig. 2). Studs were commonly 6, 7, or 8 in. wide and from 2 to 4 in. thick in such structures. Obviously the barefaced tenon wouldn't work here.

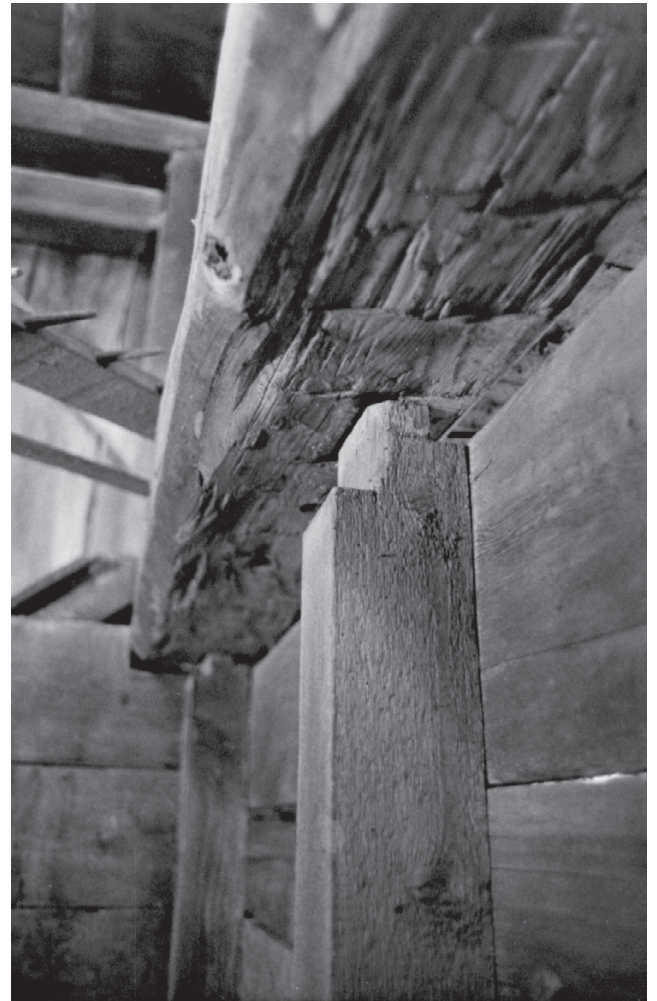
This partially withdrawn stud in a barn in Shaftsbury, Vermont, was relieved at its end to make its tenon barefaced. Uncommonly, the relief cut was not angled, and gives the appearance of a second cheek and shoulder.

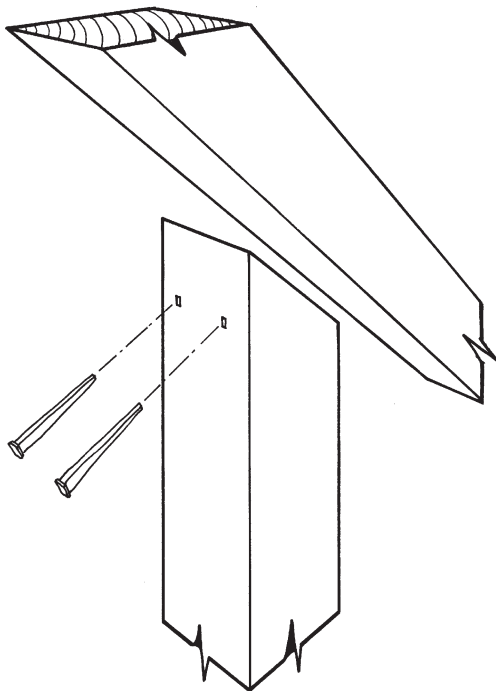
Fig. 3. Studs are subservient to braces (which must be uninterrupted to do their work well) and consequently are merely cut to match the angle and secured with nails. However, the other end of such studs is still tenoned.

Where a stud met a brace or rafter, it was rarely mortised in. The stud would be fitted after the frame was reared. Typically it was butted and nailed (Fig. 3). A less common but stronger solution was to use a beveled lap joint (Fig. 4). It too was secured with nails.

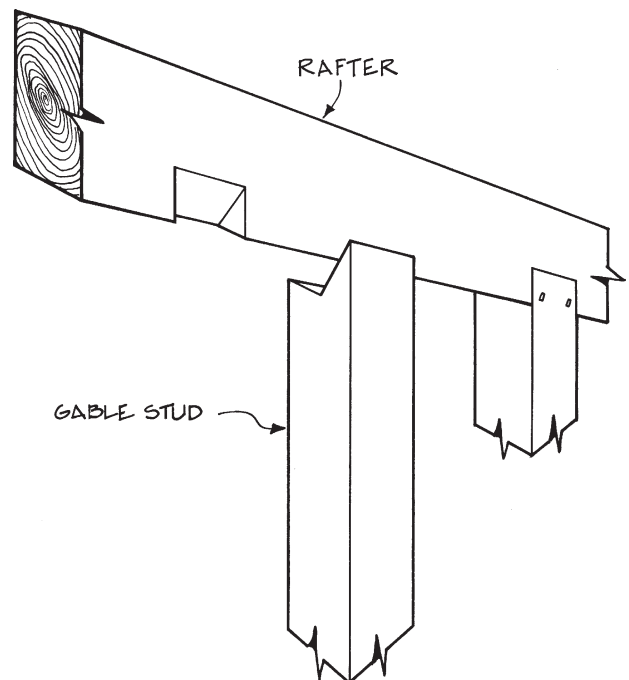
Fig. 4. A beveled lap provides a sound solution to inserting studs after erection. It is a joint easily fashioned in situ.

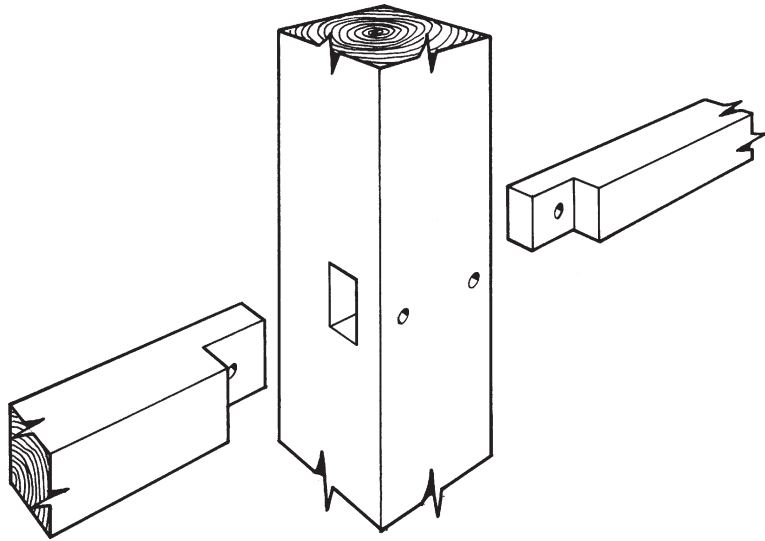
Fig. 5. Barefaced and pinned girts in a typical scribe rule building.

Girt joinery closely resembles stud joinery. The barefaced tenon is common, as are the sizes 3x4 and 4x4 (Fig. 5). Many barns built before the advent of the circular sawmill used girts hewn on only one face and squared up to a consistent size only at the joints (Fig. 6). For girts with longer spans or with floor loads to support as well, a standard mortise and tenon replaced the barefaced tenon (Fig. 7).

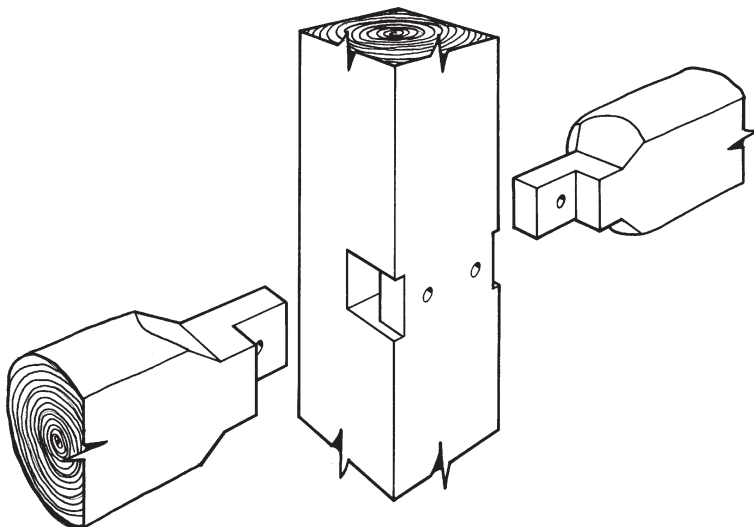
Fig. 6. Barefaced and pinned girts in a typical square rule building. To save on hewing, these members were flattened only on the face receiving the wall sheathing. The ends are squared up at the joint. The post has its ideal-timber-within centered so the girts are housed both sides.

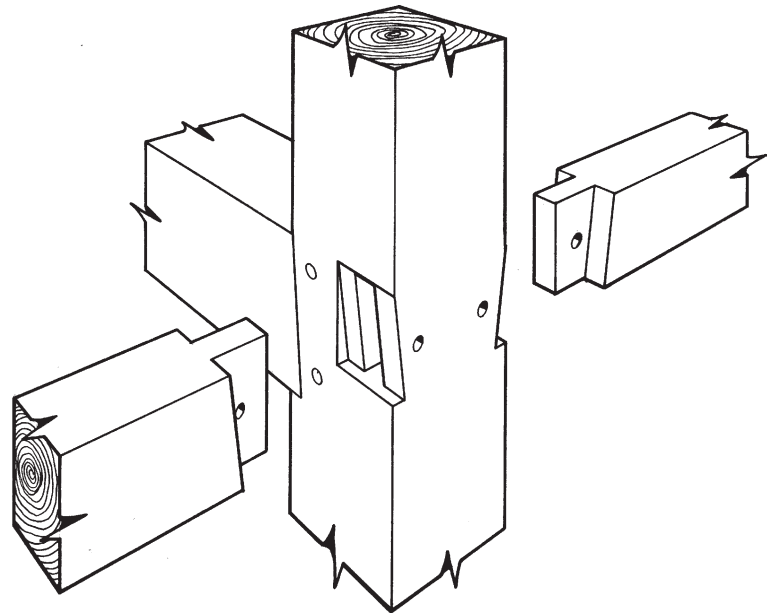
Fig. 7. Wall girts at floor level in a scribe rule building. These load-bearing girts rely on standard mortise and tenon joints with diminished bearing shoulders.

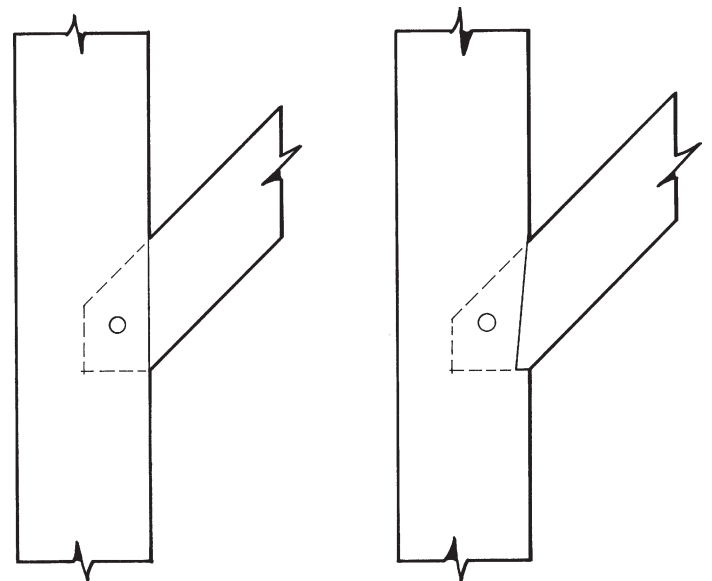
Fig. 8. Scribe rule braces: non-bearing shoulder on the left, diminished bearing shoulder on the right.

Tenoned Braces. The vast majority of tenoned braces are barefaced, as with studs and girts. Braces in frames built using the earlier scribe rule system might have no bearing shoulder (Fig. 8, left) or a diminished bearing shoulder (Fig. 8, right). The latter configuration is clearly superior, adding to the tenon end an addi-

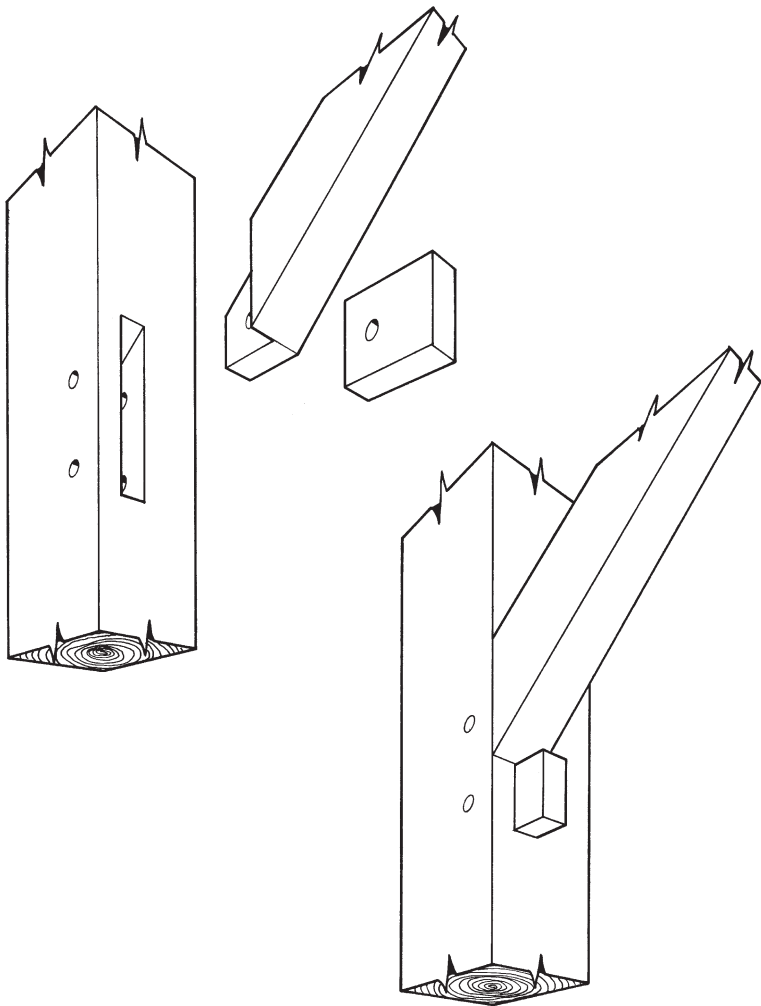
Fig. 10. Brace with packing piece. After the opposite end of this brace was inserted into its mortise, this end was swung into place. A carefully fitted block, here secured with a pin, filled the extra mortise length.

In some scribe rule framing, the mortise at one end of a brace is elongated and filled with a carefully made block (Fig. 10 left). This packing piece may be pinned and have an identification mark. Its purpose was to speed the scribing process by allowing a brace to be cut and inserted without taking apart the assembly. This technique was also used to insert a tenoned brace into a frame after erection.

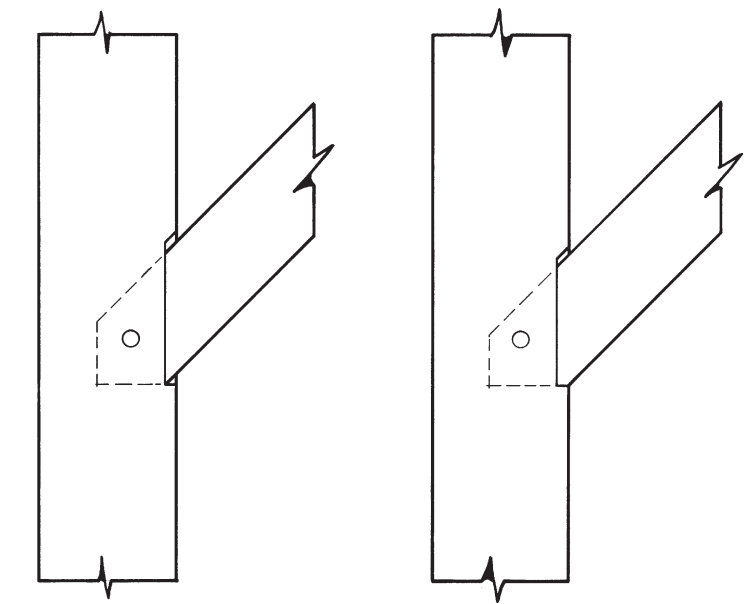
Fig. 9. Housed square rule braces with and without bearing shoulders. The brace on the left would be unhoused if meeting a "face."

face) of a timber, but, if entering an opposite surface, would be housed deep enough to meet the specified dimension of the ideal-timber-within (Fig. 9, below left). The brace itself might or might not have a bearing shoulder (typically undiminished or parallel), as the carpenter saw fit (Fig. 9). Again, the better choice was to provide the additional bearing at the nose of the brace. In square rule structures, a gap is usual at the unloaded end of the brace mortise, to allow for variations in width of the brace stock, or reflecting cross-grain shrinkage of the brace.

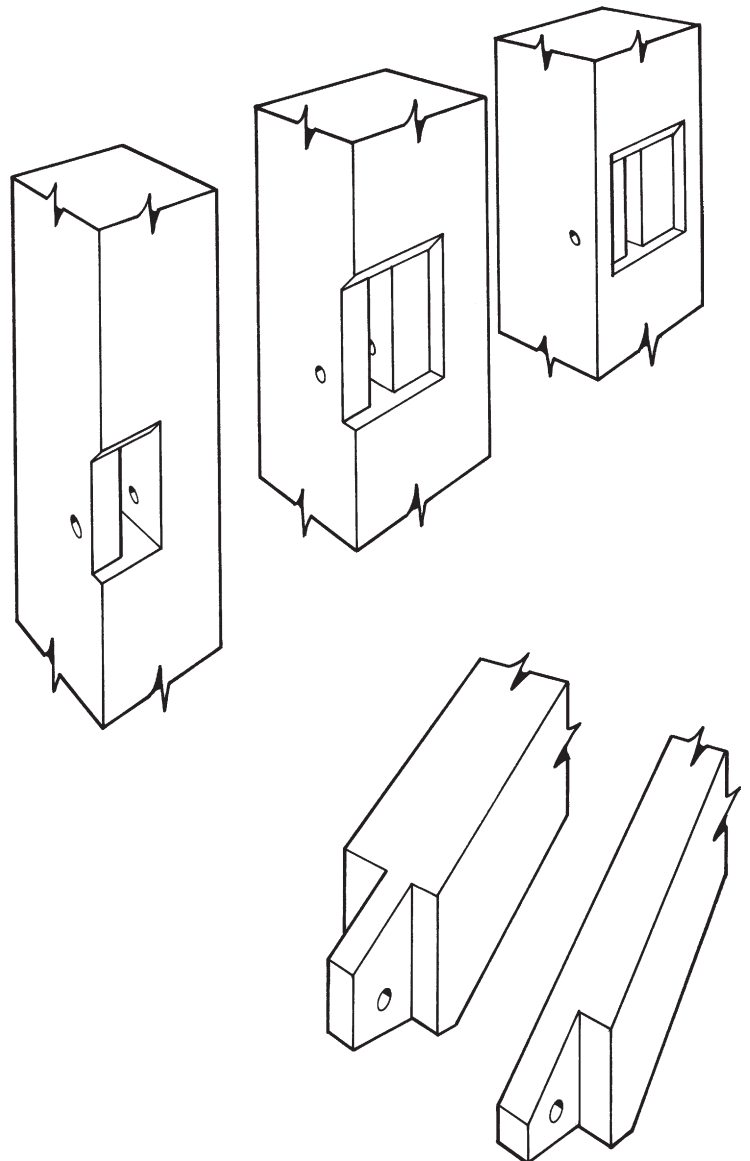
Fig. 11. Square rule brace variations. At top, left to right, barefaced, half-housed and full-housed mortises. Above, full and barefaced tenons. The full tenon joint would be chosen for expected heavy loads.

Where heavy loading was anticipated, carpenters used the standard mortise and tenon with either the diminished or parallel bearing shoulder (Fig. 11 below). In some Dutch barns, massive braces as large as 9x12 support the anchorbeams.

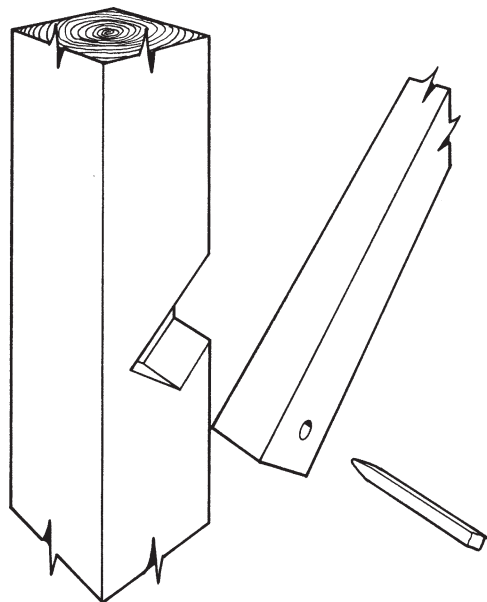
Fig. 12. This simple lap is notched in its full thickness and secured with a squarish pin.

Lapped Braces. Primarily found in early scribe rule frames, lapped braces display three variations: simple, dovetailed and notched. The simple lapped brace may be half-lapped (let in half its depth) or full-lapped (let in full depth), as shown Fig. 12. A squarish pin secures the brace from popping out and gives it some modest tensile capacity. The advantage of these simple lapped braces was in the labor they saved during scribing and cutting. Time has proved their effectiveness.

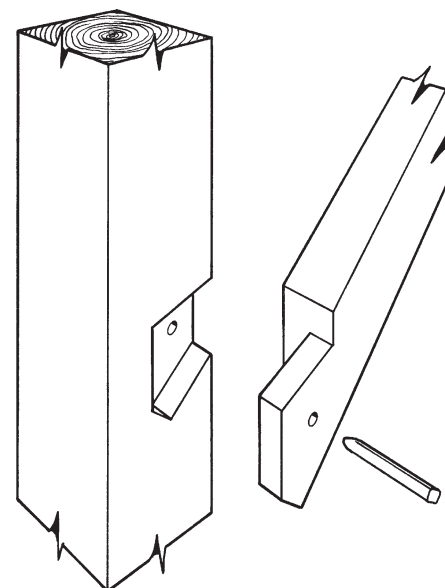
Fig. 13. Lapped half-dovetail with pin. The squared-off end of the mortise was a way to increase the compressive strength of the brace and, more important, to avoid chopping out an acutely angled housing. The width of this facet of the housing usually matches or exceeds the width of the chisel used.

The half-dovetail lap improved tensile performance with only slightly more labor (Fig. 13). As the brace is pulled, the dovetail jams on the nonparallel edges of its housing. But shrinkage after cutting diminishes the effectiveness of the dovetail, whereupon the pin must again handle tensile load. Full-dovetail laps (both sides angled) were rare.

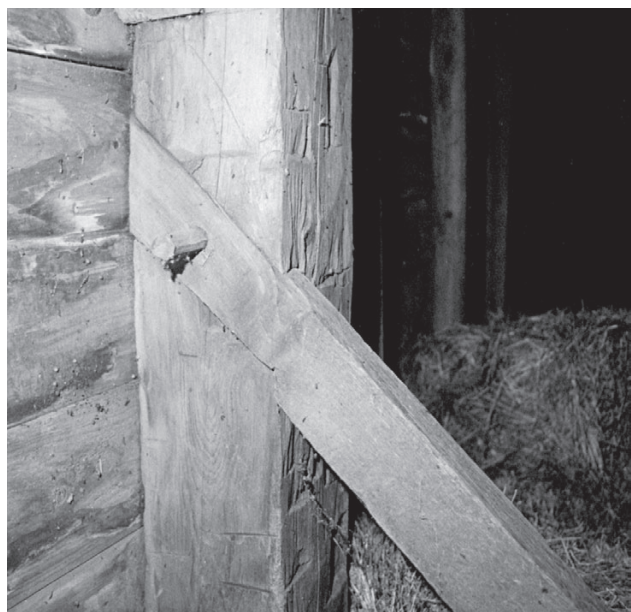
Through-lapped half-dovetails are common. The through housing removes more wood from the post than a stopped housing, but it can be sawn to full depth, saving considerable chiseling work. The dovetail slope typically is cut on the inward-facing edge of the brace. This brace runs from a post down to a tie beam in a scribe rule German barn dismantled in Alcove, New York, and moved to Long Island.

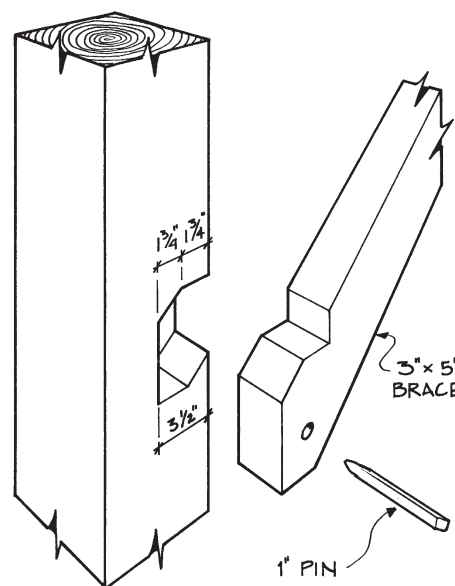
Fig. 14. Notched brace found in a 1700s meetinghouse dismantled in Pownal, Vermont, in the 1970s. It is lapped in its full thickness.

The notched lap (Fig. 14) worked differently from the half dovetail, and it was less affected by shrinkage. However, it entailed

more cutting time. There was less sawing and more chopping. Interestingly, this joint is found on one of the oldest surviving timber-framed barns in England, the Barley barn at Cressing Temple ca. 1200. The joint persisted in America (though in limited use) until the end of the scribe rule era.

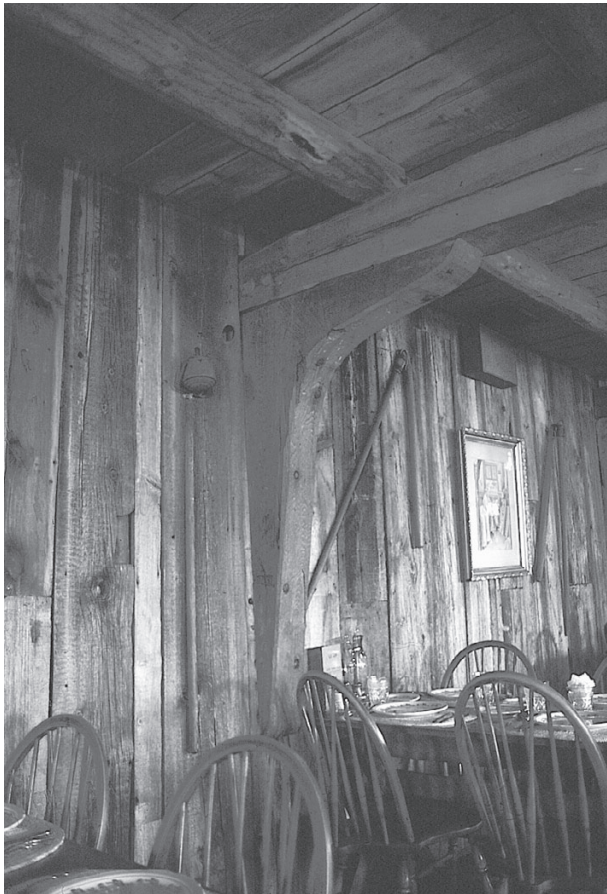
Dutch barns often had extremely long braces. In this upstate New York example, they are half-lapped where they cross.

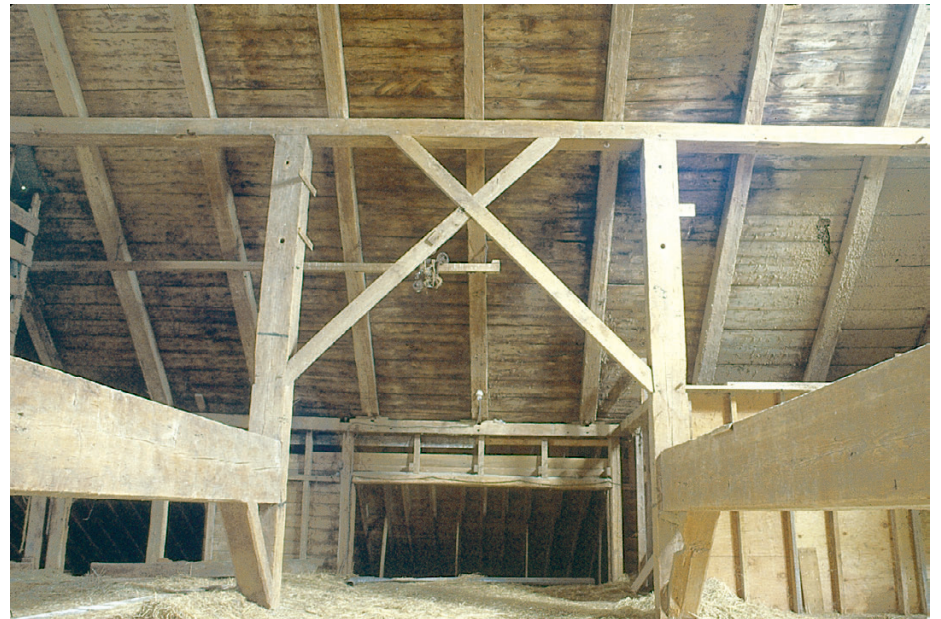
To conserve headroom, knees were used in buildings as well as ships. Cut from the tough root-trunk or trunk-branch portion of the tree, they were pinned or bolted to the post and crossbeam. This one stiffens a Kennebunkport, Maine, gristmill and restaurant.

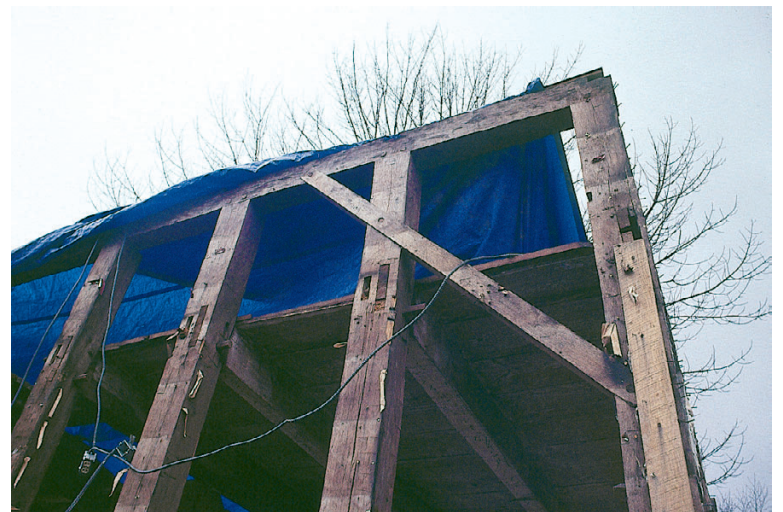
In Dutch houses, where wall posts are closely spaced, builders might use passing braces to achieve a long (and so more effective) brace length. In this Alford, Massachusetts, house, undergoing renovations, the brace passes one post where it is lapped its full thickness and secured with a pin. Below, in lieu of normal braces, some German carpenters would angle a stud to serve as both brace and stud, as in this structure in Ephrata, Pennsylvania.

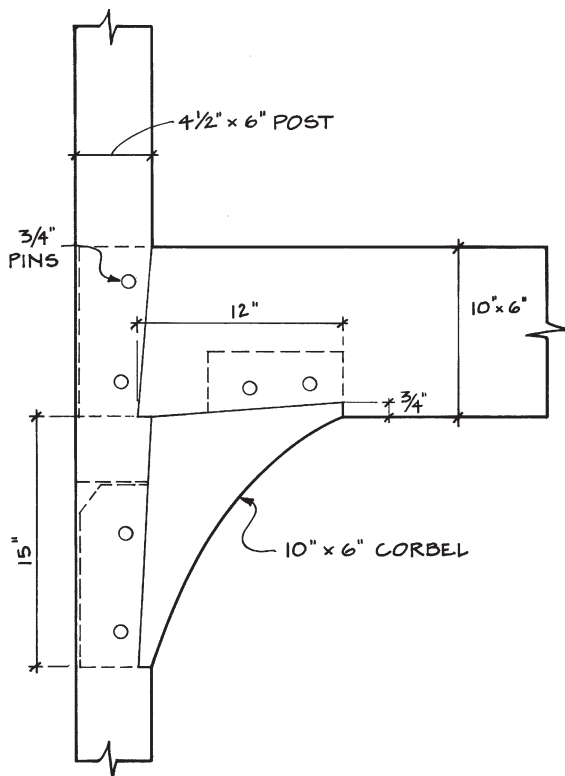
Fig. 15. Some early Dutch houses used short, solid braces called corbels, which protrude less into the interior space than standard braces and form a decorative feature. This example is from an 18th-century house (now dismantled) in Muitzenkill, N.Y., on the upper Hudson River.

Special bracing types. Other devices were used than the standard diagonal brace to stiffen a structure. Early Dutch houses occasionally have “corbels” that function both as brace and (like the masonry counterpart) as support. In some German, as well as French, Swiss, Polish and Danish structures, the walls include distinctly leaning studs (*streben* in German, *écharpes* in French). These serve both as post and brace, thus saving framing time and often carrying bracing loads directly from plate to sill. Finally, in coastal communities with a shipbuilding tradition, carpenters sometimes resorted to naturally crooked ship’s knees for bracing, which gained headroom and shortened effective beam spans. —JACK A. SOBON
