ITS
NUMBER 52

Interpreting The Secretary of the Interior's Standards for Rehabilitation

Subject: Incorporating Solar Panels in a Rehabilitation Project

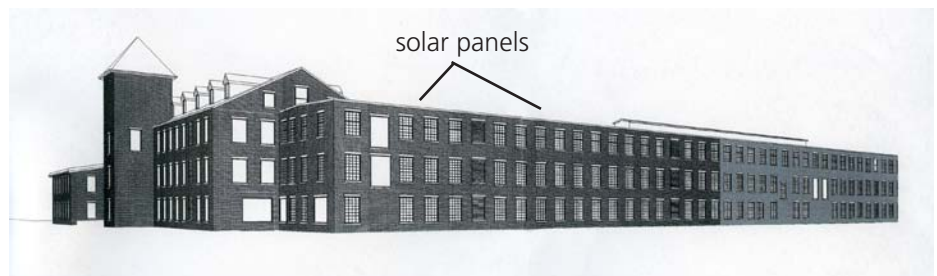
Because of the size of this historic mill, a large array of solar panels could be installed on the flat roof without being seen from the ground.

The rehabilitation of this mid-nineteenth century mill incorporated a large, roof-mounted photovoltaic installation. Although the historic building does not have a parapet wall at the roofline, the height of the building and the arrangement of the panels render the entire installation invisible from the ground. It is important to note that the panels are placed horizontally. Had the panels been installed with a vertical tilt, the angle required to maximize efficiency would have caused the panels to extend significantly higher above the roof. Simply changing the direction in which the panels are tilted can affect their visibility and reduce their impact on the character of the historic property.

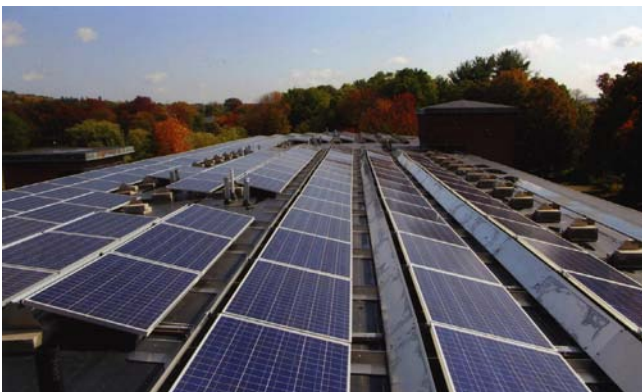
Solar panels installed on the flat roof.

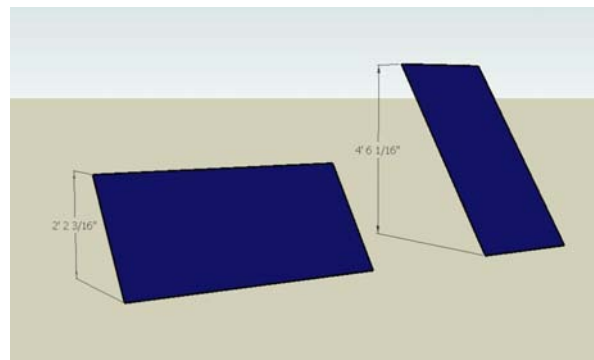
By placing the panels horizontally, the overall height of the installation and its visibility is reduced.

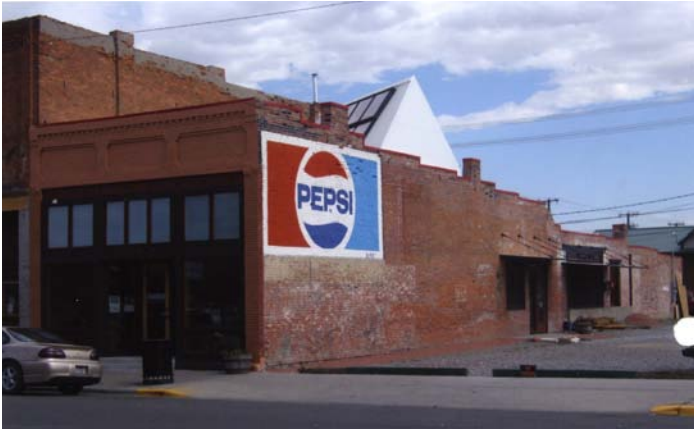
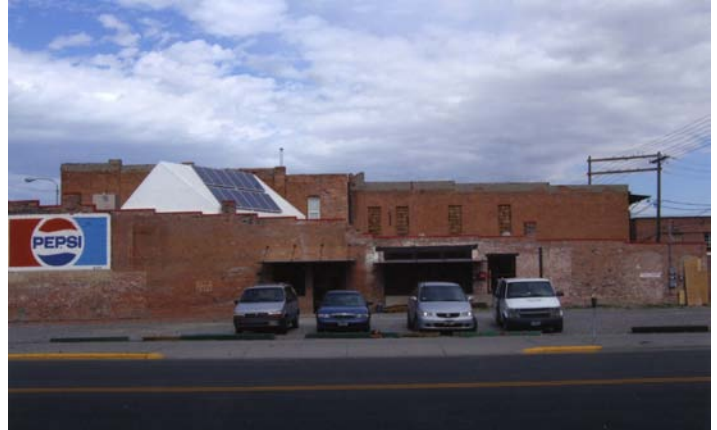
The addition of a large rooftop monitor featuring skylights on the front slope and solar panels on the rear slope is not compatible with the historic character of this small, one-story commercial building.

Application 2 (*Incompatible treatment*): During the rehabilitation of this late-nineteenth century commercial building, a conspicuous rooftop monitor with prominent solar panels and skylights was constructed on the one-story structure. The size and finish of this rooftop addition are incompatible with the historic character of the building. However, the building could have accommodated both skylights and solar panels if they had been installed differently. An alternative design that could have met the Standards would have included low-profile skylights and solar panels concealed behind the parapet wall.

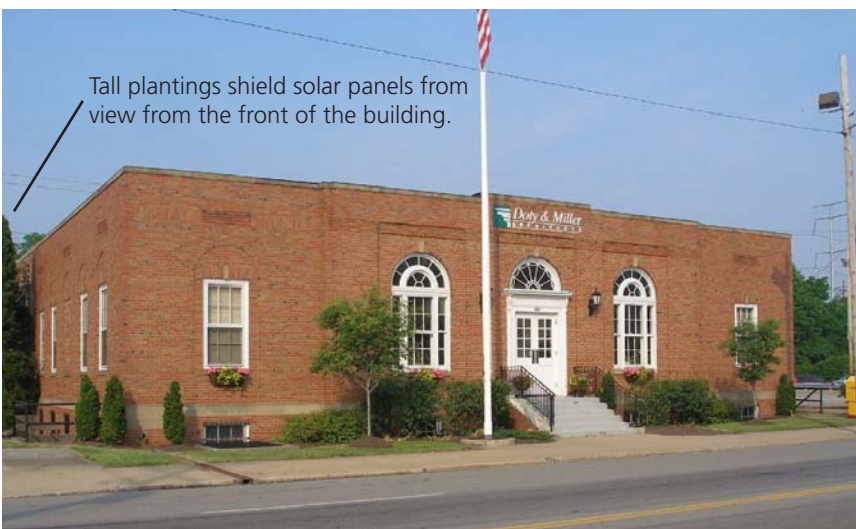
Left: The solar panels are not visible from the front of the building. Additionally, even if the vegetation were removed, the installation would only be minimally visible along an alley at the rear of a secondary side elevation.

Application 3 (*Compatible treatment*): The rehabilitation of this historic post office incorporated solar panels as dual-function features: generation of electricity and shading for south-facing windows. In this instance, the southern elevation of the building is also a secondary elevation with limited visibility from the public right of way. Additionally, because this area of the building is immediately next to the post office’s loading dock, it has a more utilitarian character than the primary facades and, therefore, can better accommodate solar panels. Because the panels are in a suitable location at the rear of the property and are appropriately sized to serve as awnings, they do not affect the overall historic character of the property. Additionally, a screen of tall plantings shields the solar panels from view from the front of the building, further limiting their visibility.
