Interpreting The Secretary of the Interior's Standards for Rehabilitation

Subject: Installing Green Roofs on Historic Buildings

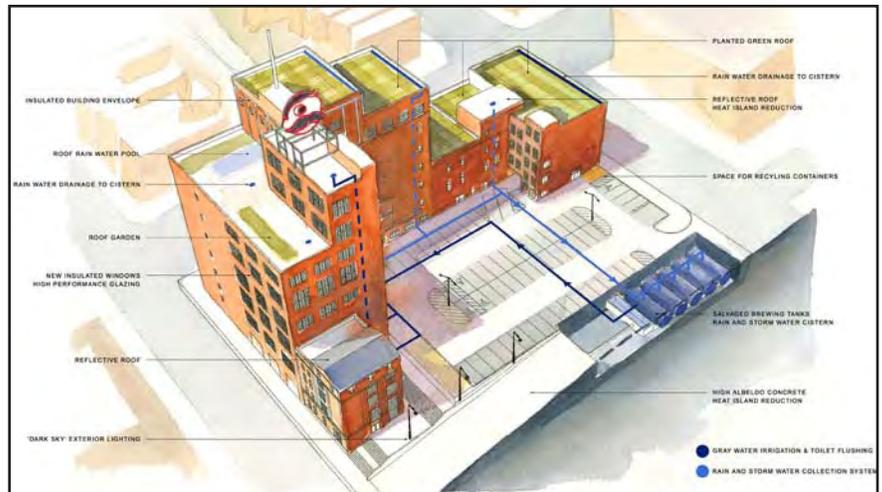
*Above: The plantings are low and are not visible from the surrounding streets due to the high parapets of the historic buildings.
Below: View of the green roofs after installation.*

Application 1 (Compatible treatment): A defunct brewery complex, constructed in the late-nineteenth century, was rehabilitated for mixed use including office space, storage, and retail. The owners wanted to integrate green features into the project to make it more sustainable and to take advantage of local energy tax credits as well as the Federal Historic Preservation Tax Incentives. Accordingly, green roofs were constructed on several of the buildings with flat roofs that were suitable for such an installation. These buildings are tall with sufficiently high parapets so that the roof plantings are not visible from the public right of way. The incorporation of green roofs on these historic brewery structures meets the Standards.

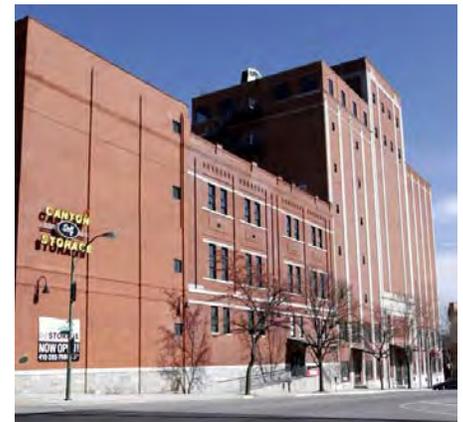
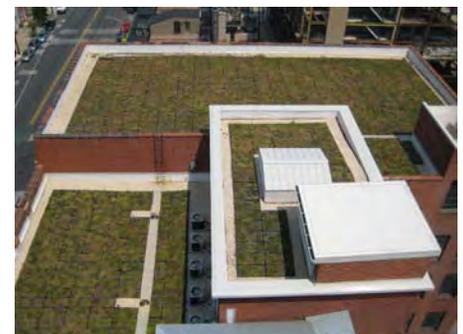
The location of the green roofs as well as water collecting tanks and graywater redistribution systems are illustrated in this rendering of the brewery complex.

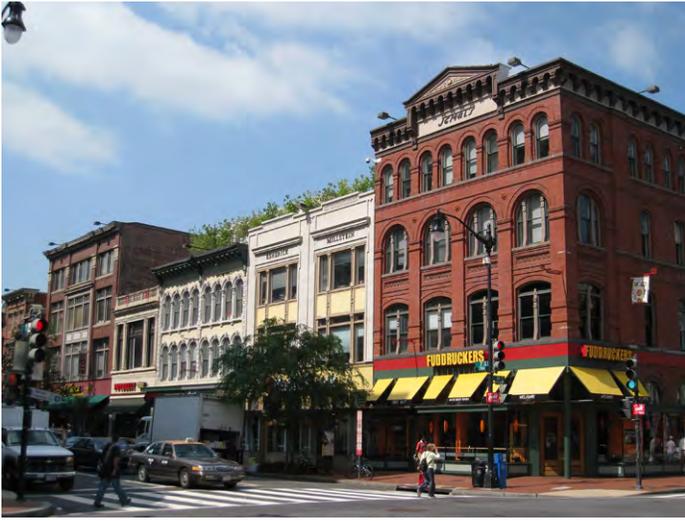
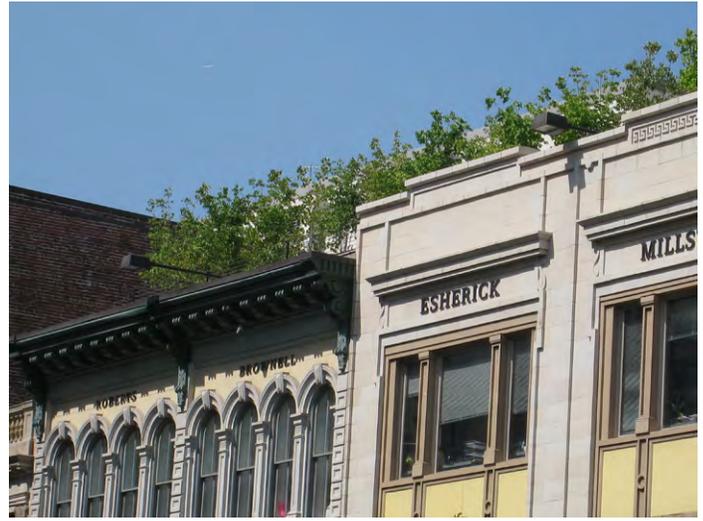
The plantings on these commercial buildings—highly visible above the parapets—are not in keeping with the historic character of the structures.

Application 2 (*Incompatible treatment*): Two neighboring late-nineteenth and early-twentieth century commercial buildings added green roof features to take advantage of the energy benefits and to provide a pleasant space for building occupants. The three-story buildings front a busy city street where they are highly visible from many vantage points along the street. Although the buildings have substantial parapets, the trees, which can be seen from the street below, negatively impact the character of these historic buildings.

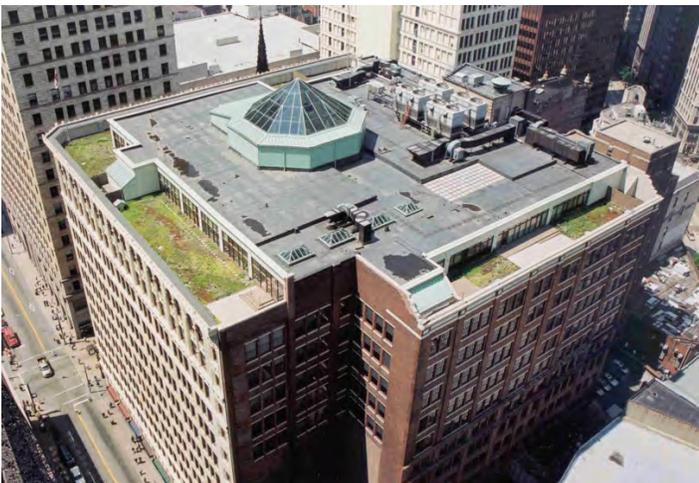
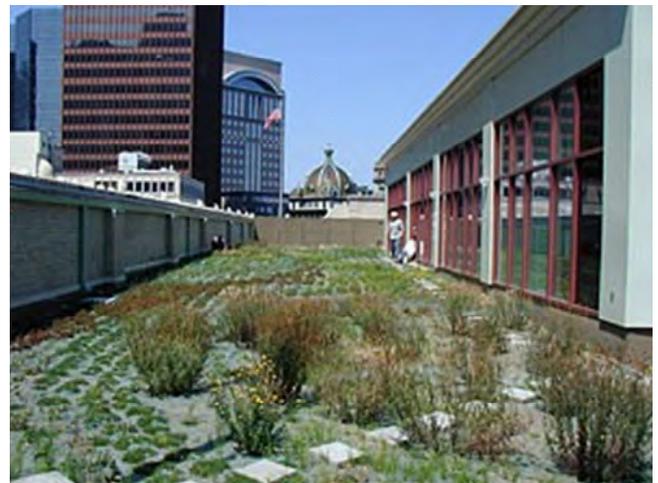
*Left: Roof of the rehabilitated department store building with of green roof sections.
Right: The tall parapet conceals the plantings and the penthouse from the street below.*

Application 3 (*Compatible treatment*): The rehabilitation of this early-twentieth century former department store for office and retail use included large sections of green roof. The green roof consists of planted terraces used by tenants of the penthouse offices that were also added as part of the rehabilitation. The sustainable green roof increases the energy efficiency of the building, and the green groundcover also acts as an acoustical damper for the rooftop offices. The tall parapets completely hide the green roof from view—and also conceal the new penthouse addition, ensuring that the historic character of the building is retained while incorporating this energy-efficient and environmentally-friendly feature. This project meets the Standards.
