National Park Service  
Cultural Landscapes Inventory  
2007

Tuolumne Meadows Historic District  
Yosemite National Park

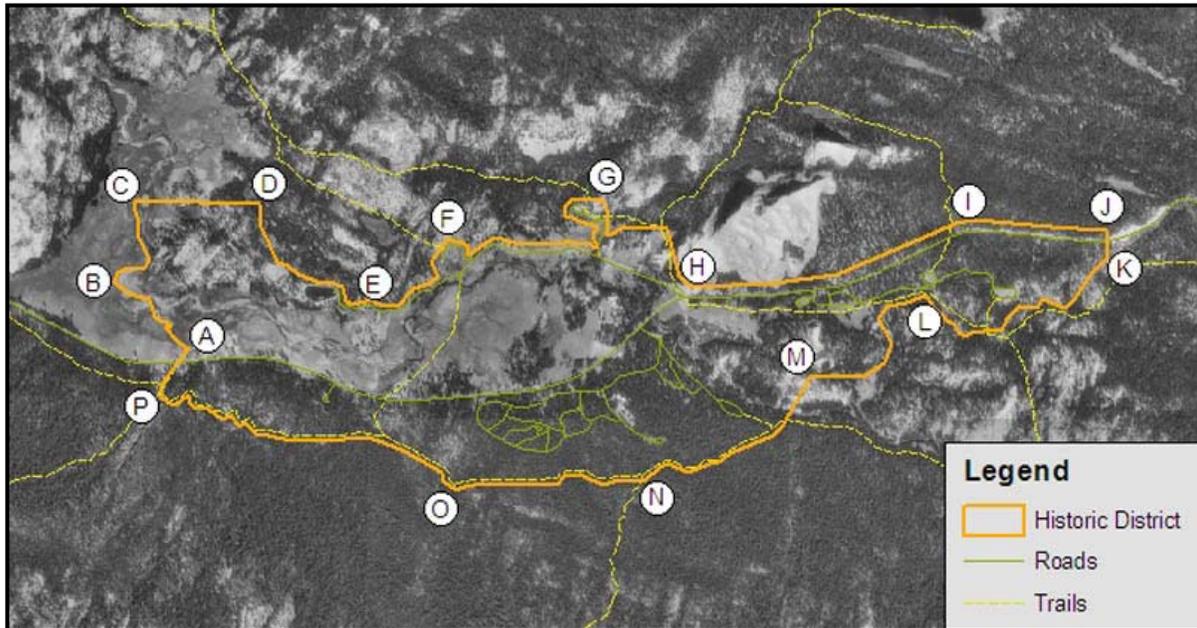
*Boundary Description #1: Map illustrating boundary of Tuolumne Meadows Historic District with location of selected reference points. Coordinates of points are given in table below. The boundary is consistent with the 1985 wilderness boundary.*

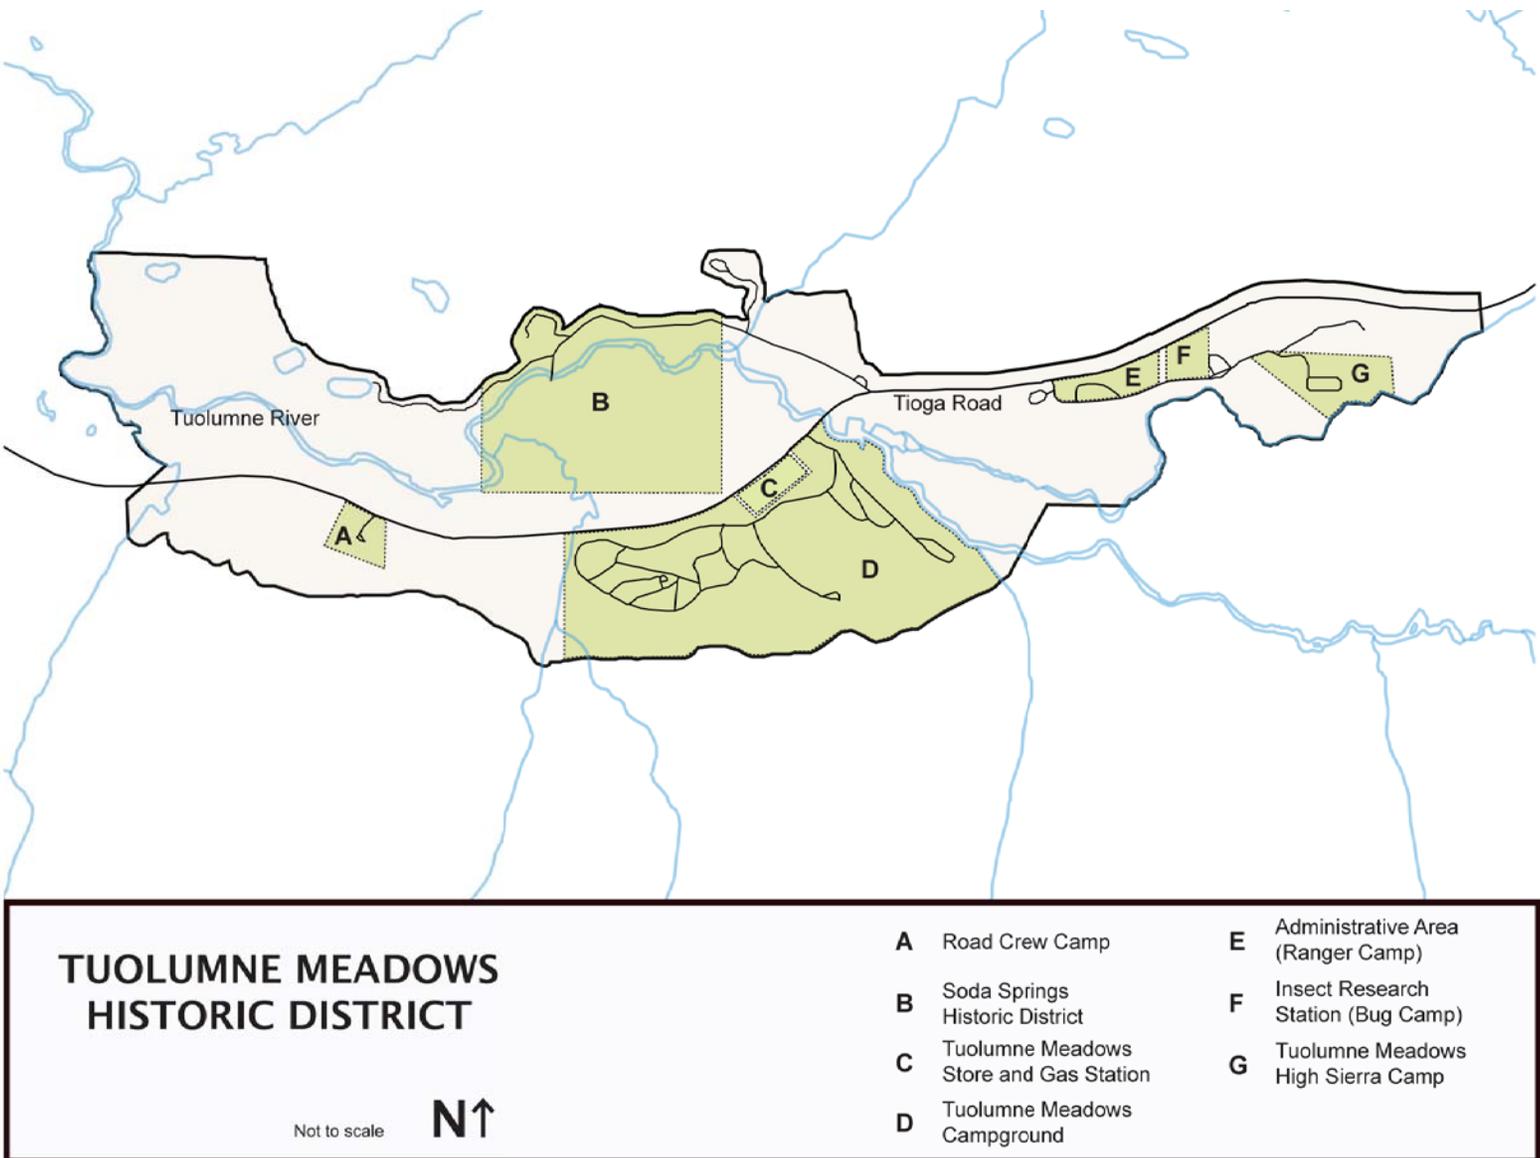
Site Plan #1: Map showing existing development and boundary of Tuolumne Meadows Historic District. (YOSE 2006)

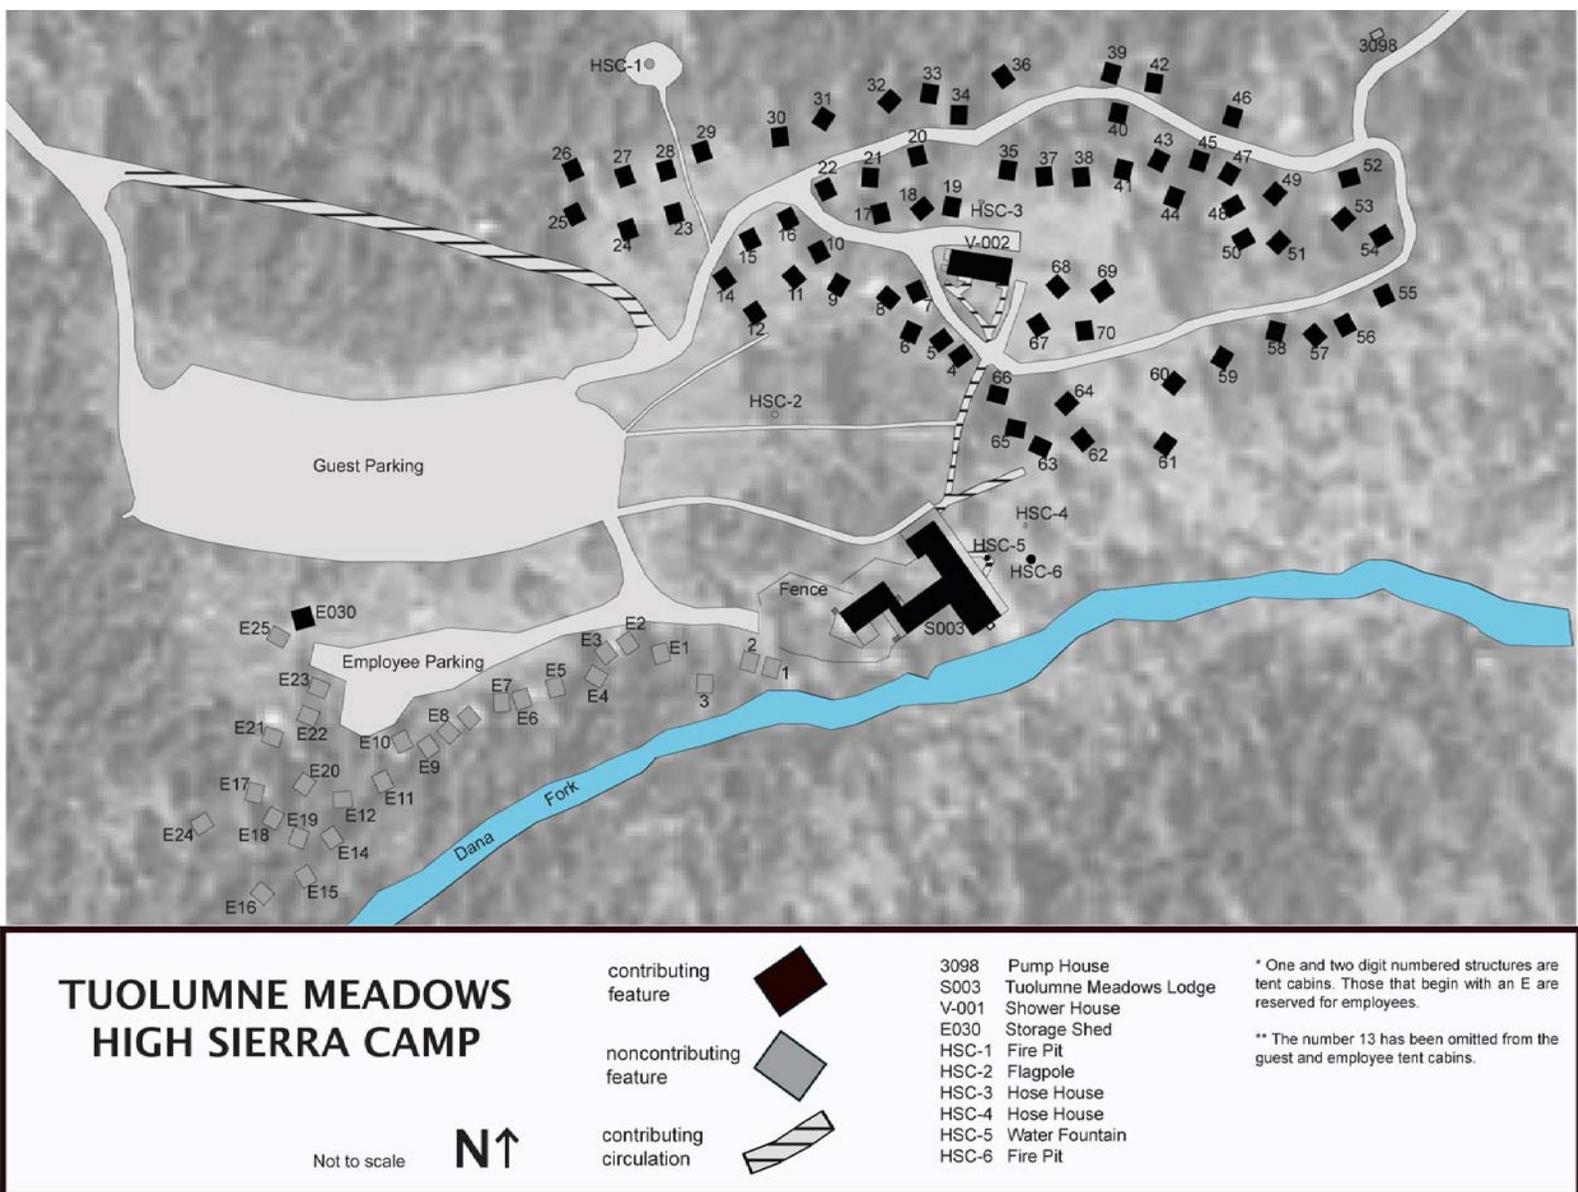
Site Plan #2: Map showing existing development of the Tuolumne Meadows Lodge and High Sierra Camp. (YOSE 2006)

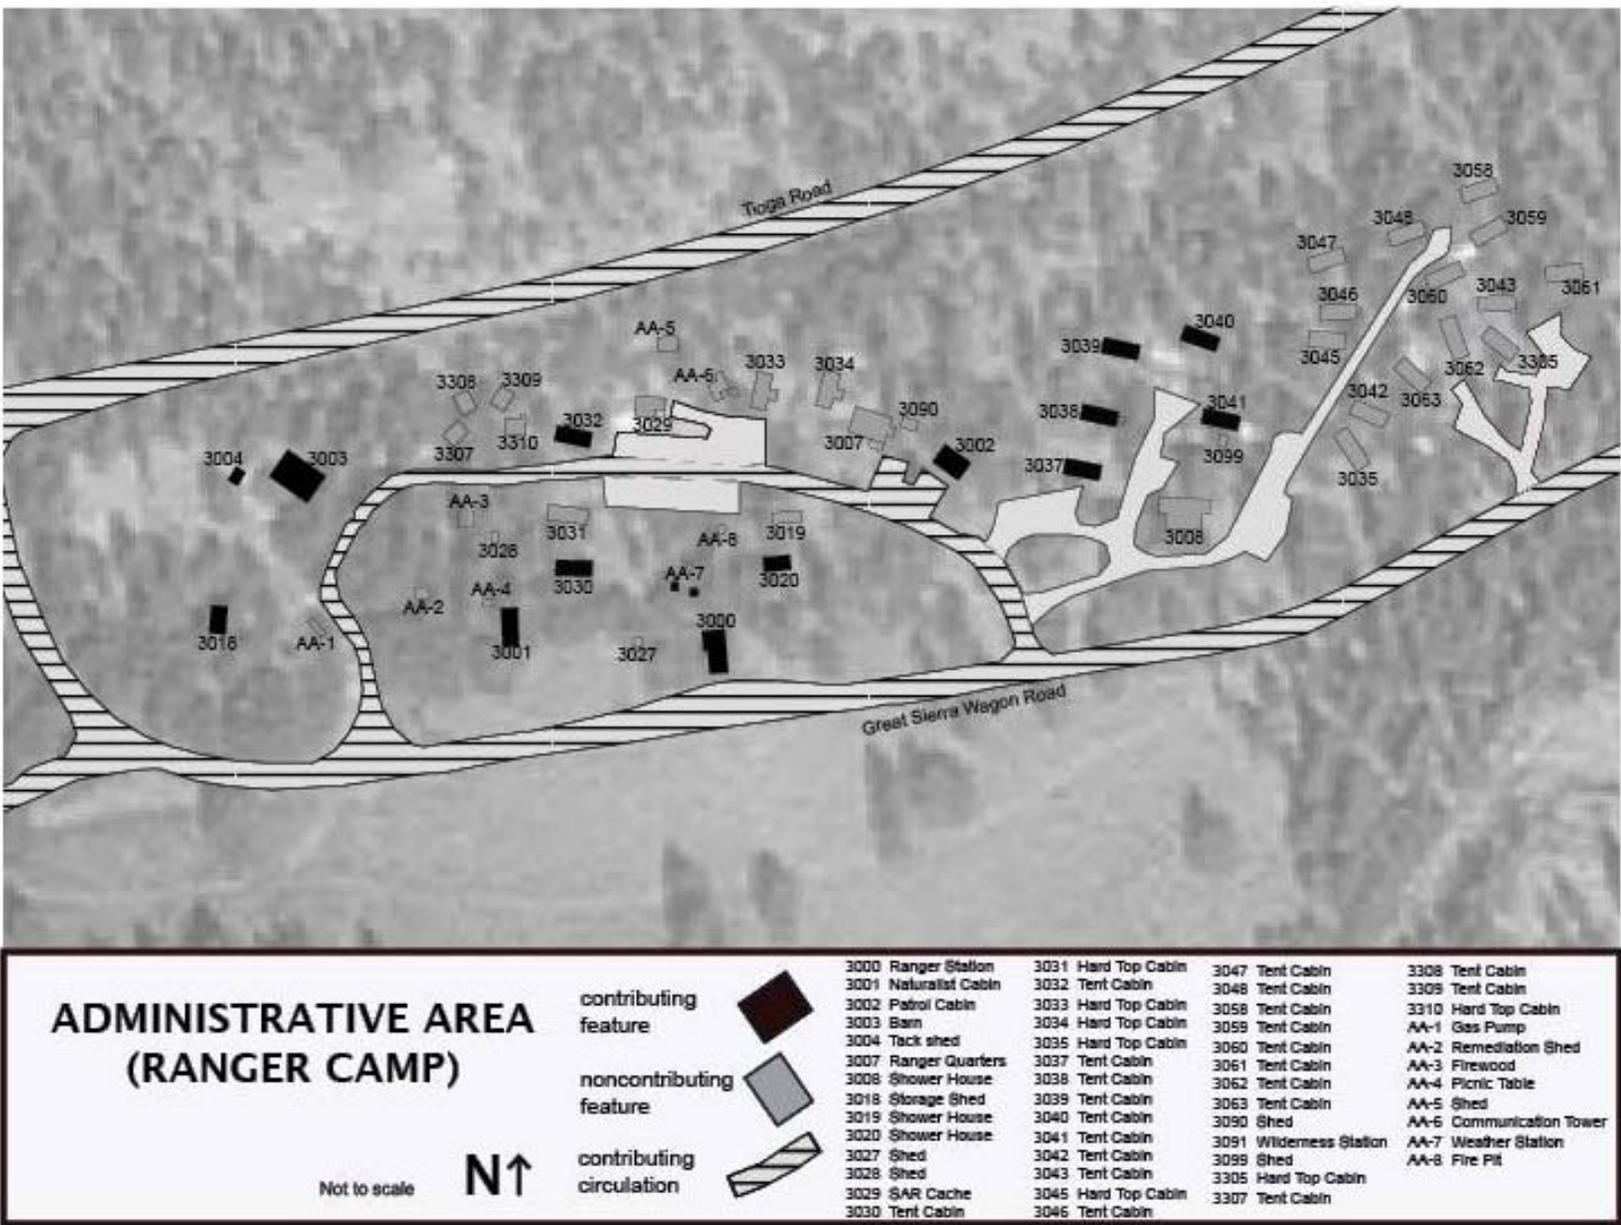
Site Plan #3: Map showing existing development of the Administration Area (Ranger Camp) development. (YOSE 2006)

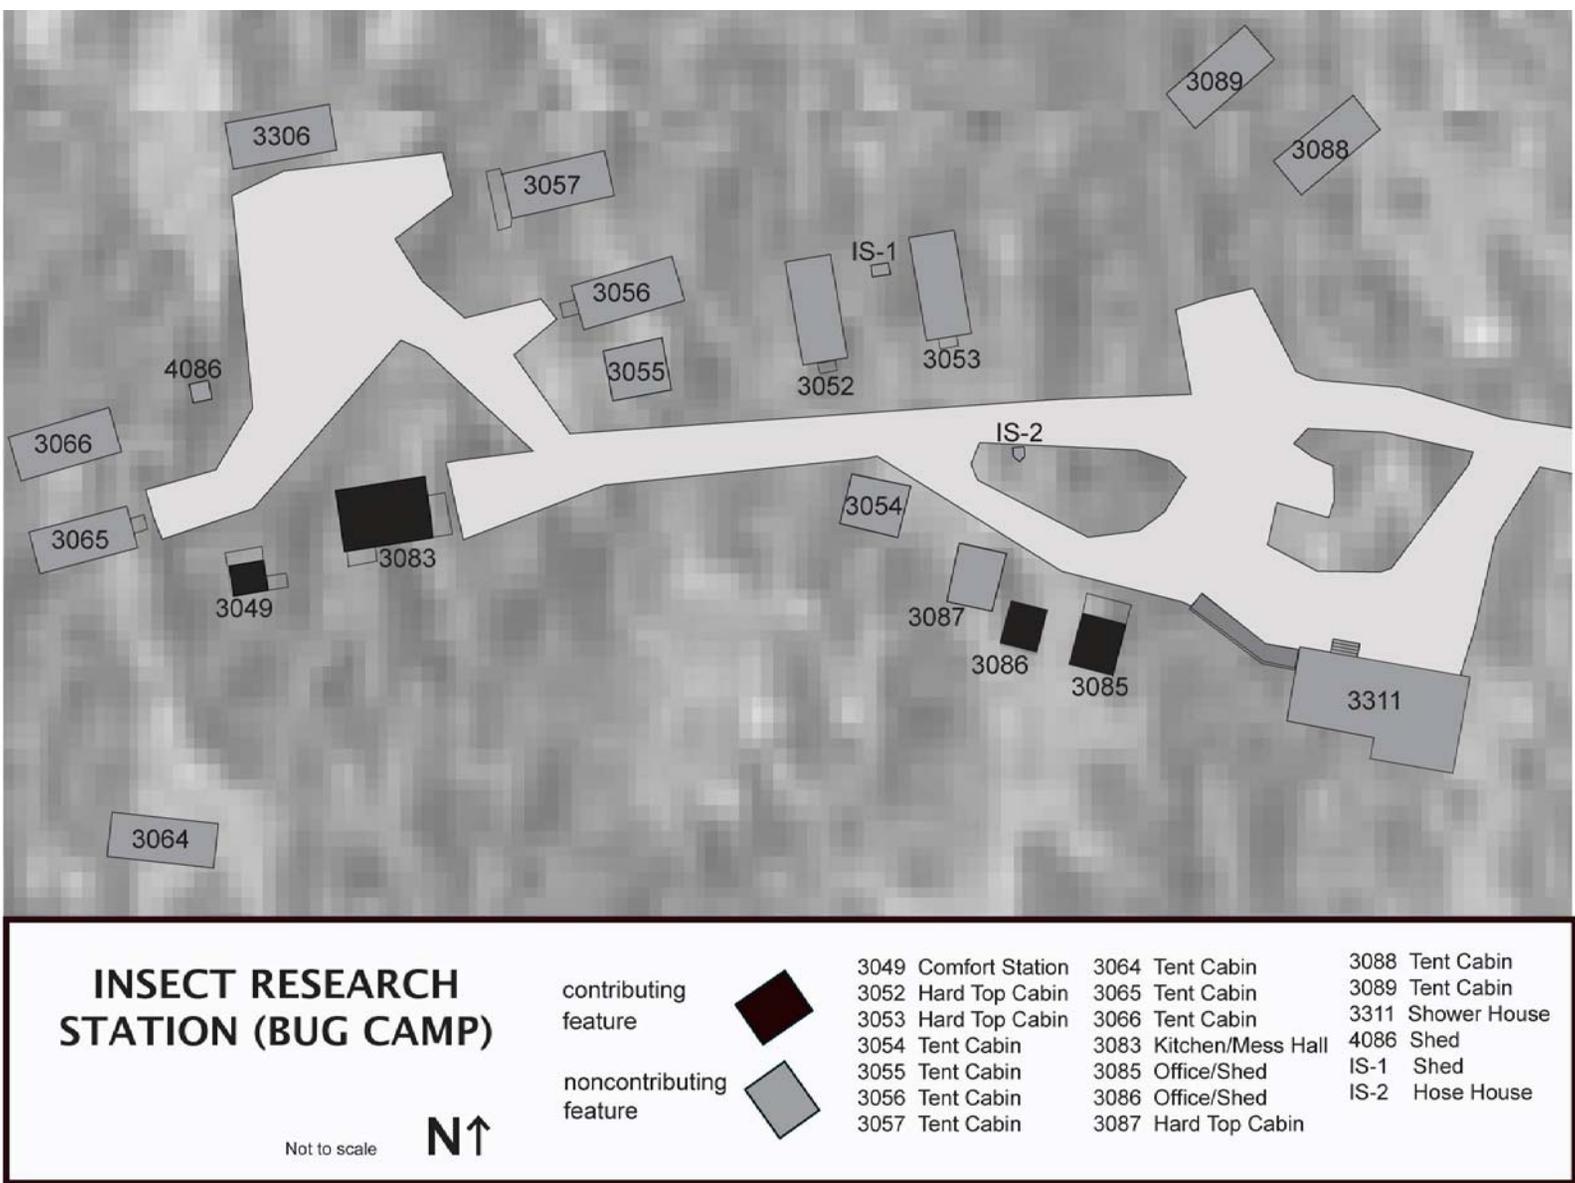
Site Plan #4: Map showing existing development of the Insect Research Station (Bug Camp) (YOSE 2006).

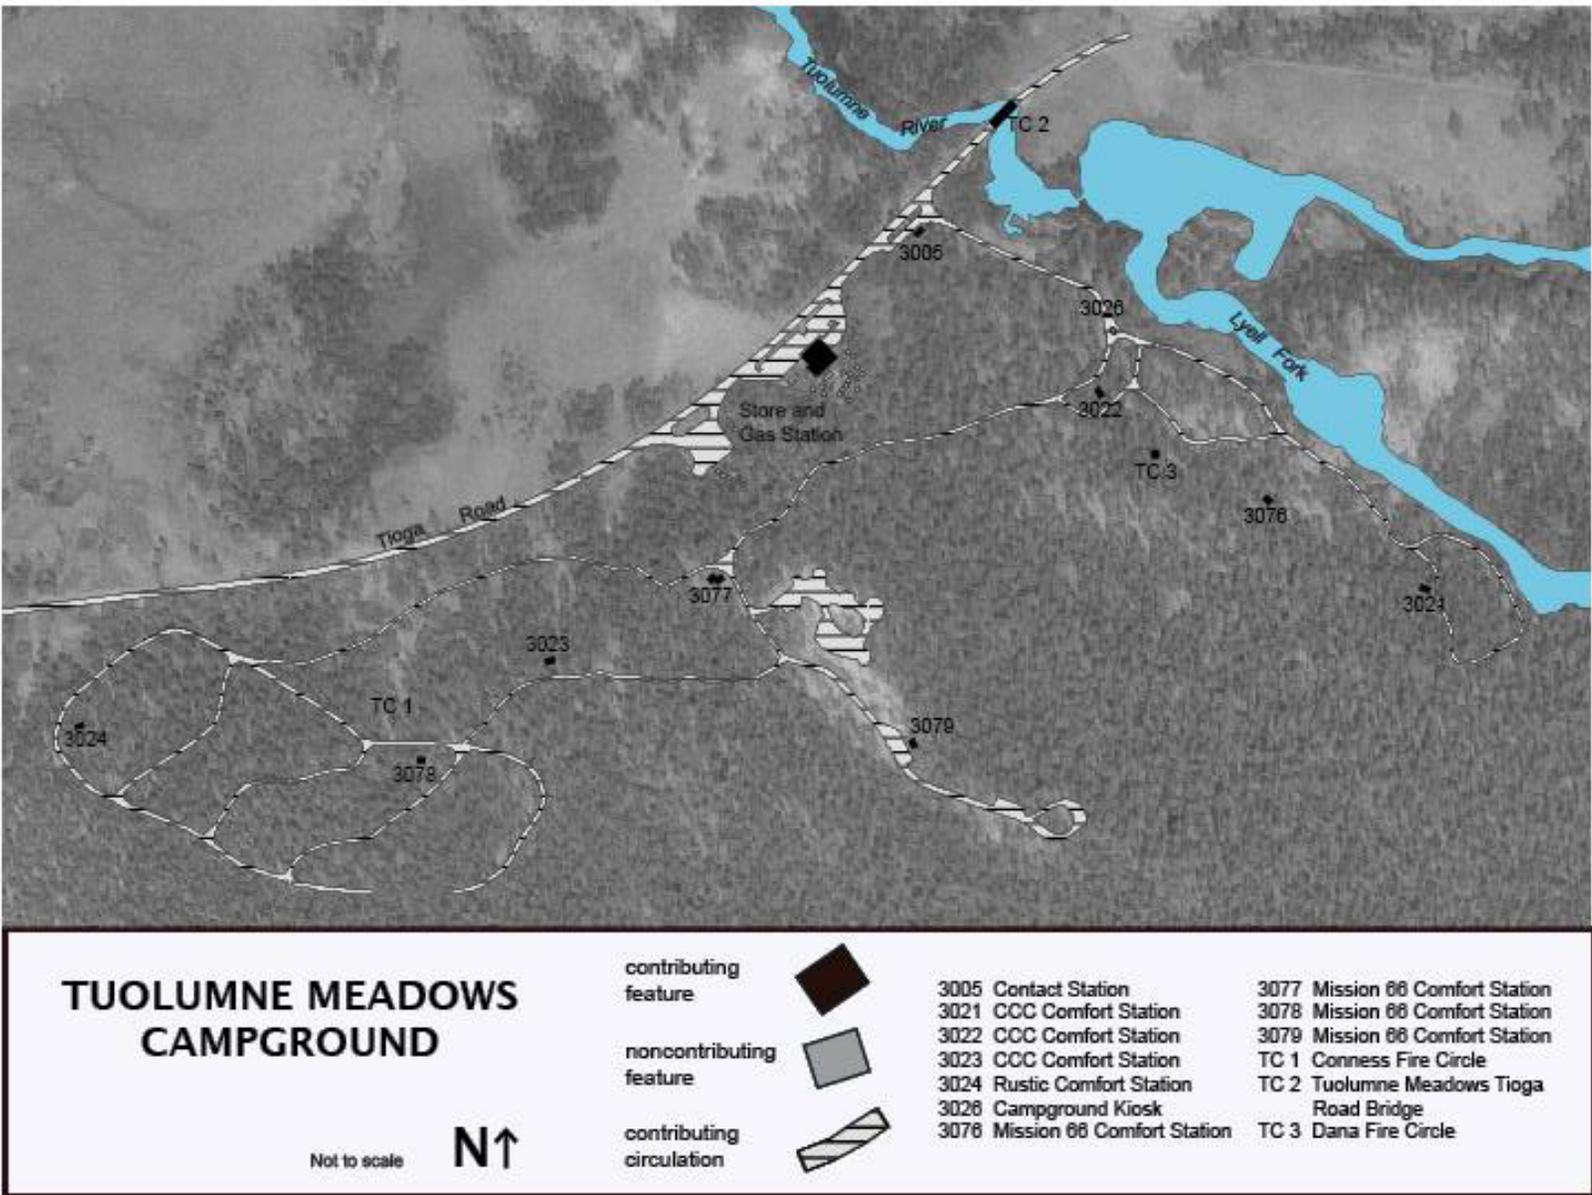
Site Plan #5: Map showing existing development of the Tuolumne Meadows Campground (YOSE 2006).

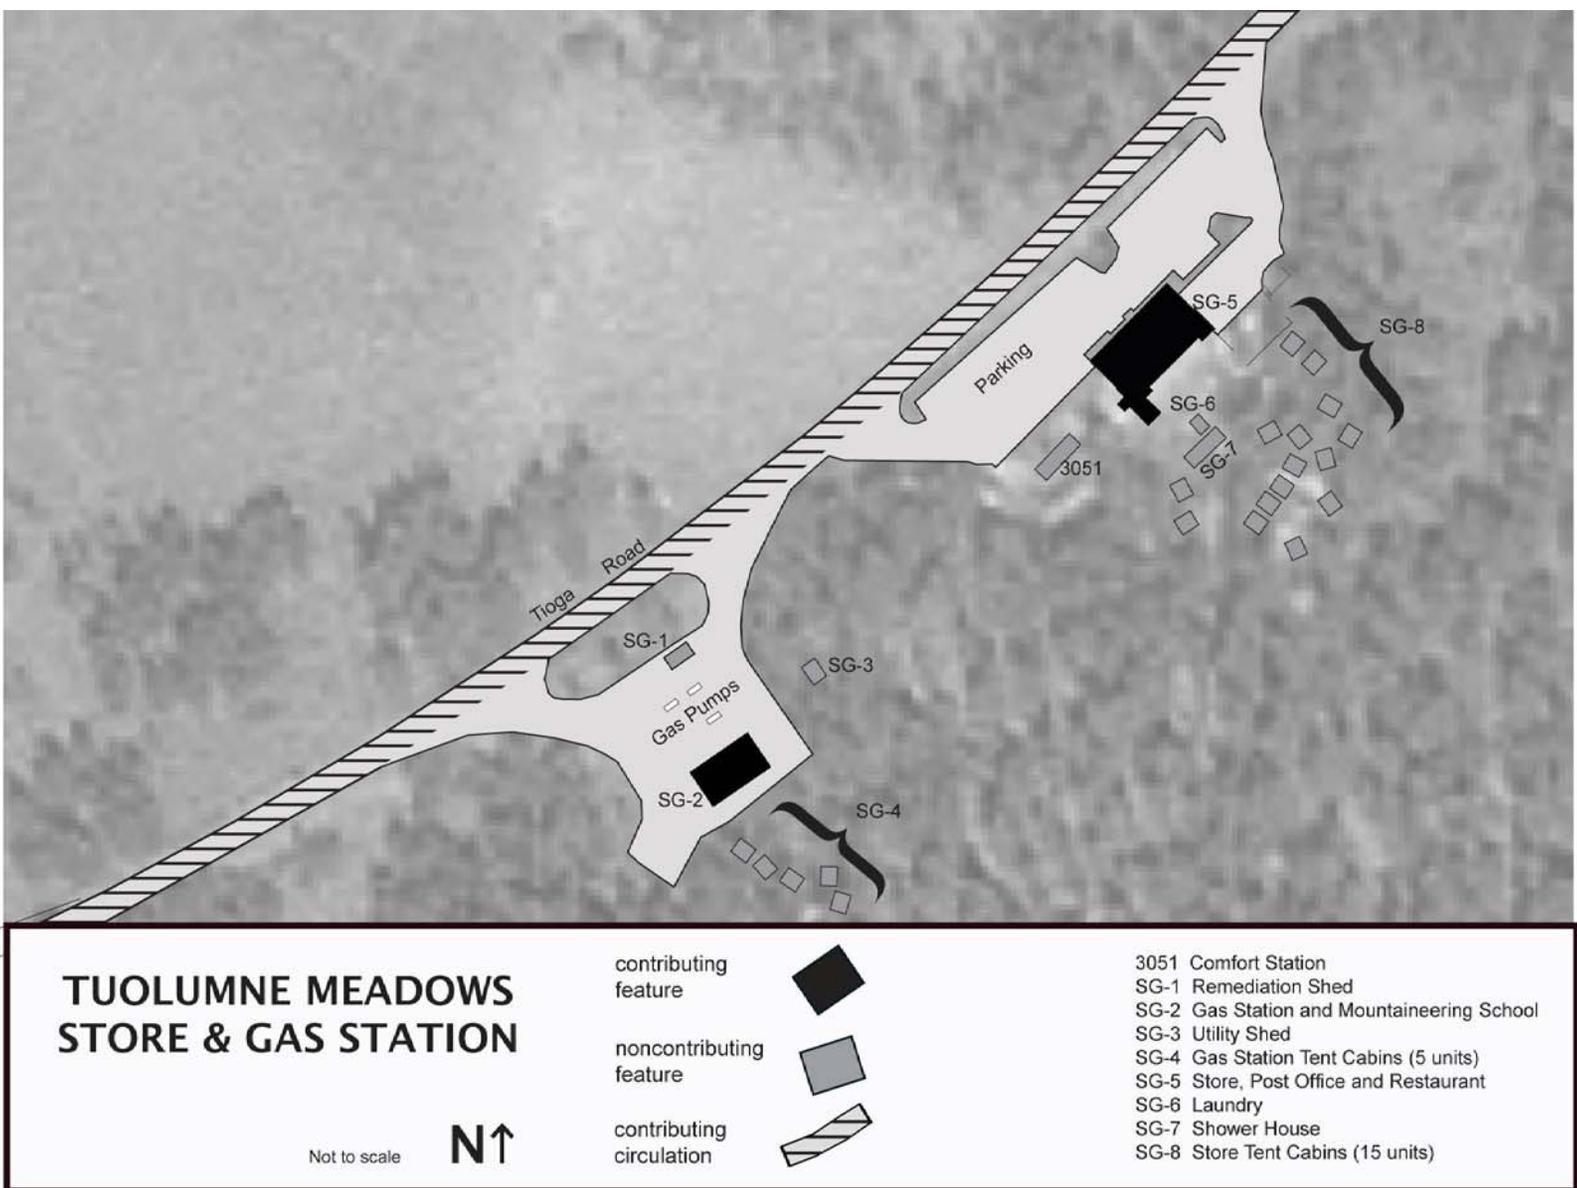
Site Plan #6: Map showing existing development of the Tuolumne Meadows Store and Gas Station (YOSE 2006).

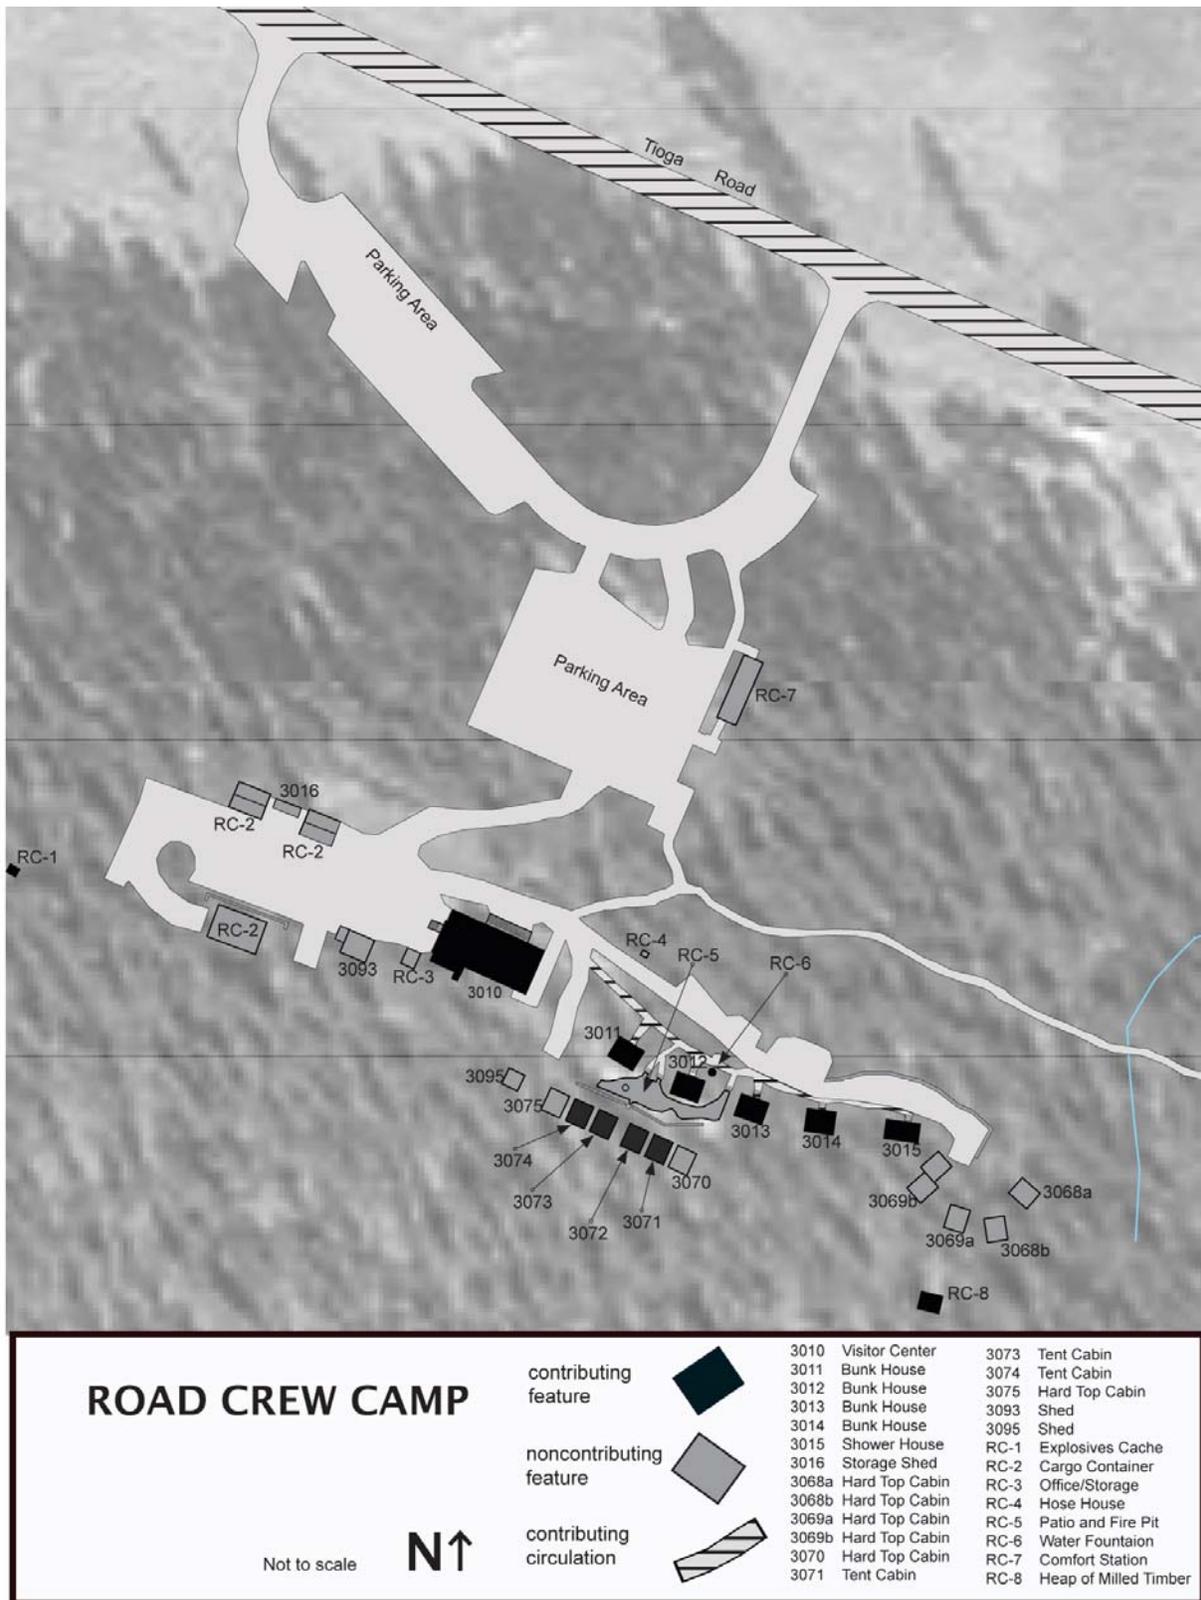
Site Plan #7: Map showing existing development of Road Crew Camp (YOSE 2006).

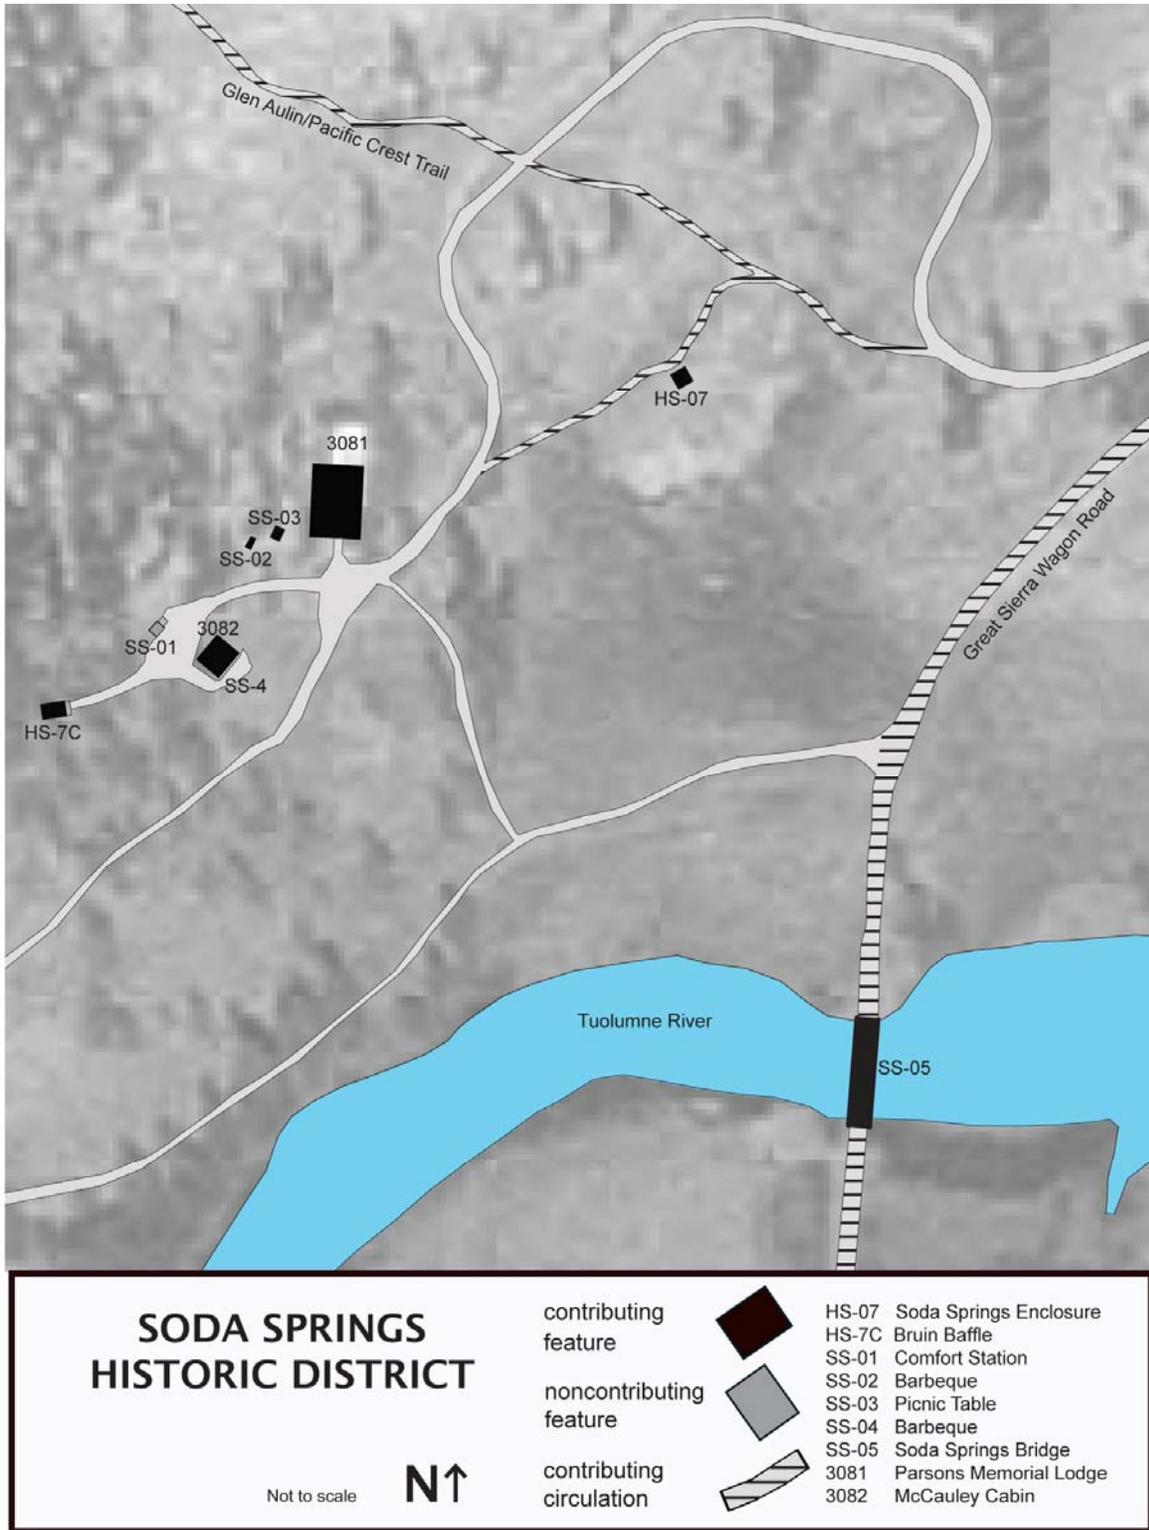
Site Plan #8: Map showing existing development of Soda Springs (YOSE 2006).

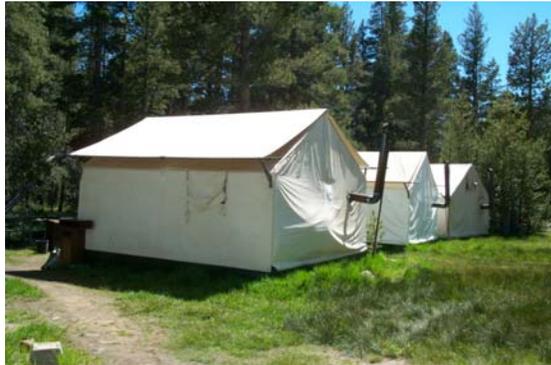
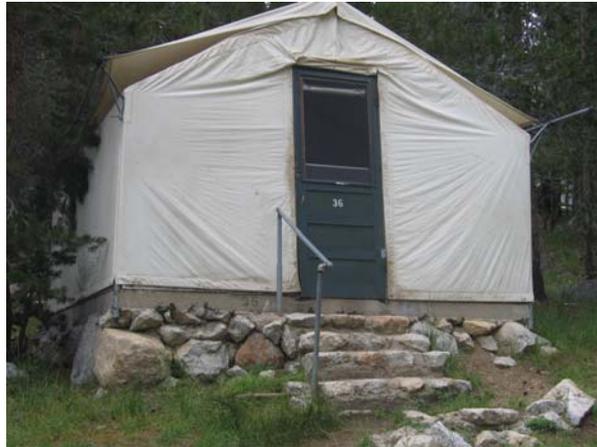
*Buildings and Structures #1 & #2: Typical tent cabins at Tuolumne Meadows Lodge and High Sierra Camp. Stone rubble foundation beneath concrete slab is illustrated in second photo. (YOSE, 2006)*

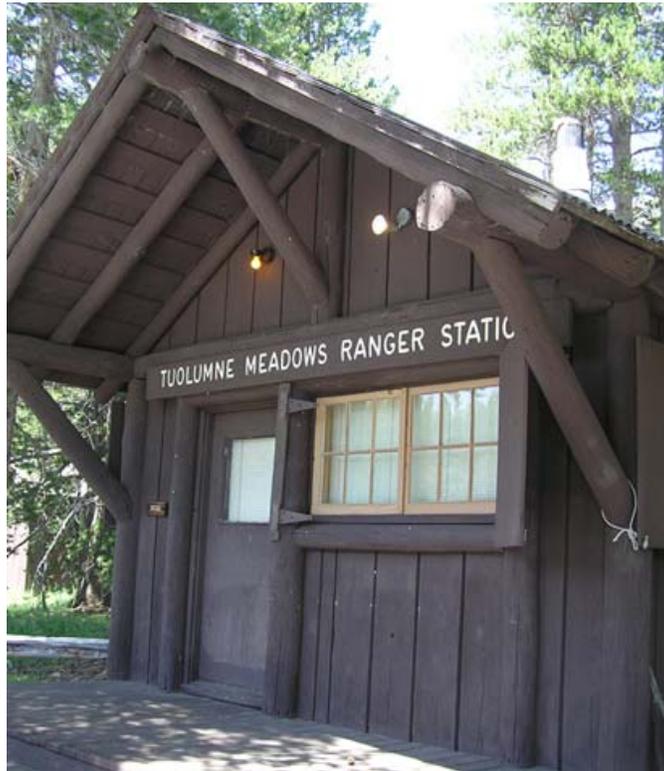
*Buildings and Structures #3: View of the front entry to the ranger station (bldg. #3000), facing northwest, in the Administrative Area. (YOSE, 2006)*

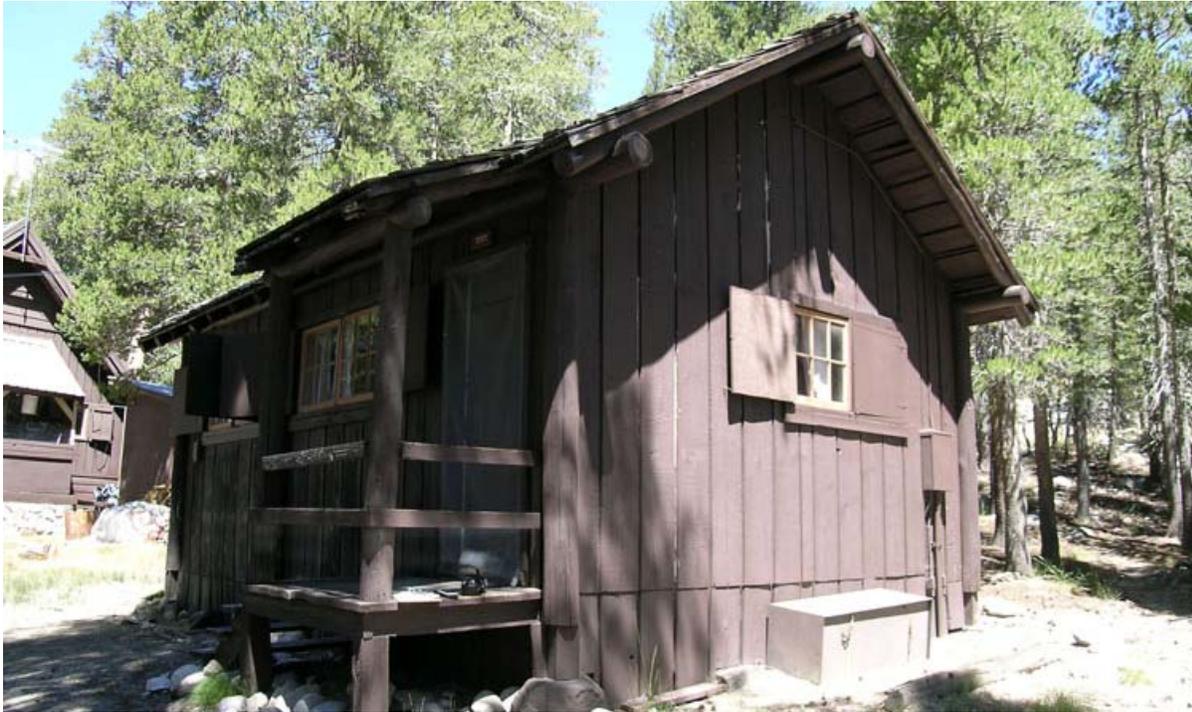
*Buildings and Structures #4: View of the front entry to the patrol cabin (bldg. #3002), facing north, in the Administrative Area. (YOSE, 2006)*

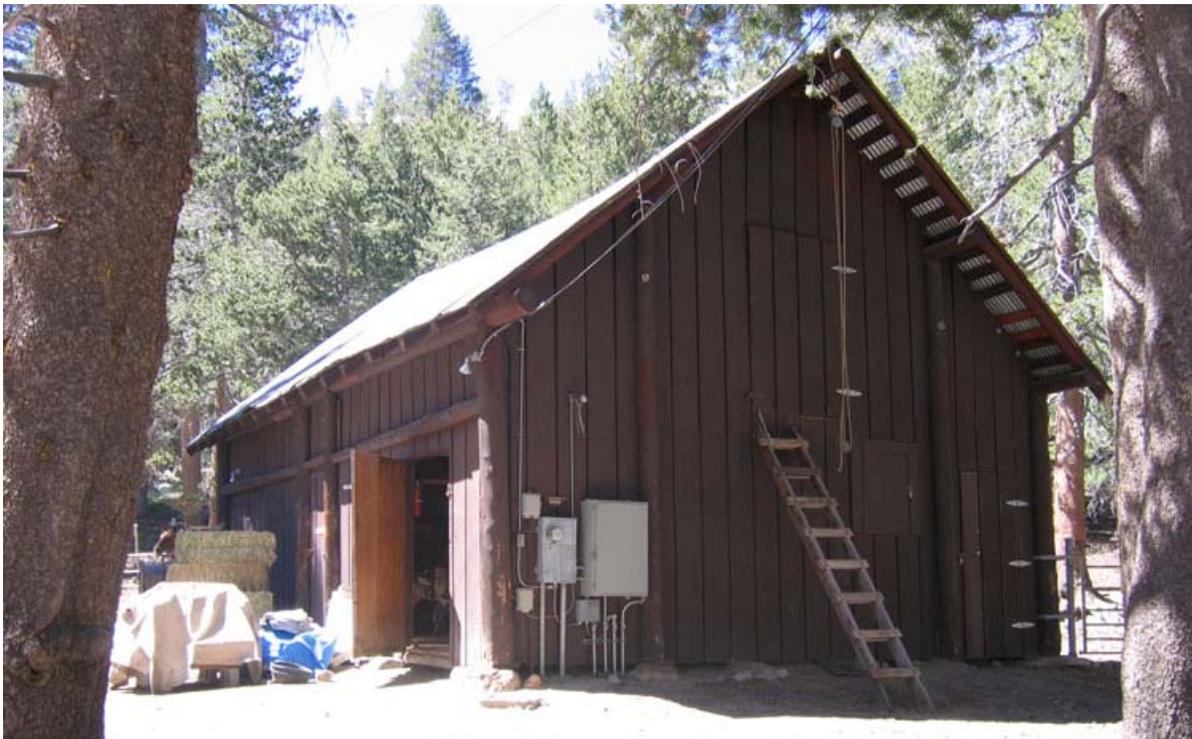
*Buildings and Structures #5: View of the barn (bldg. #3003), facing north, in the Administrative Area. (YOSE, 2006)*

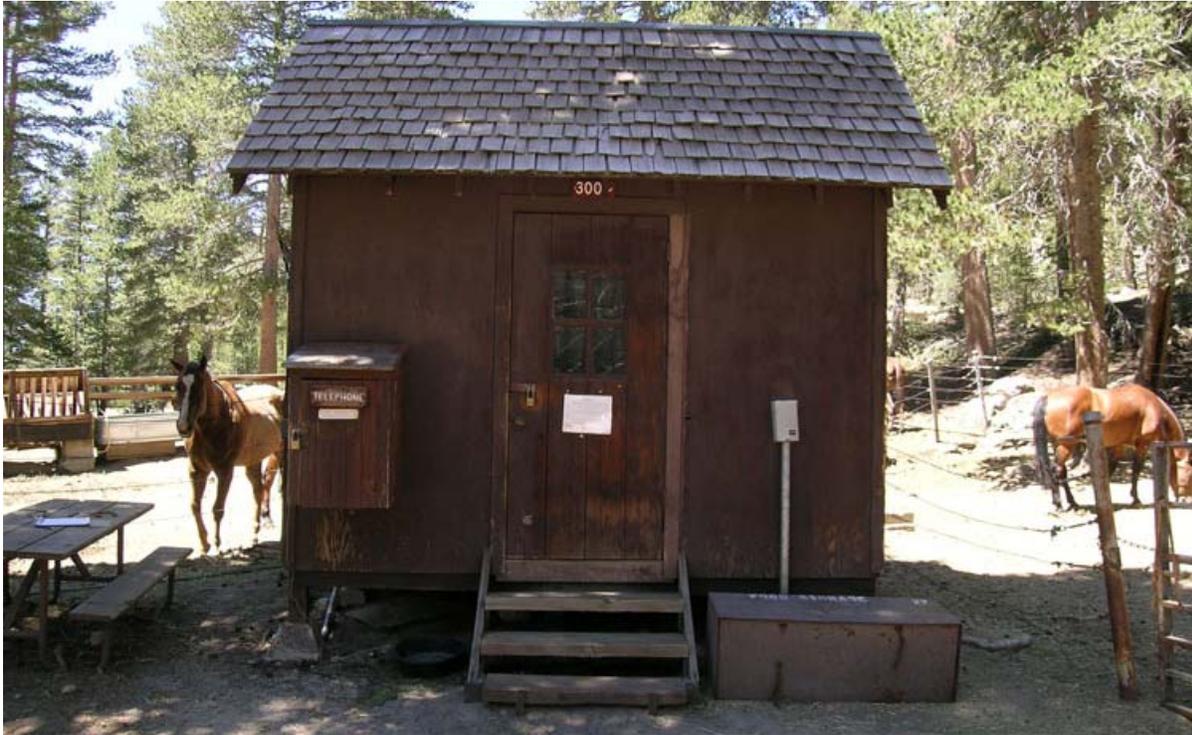
*Buildings and Structures #6: View of the pack shed (bldg. #3004) and telephone box, facing northwest, in the Administrative Area. (YOSE, 2006)*

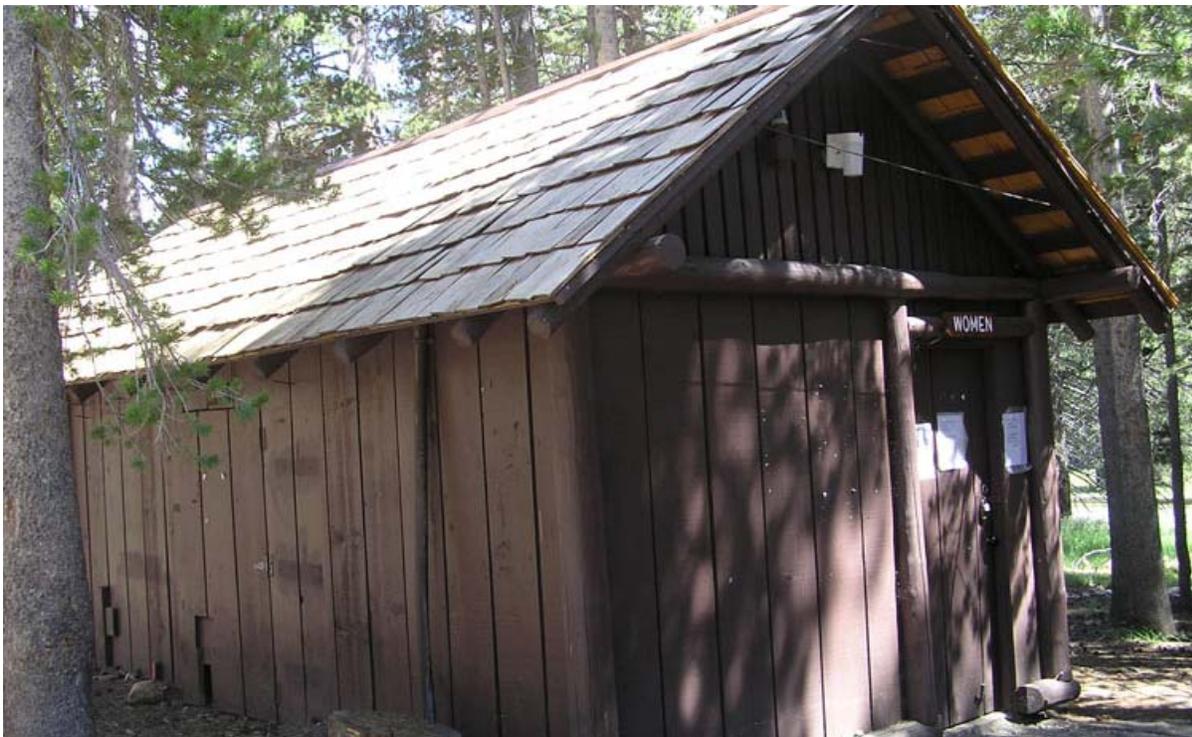
*Buildings and Structures #7: View of the comfort station (bldg. #3018), facing southeast, in the Administrative Area. (YOSE, 2006)*

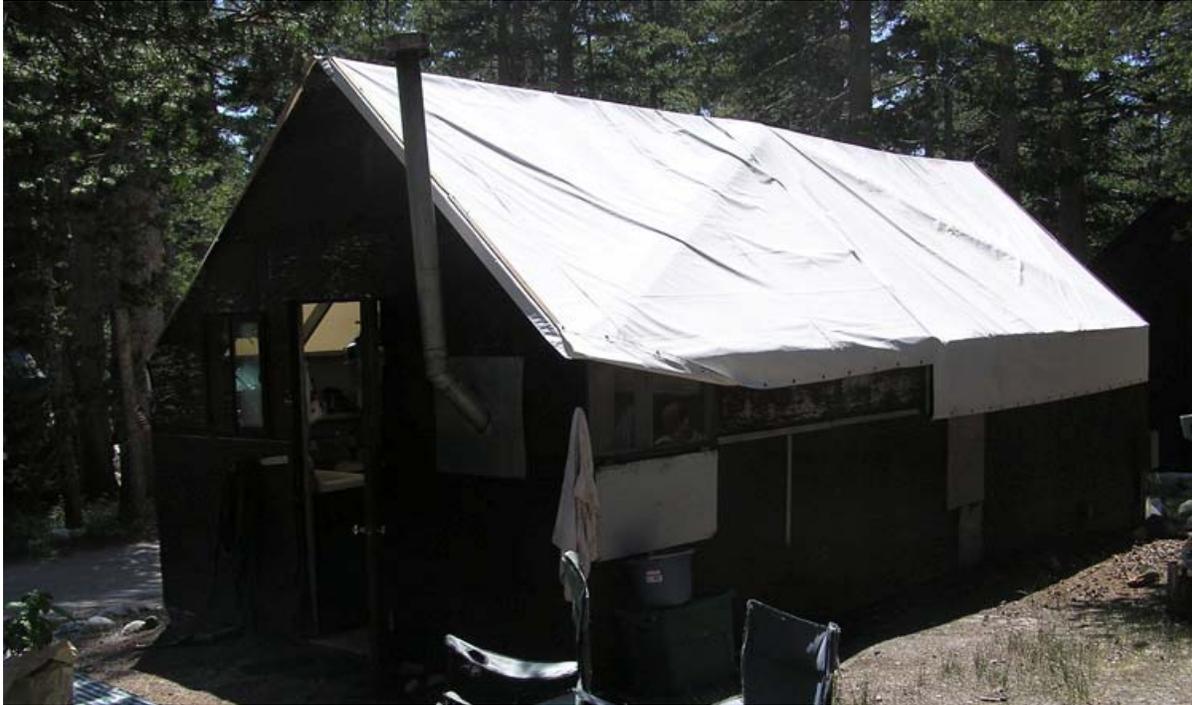
*Buildings and Structures #8: View of one of the 5 original tent cabins (bldg. #3032), facing southwest, in the Administrative Area. (YOSE, 2006)*

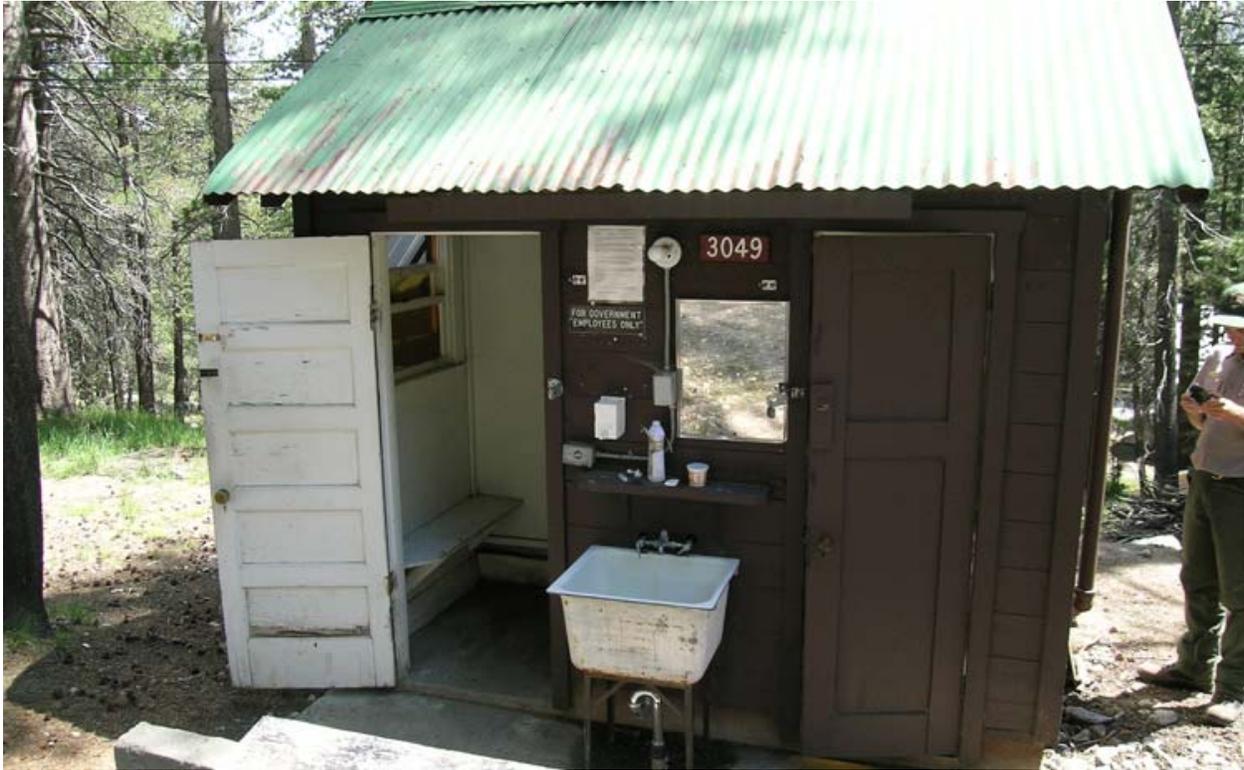
*Buildings and Structures #9: View of the historic comfort station (bldg. #3049), facing south, located at the Insect Research Station. (YOSE, 2006)*
