National Park Service  
Cultural Landscapes Inventory  
2007

Tuolumne Meadows Historic District  
Yosemite National Park

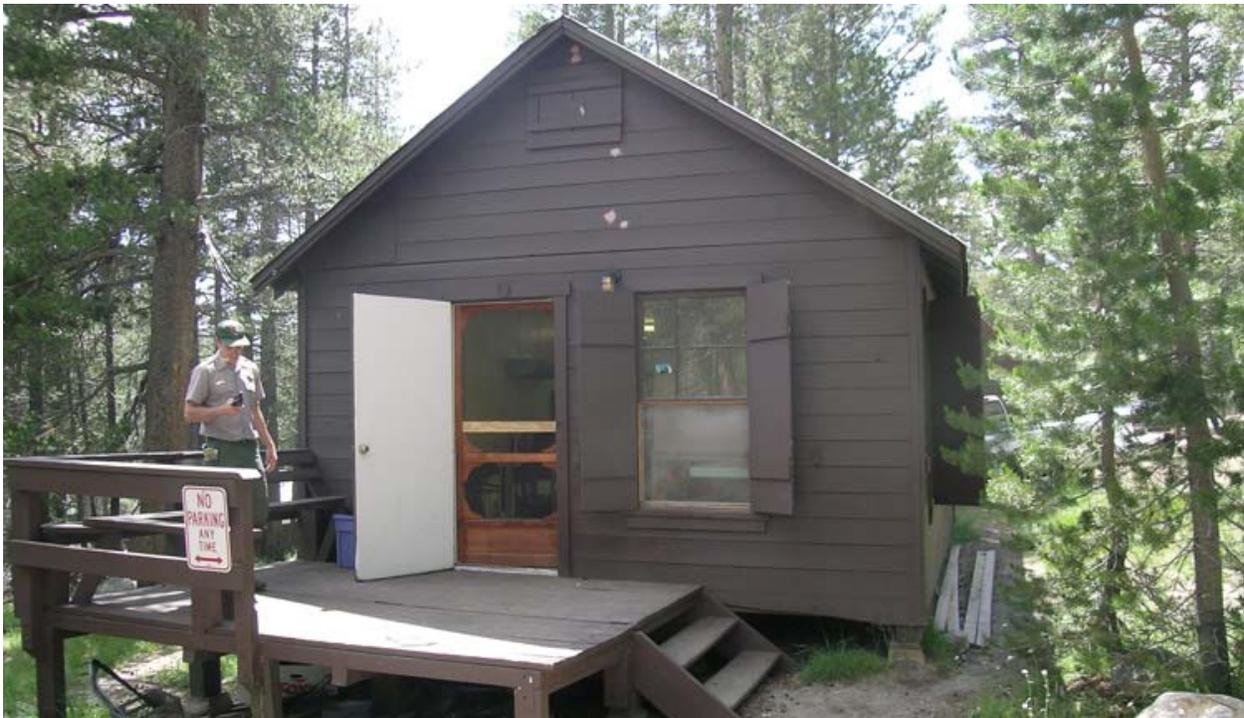
*Buildings and Structures #10: View of the mess hall (bldg. #3083), facing west, located at the Insect Research Station. (YOSE, 2006)*

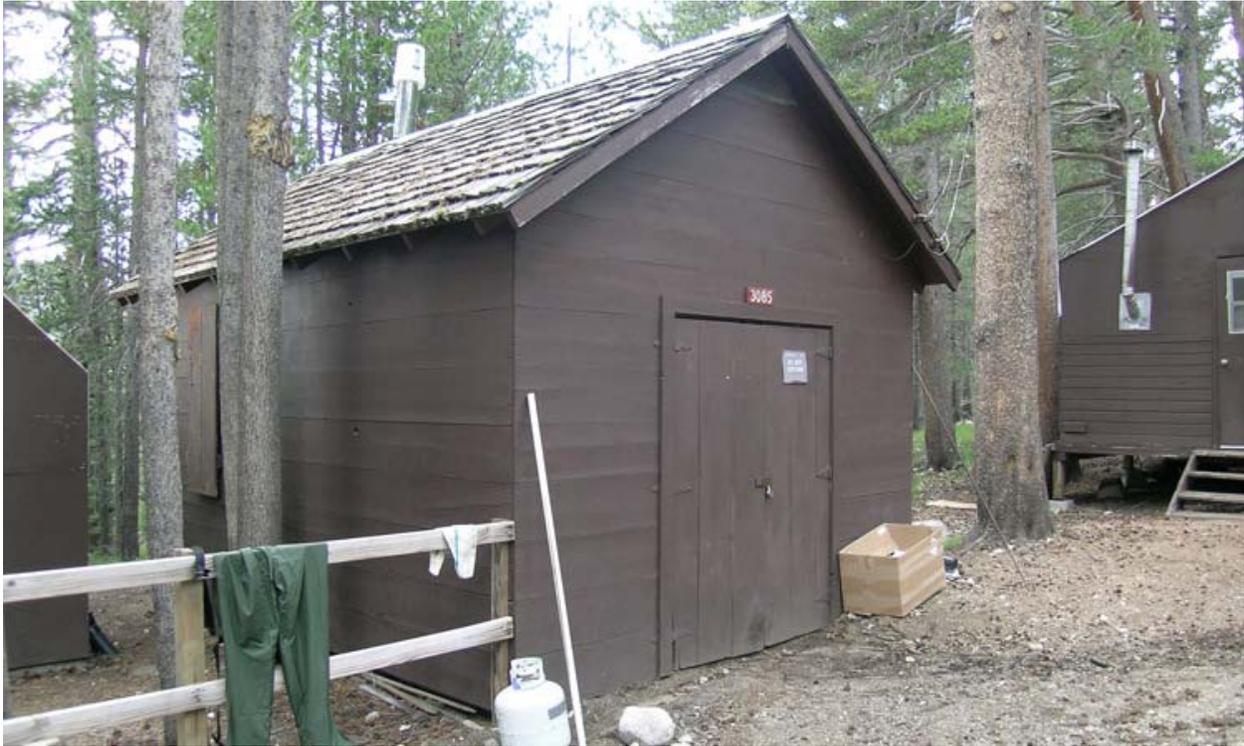
*Buildings and Structures #11: View of the storage shed/office (bldg. #3085), facing south, located at the Insect Research Station. (YOSE, 2006)*

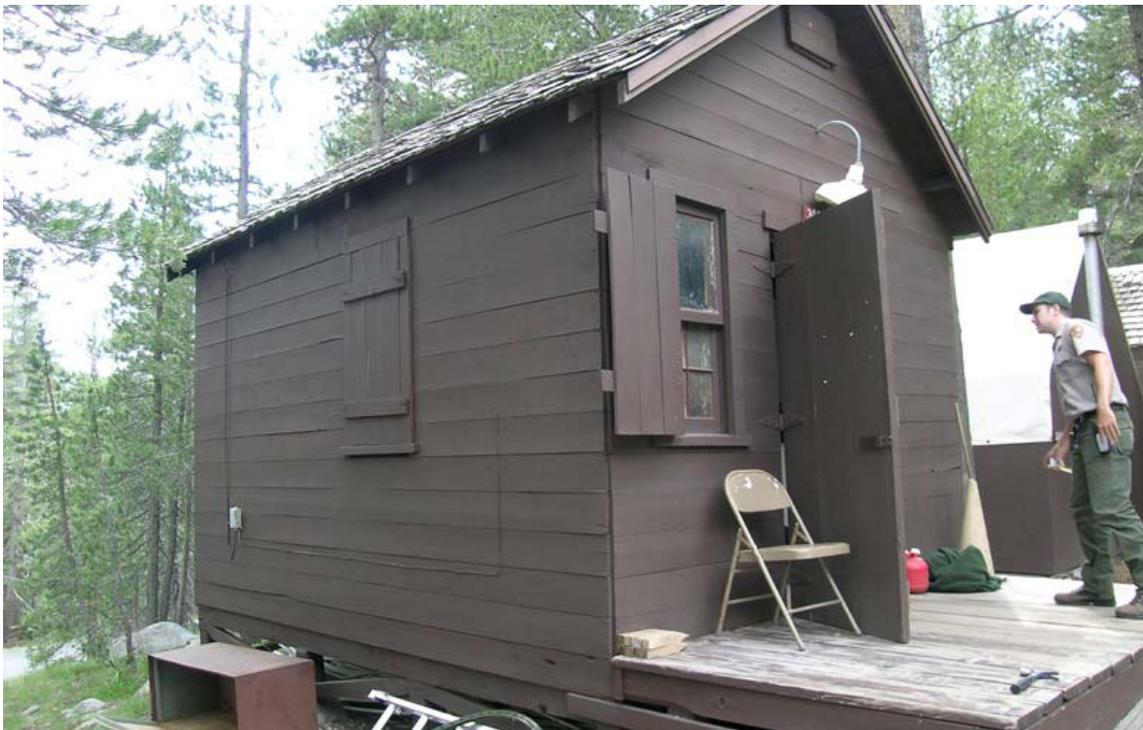
*Buildings and Structures #12: View of the storage shed/office (bldg. #3086), located at the Insect Research Station. (YOSE, 2006)*

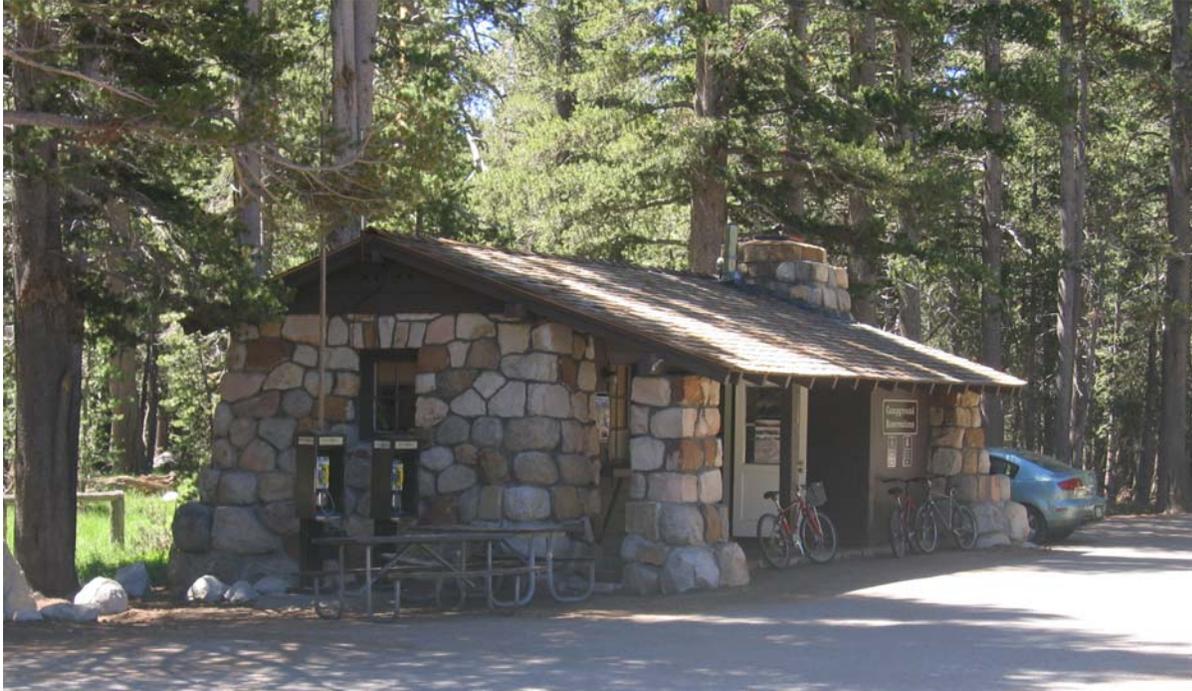
*Buildings and Structures #13: View of the contact station located along the Tioga Road at the entrance to the Tuolumne Meadows Public Campground. (YOSE, 2006)*

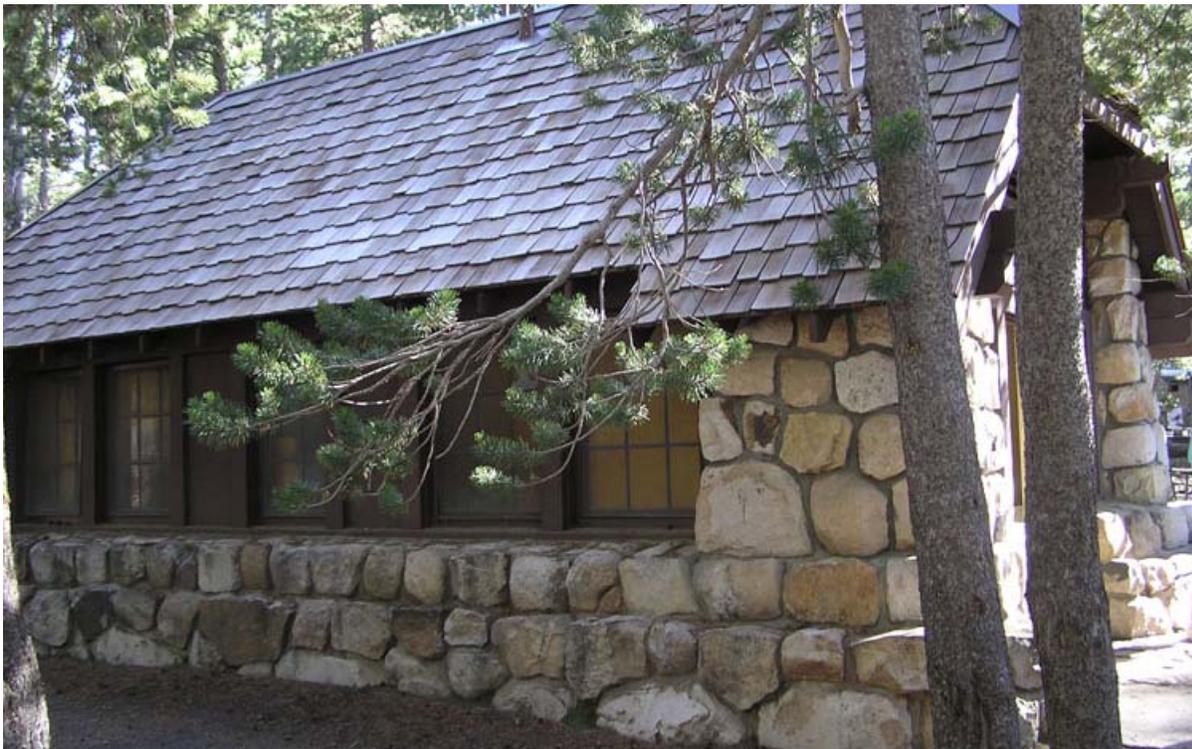
*Buildings and Structures #14: View of a 1934 rustic comfort station (bldg. #3022), located at the Tuolumne Meadows Public Campground. (YOSE, 2006)*

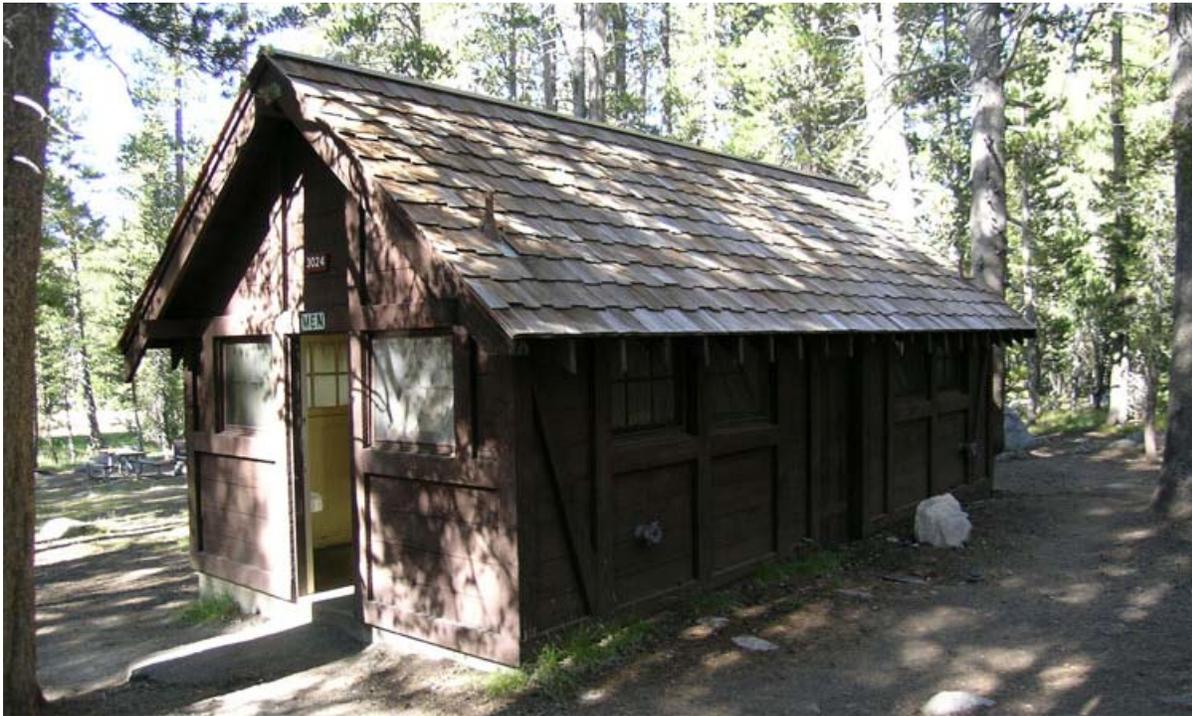
*Buildings and Structures #15: View of the 1931 comfort station (bldg. #3024), located at the Tuolumne Meadows Public Campground. (YOSE, 2006)*

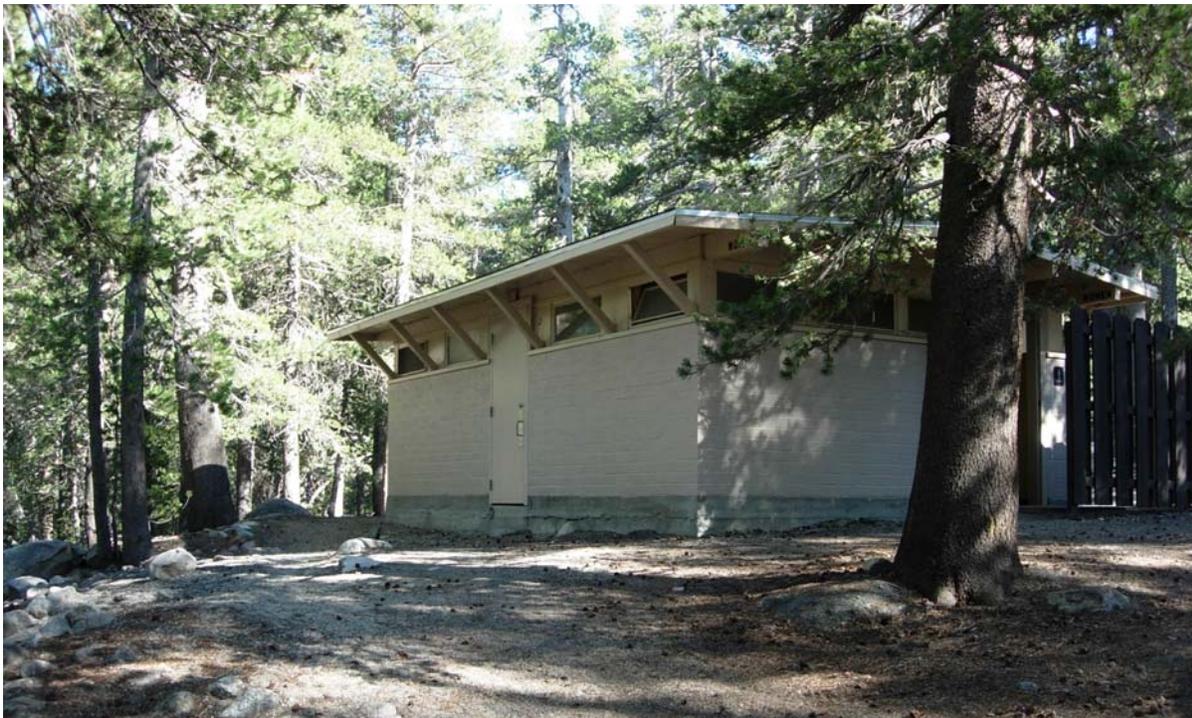
*Buildings and Structures #16: View of a Mission 66 comfort station and typical setting in the Tuolumne Meadows Campground. (YOSE, 2006)*

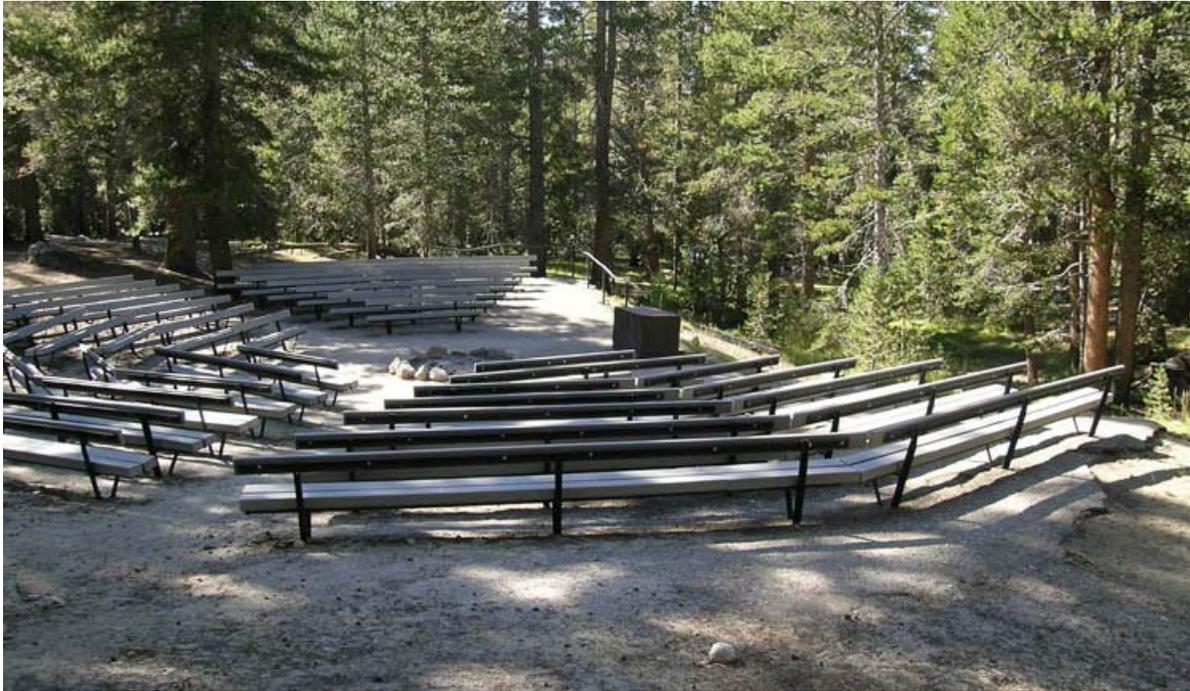
*Buildings and Structures #17: View of the Dana Campfire Circle, facing west, located at the Tuolumne Meadows Public Campground. (YOSE, 2006)*

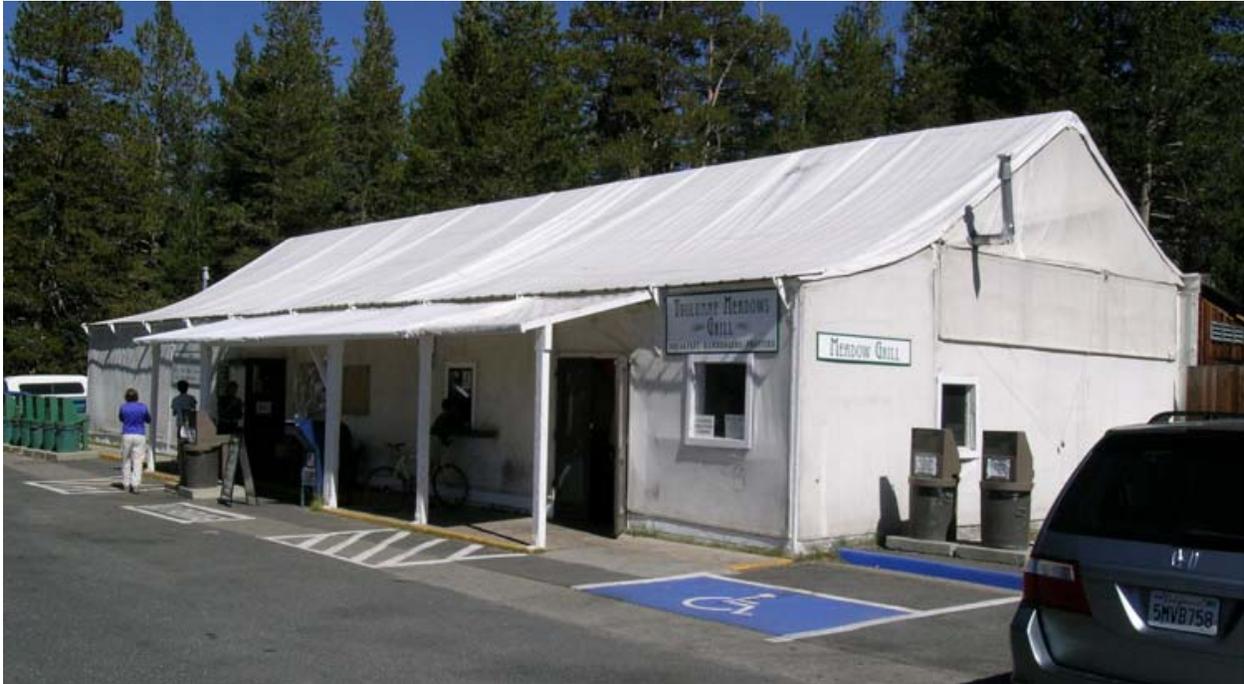
*Buildings and Structures #18: View of the Tuolumne Meadows Store, facing southeast. (YOSE, 2006)*

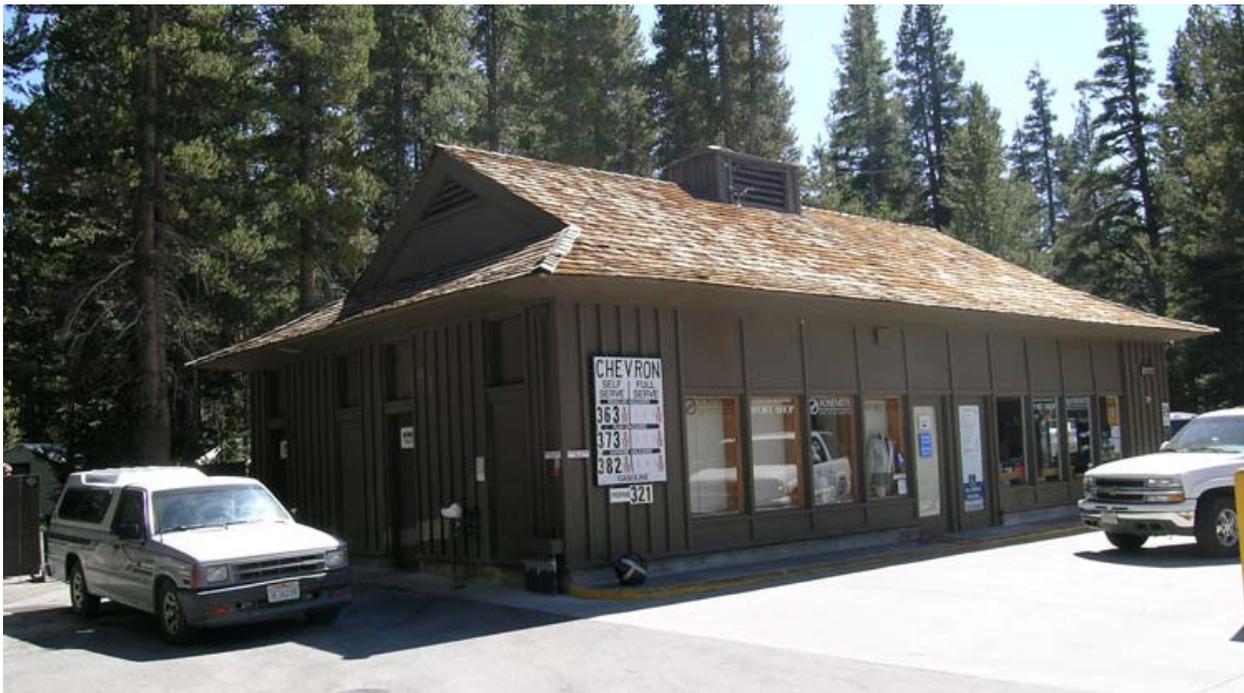
*Buildings and Structures #19: View of the Tuolumne Meadows Gas Station, facing southwest. (YOSE, 2006)*

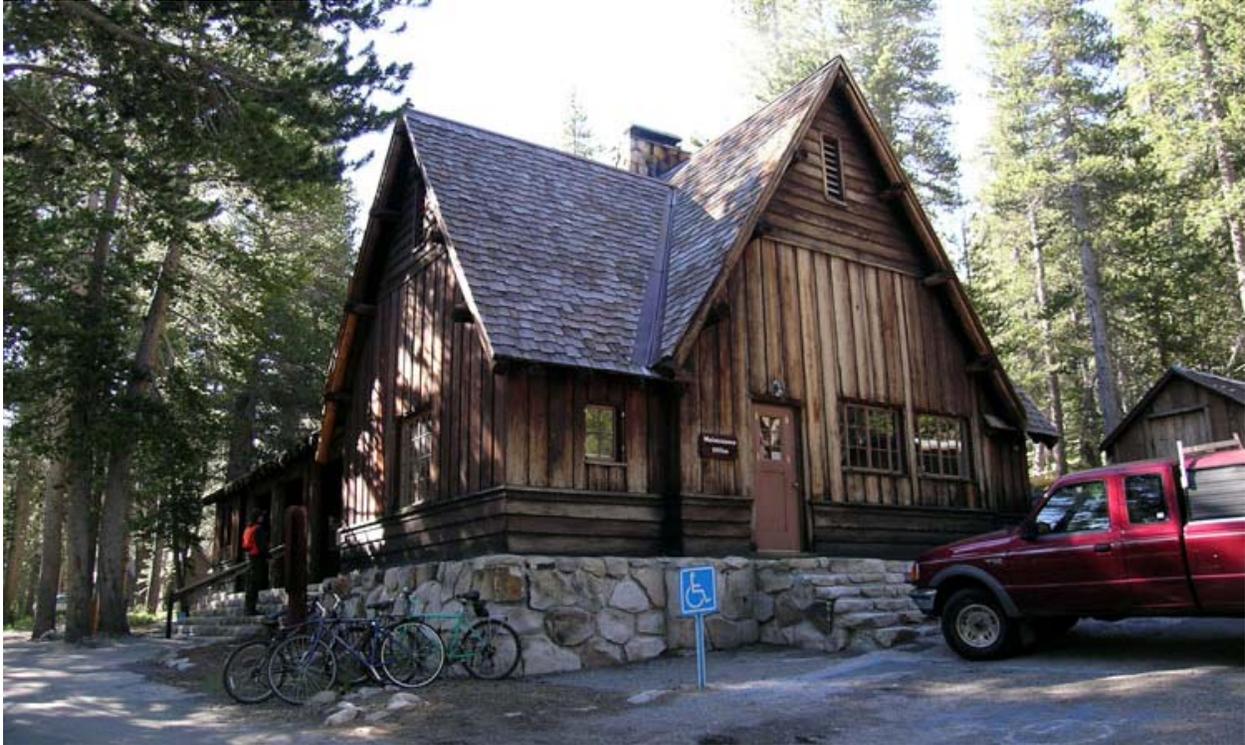
*Buildings and Structures #20: CCC-constructed Mess Hall (bldg. #3014), now Tuolumne Meadows Visitor Center. (YOSE, 2006)*

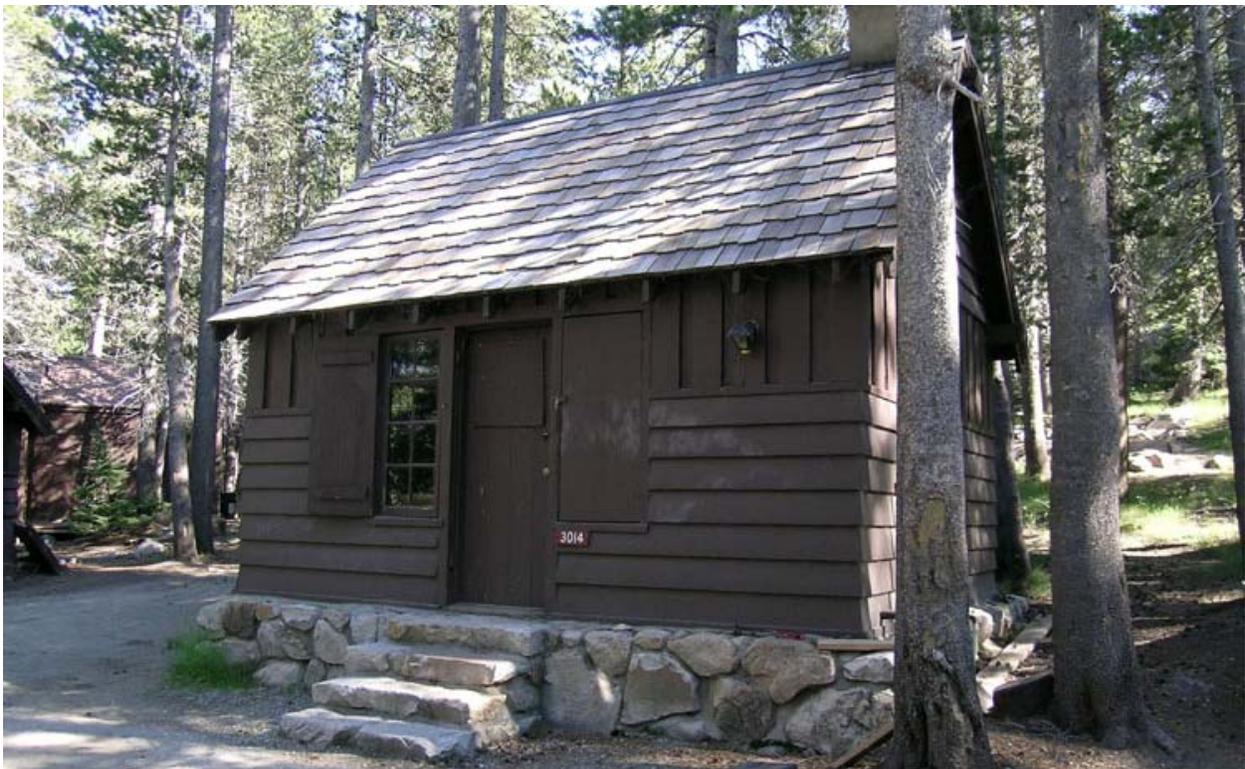
*Buildings and Structures #21: CCC-constructed bunkhouse (bldg. #3014). (YOSE, 2006)*

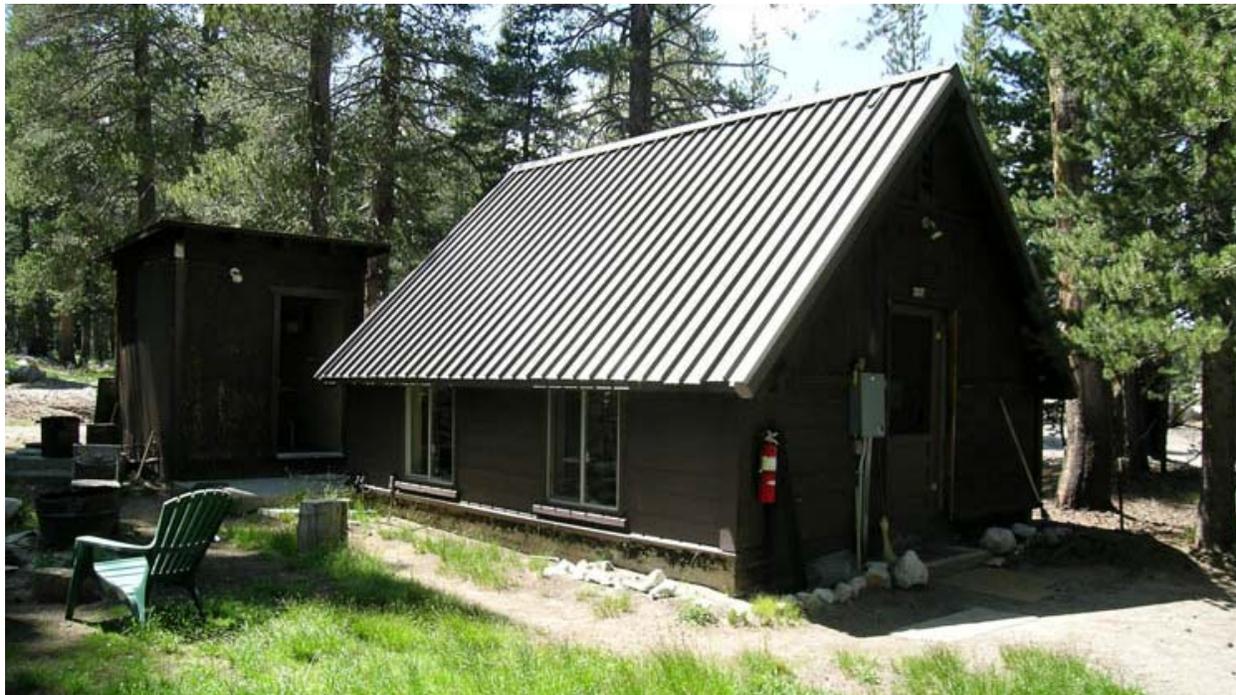
*Buildings and Structures #22: View of historic pump house (bldg. #3017), facing northwest. Sump is behind the building. (YOSE, 2006)*

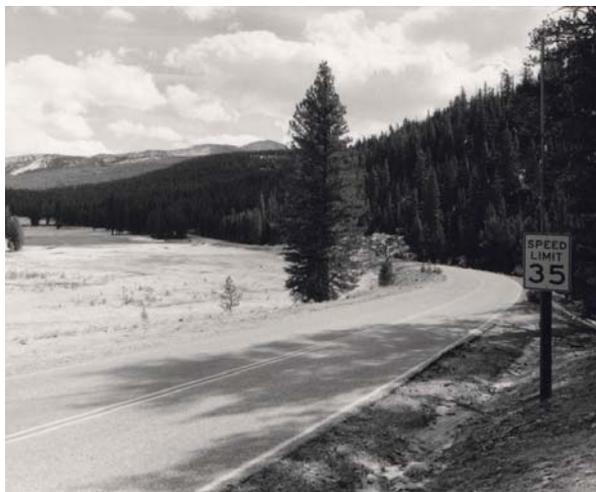
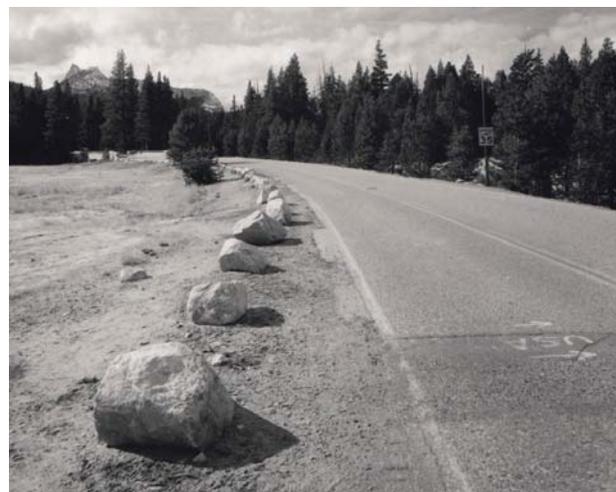
*Circulation #1 and #2: Two photos of the Tioga Road illustrating its orientation to natural systems and features and to views and vistas. (HAER, 1991)*

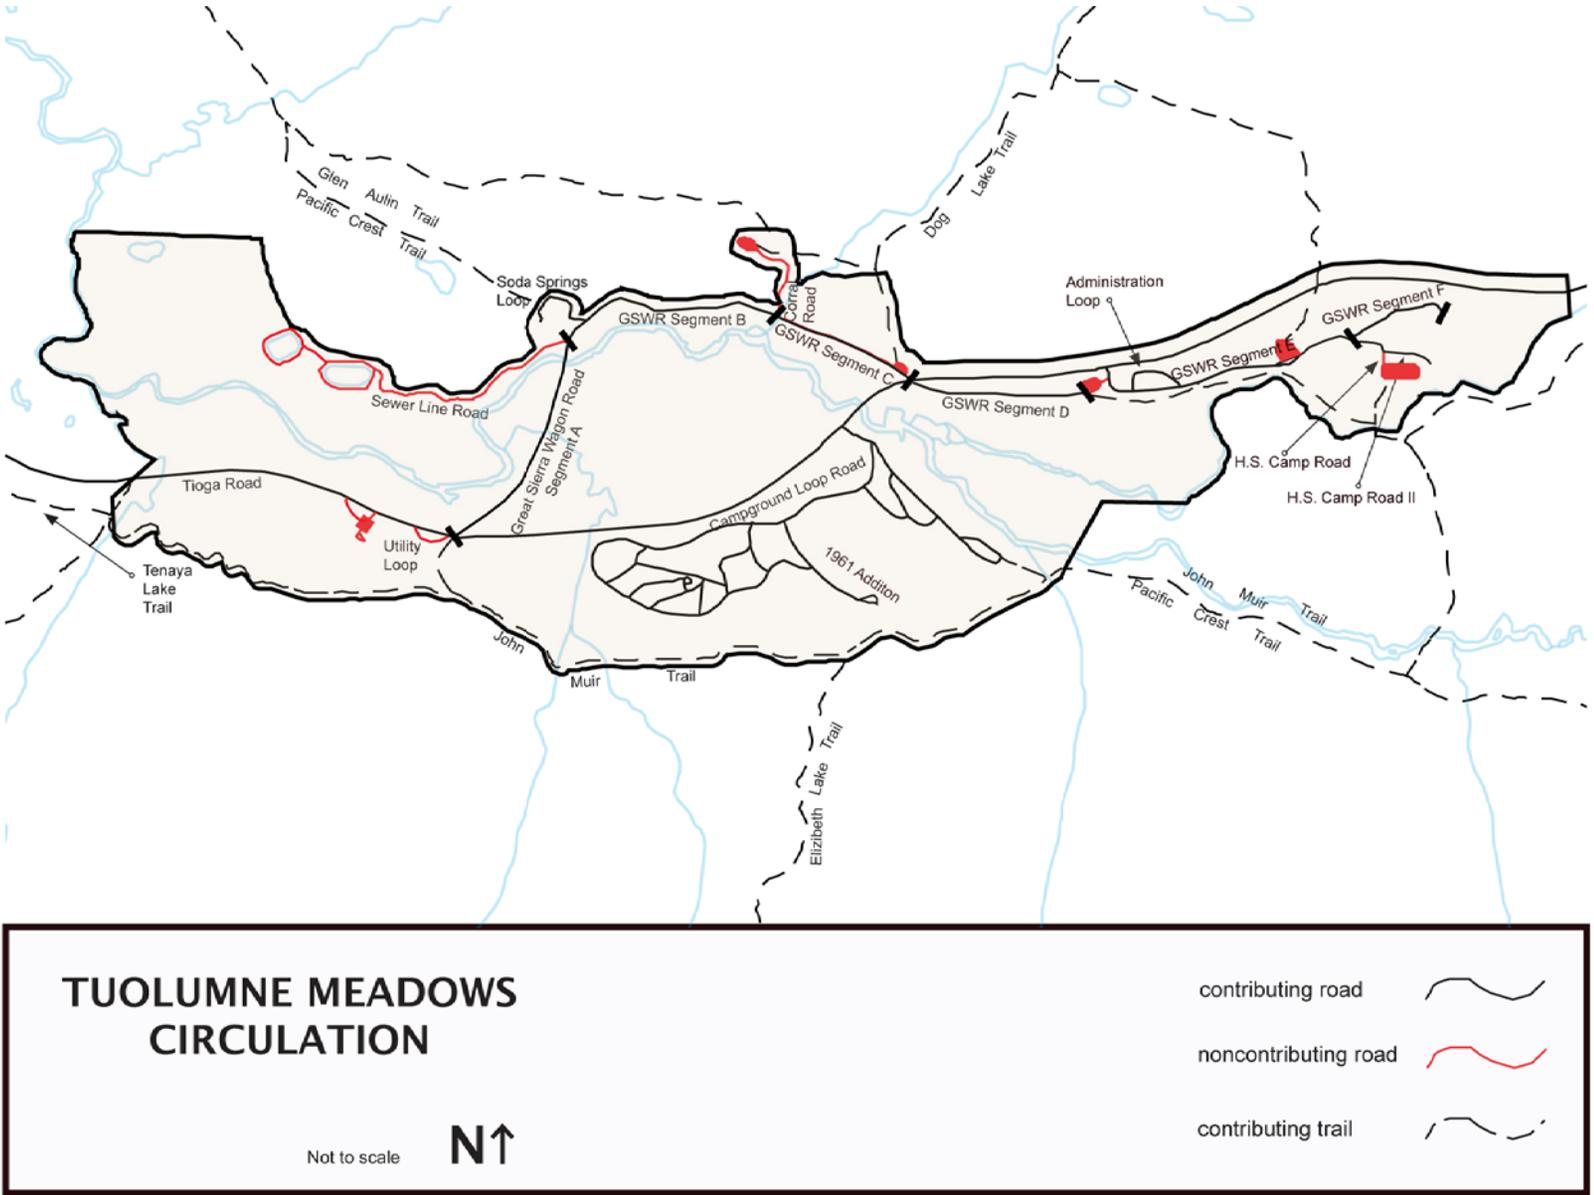
Circulation #3: Map showing existing roads and trails within the historic district.
