# Zion Resource Brief

## Resource Management and Research Division:

### Physical Sciences: Climate Change, Air Resources, Geology, Paleontology, & Hydrology

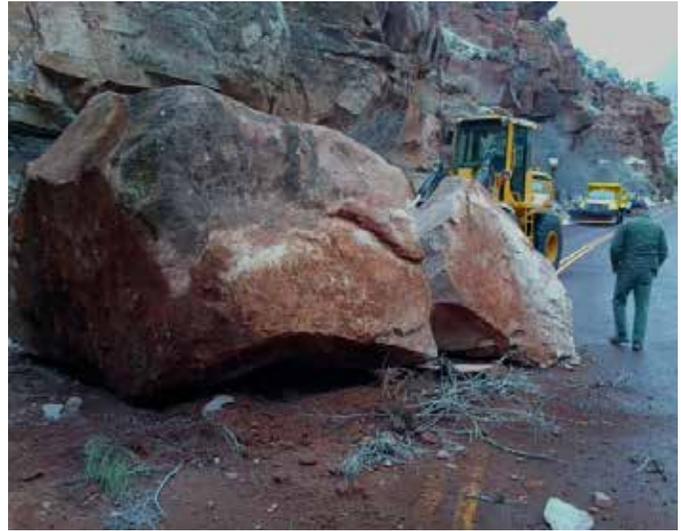
Rockfall near Canyon Junction-2012

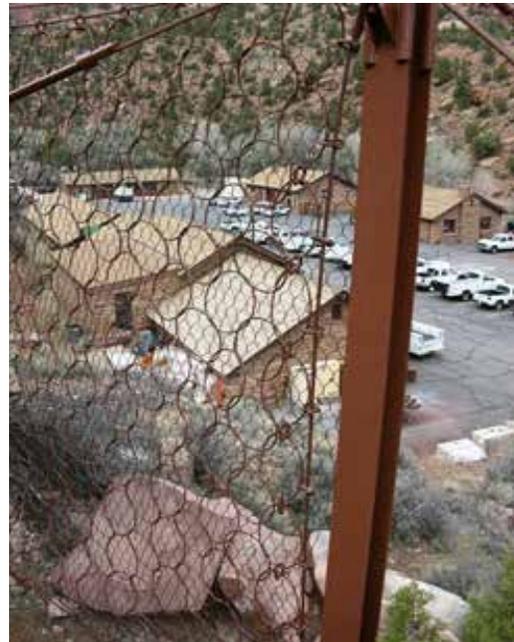
Rockfall barrier above Zion Maintenance Yard

A rockfall in fall 2010 smashed into the sign shop at the Zion maintenance yard busting a large hole in the 18-inch thick sandstone wall. It was almost an exact repeat of a rockfall in 1941. In response, rockfall barriers have been installed on the slope above the maintenance building.

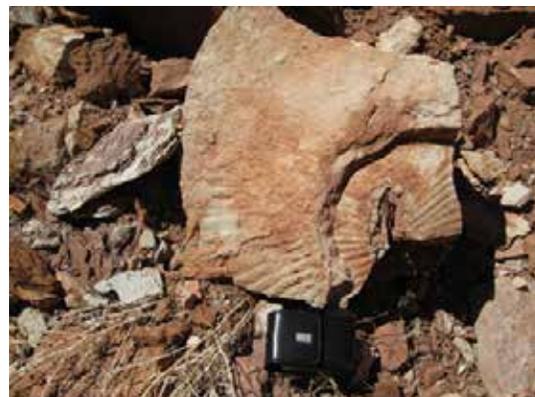
Fossil of a *Sanmiguelia* species found in 2012.

The Zion area is rich with paleontological resources. In addition to the well known occurrences of petrified wood in the Chinle Formation, dozens of track sites have been identified in the Kayenta, Moenave, and Moenkopi formations and, more rarely, in the Navajo Sandstone. The tracks were left by dinosaurs and earlier dinosaur-like creatures large and small. Monitoring of 21 sites in 2012 showed that several had been damaged or lost due to natural erosion in the 5 years since they were last visited. The exceptional rate of erosion in Zion exposes many fossils, but also takes them away. Five new sites were documented in 2012 including the discovery of a fossil of the genus *Sanmiguelia* which are some of the earliest known flowering plants.
