Carl Sandburg Home National Historic Site

Chicken House/Wash House

Historic Structure Report

September 2007

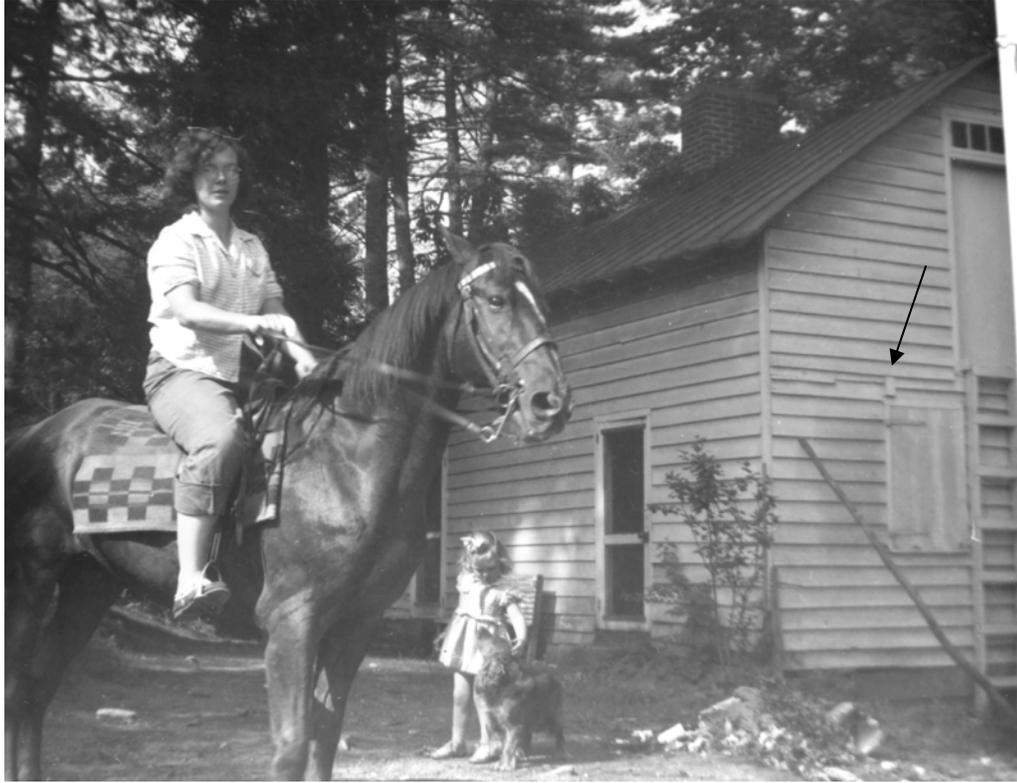
Figure B-2 Helga Sandburg on horse, with daughter Paula outside Chicken House, c. 1946. Note framing protruding from siding at arrow and lack of goat entrances on north elevation, and ladder aligned with eastern window. (CARL3000/08/25P)

Photographic documentation from the early Sandburg occupancy shows that there once were two framing members protruding from the weatherboard siding on the north elevation, on either side of the door to the second level, approximately at floor level. One of these is still existing, and measures 4 ½" by 3 ½". It is plausible that these are remnants of early landing framing that survives behind the siding. Selective removal of building elements to expose framing and archaeology would likely

identify important design characteristics of this feature. The same photograph shows the ladder on the north elevation providing access to the upper level. It was not centered beneath the upper door, but rather adjacent to the eastern (left) window. The ladder remains, but is now aligned with the western (right) window, suggesting that it was moved mistakenly during the 1970s renovations. As Memminger was a slave owner, it is believed that the building originally housed enslaved persons for the summer months while the family was in residence. Therefore, no means for heating the building would have been needed and none were observed.

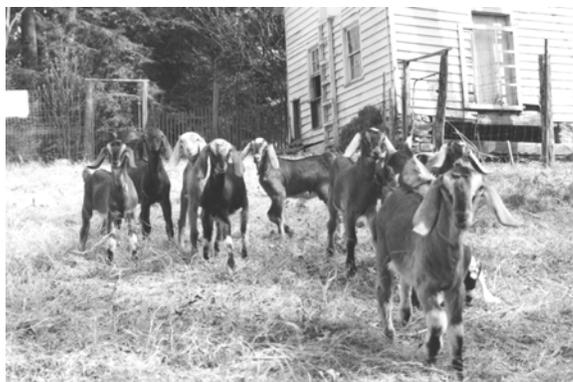
Figure B-5 Nubian kids in Chicken House yard.
Note two small openings added on north elevation.
(CARL3000/44/103P)

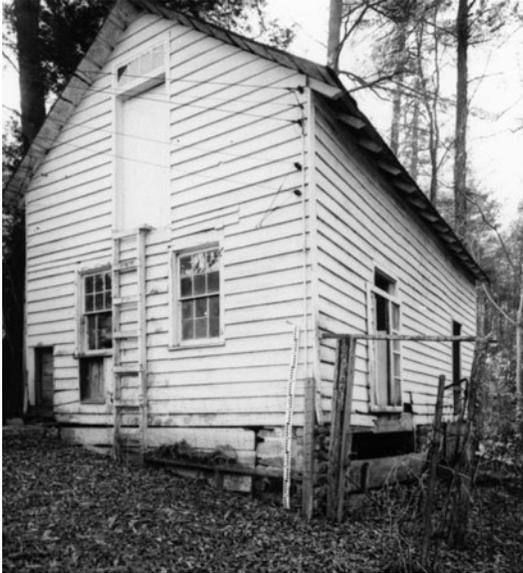
*Figure B-11 Northwest oblique, Dec. 1969.
(CARL4012/3)*

shows deteriorated siding near the northeast corner of the building on the north and east elevations, missing siding and a sagging sill along the west elevation, and sections of windows covering the door openings on the south elevation. Shutters were missing on the north elevation, in addition to some window muntins.

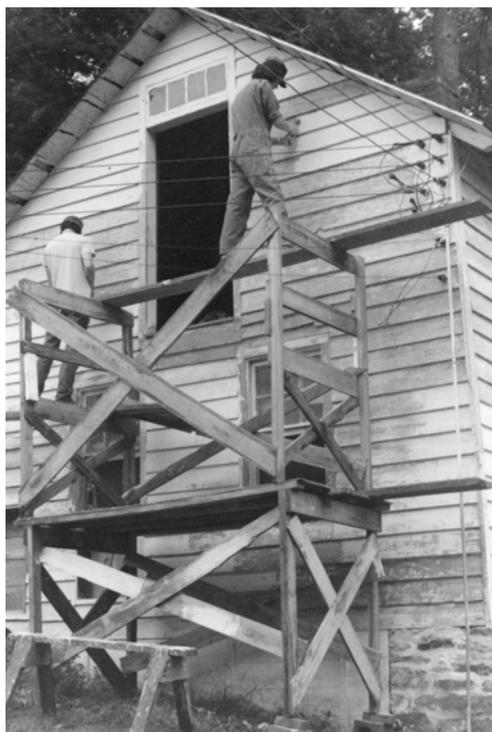
Figure B-14 North elevation being repainted, October 1979 (CARL4004/15-32P)

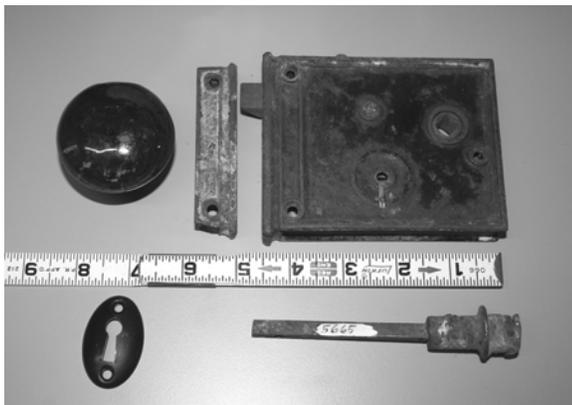
*Figure B-17 Box lock in museum collection,
February 2007*

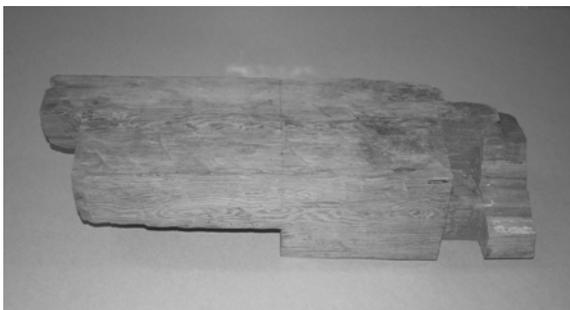
Building fragments were taken from the Chicken House/Wash House and other buildings at the time of the 1970s repair, to be catalogued and placed in storage. Unfortunately, their precise locations within the building were not recorded, and some materials now in the museum collection seem unlikely to have originated at the Chicken House/Wash House. The artifacts in question include a section of green mineral asphalt roofing with 5" exposure, a tongue- and-groove board appearing to have come from a roof deck, and a circular-sawn stud with wire nails and lime stains indicating plaster applied to the wall. No evidence within the building suggests that plaster or asphalt roofing has ever been in place on any surface, and the existing roof decking appears to be the original. Artifacts in storage that do appear to have come from the Chicken House/Wash House include a hewn sill

*Figure B-16 Hand-hewn section of sill in museum
collection, February 2007*

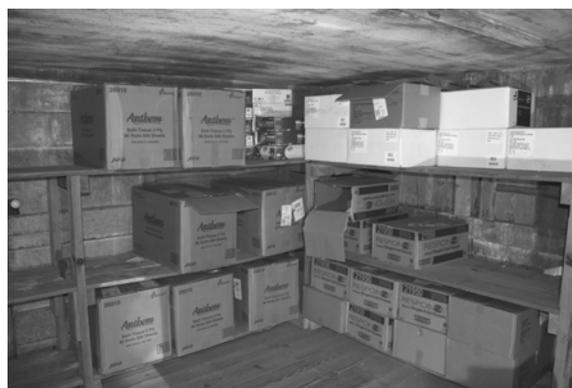
Figure B-20 Wooden storage shelves along north and west walls of south room, February 2007

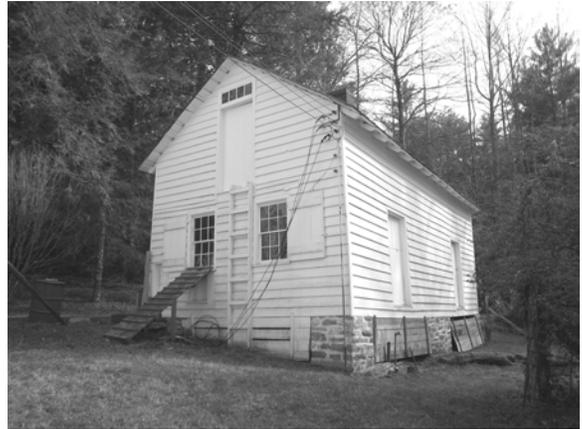
The foundation of the building is stone blocks set in mortar, and was entirely rebuilt in the repairs of the late 1970s. Two openings on the west elevation and one on the north provide access to the crawl space under the building; the openings are covered by wood boards set between the stone piers.

Figure C-1 Northwest oblique of Chicken House/Wash House

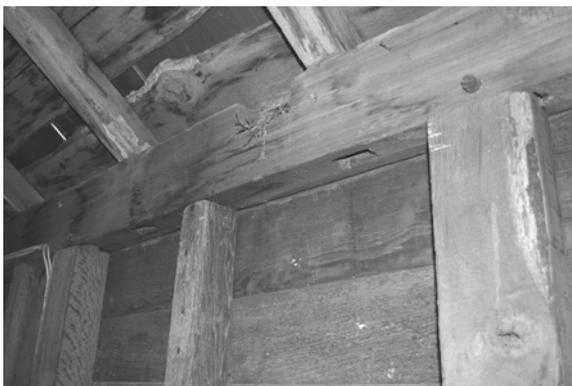
Figure C-4 Wall and roof framing visible in upper half-story

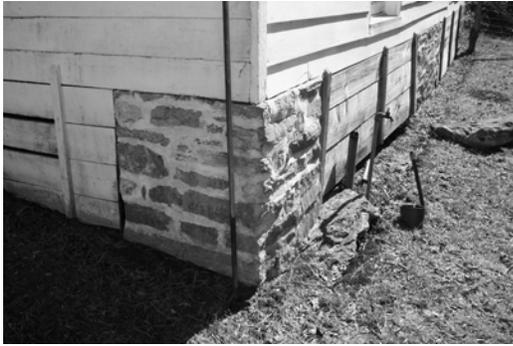
Two large openings in the west foundation wall and one on the north lead to the crawl space below the building. Each opening is covered by a modern wood panel built of three horizontal boards connected with three vertical battens. The panels are nailed in place to the frame walls through the top of the battens. The horizontal boards are spaced slightly to allow ventilation to the crawl space. These wood panels are unpainted on the west elevation and painted on the north elevation. The panels are 1970s replacements for earlier, deteriorated board panels visible in Sandburg-era photographs.

Figure C-27 Northwest corner of building showing wooden panels at foundation level

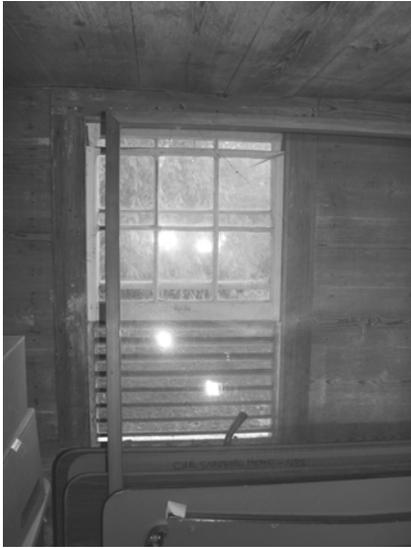
A wooden louver is in place at the window near the southeast corner of the building. The bottom sash of the window is in a raised position, with the louver in its place underneath. The louver was installed by the NPS in the 1970s repairs.

Figure C-33 Interior of louvered window

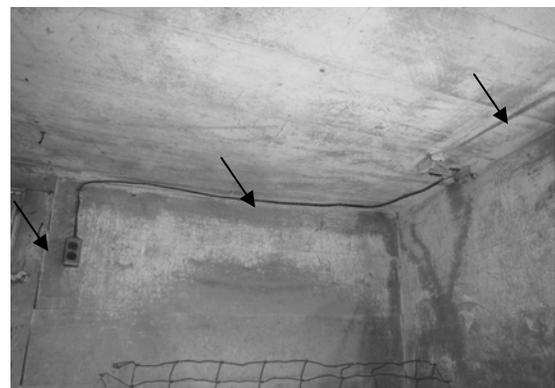
Figure C-38 Outlet and Romex along west wall, two-wire knob and tubing along north wall

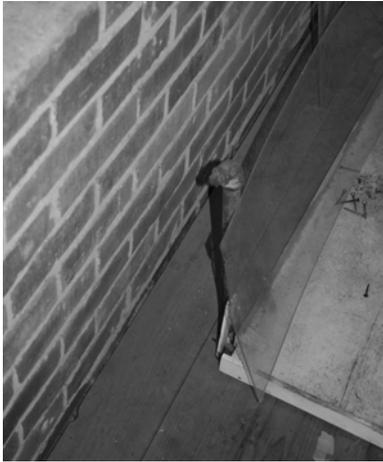
Figure C-39 Galvanized pipe adjacent to wash tubs

Plumbing Systems: A galvanized pipe near the firebox likely provided water for the wash tubs. It is no longer functional.

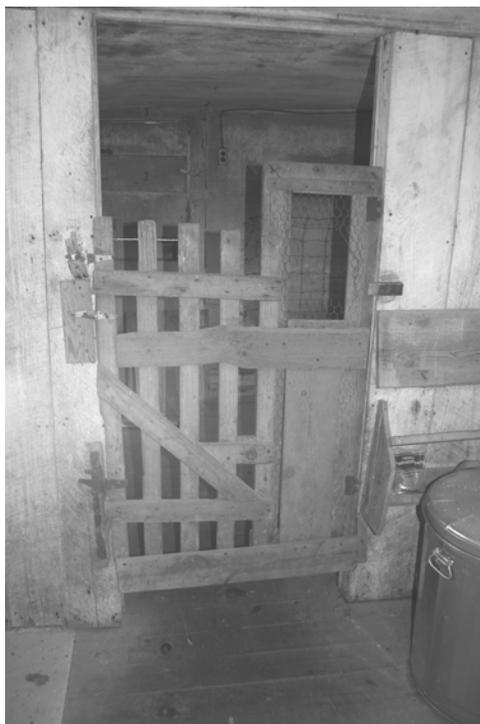
Figure C-45 Door opening with wooden gate on west wall of Room 102B

another 1'-11" from the firebox opening under the wash tub. A wooden trough is mounted on the west wall north of the door. Attached above the trough is a section of wire grid fencing, probably installed during the Sandburg occupancy to hold hay for their goats.

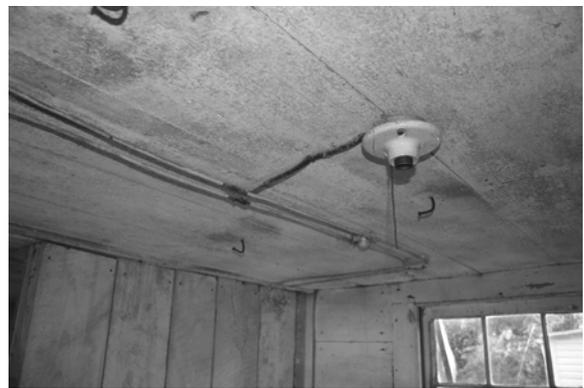
Figure C-47 Ceramic light socket and knob-and-tube wiring in Room 102B

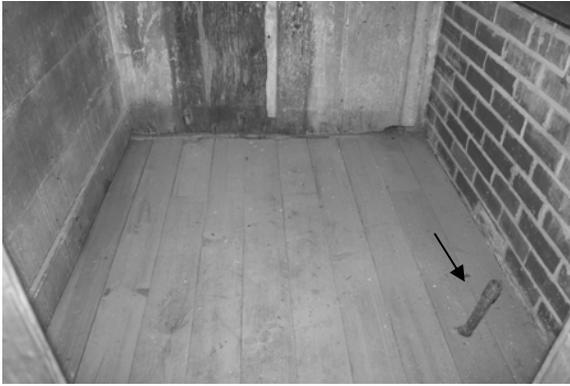
Figure C-48 Galvanized pipe and interior of closet

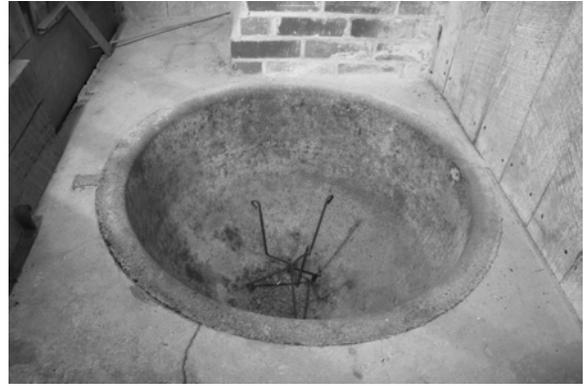
Figure C-51 Wash tub in Room 102B

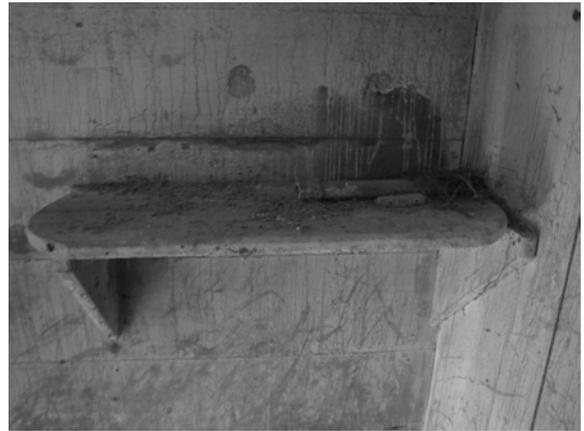
Figure C-52 Early shelf on east wall

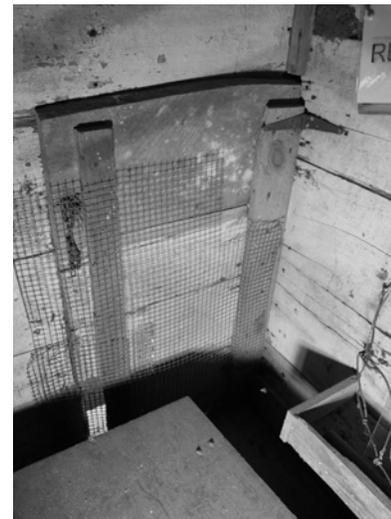
Figure C-53 Hinged goat door on north wall of Room 102B with adjacent feed trough

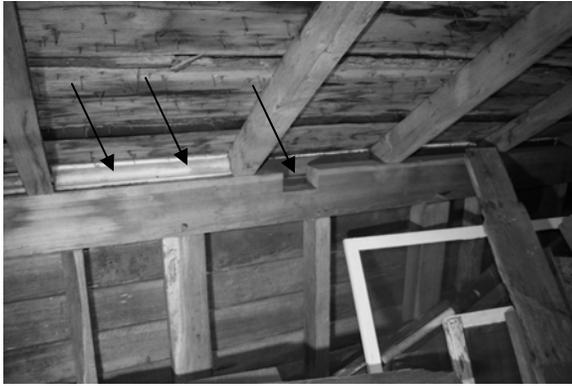
The second floor is a half-story area with exposed wall and roof framing. Wall studs extend up from the floor about 3'-9" to a 4" by 7 5/8" plate supporting the roof rafters. Two large notches in the plates suggest that large tie beams were intended to connect the east and west walls; however, it appears that they were never installed.

Figure C-54 Notches in top plate suggest collar ties; note painted sections of crown moulding along parts of top plate

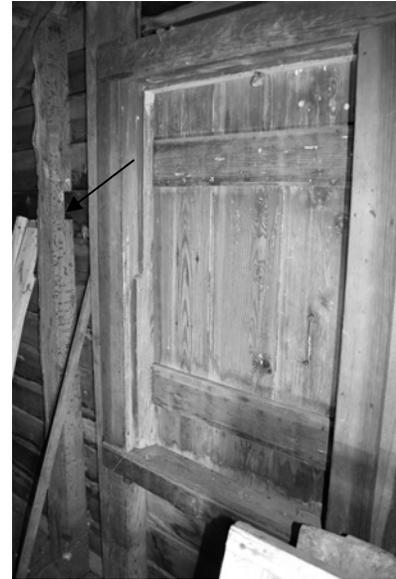
Figure C-57 Window opening at south wall of Room 201A, with shutter closed and stud notch indicated

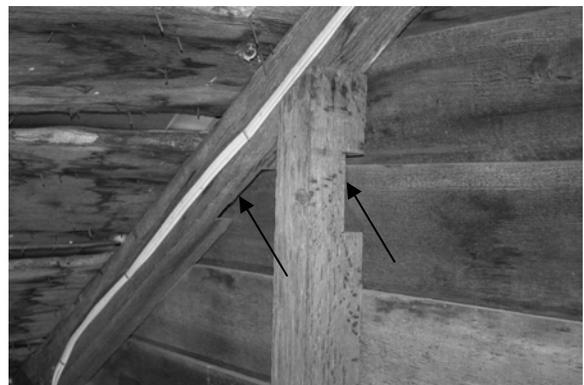
Figure C-59 Notches in studs at north gable end

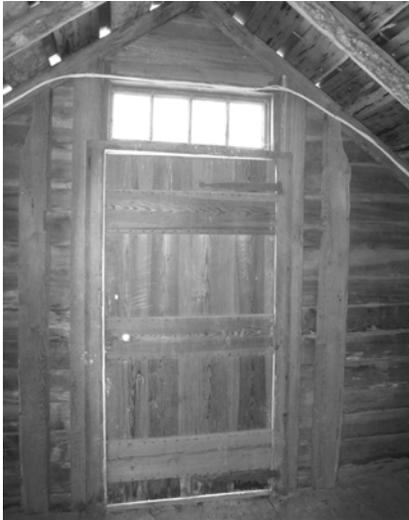
Figure C-60 Door opening and transom on north wall of Room 201B

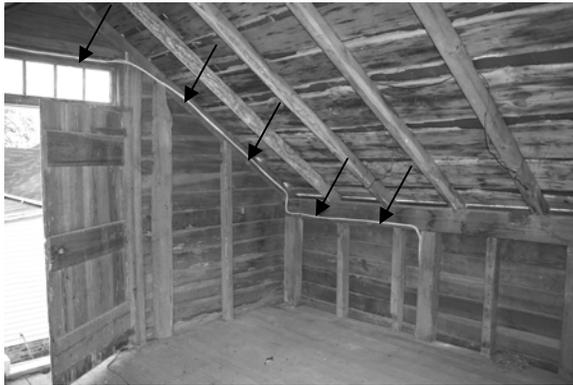
Figure C-61 Romex wiring leading from service point to disconnect box below

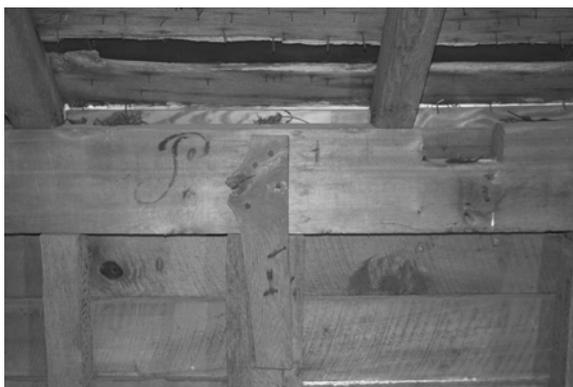
Figure C-62 Letter "P" inscribed on west top plate

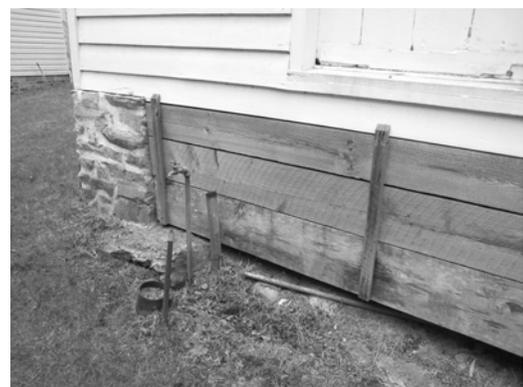
Figure C-65 Hose bib at west elevation

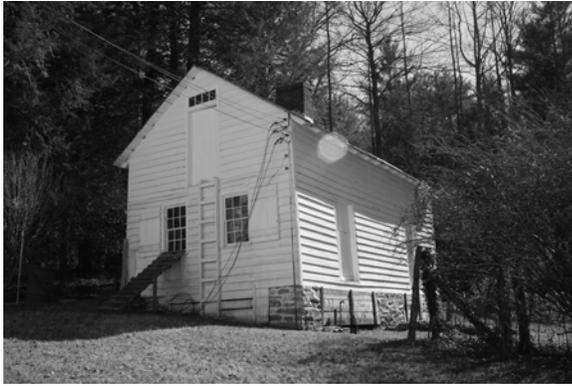
Figure B-1 Northwest oblique of Chicken House/Wash House, February 2007

The building is in generally good condition. Opening the interiors of the building for
