HISTORIC STRUCTURE REPORTS
FOR TEN BUILDINGS

ADMINISTRATIVE, PHYSICAL HISTORY AND ANALYSIS SECTIONS
KLONDIKE GOLD RUSH NATIONAL HISTORICAL PARK
SKAGWAY, ALASKA

Prepared by
Catherine H. Blee, Archeologist,
Robert L. Spude, Historian
and
Paul C. Cloyd, E.I.T. Historical Architect

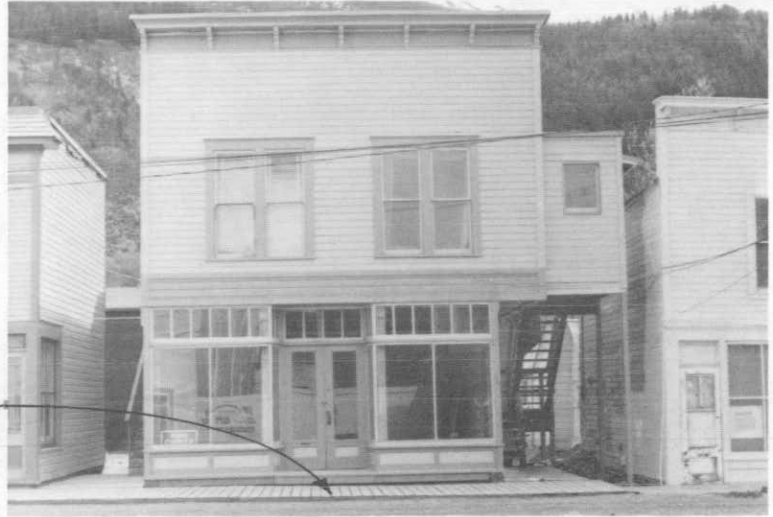
Photograph 10. April 1981. West elevation.

Elevate boardwalk
to door sill level

Remove corrugated metal,
conduit and wires

Infill opening with
matching siding

Remove bars

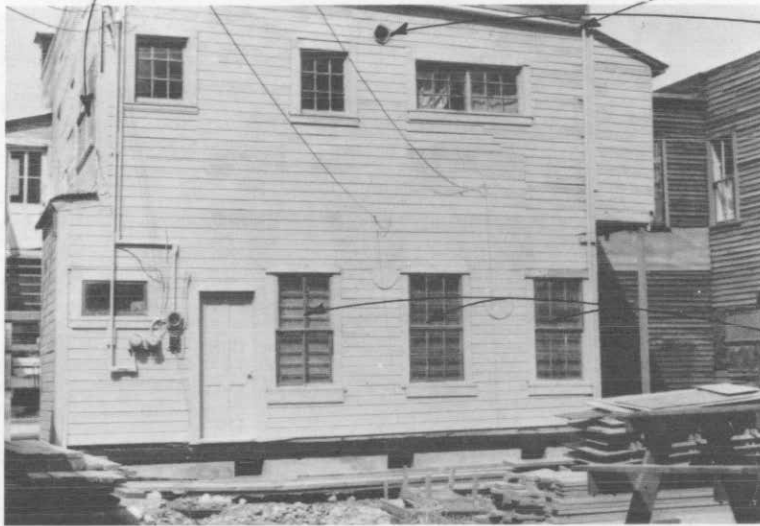
Photograph 11. April 1981. East elevation.

Restore roof

Install screen

Remove eaves

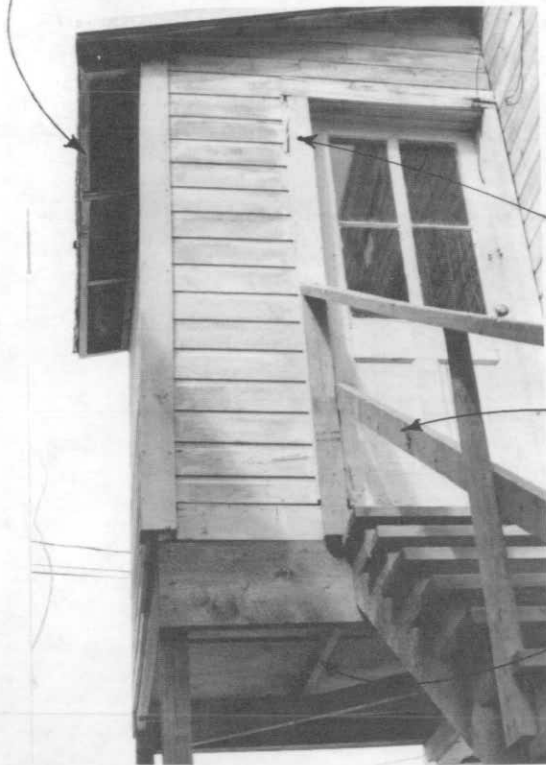
Photograph 13. South vestibule, east door.

Repair trim

Replace stair railing

Upgrade framing

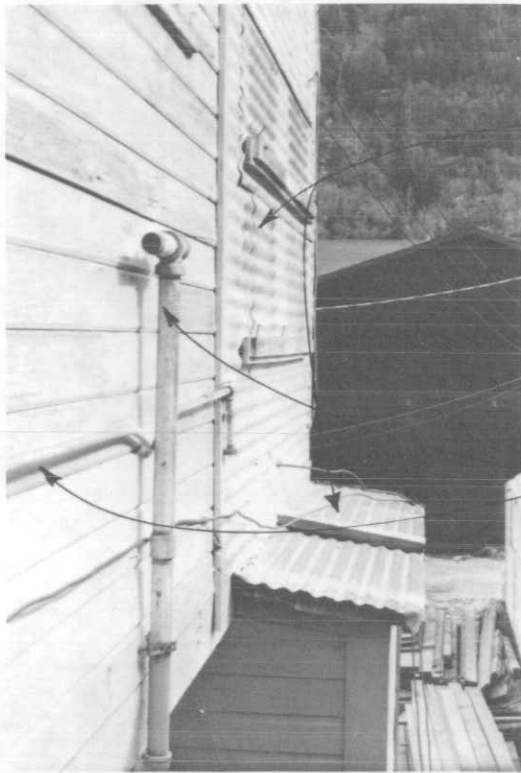
Photograph 14. South elevation detail.

Remove corrugated metal

Remove miscellaneous conduit, piping and wires

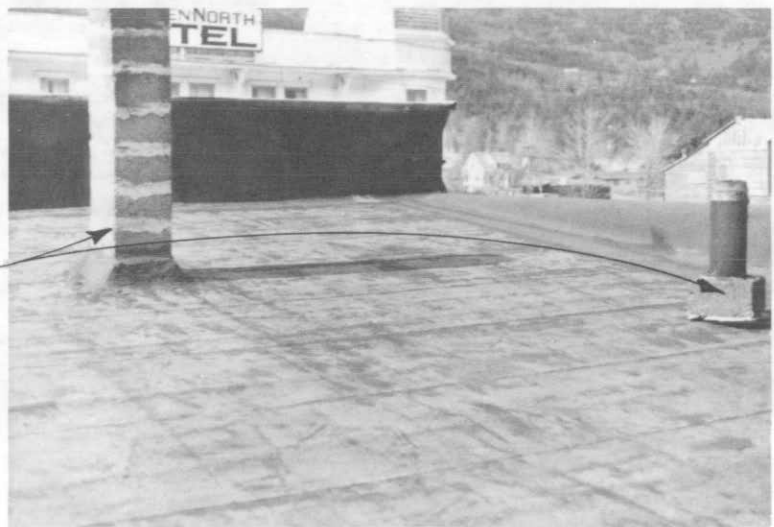
Photograph 15. Northwest roof area.

Remove chimney and stack vent

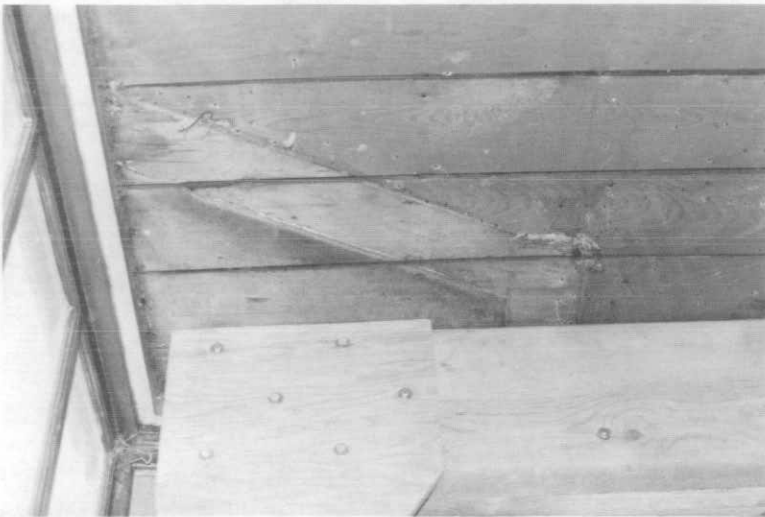
Photograph 20. Ghost of original glass facade configuration.

Infill of historic interior stairway

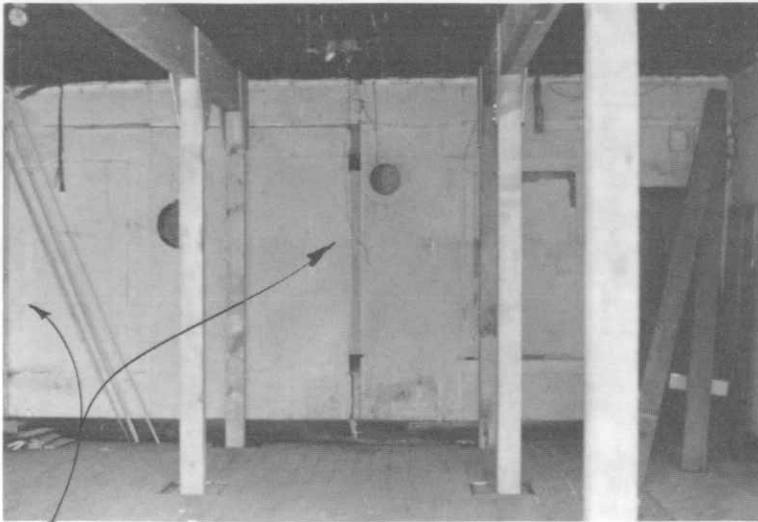
Photograph 22. Main room, east wall.

Remove celotex,
columns and beams

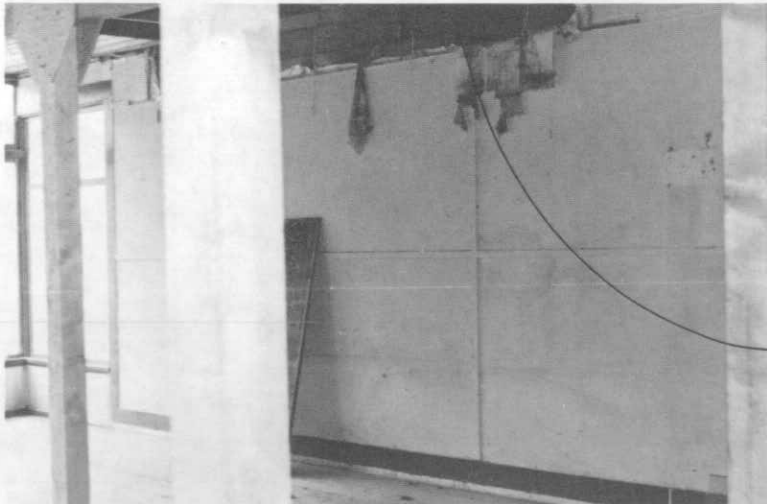
Photograph 24. Main room, northwest corner.

Retain interior sheathing in place

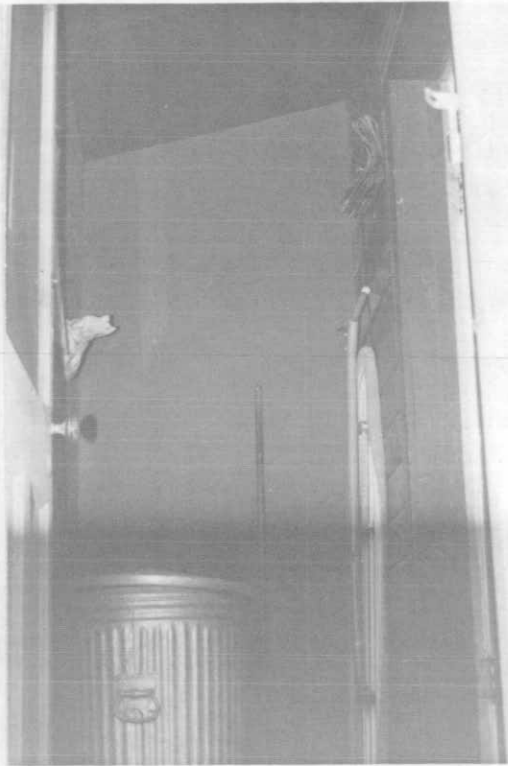
Photograph 25. North vestibule,
view toward east.

Install sheetrock finish
over existing sheathing

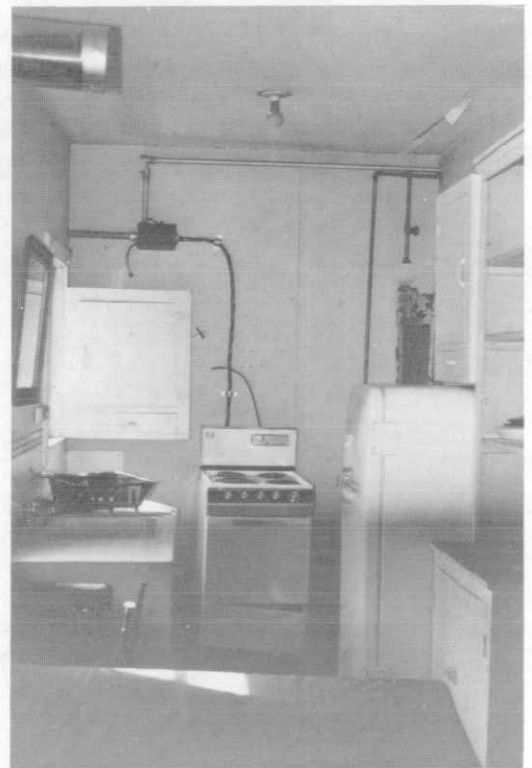
Photograph 32. East kitchen, south wall.

Remove masonry flue

Upgrade ceiling joists
for clear span

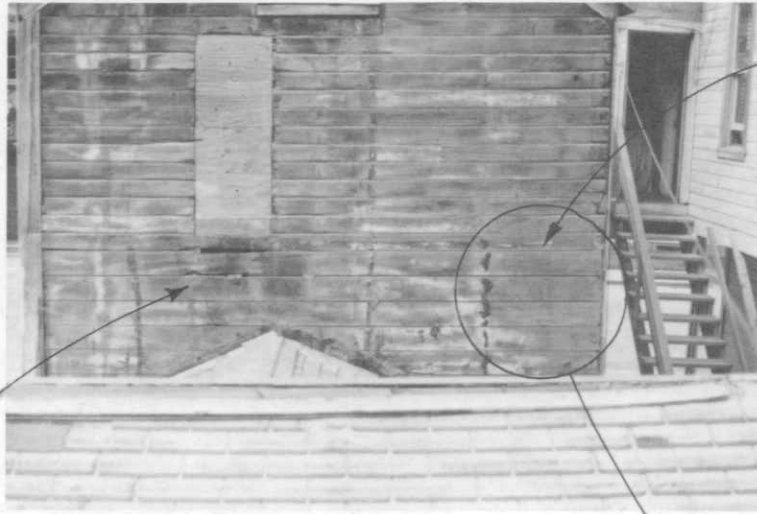
Photograph 20. East elevation.

Flashing remnants of original shed roof

Sheathing boards

Repair exterior siding

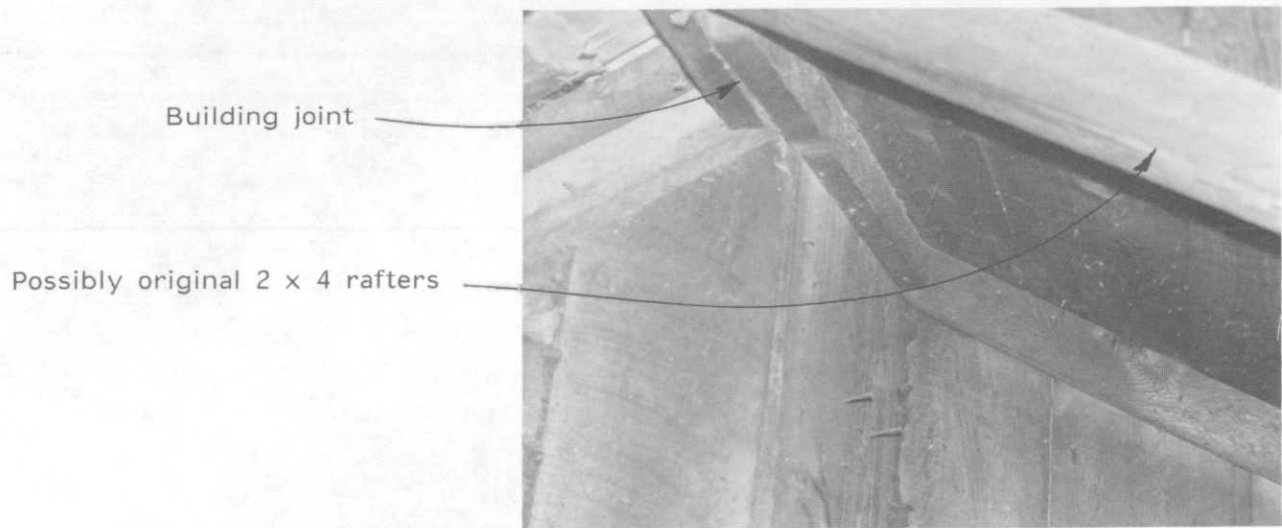
Photograph 43. Offset detail, north end.

Building joint

Possibly original 2 x 4 rafters

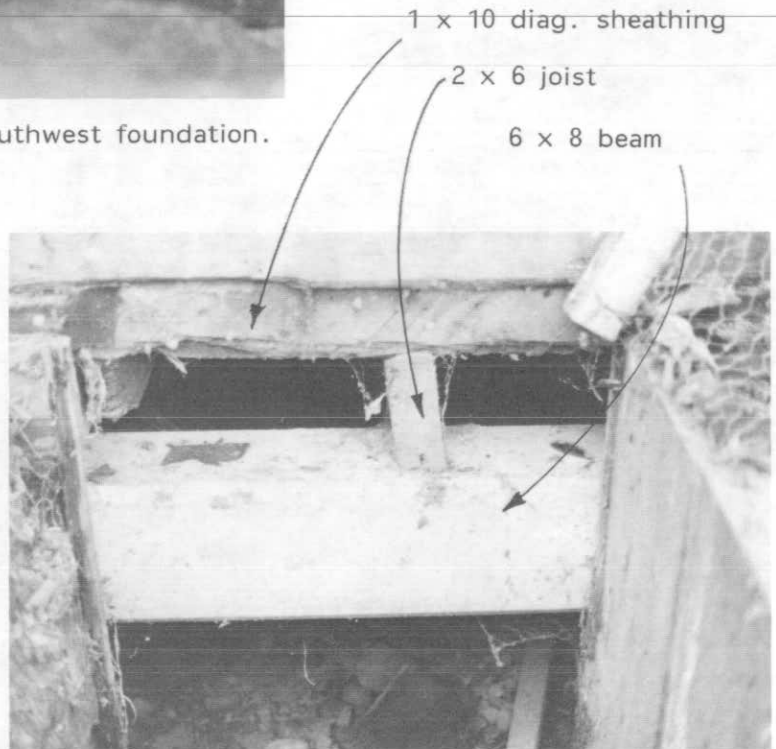
Photograph 51. West building, sill detail.

1 x 10 diag. sheathing

2 x 6 joist

6 x 8 beam

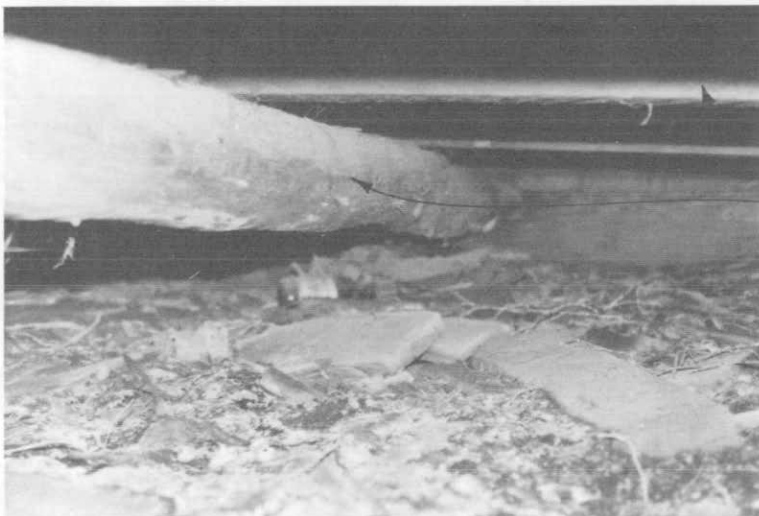
Photograph 52. Center building, west floor framing.

2 x 6 floor joist

8" Ø beam

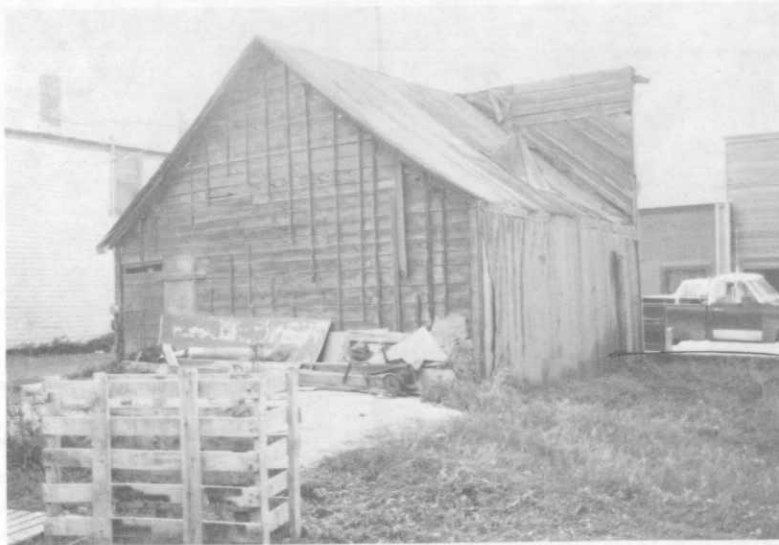
Note dampness
retained by
asphaltic cover

Photograph 15. 1977. View from northeast;
building on original site.

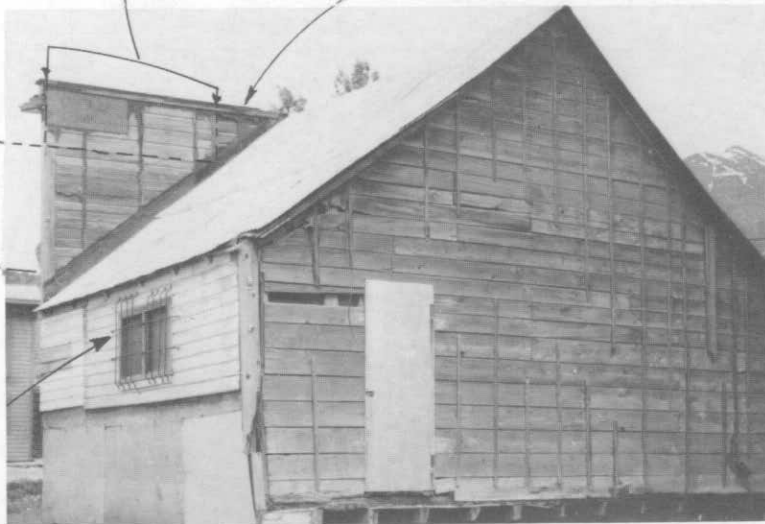
Photograph 20. 1981. View from southeast. N.P.S. photograph by T. Busch.

Remove roofing

Remove siding

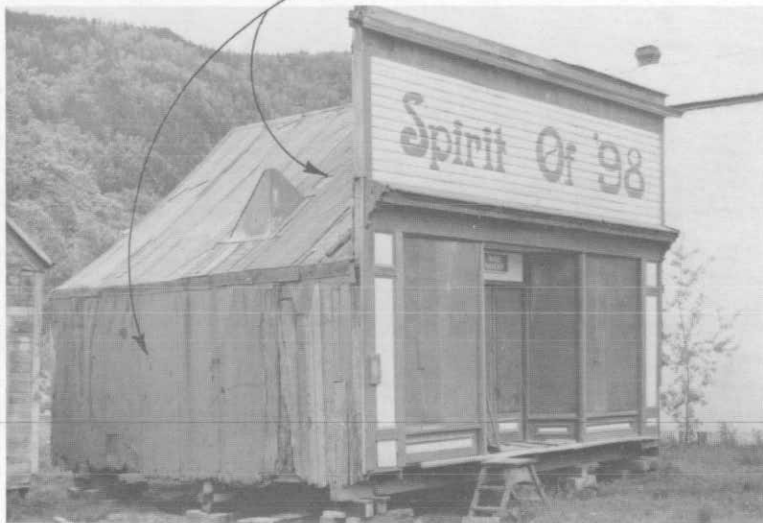
Photograph 21. View from northwest.

Remove asphaltic roll roofing

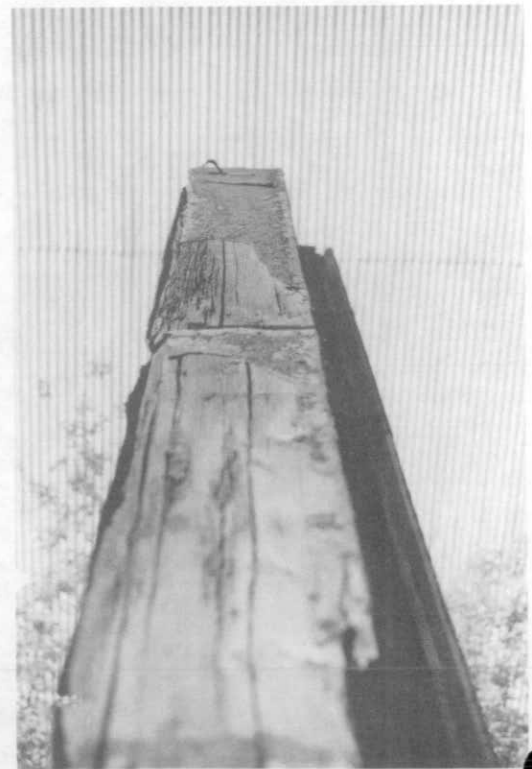
Photograph 26. Top of false front.

Remove roofing
throughout

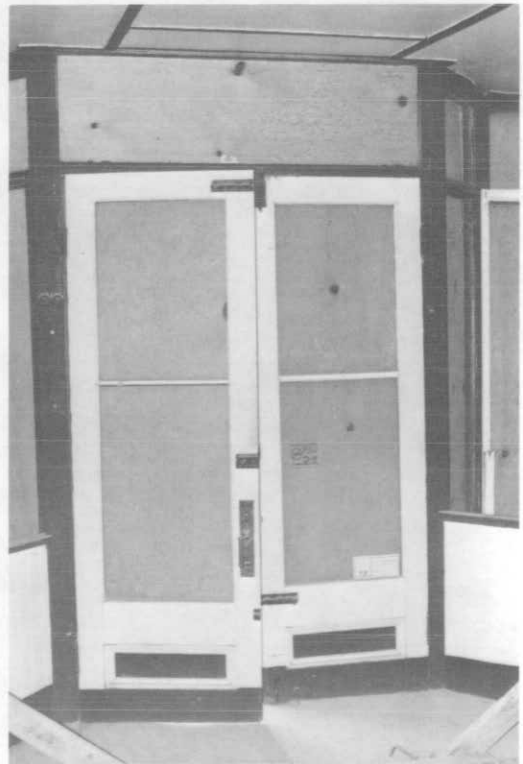
Photograph 29. Interior, west entry.

Disconnect and retain knob
and tube wiring in place

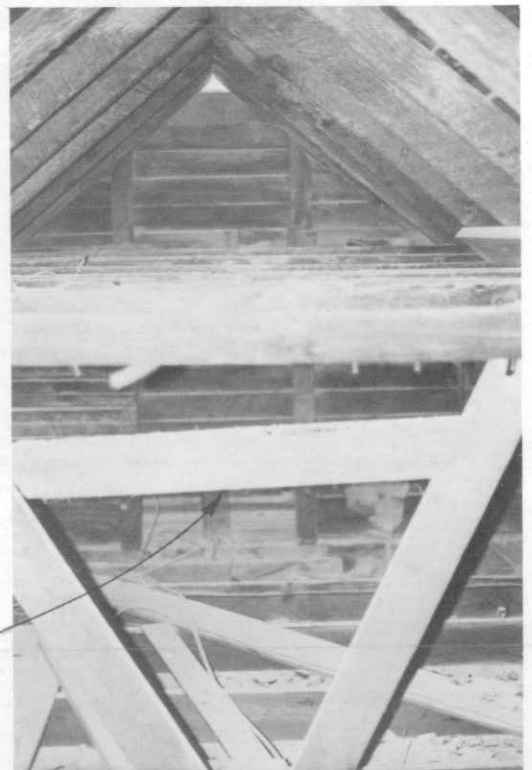
Historic window location

Photograph 32. Attic, west end.

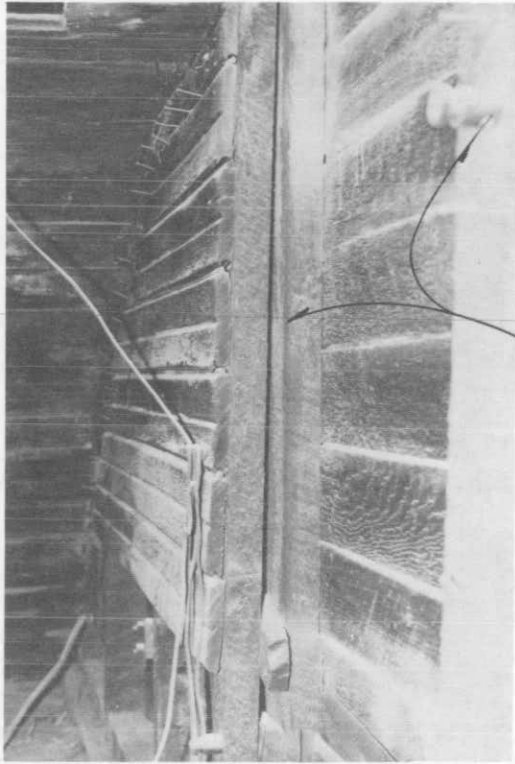
Historic window framing

Photograph 33. West attic wall.

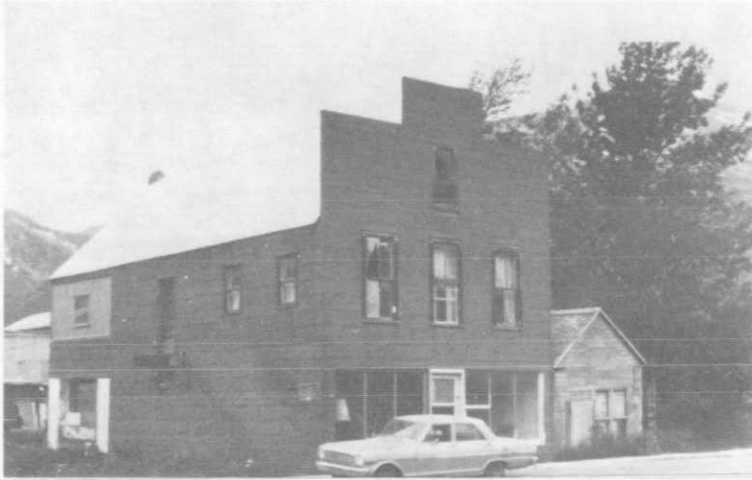
Note eave detail in comparison with photograph 1.

Photograph 2. 1972. Building on original site.

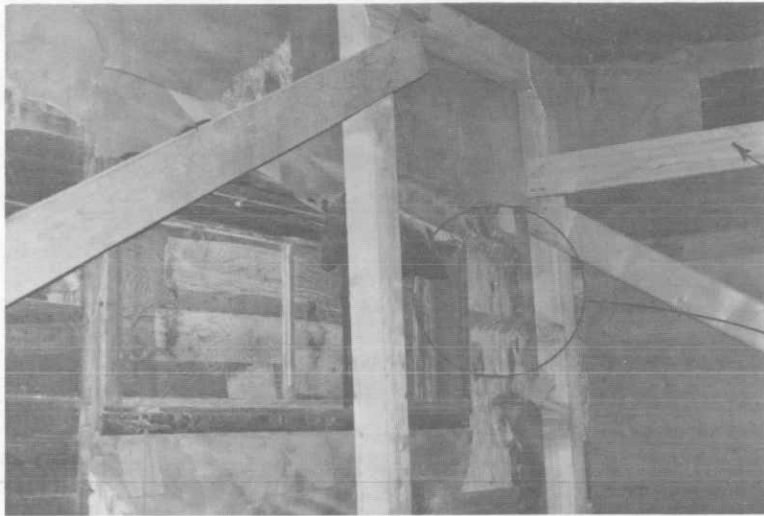
Heavy timber frame installed 1979

Photograph 16. Southwest corner, west room.

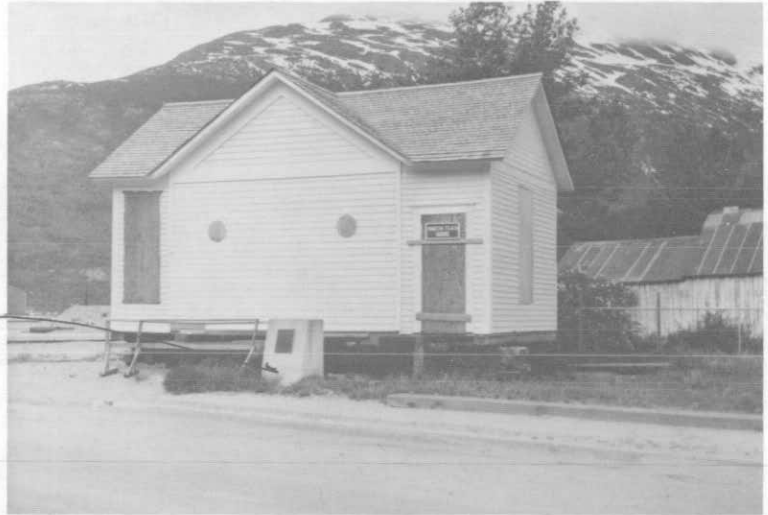
Photograph 9. East elevation.

Align structure parallel to street

Relocate marker

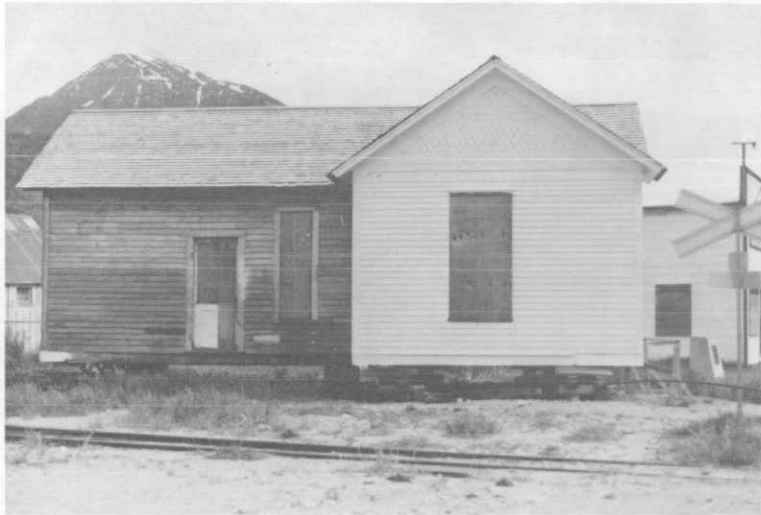
Photograph 10. South elevation.

Replace cribbing with new foundation

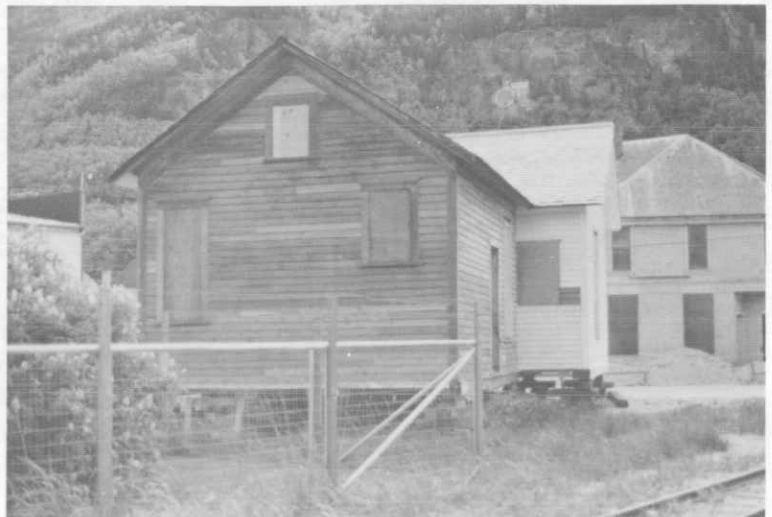
Exterior painting completed
June 1981

Photograph 11. West elevation.

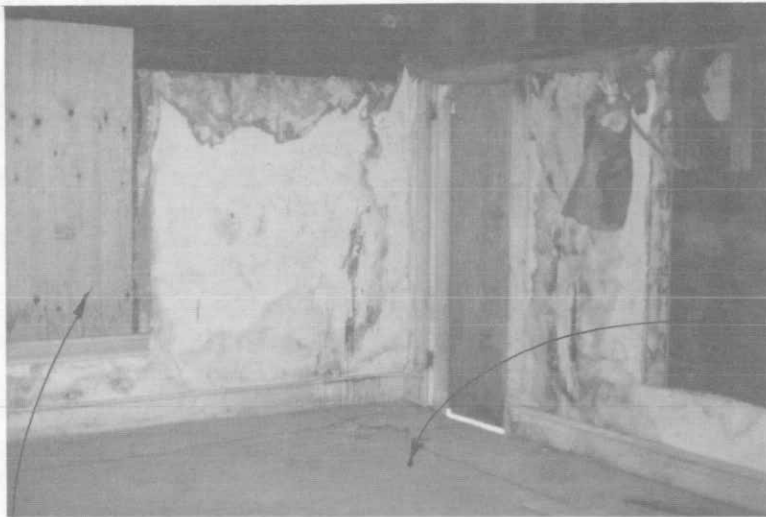
Photograph 15. Northeast corner, room 1.

Install carpet

Restore windows

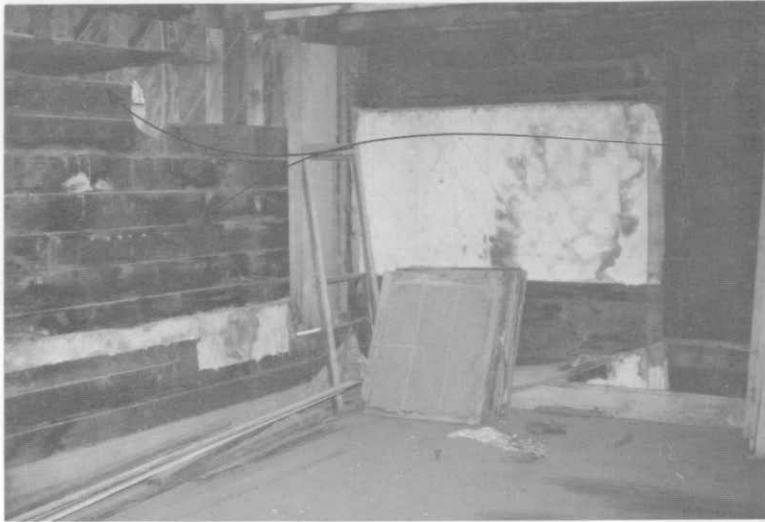
Photograph 18. Southeast corner, room 1.

Remove sheathing,
install batt insulation

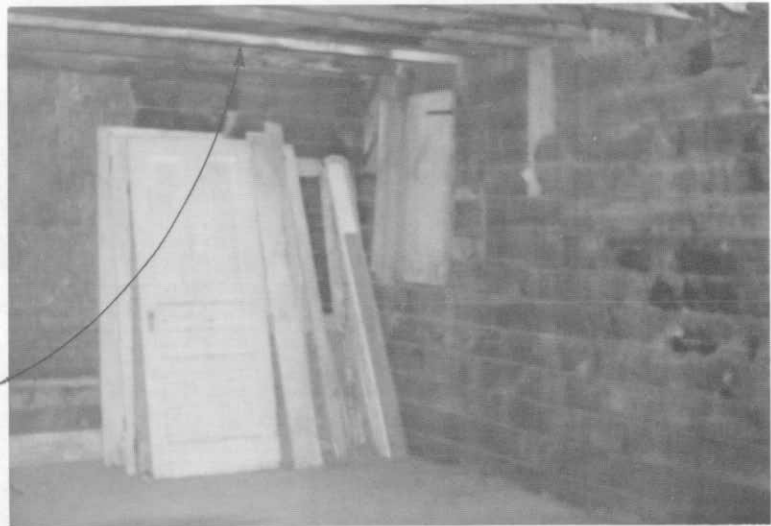
Photograph 19. Southwest corner, room 1.

Remove false ceiling joists

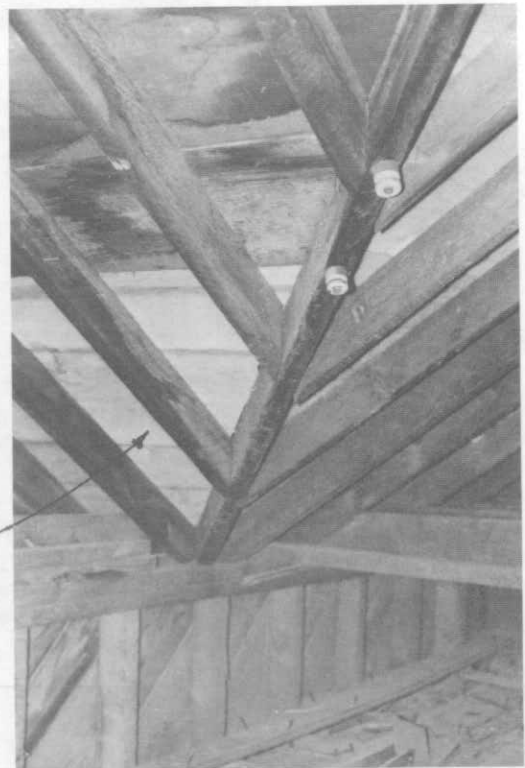
Photograph 25. East attic, south end.

N.P.S. roof deck repair

Remove cribbing, install permanent foundation

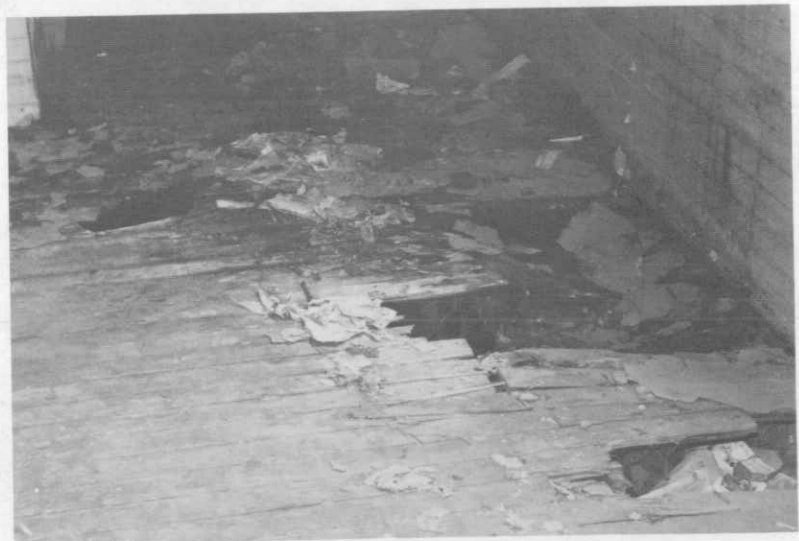
Photograph 34. 1978.
As found floor conditions.

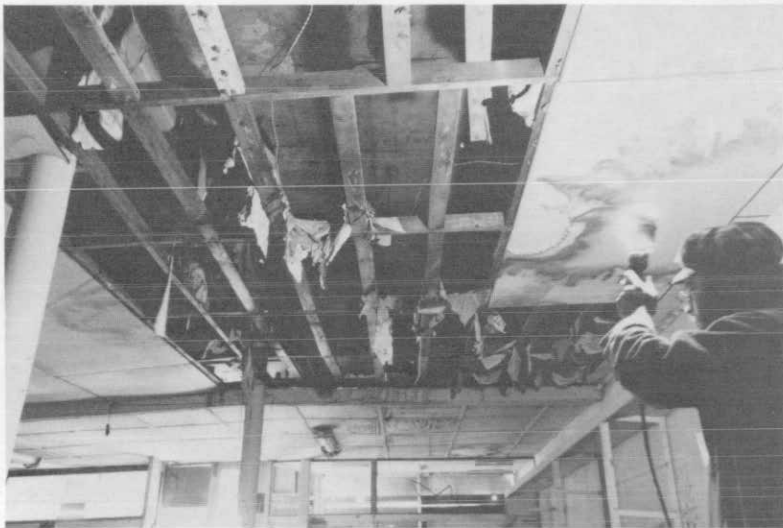
Photograph 42. False ceiling. 1978.

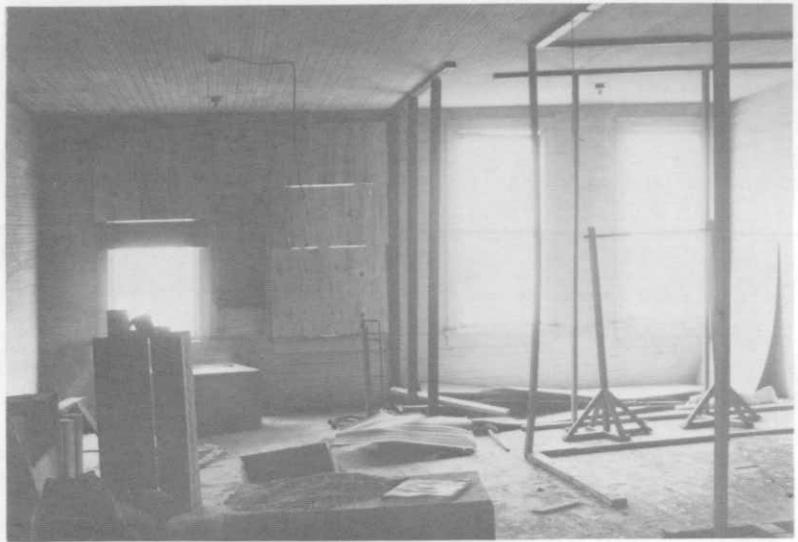
Photograph 44. 1978. As found conditions, west wall.

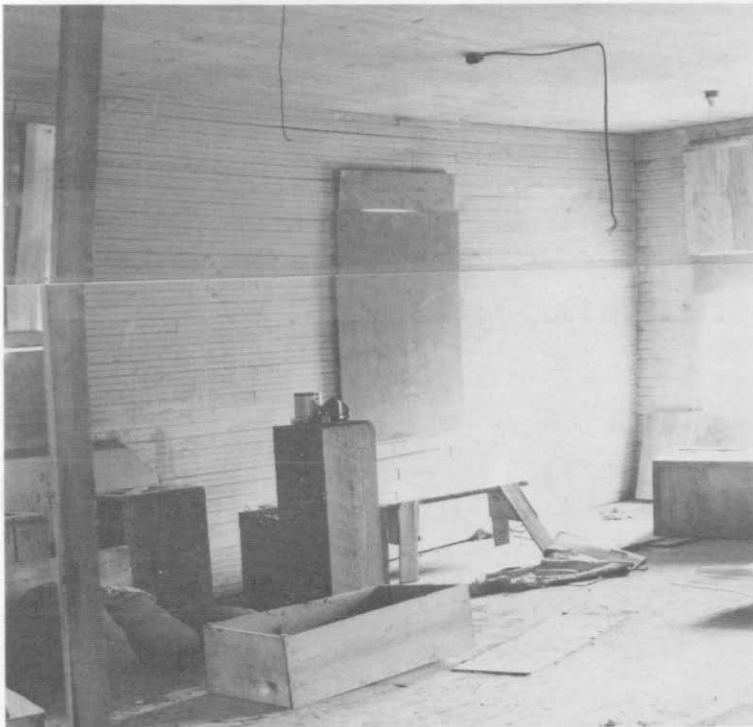
Photograph 45. 1978. As found conditions, southwest corner.

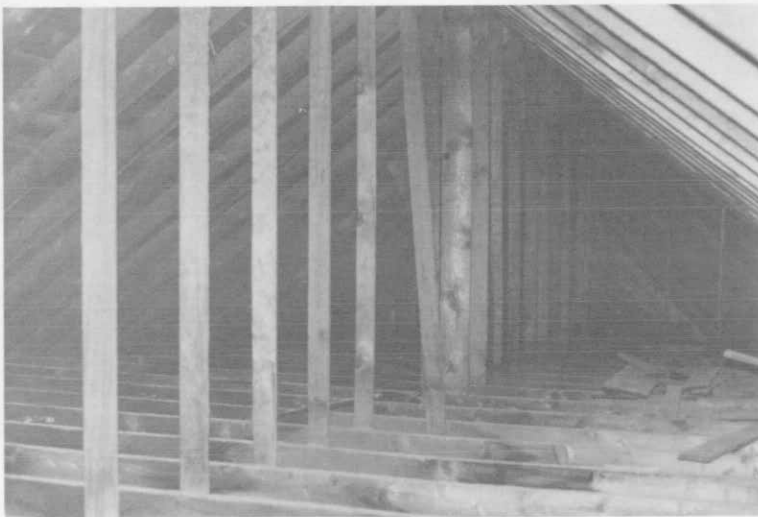
Photograph 55. Southeast portion.

Ghost of 1900
original trim

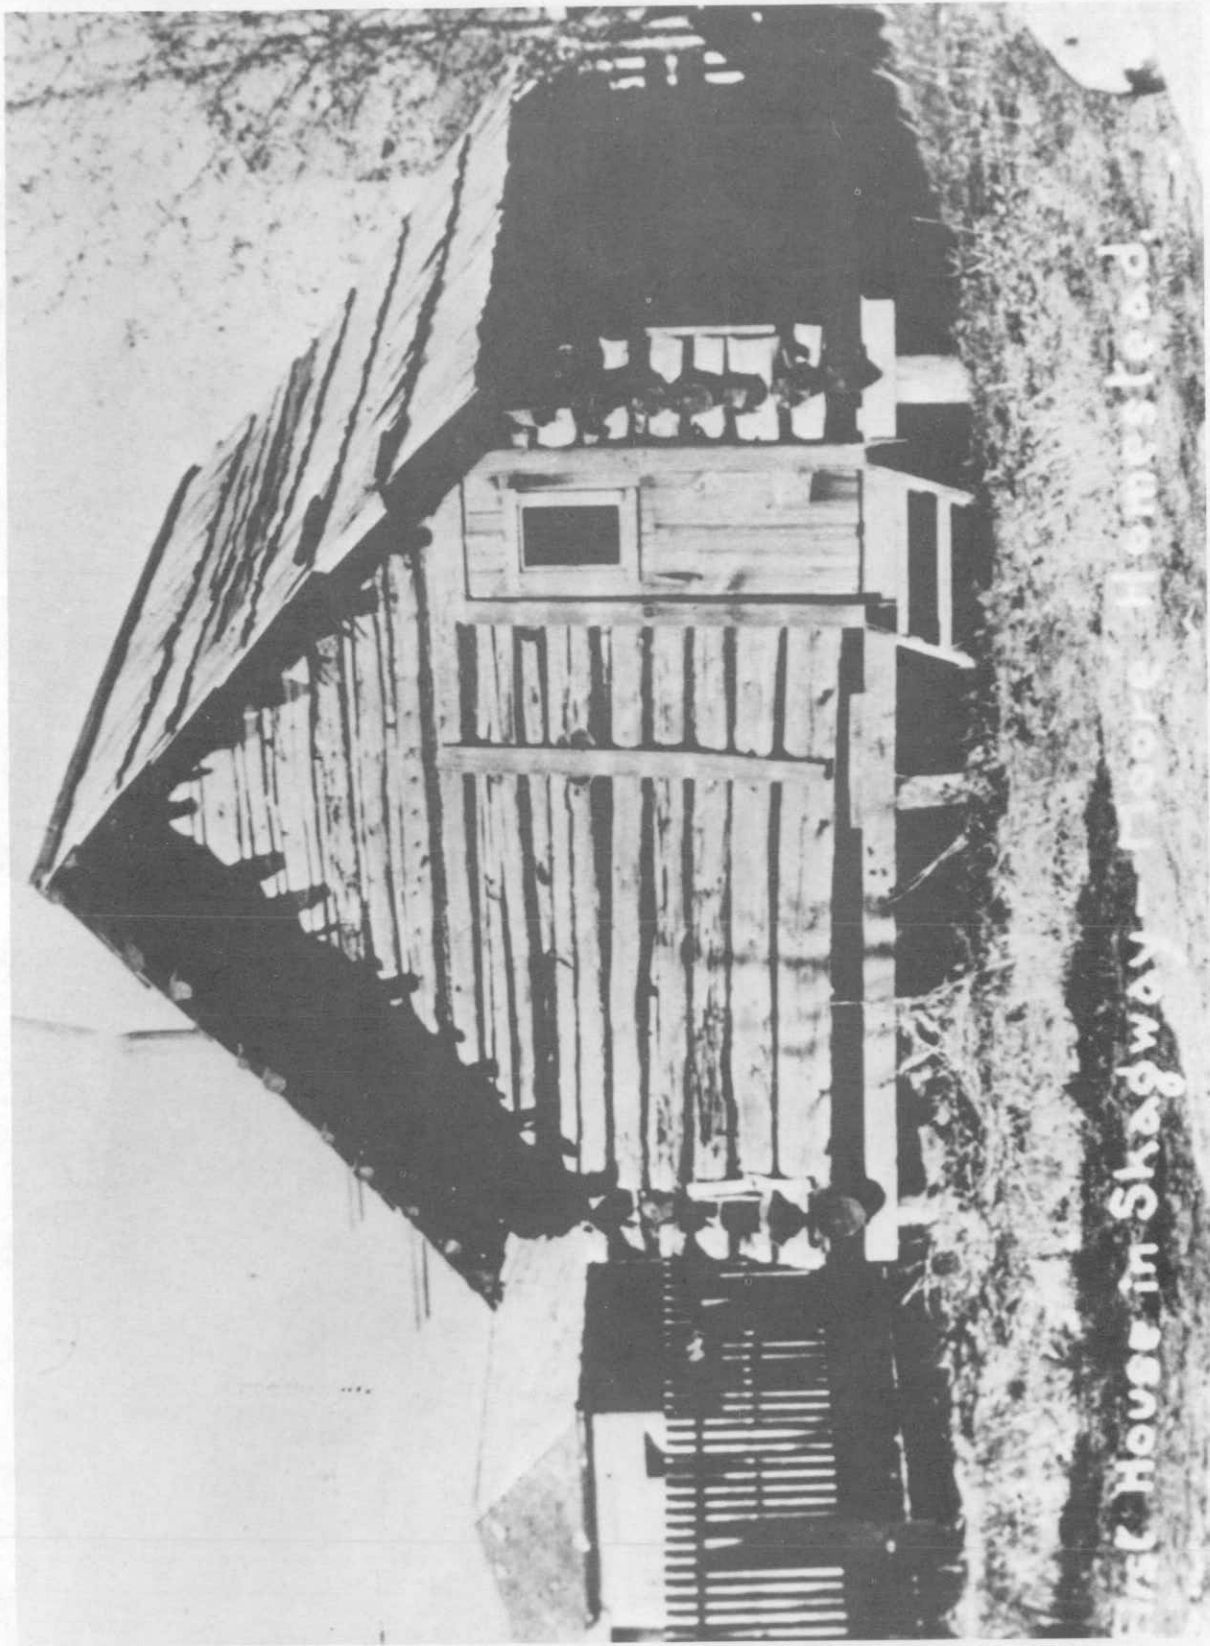
Photograph 19. Date unknown. Moore cabin, view from southeast. Anchorage History and Fine Arts Museum.

Note condition of roof

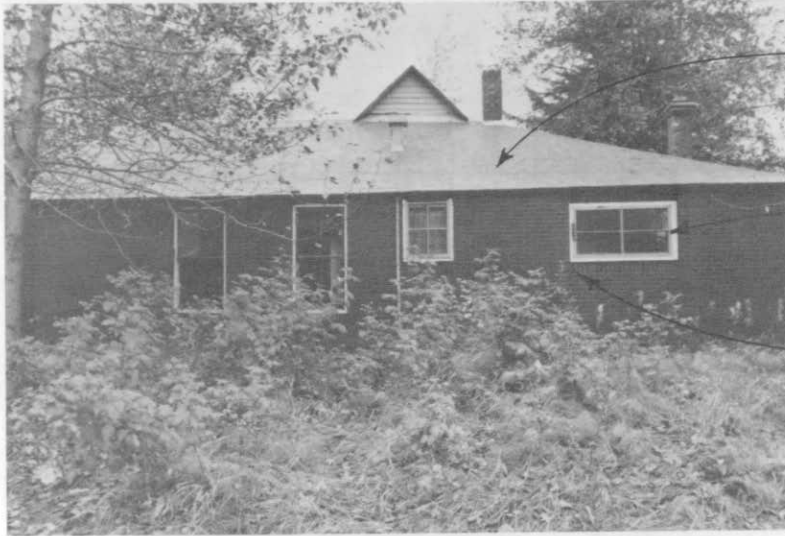
Roofing material removed
summer 1981

Infill window

Infill windows

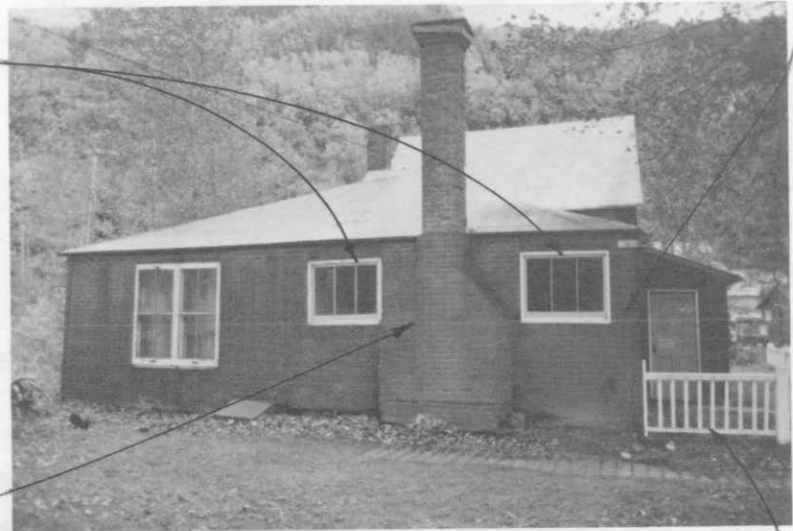
Photograph 23. West elevation.

Chimneys removed
summer 1981

Railing removed summer 1981

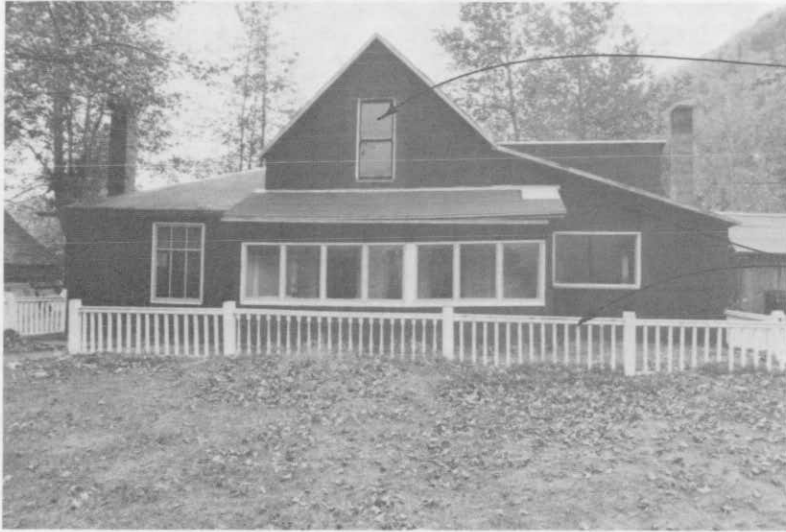
Window restored to off-center location summer 1981

Asphaltic sheathing and railing removed summer 1981

Photograph 25. South elevation, Oct. 1979.
N.P.S. photograph by R. Copeland.

Wood shingle roof installed summer 1981

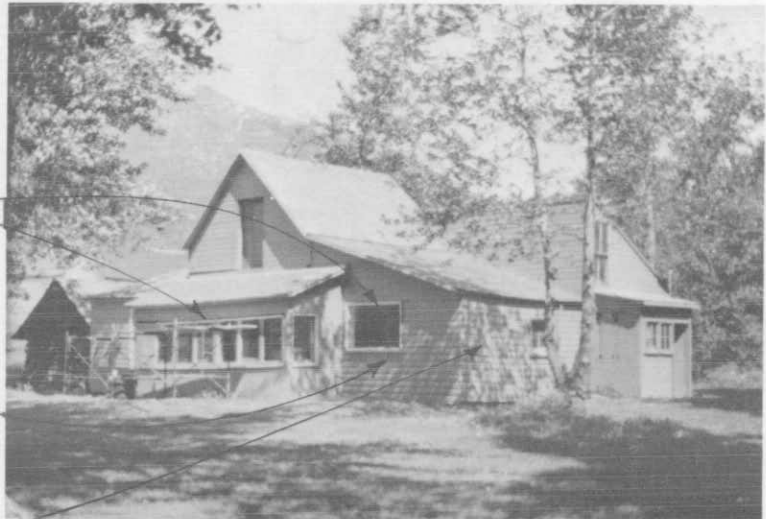
Infilled areas of original window

Infill of historic window (not an original window, see photograph 8)

Photograph 26. View from southeast, July 1981.

Removal of all as-found roofing materials occurred in the summer of 1981 and were replaced with plastic coated steel foil and fire retardant treated shingles (see photographs 26 and 27). Rebuild chimneys with reinforced masonry using 1:4:8 (Portland cement:lime: sand) mortar. Install 1 by 3-inch wood ridge capping.

Remove window and porch

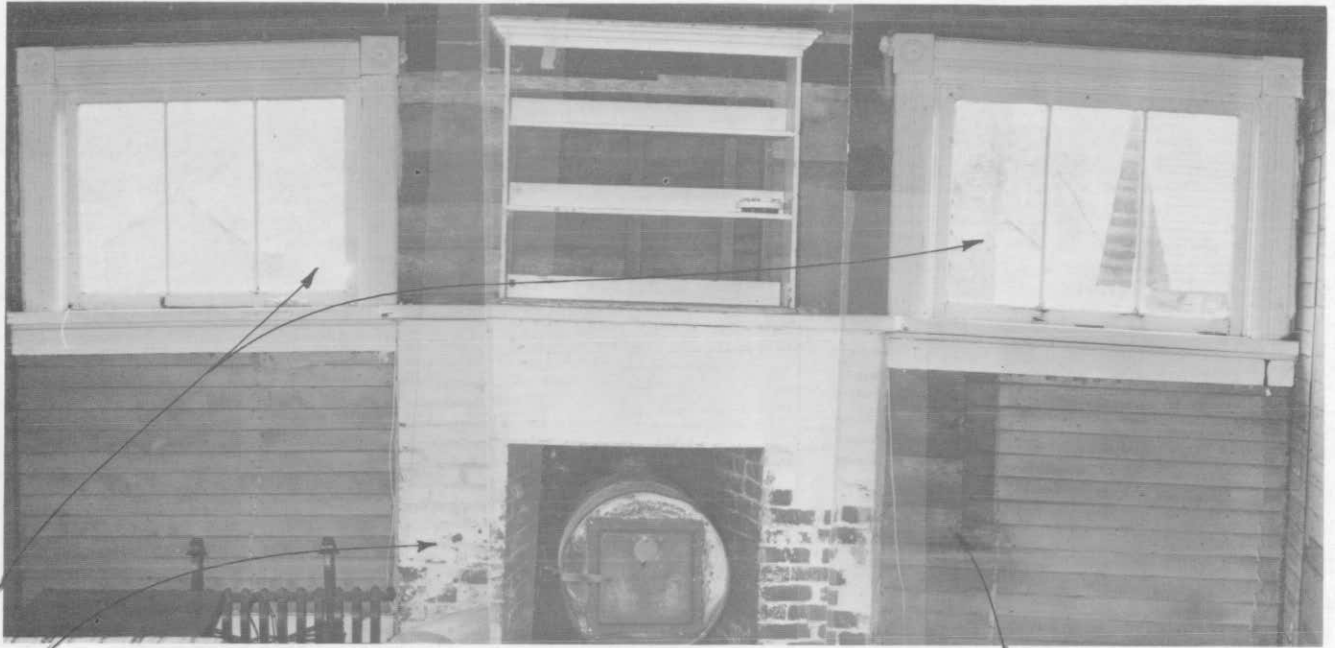
Photograph 30. West wall of parlor. June 1981.

Location of flue at wall

Door installation probably post 1915

Remove fireplace

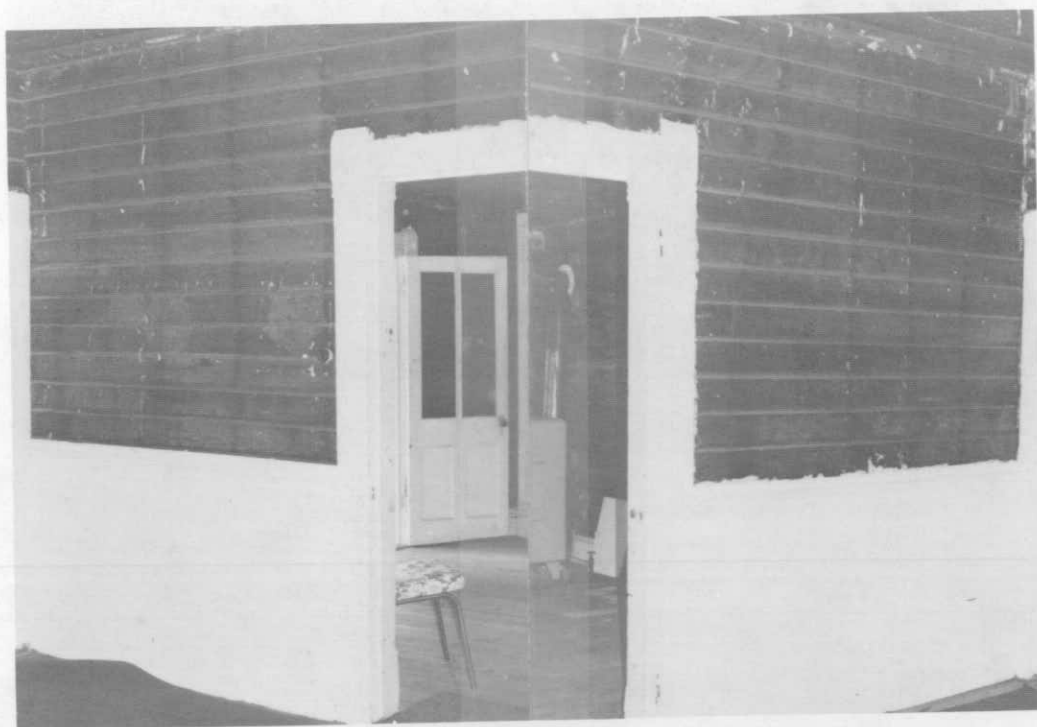
Photograph 37. West wall of kitchen. June 1981.

Location of original window

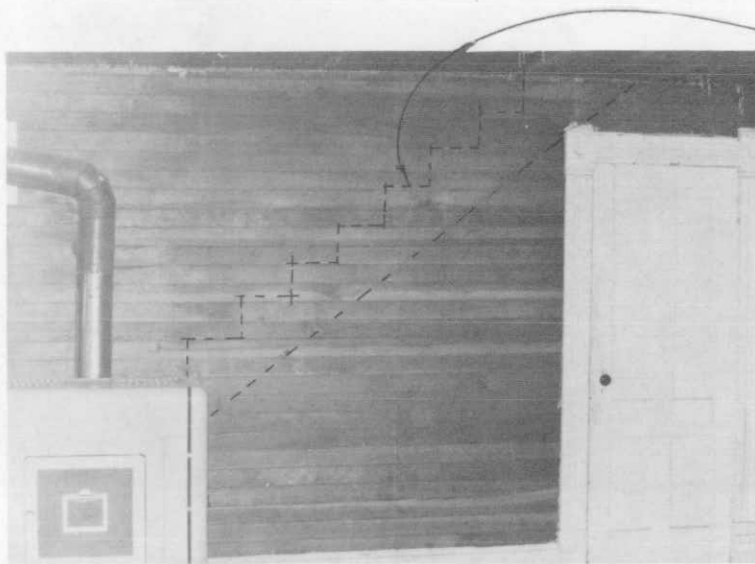
Photograph 42. Dining room, north wall.

Ghost outline of
former stairway

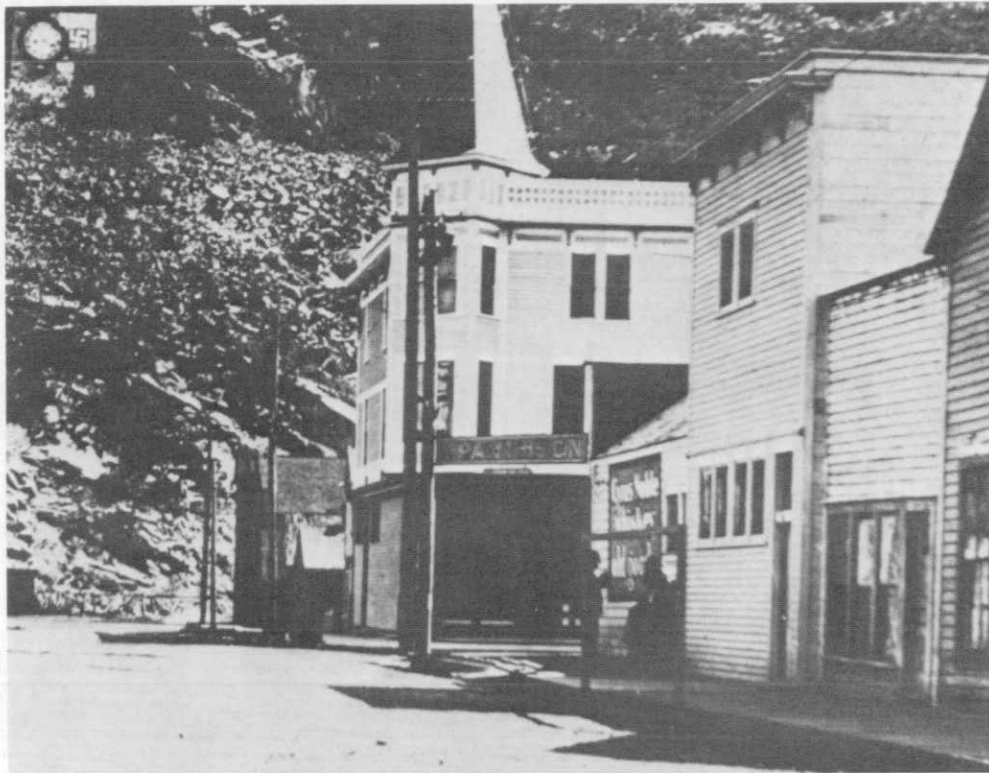
Photograph 13. Detail from a 1908 photograph. North elevation, two story west addition in place. Yukon Archives.

Restore doorway
and transom
(see photograph 13)
