HISTORIC STRUCTURE REPORTS
FOR TEN BUILDINGS

ADMINISTRATIVE, PHYSICAL HISTORY AND ANALYSIS SECTIONS
KLONDIKE GOLD RUSH NATIONAL HISTORICAL PARK
SKAGWAY, ALASKA

Prepared by
Catherine H. Blee, Archeologist,
Robert L. Spude, Historian
and
Paul C. Cloyd, E.I.T. Historical Architect

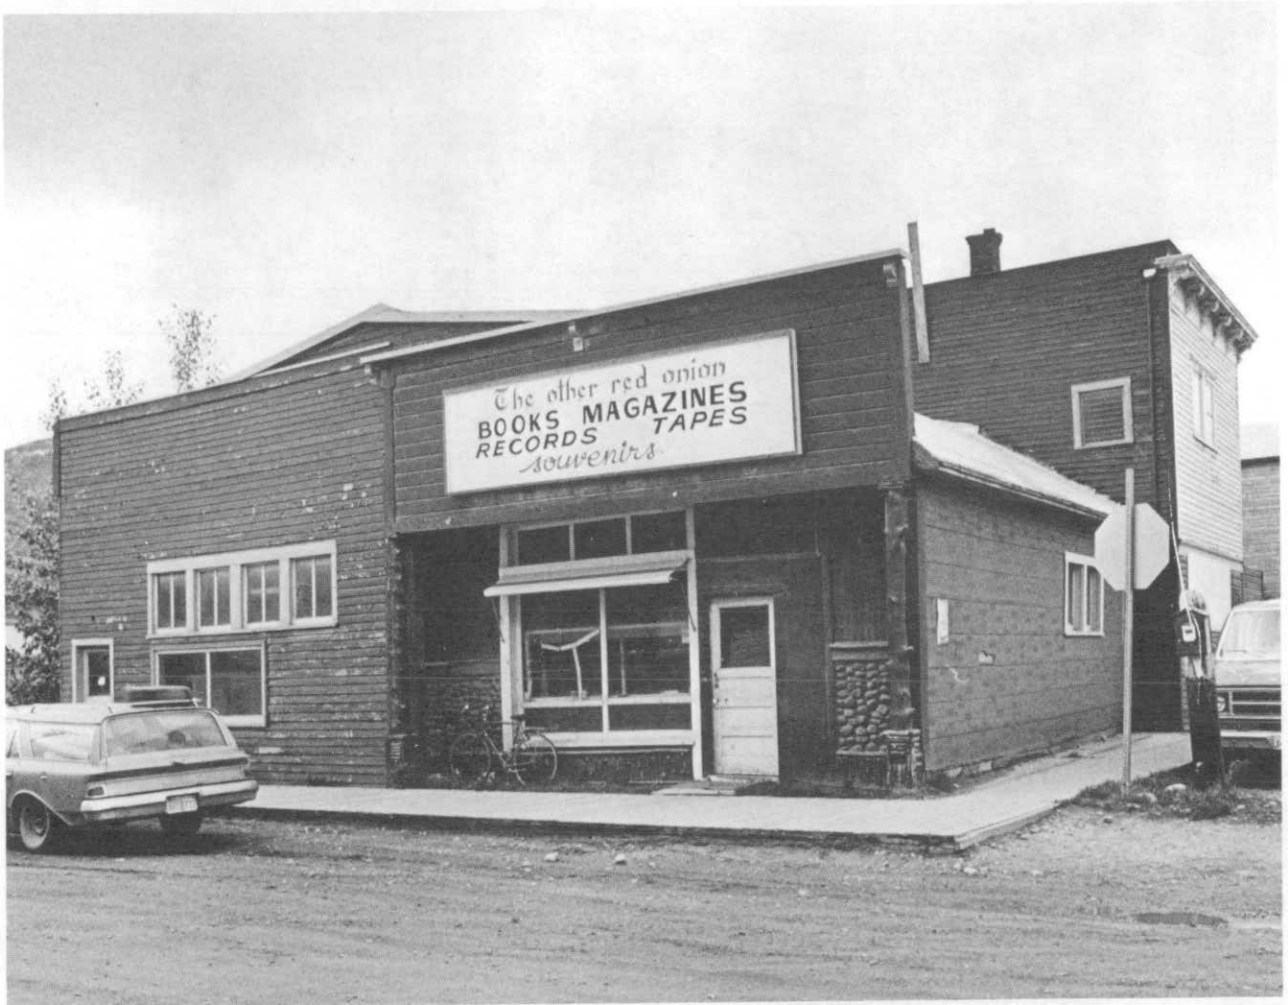
Photograph 20. 1979. View from northeast.

Remove ca. 1958
roof structure

Reopen double
doorway

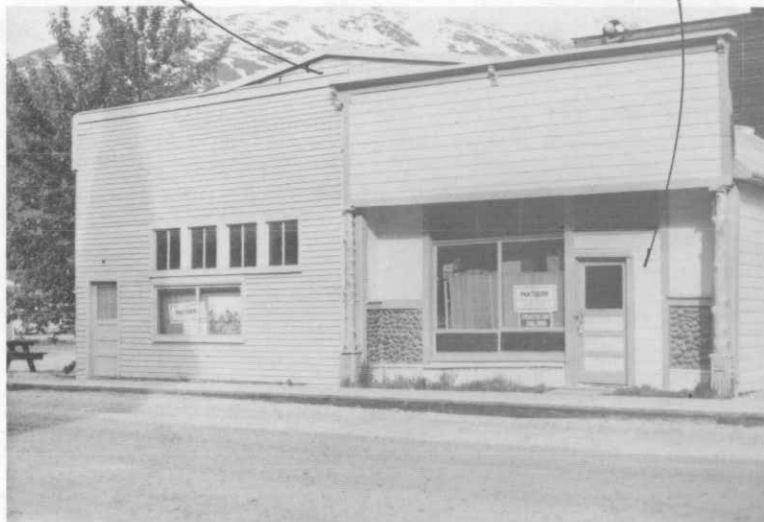
Photograph 21. East elevation.

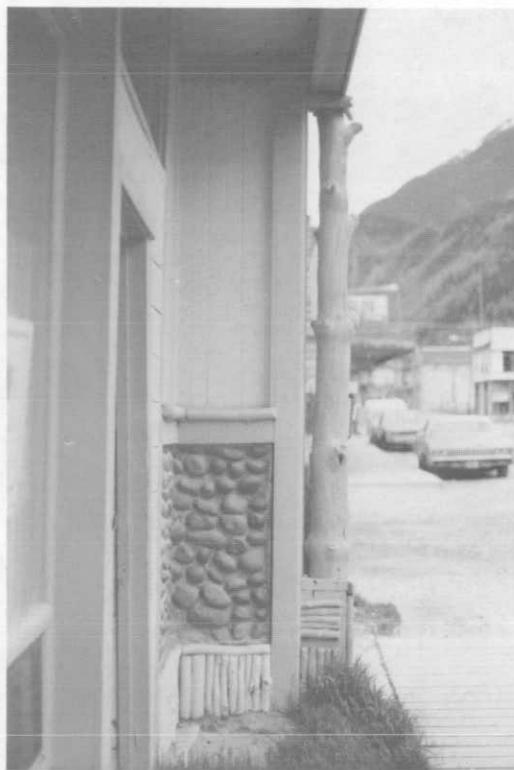
Photograph 22. East facade detail.

Remove
boards

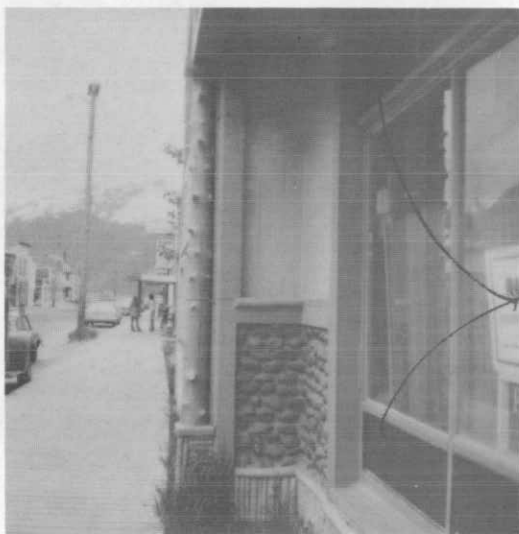
Photograph 23. East facade detail.

Replace trim piece

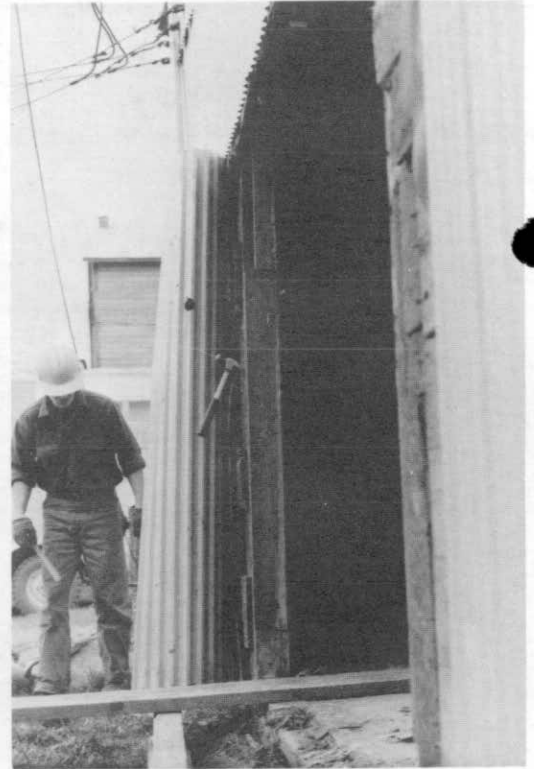
Photograph 26. Wall detail
indicates much scrap material
used in 1943 addition.

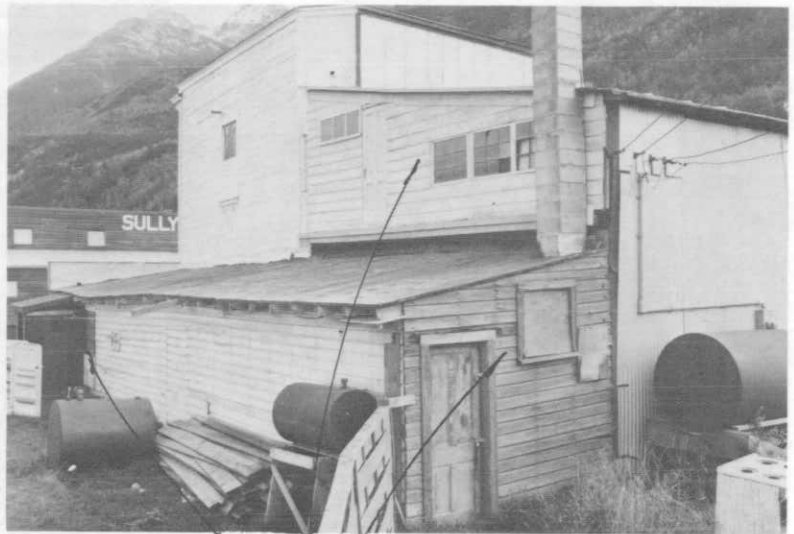
Photograph 28.
View from
southwest.

Restore window

Remove ca. 1958 and
1943 additions

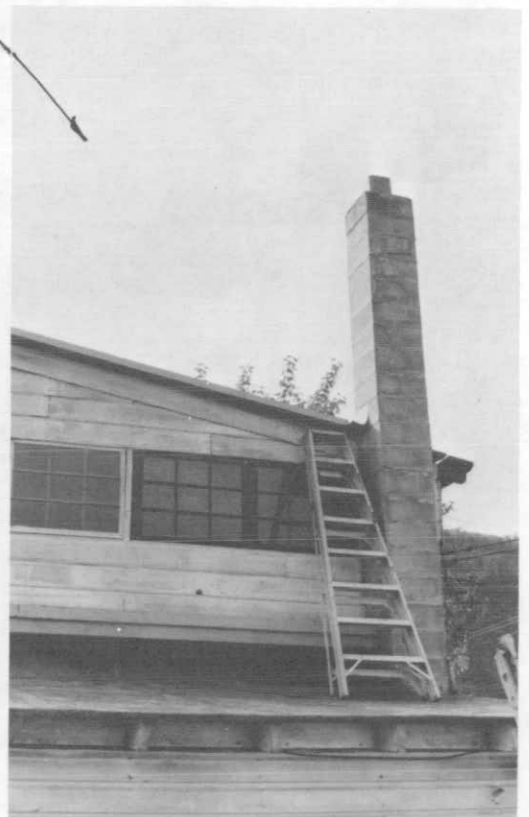
Photograph 30. West elevation detail.

Rehabilitate flashing, leader
box and downspout

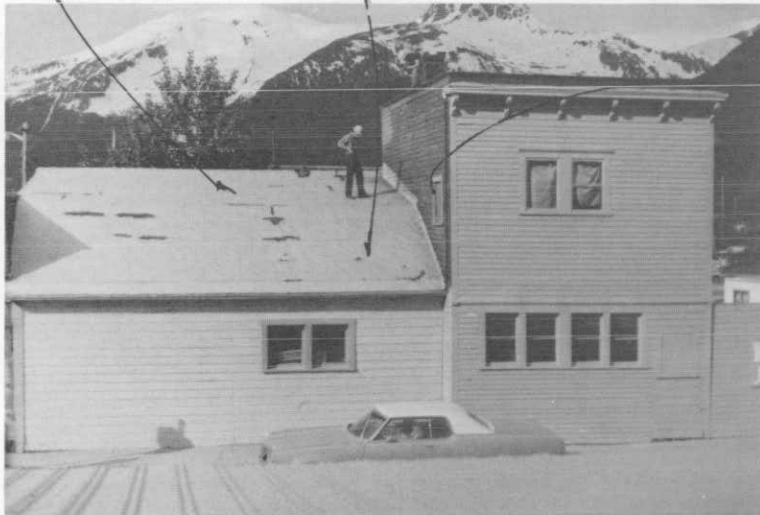
Photograph 35. North elevation.

Restore window with regular glazing

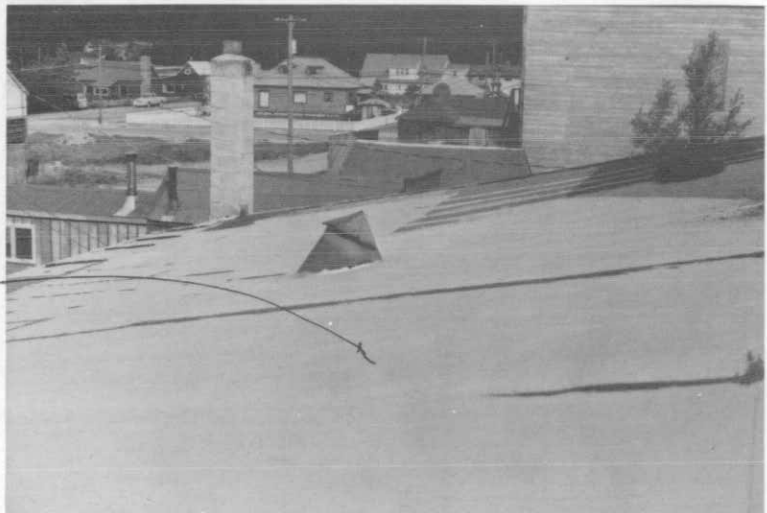
Photograph 36. Ca. 1958 roof, view toward southwest.

Remove entire 1958 roof structure

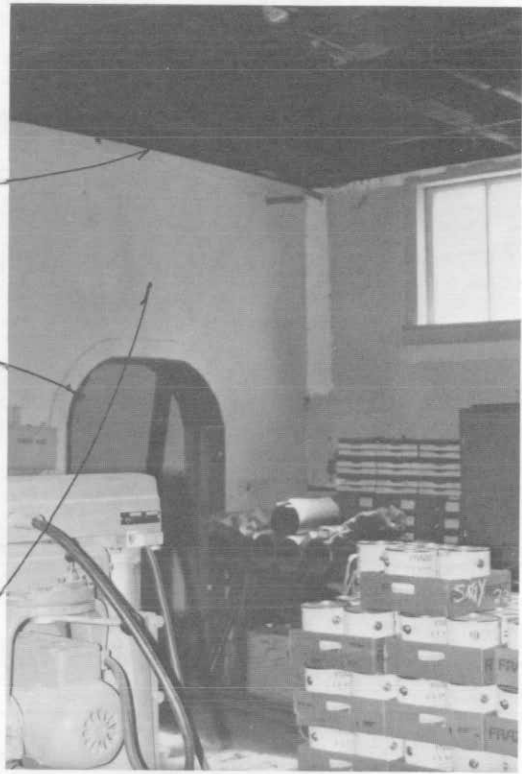
Photograph 40. Room 102,
northeast corner.

Remove false ceiling

Infill doorway

Remove interior finishes

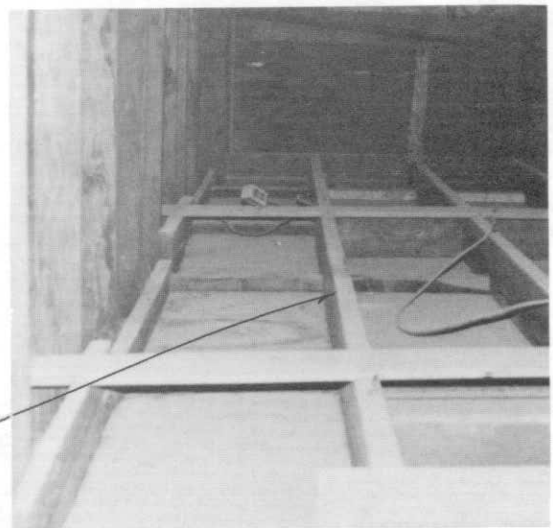
Photograph 43. East portion of attic
over room 102.

Ceiling structure removed, summer 1981.

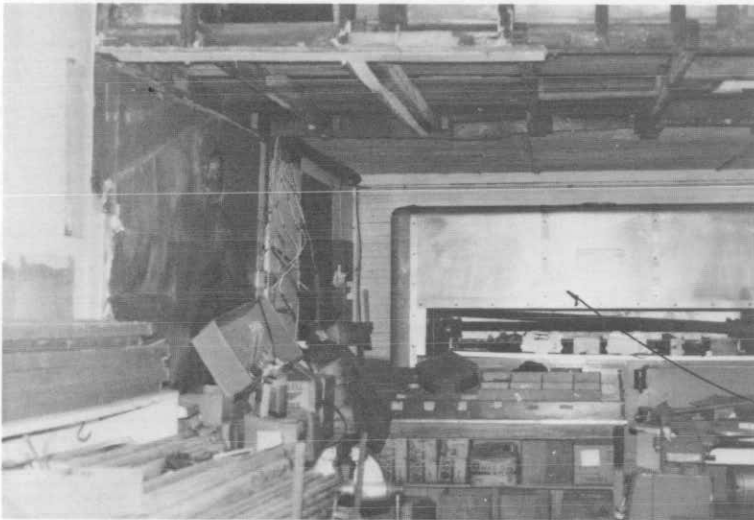
Photograph 46. Room 102, southwest corner.

Bakery oven removed, summer 1981.

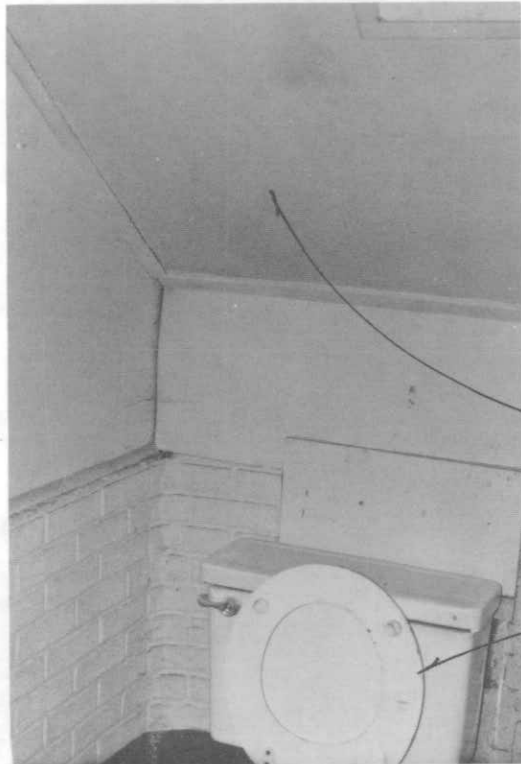
Photograph 49. Room 105, northwest corner.

Remove fiberboard

Rehabilitate or replace fixtures

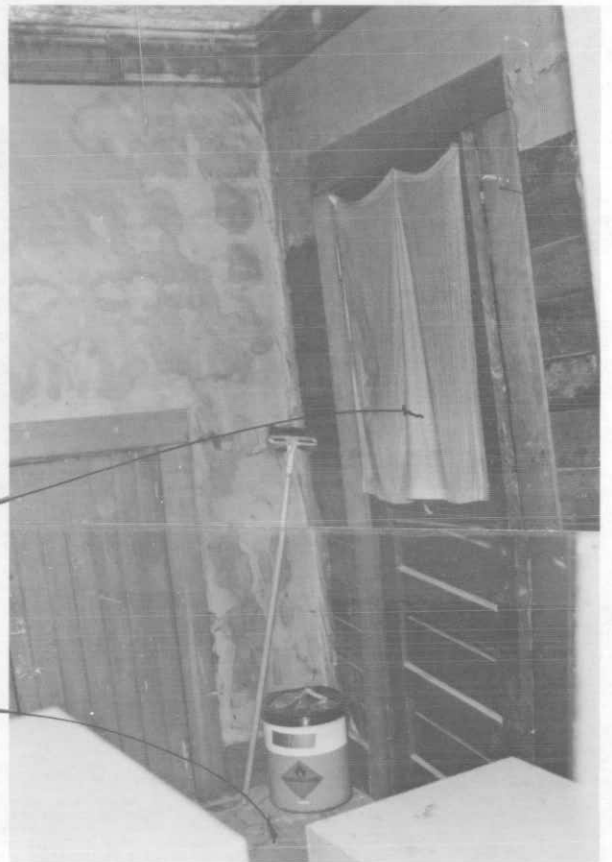
Photograph 63. Room 201.

Remove portions of wallpaper finishes to allow inspection and repair of water damage.

Retain wallpaper in place where no damage is evident

Rehabilitate and weatherstrip doorway

Clean and repair floor boards as required

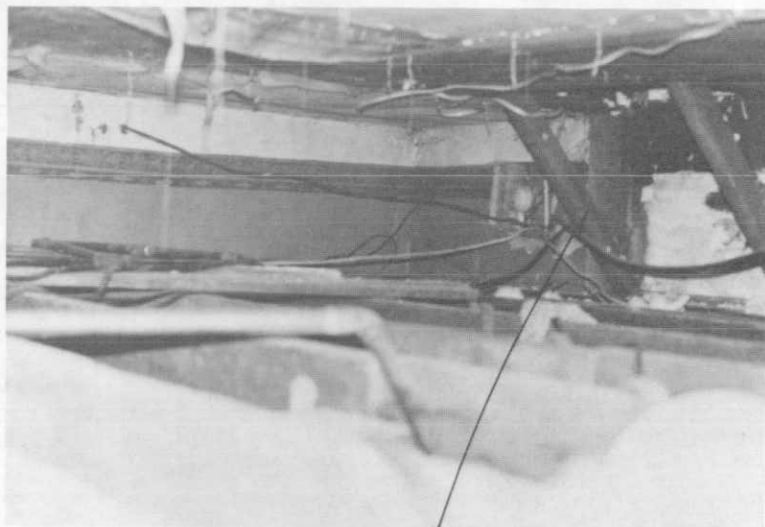
Photograph 34. Southwest corner.

Floor space between 1900 ceiling and 1937 ceiling

Historic wall and border papers

Install vapor retarder and batt insulation at exterior wall. Remove all excess wiring, pipes and debris.

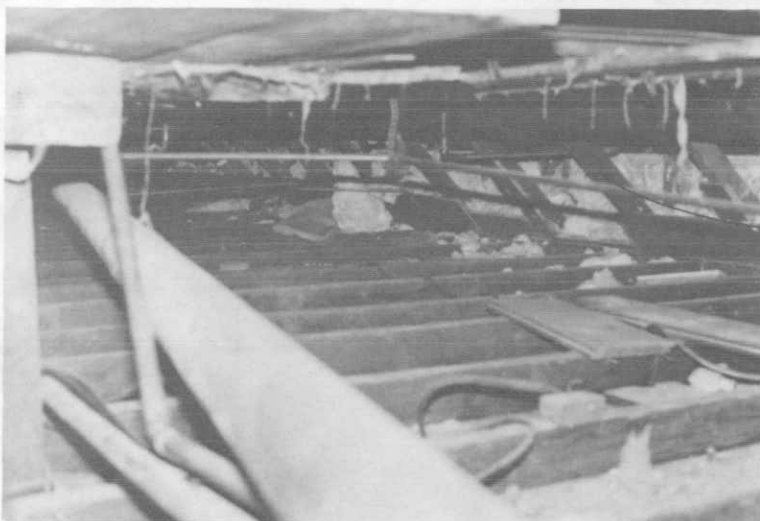
Photograph 35. Northeast portion.

Knee braces formed canted ceiling in original mission hall.

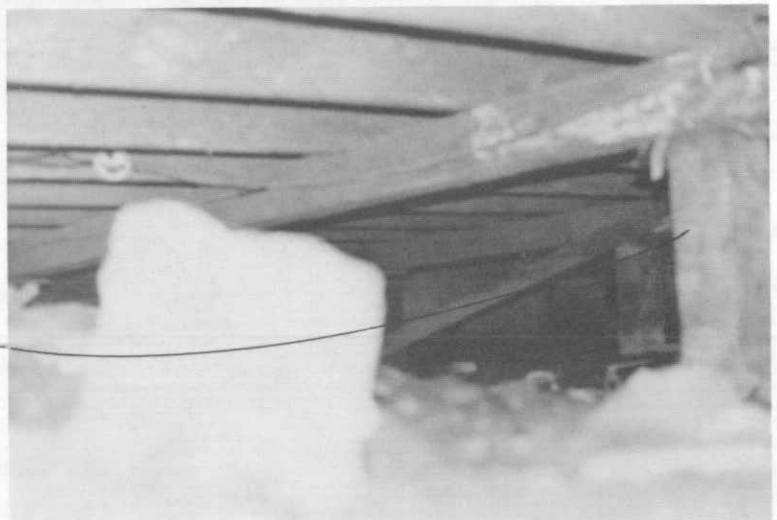
Photograph 39. Crawlspace, east portion.

Historic chimney location

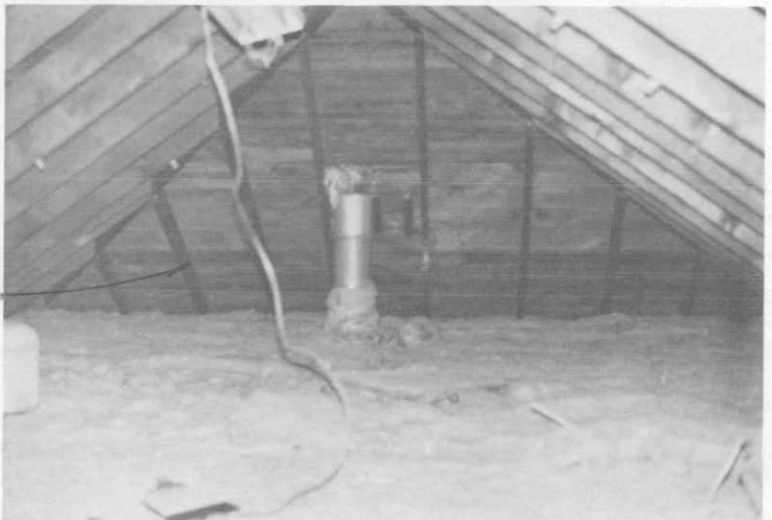
Photograph 42. North end.

Main attic

North and south rafters installed
in 1937 remodeling
