LINCOLN HOME  
INTERIOR AND EXTERIOR RESTORATION  
LINCOLN HOME NATIONAL HISTORIC SITE  
HISTORIC STRUCTURE REPORT  
ARCHITECTURAL DATA SECTION - VOLUME II

Architectural Data Section - Volume II of II

Lot 8 - Block 10  
Lincoln Home National Historic Site  
Springfield, Illinois

20 February 1984

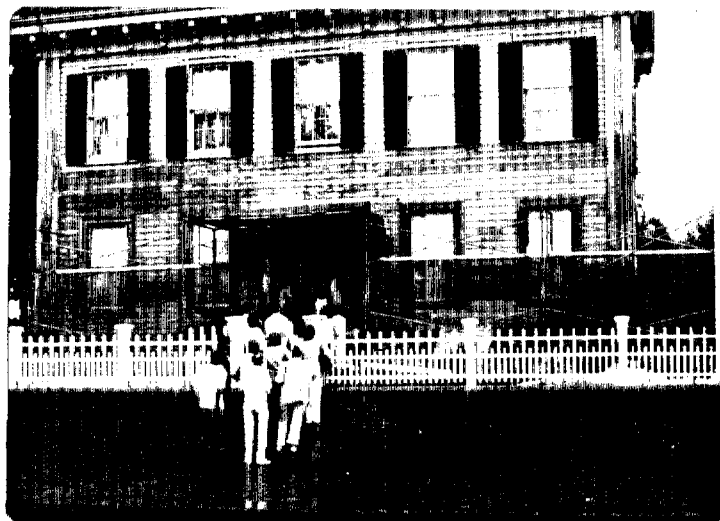
Photo showing view of paint removed, lower part of house, in front, west.

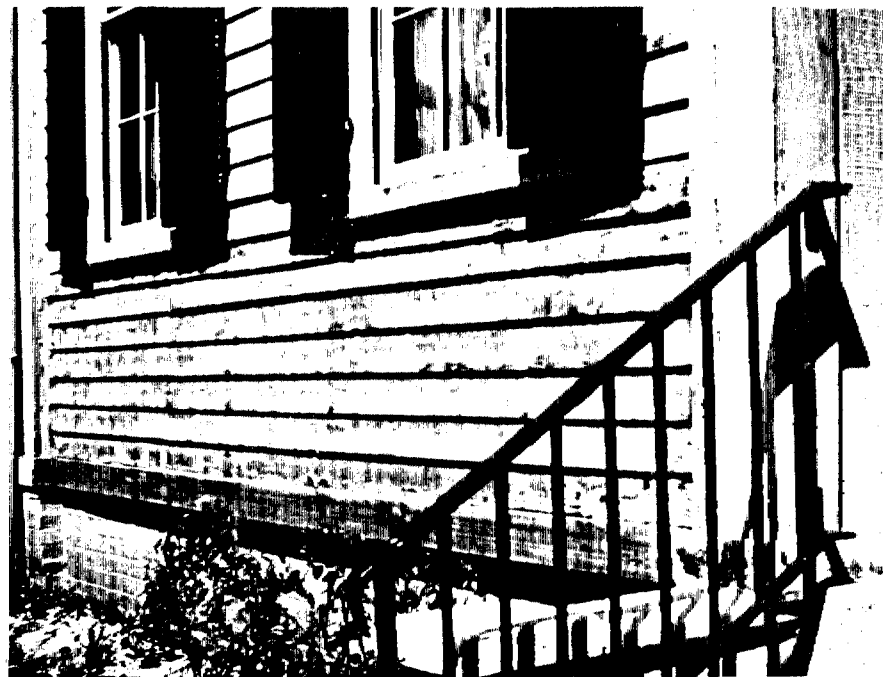
Photo showing deteriorated paint removed from windowsills down. This paint was removed with a paint scraper in front, west.

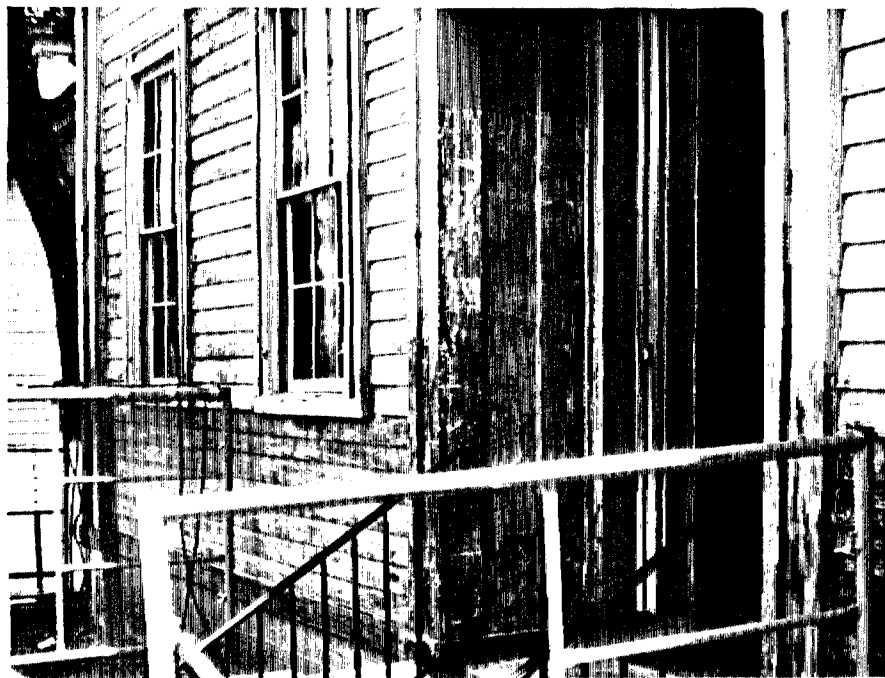
Photo showing part of the deteriorated paint removed,  
lower part in front, west.

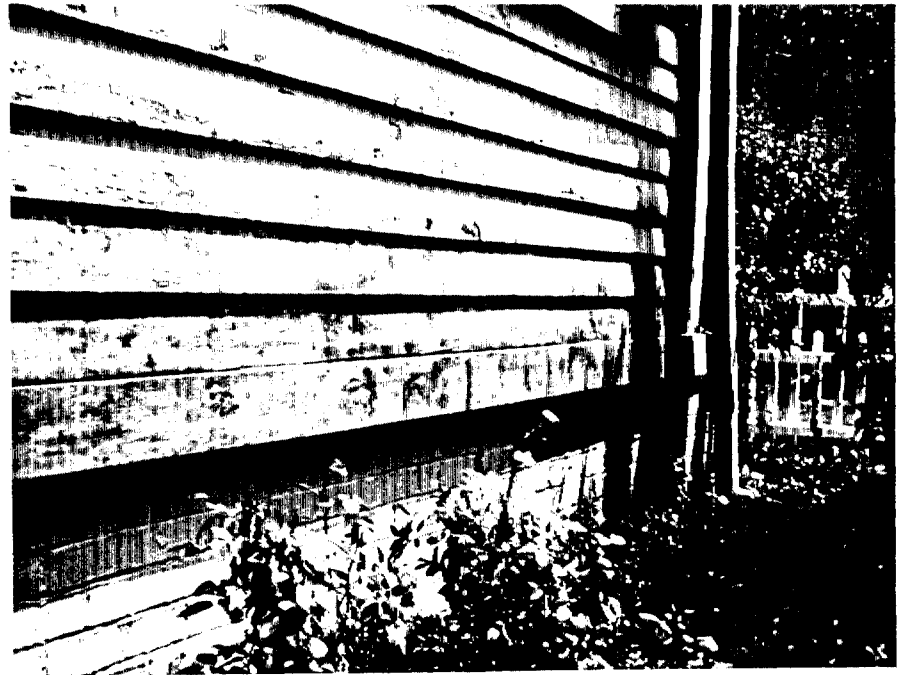
Photo showing part of paint removed from bottom boards in front, west.

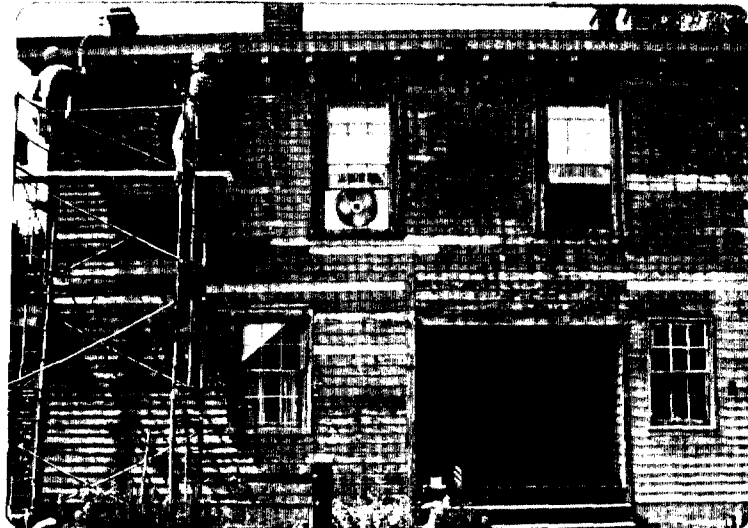
Photo showing workmen removing paint on back side, east.

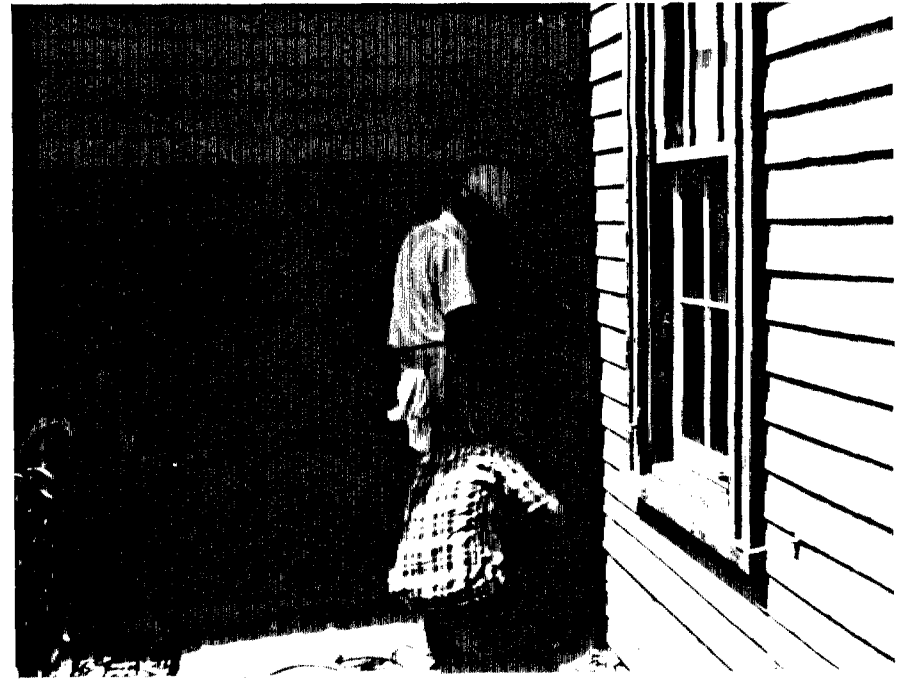
Photo showing workmen from roof of south porch. This was done with hydelectric paint remover.

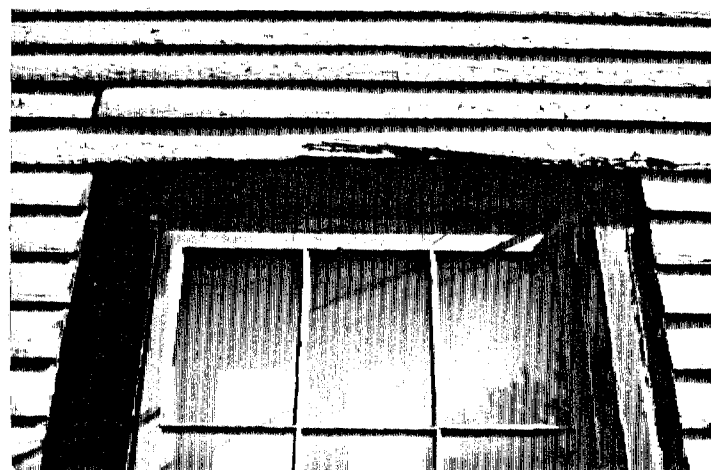
Photo showing trim removed from window jamb. Part of this trim was deteriorated. Also showing deteriorated siding, south side.

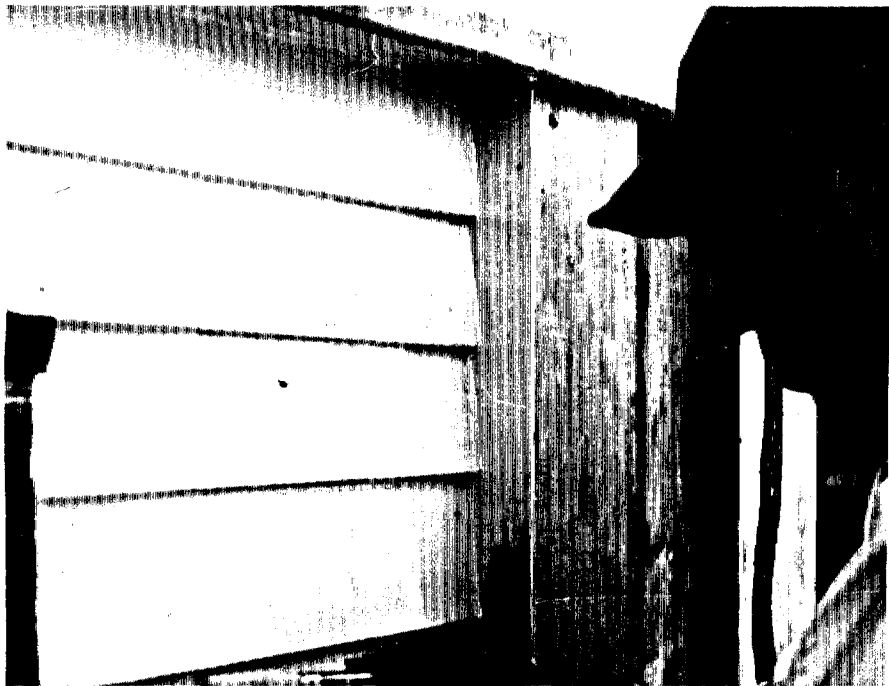
Photo showing primer coat being applied on southwest corner at the top of wall. Porter Paint No. 565-SP 29341 primer tinted toward finish coat color. Munsell Color No. 7.5 YR 8/3, made from blending 8/2 and 8/4.

NOTE: 1 pint boiled linseed oil and 1/2 pint paint thinner per gallon was added by the manufacturer. Also before applying additional two pints of Penetrol wood treatment was added per gallon to the primer only.

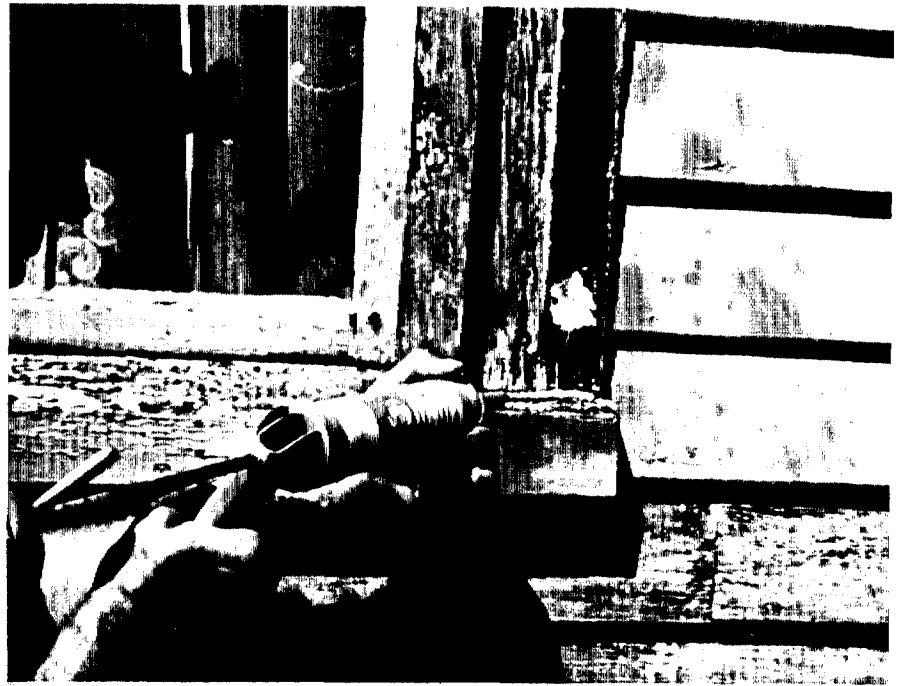
Photo showing applying caulking Tremco (Mono Caulking) Spec. USTT S 00230. This was used on all small open joints (cracks) at end of boards (butt) as a filler on south side.

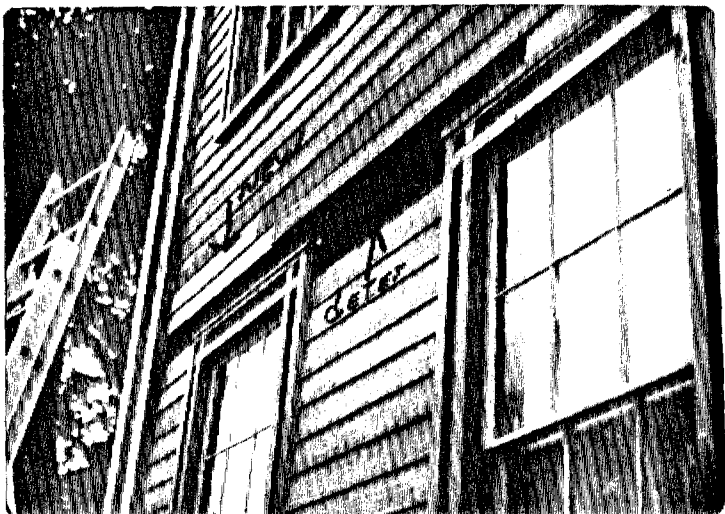
Photo showing deteriorated material removed and new replaced. Arrow showing this.

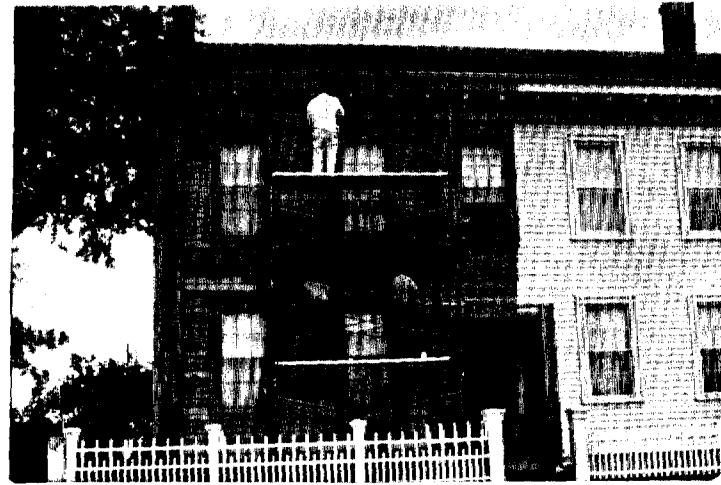
Photo showing applying primer coat paint on top, and workmen replacing deteriorated material. Arrow showing boards that have been replaced on front (west).

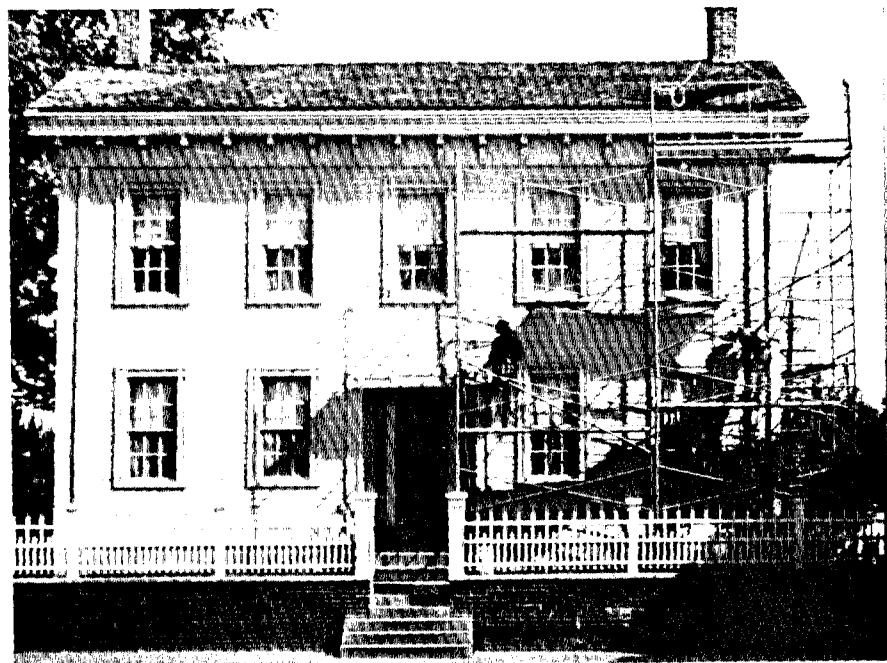
Photo showing primer paint on front (west).

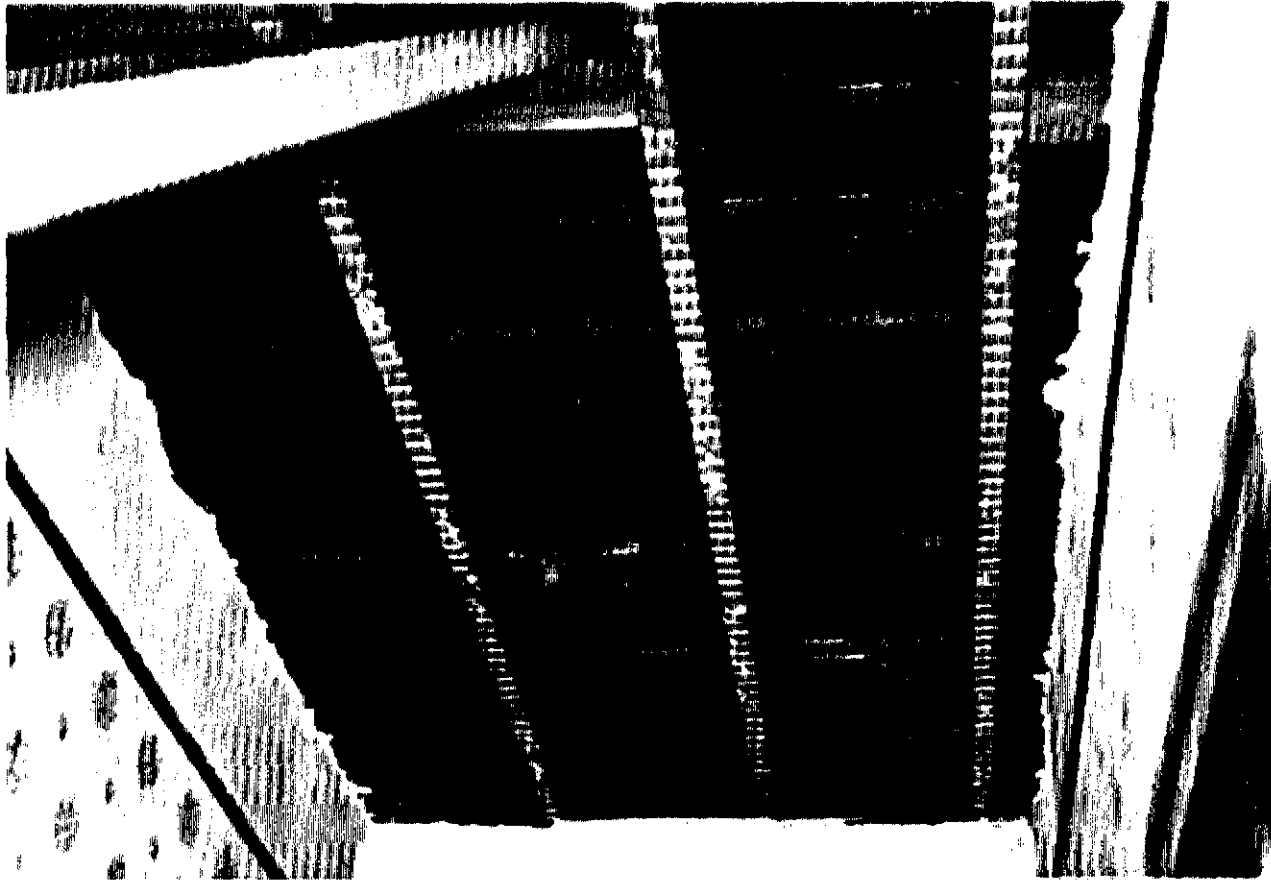
H - 3

Second floor, front hall ceiling removed, exposing ceiling joists,  
roof rafters and roof sheathing

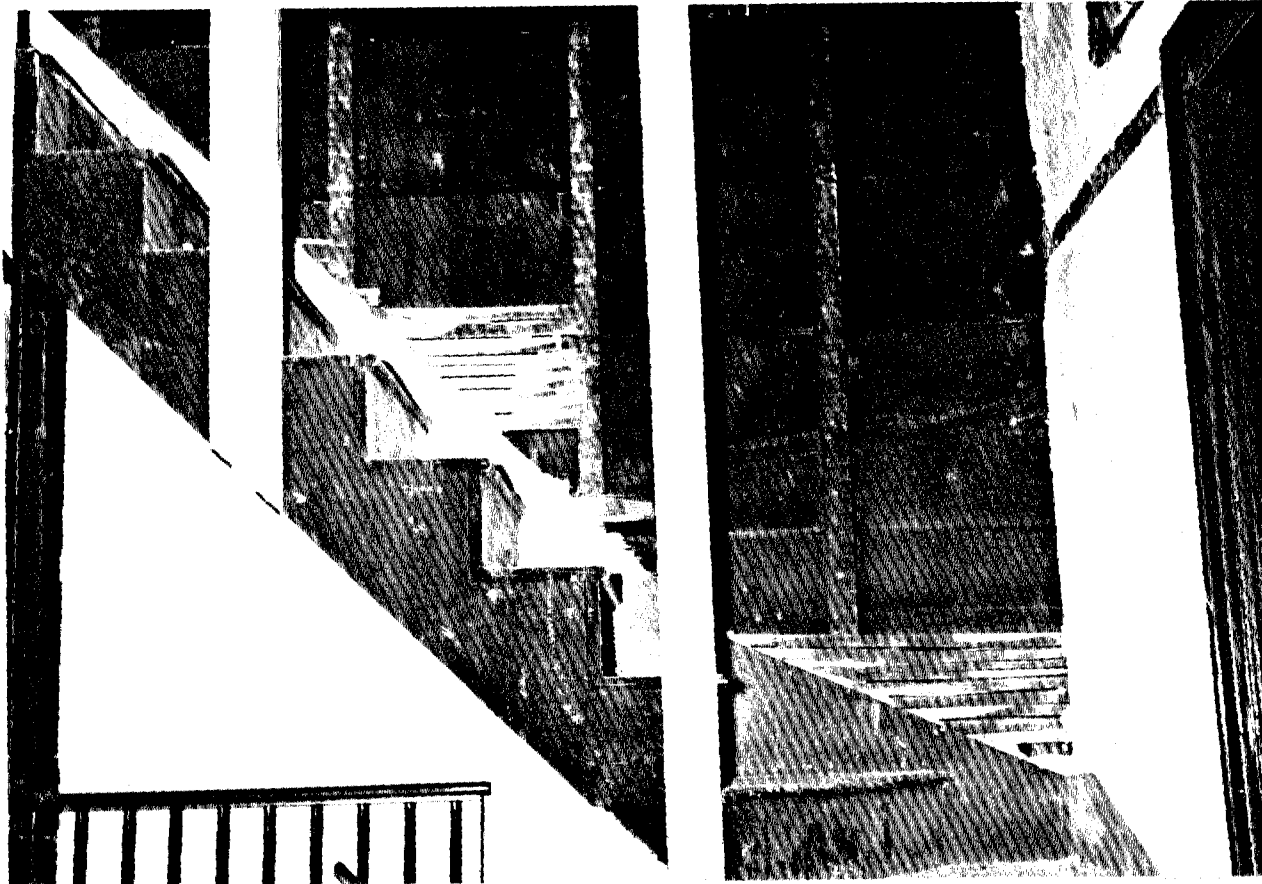
H - 14

First floor, back stairs, view from kitchen; wall partly removed, exposing the wide sheathing constituting the east wall.

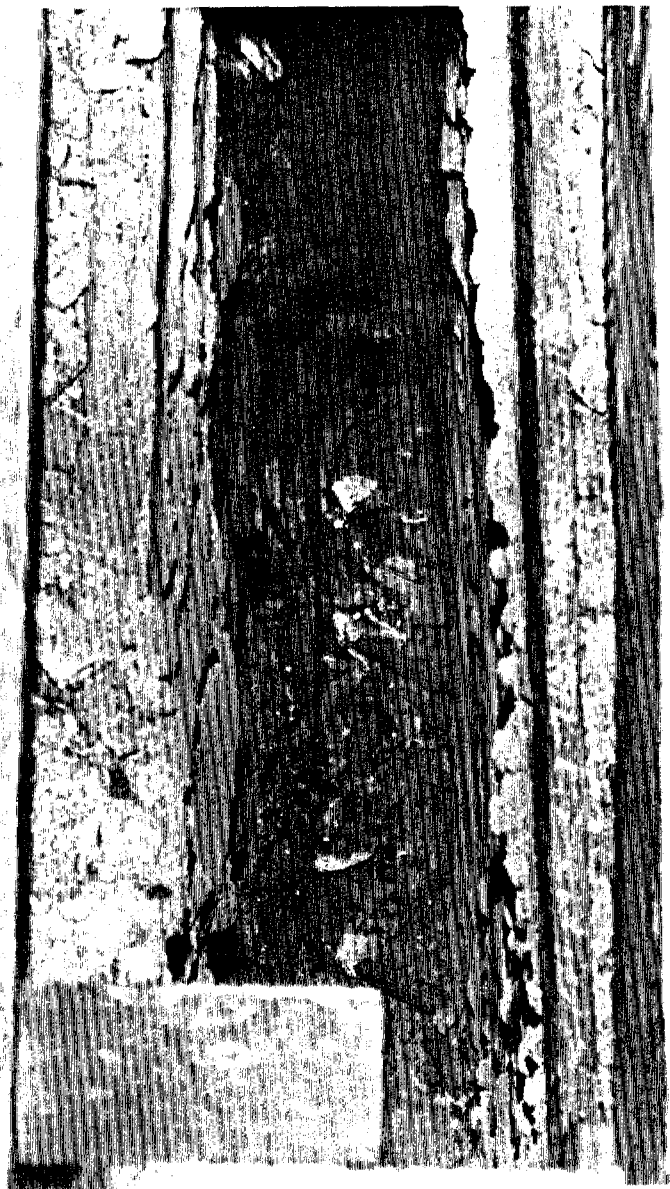
View down, into the cavity between  
the walls above the doorway on the  
first floor, looking at the lintel  
which supports the center stud

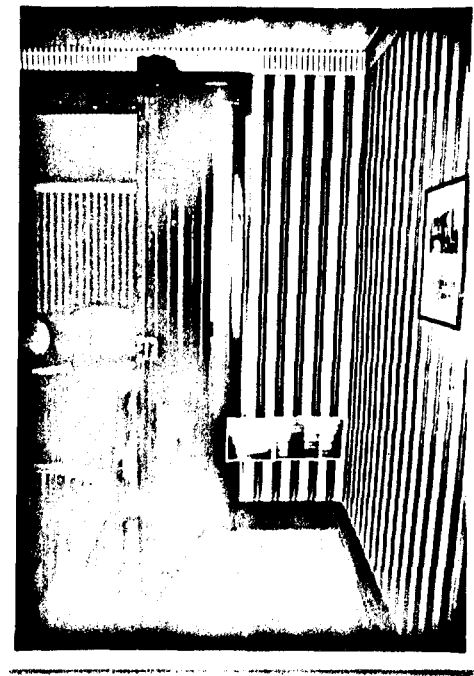
29. Front Parlor, East Wall (101)

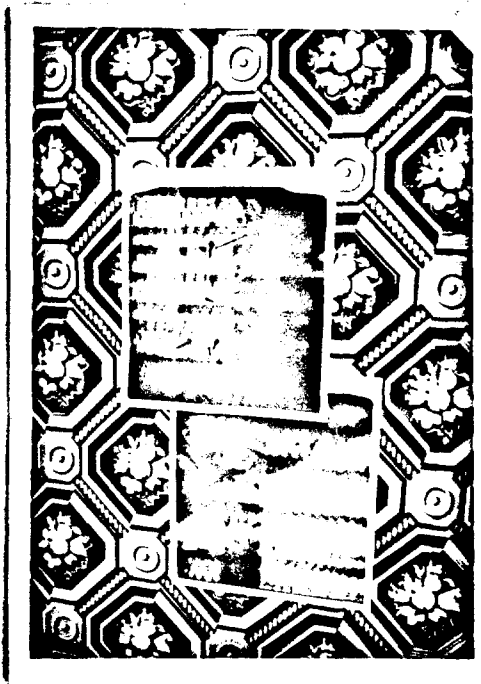
22. Close-up of Stud-blocking

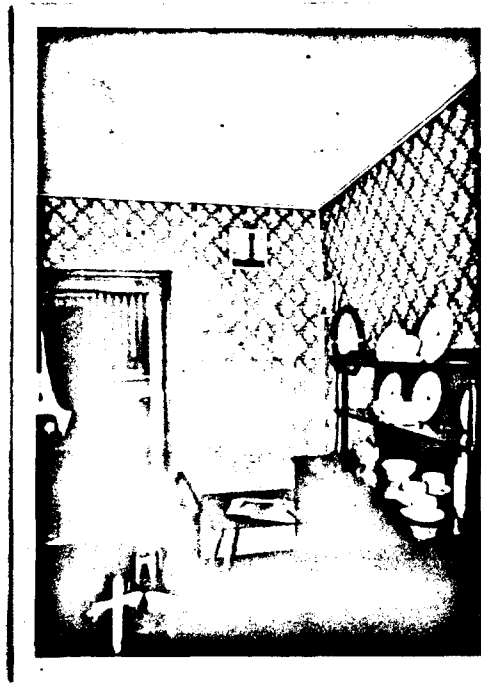
23. Dining Room, North-east corner (107)

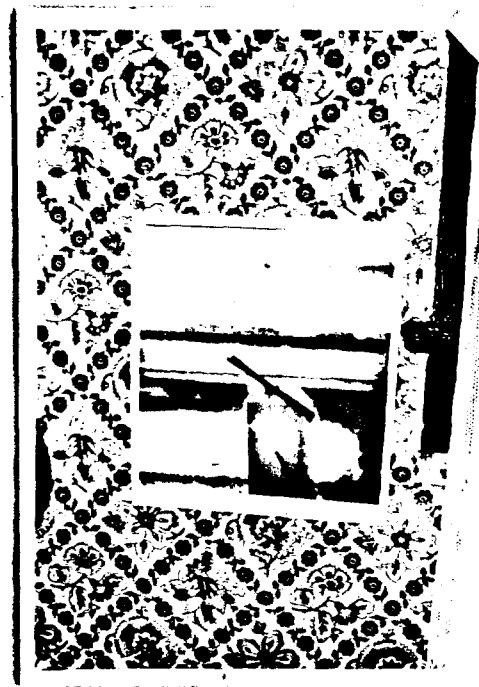
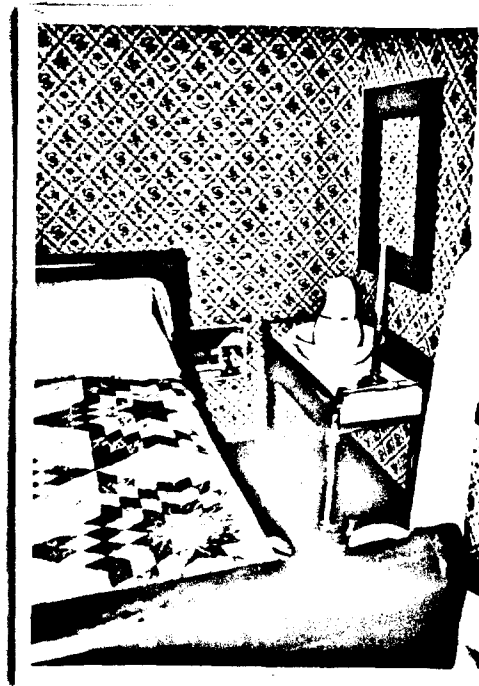
18. Plate framing, East Wall,  
Boys Bedroom (208)

16. Plate framing, South-west corner, Boys Bedroom (208)

17. Plate framing, East Wall, Boys Bedroom (208)

14. Plate framing, South-west  
corner, Boys Bedroom (208)

15. Plate framing, South-west  
corner, Boys Bedroom (208)

Boys Bedroom (208) (X-rays LH 22, 23, 24). The existence of the original 3" wall plate was found at 2'-0" ± above the second floor level (Figures 14, 15, 16, 17, 18). The existence of a wind-brace at a 45° angle was found in the east wall of this room, extending from the plate to the corner (Figures 17, 18).

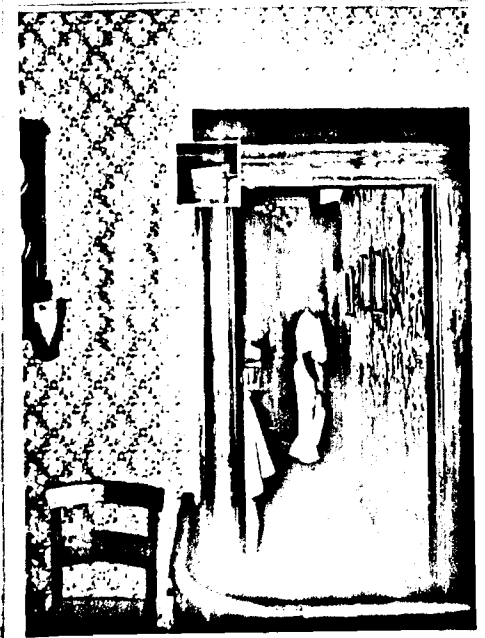
40. Dining Room, West wall at  
door jamb (107)
